Inspection report

Client: Council of the Isles of Scilly

Site: Porthmellon Incinerator, Isles of Scilly

Chimney: Incinerator stack

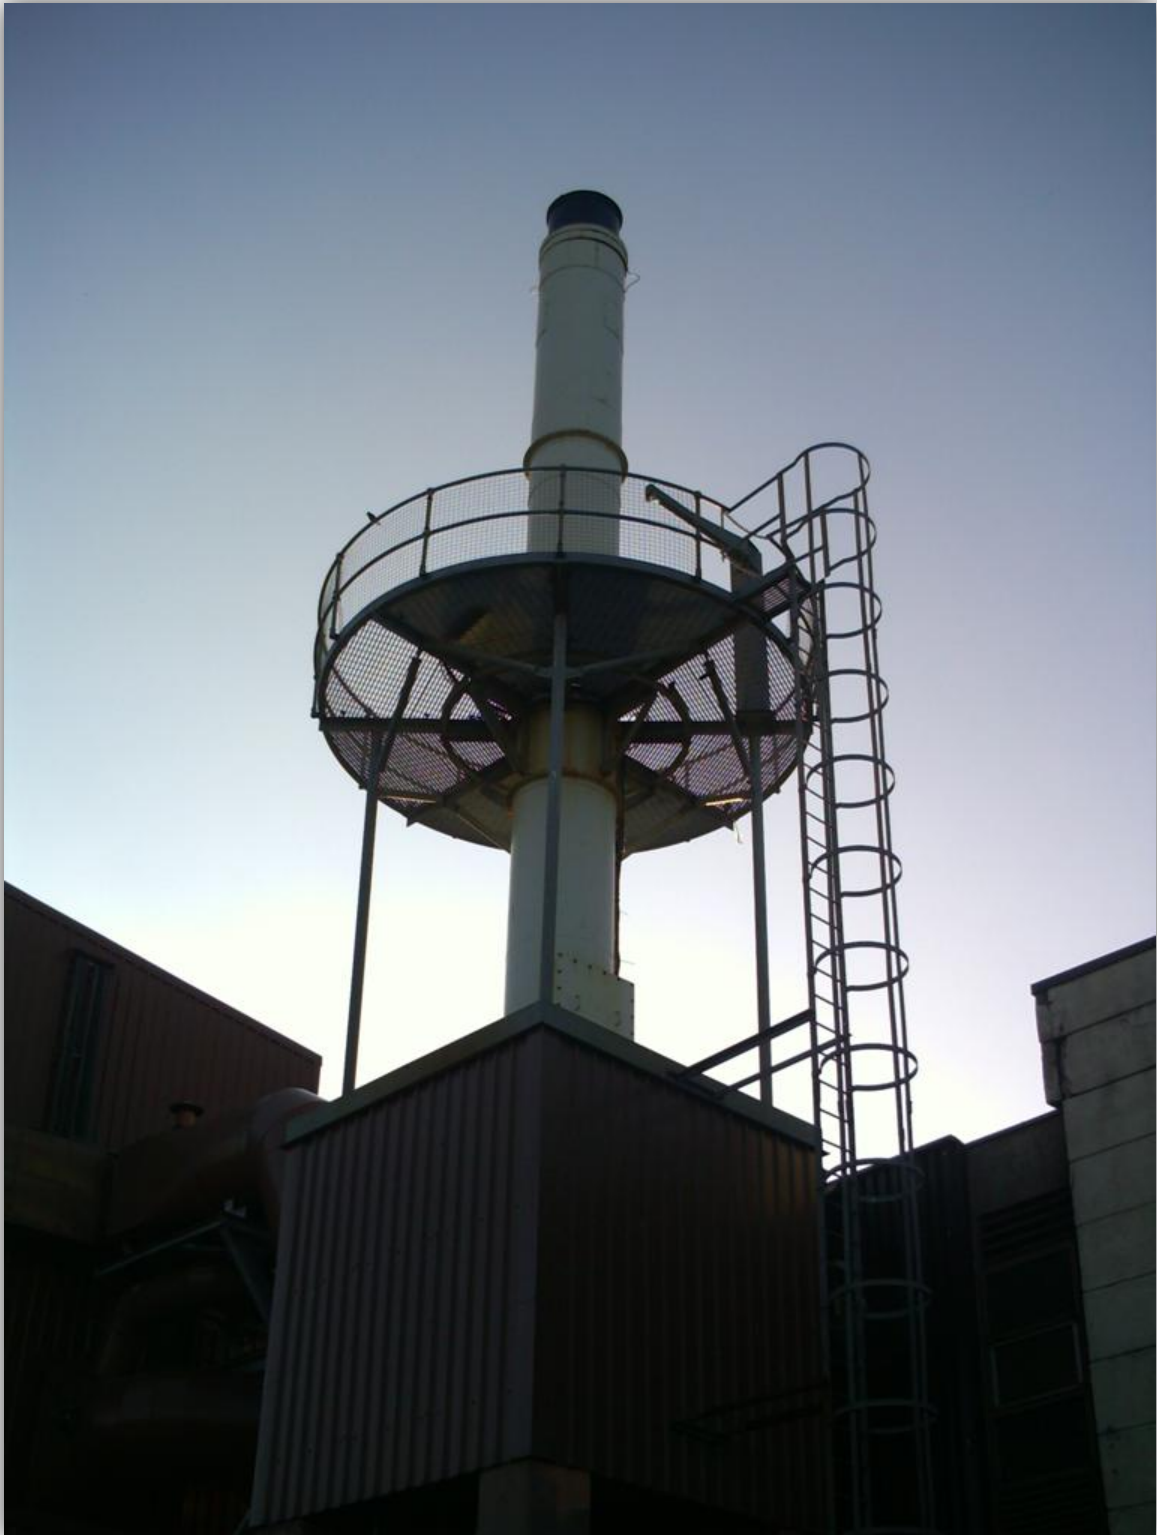
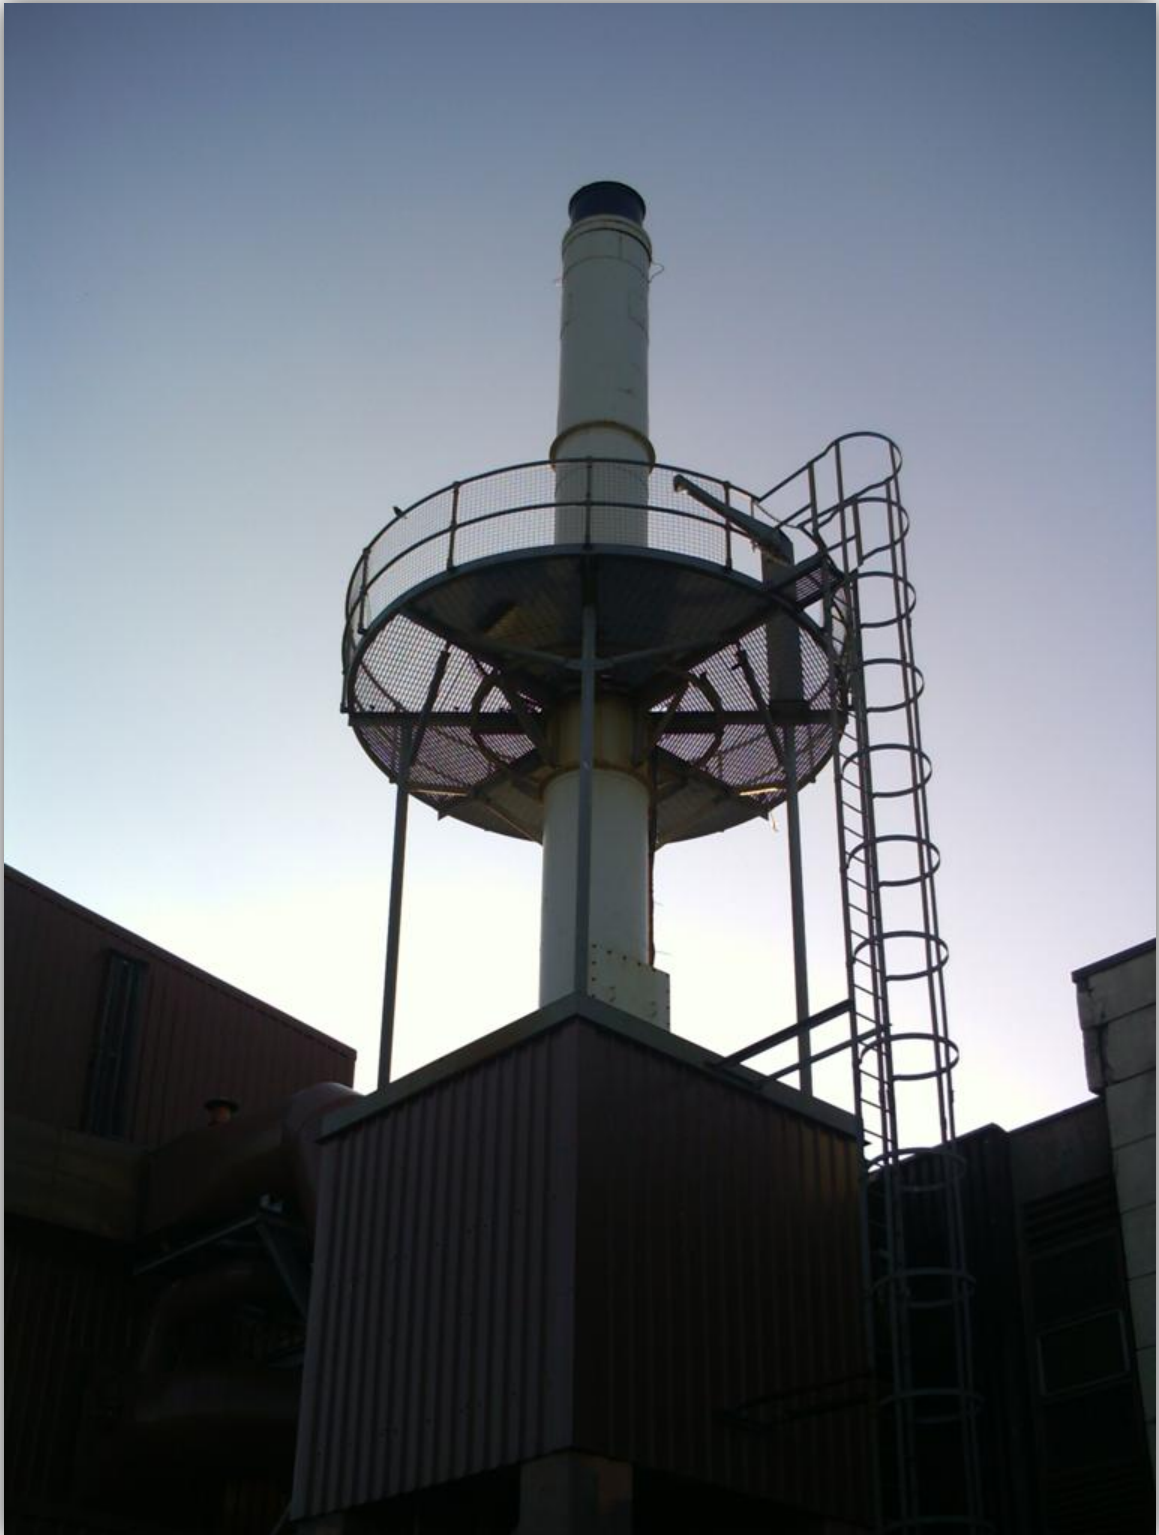
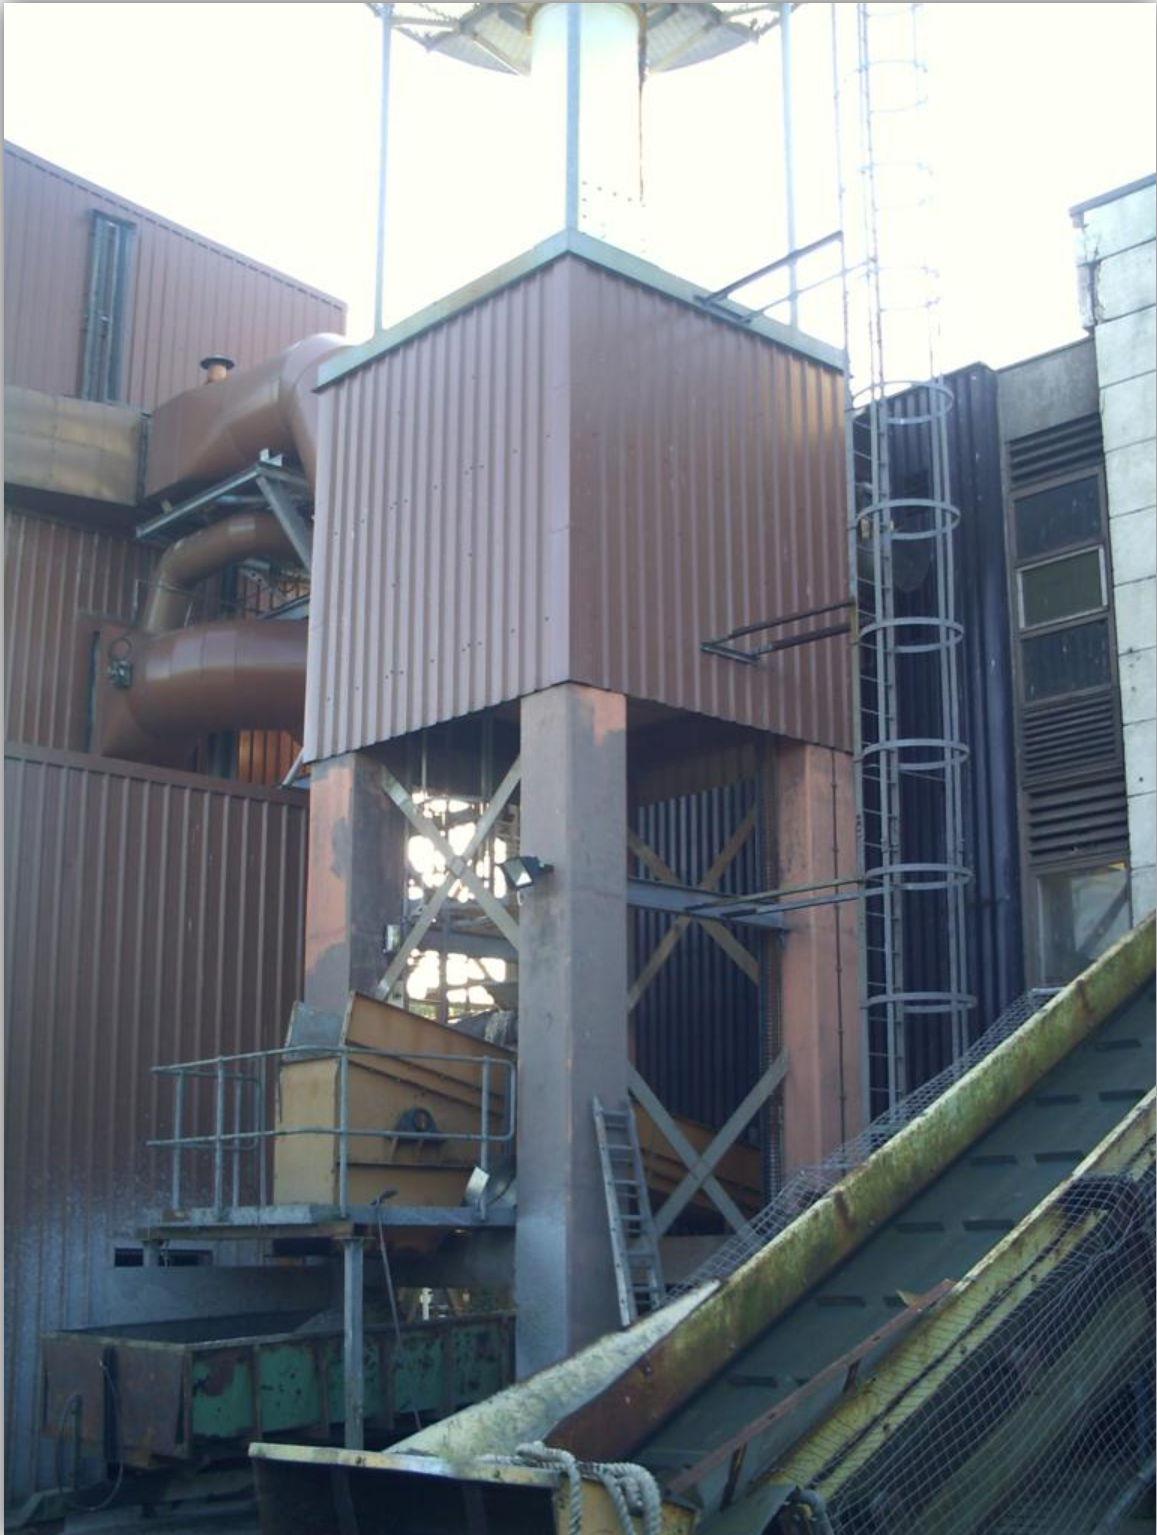
Report	Comment	Photo No.
There was no access system fitted to the chimney above gantry level.	BS EN 13084-1:2000 Section 4.8.1 - Chimneys of more than 5 metres height above a structurally accessible level (for example a roof of an adjacent building) shall be provided with an access system from this level to the top with the purpose of allowing inspection and maintenance.	001 - 002
A caged access ladder provided access to the chimney at gantry level.	HSE's research report 258 "Preliminary investigation into the fall arresting effectiveness of ladder safety hoops" - "In three of the tests the test dummy fell six metres down the cage onto the floor, after first striking the cage several times. The final impacts were around 23g, which in real life would be fatally injurious. In four of the tests the test dummy managed to jam in the cage but at levels of impact that would cause significant injury. In such a case rescue would be extremely difficult." "RR258 concluded that hooped ladders could not stop a fall positively, and unless they could be modified in some way to demonstrate that they could, their use should be abandoned."	001 - 003

The safety chains fitted to the summit of the caged ladder were found to be insufficient.	BS 4211:2005 - Section 6 – Passage from the ladder to an arrival area, shall be protected by a full depth self closing gate.

Report	Comment	Photo No.
There was no permanent fall arrest system fitted	The Work at Height Regulations 2005 – Section 6.3 – Where work is carried out at height, every employer shall take suitable and sufficient measures to prevent, so far as is reasonably practicable, any person falling from a distance liable to cause personal injury.	001 - 003

<i>Section(s)</i>	<i>No.</i>	<i>Recommendation</i>	<i>Action</i>
Chimney access	1	Install a permanent ladder fall arrest system to EN 353-1, to comply with BS EN 13084-1:2000 Section 4.8.1. The provision of access.	
	2	Remove the caged ladder hoops and straps, install a fall arrest rail and accessories to facilitate safe access and rescue.	
	3	Supply and fit a full depth self closing gate to the summit of the caged ladder.	
Chimney information plate	4	Obtain all the relevant information, manufacture and install a chimney information plate to comply with BS 4076:1989 Section 4.6.	
Chimney windshield	5	Prepare and paint chimney windshield throughout its full height.	
	6	Prepare and paint chimney smokeband.	
Chimney flanges	7	Prepare and paint chimney flanges, nuts, bolts and washers.	
Chimney cope ring	8	Prepare and paint chimney cope ring.	
Lightning conductor system		See attached test certificate.

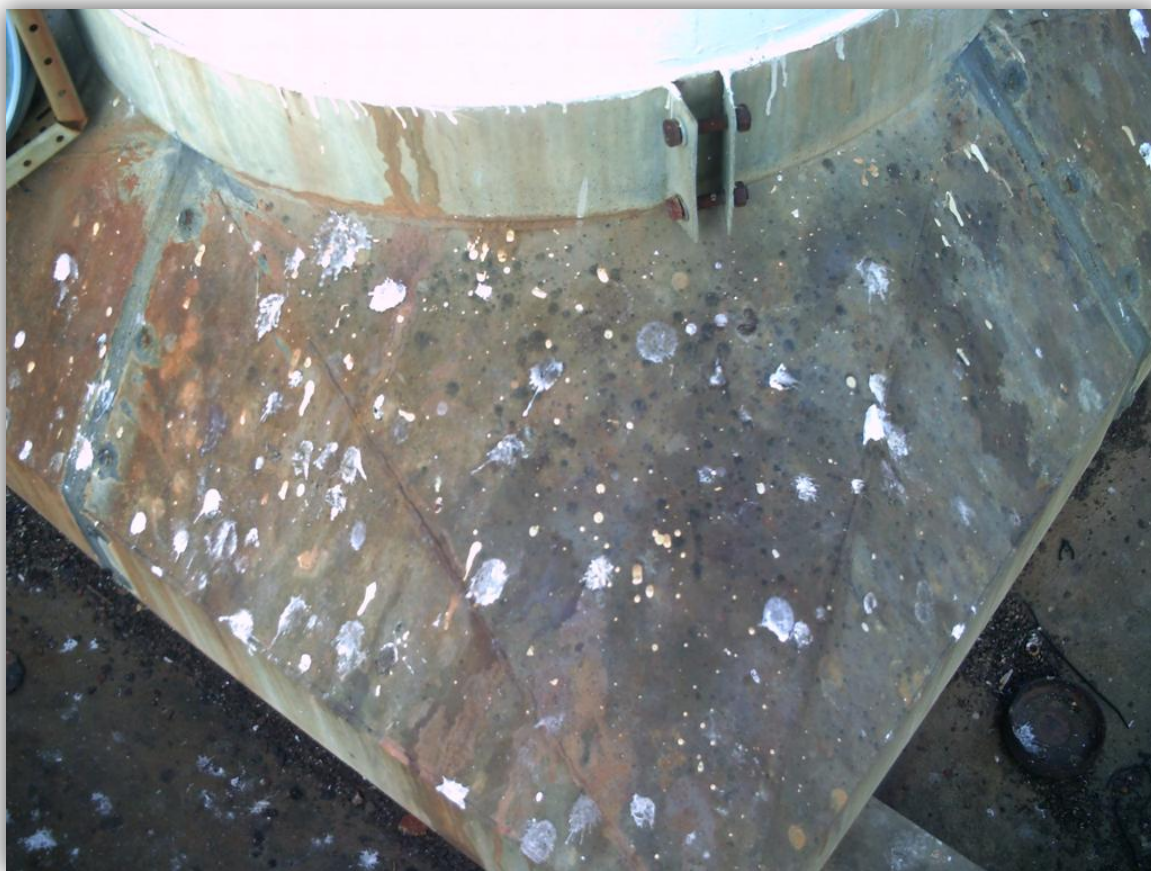
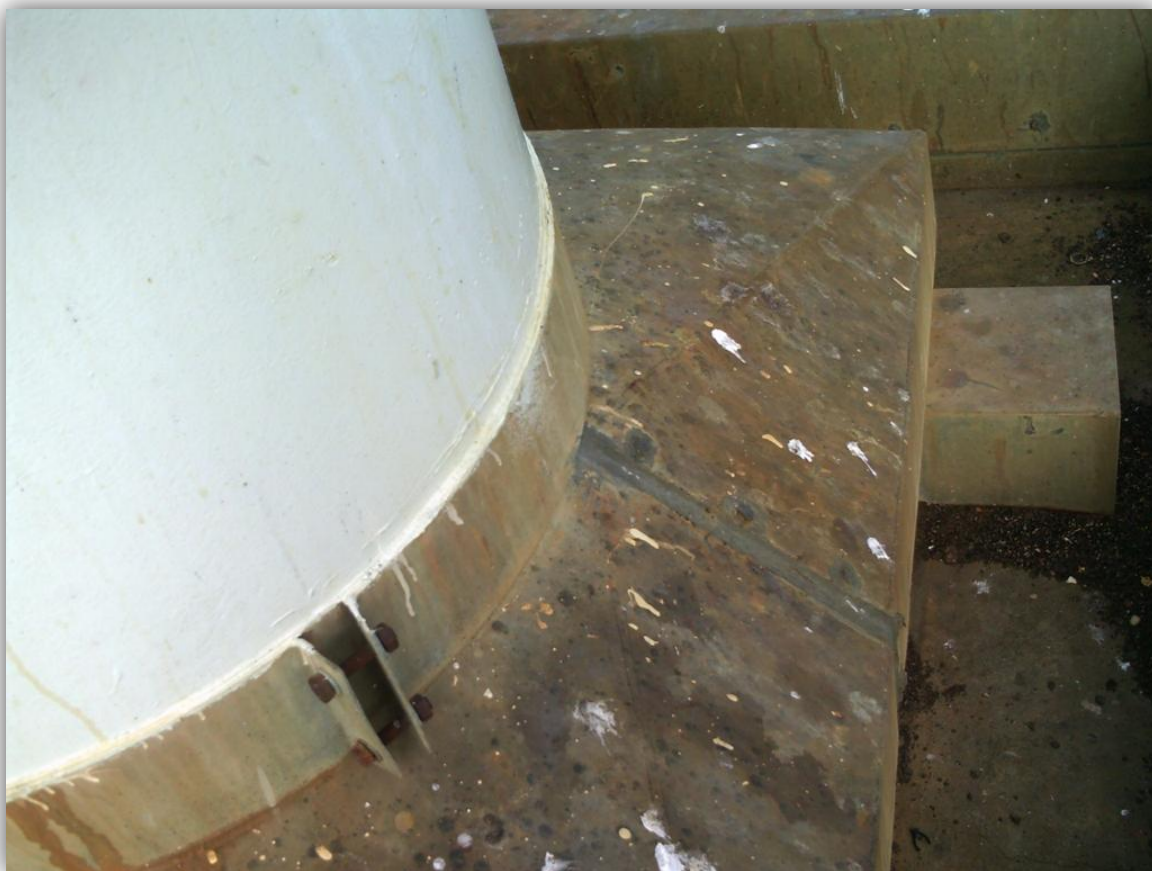
<i>Report</i>	<i>Comment</i>	<i>Photo No.</i>
The weather shroud covering the foundation of the chimney was found be in reasonable condition, however heavy staining was in evidence.		004 - 005

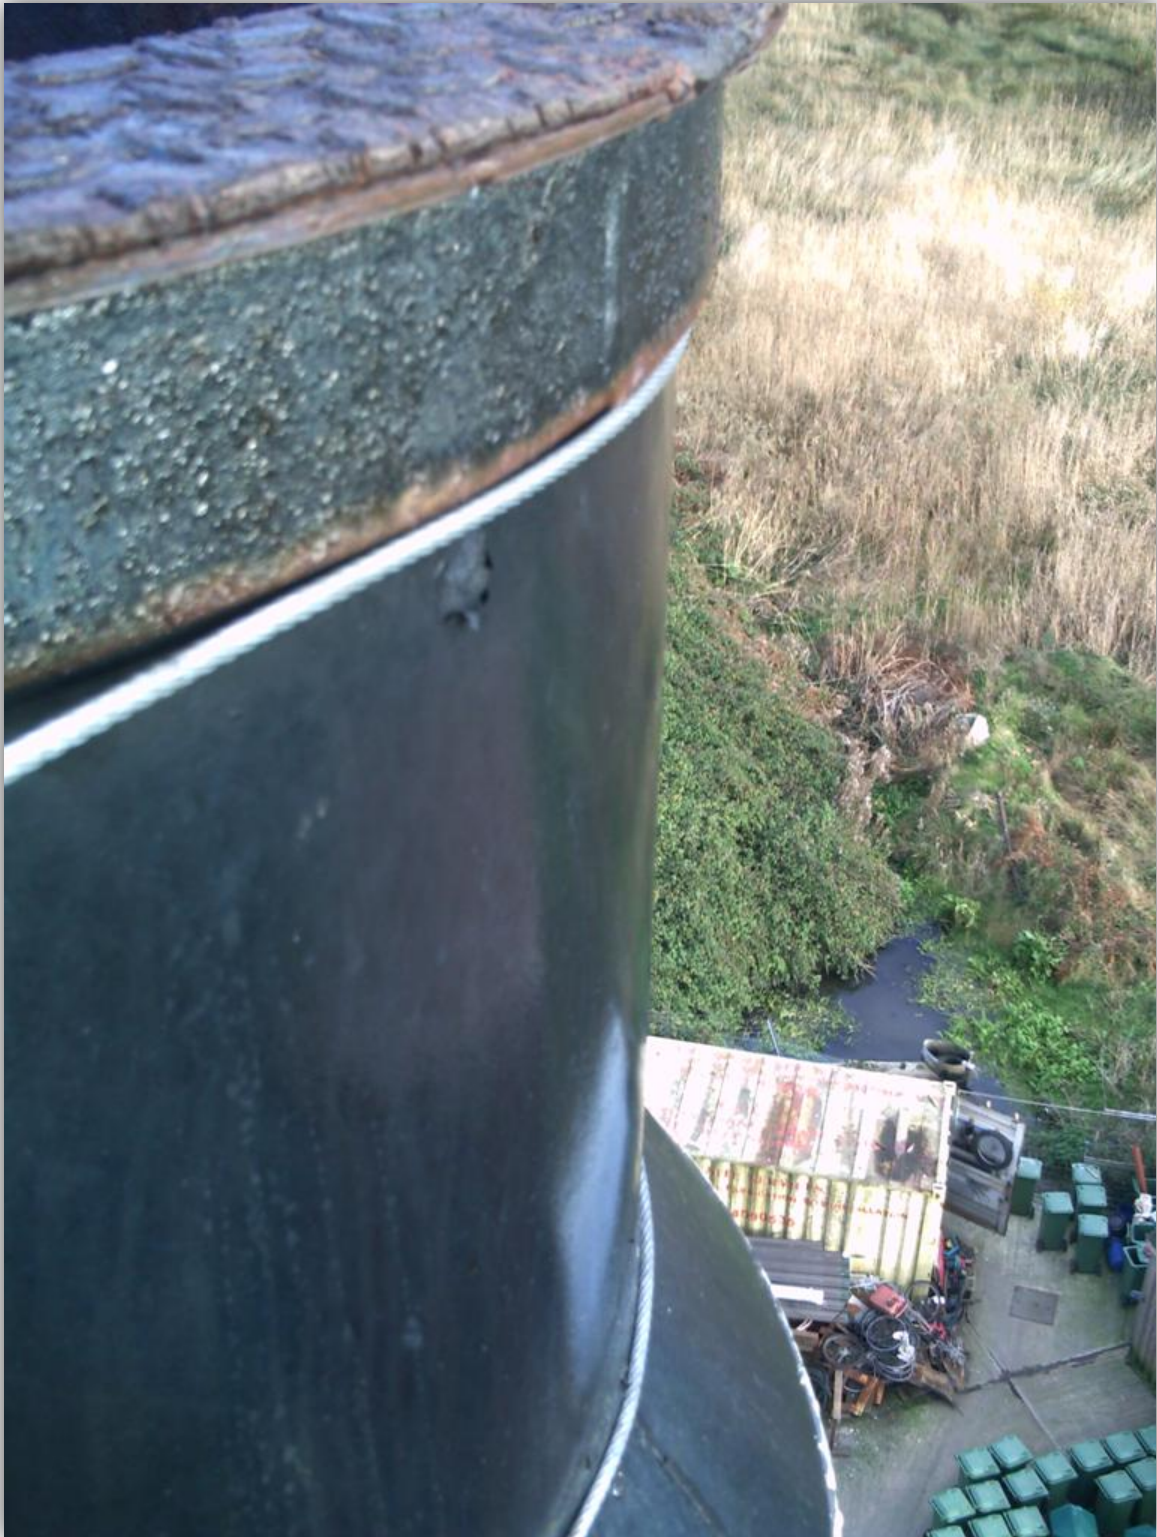
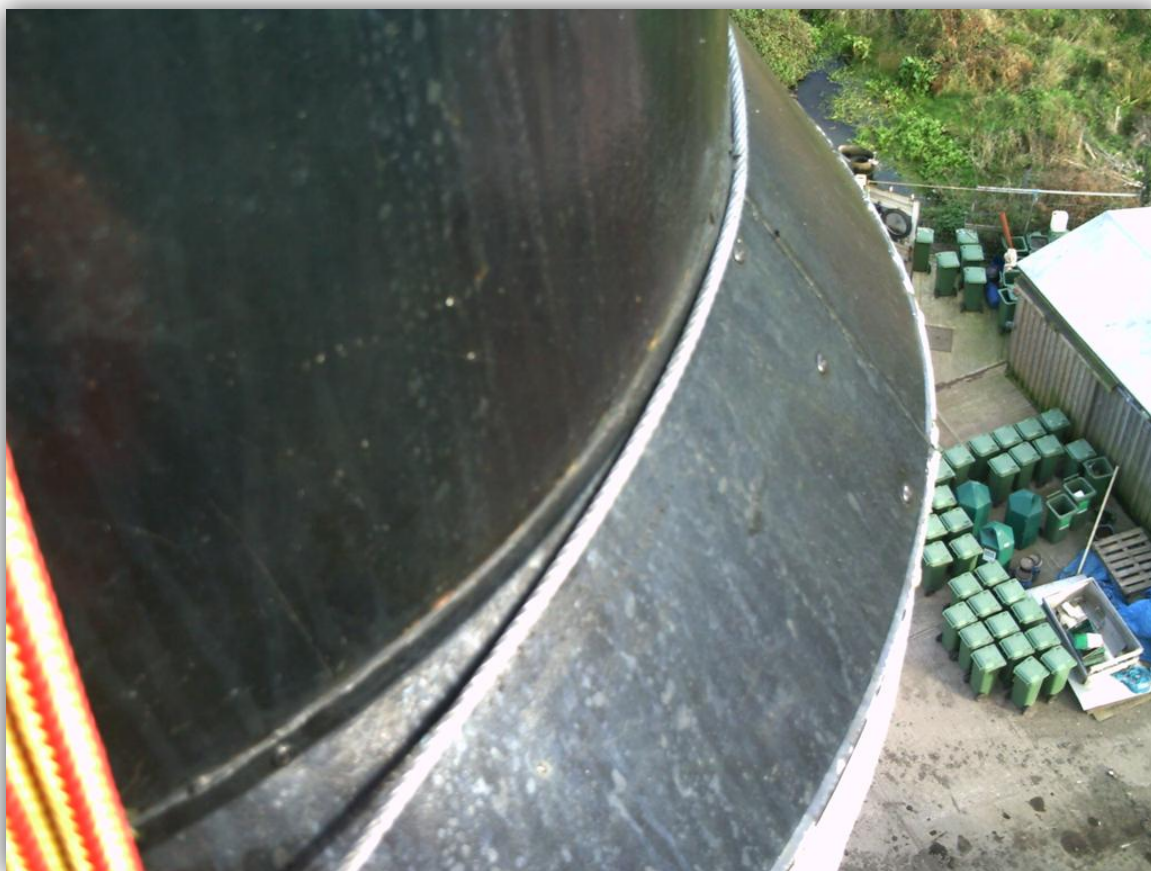
<i>Report</i>	<i>Comment</i>	<i>Photo No.</i>
The smokeband area of the windshield was showing early signs of paint protection failure.	BS EN 13084-1:2000 Section 4.6 - Generally chimneys have to be protected against corrosion or chemical attack by means of protective coating.	006 - 007
Throughout the windshield there were isolated areas of paint protection failure and surface corrosion.		008 - 010
The access door frame was found to be showing paint protection failure and surface corrosion.		011
Below the inspection port level the windshield steelwork was found to be heavily stained.		012 - 018

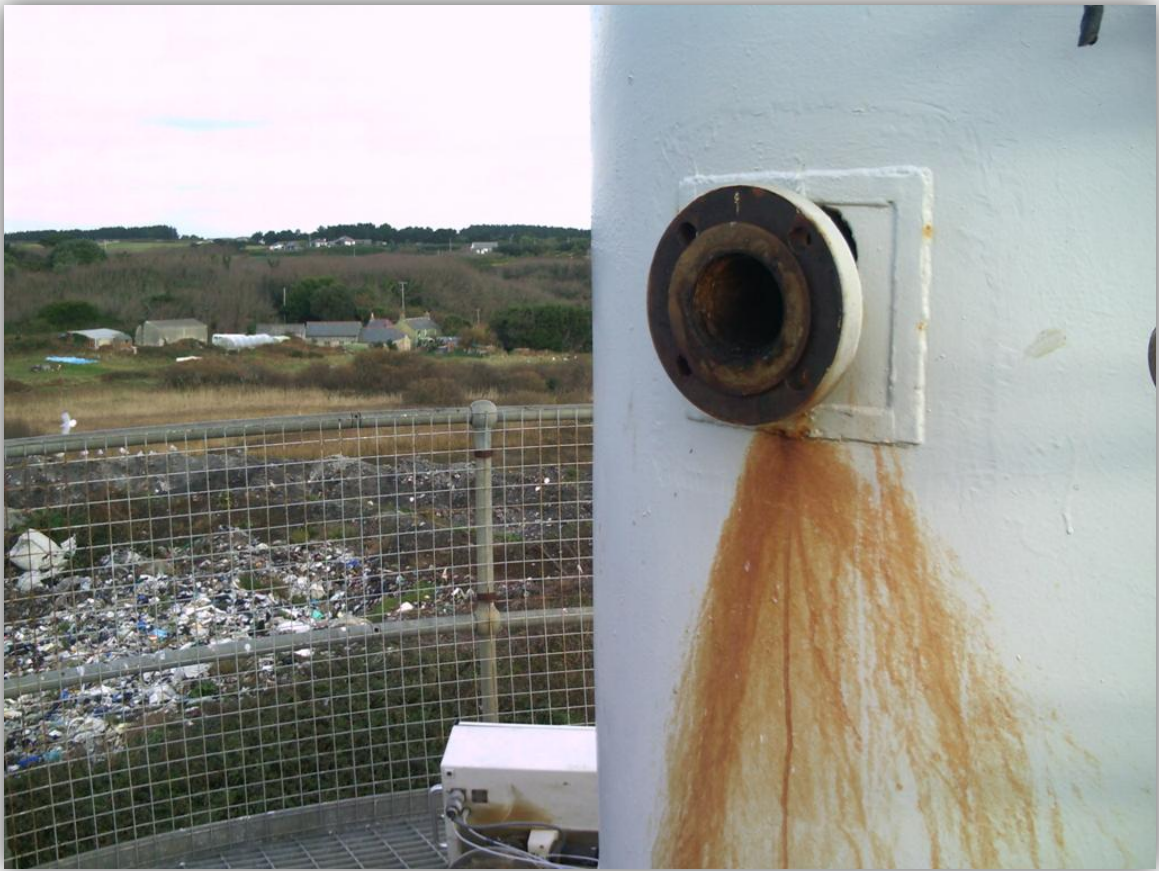
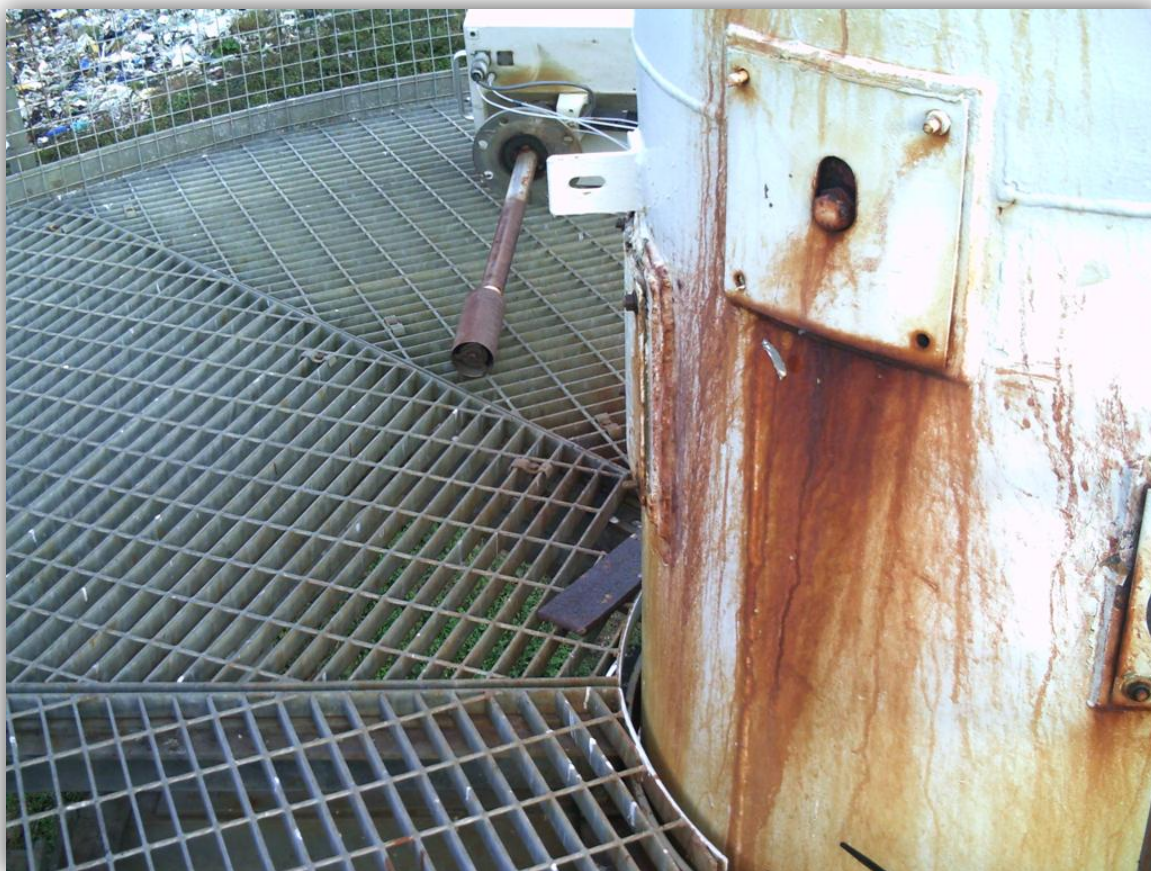
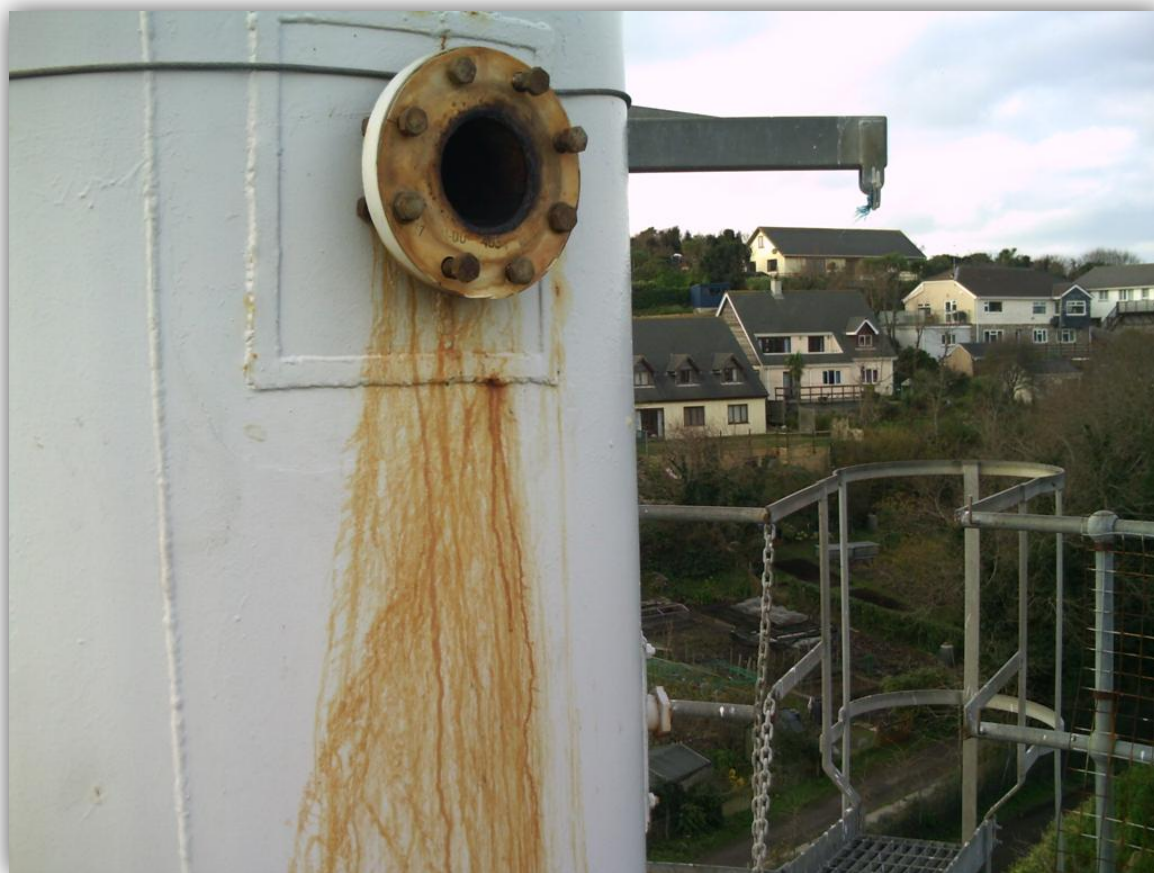
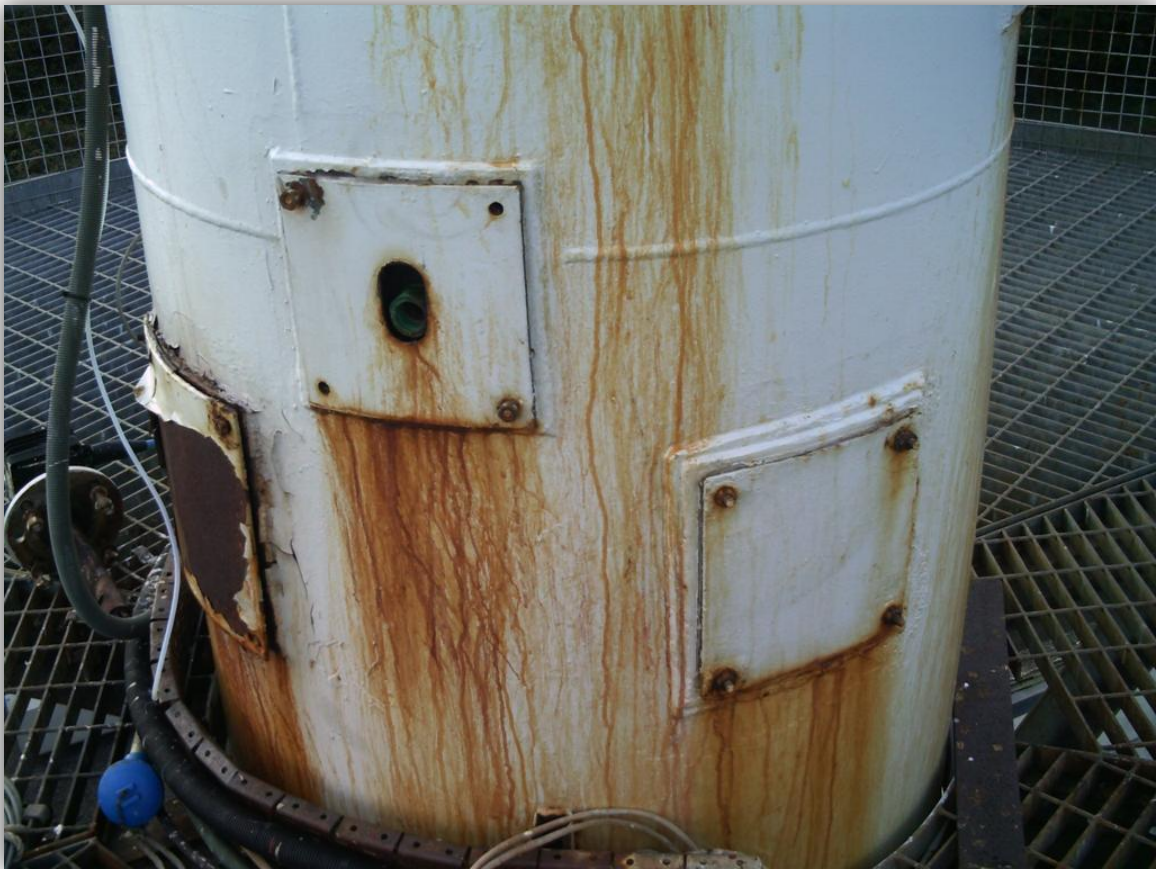
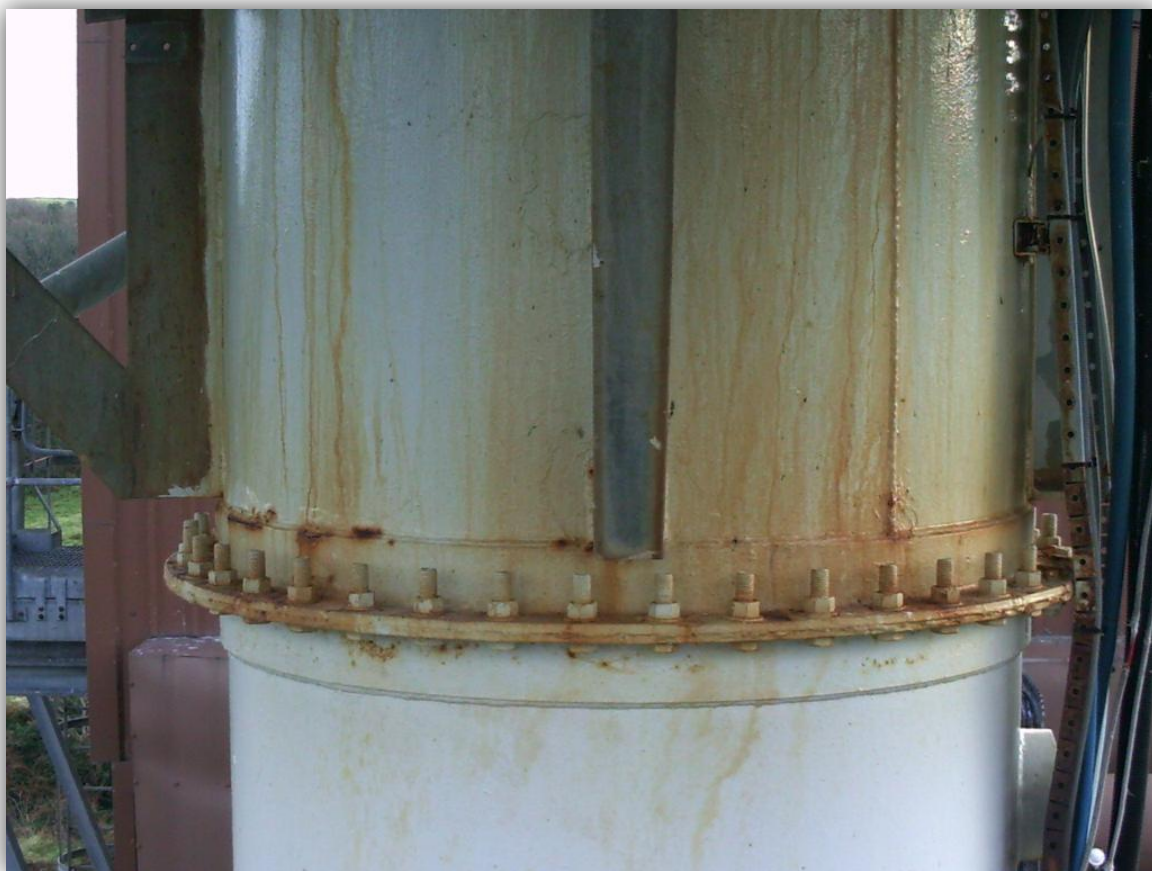
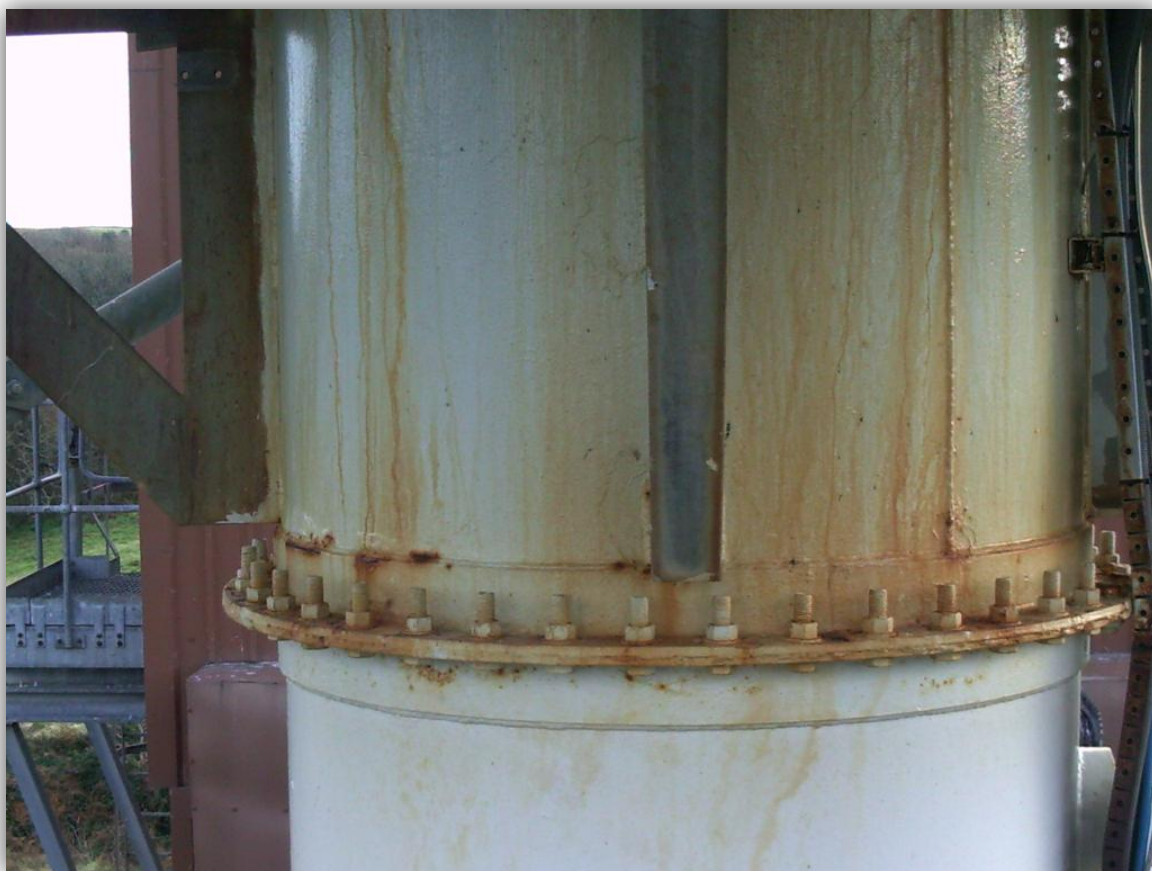
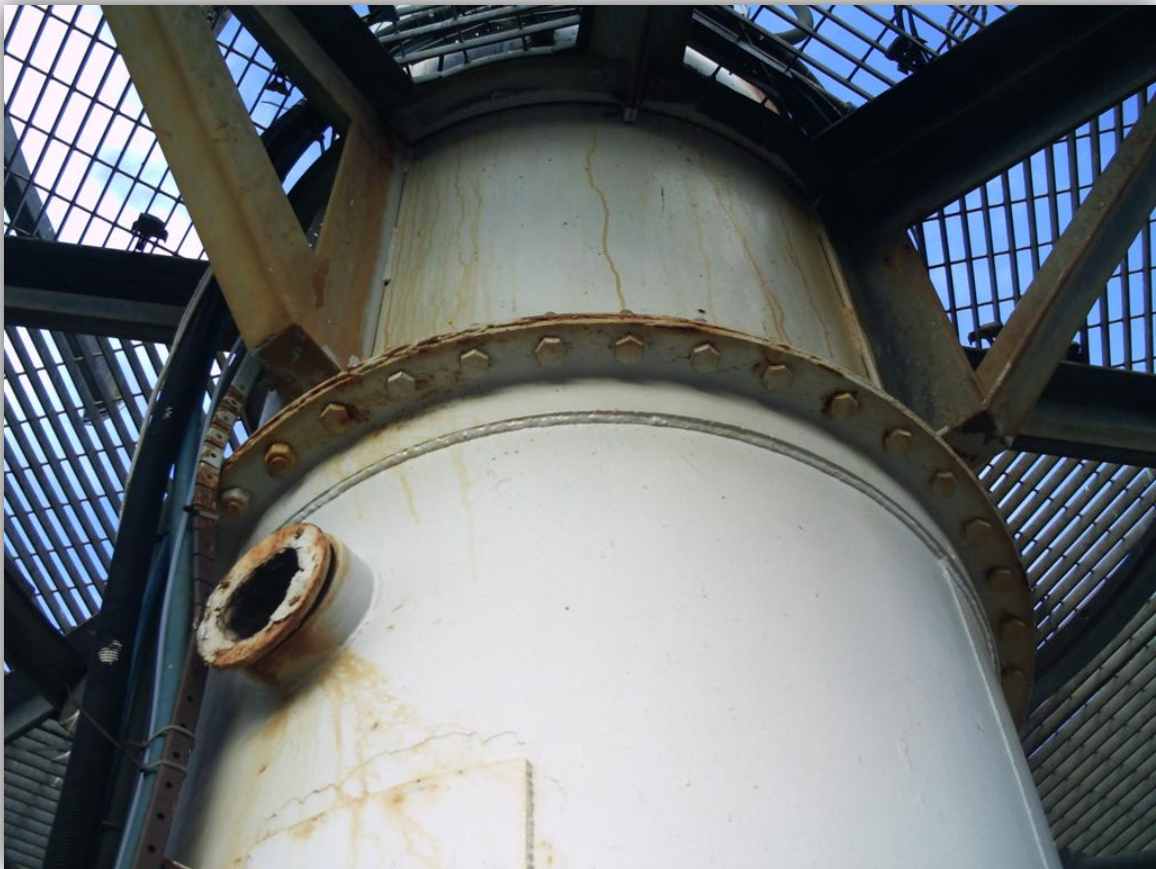
The chimney flanges, nuts, bolts and washers were found to be showing paint protection failure and minor surface corrosion.

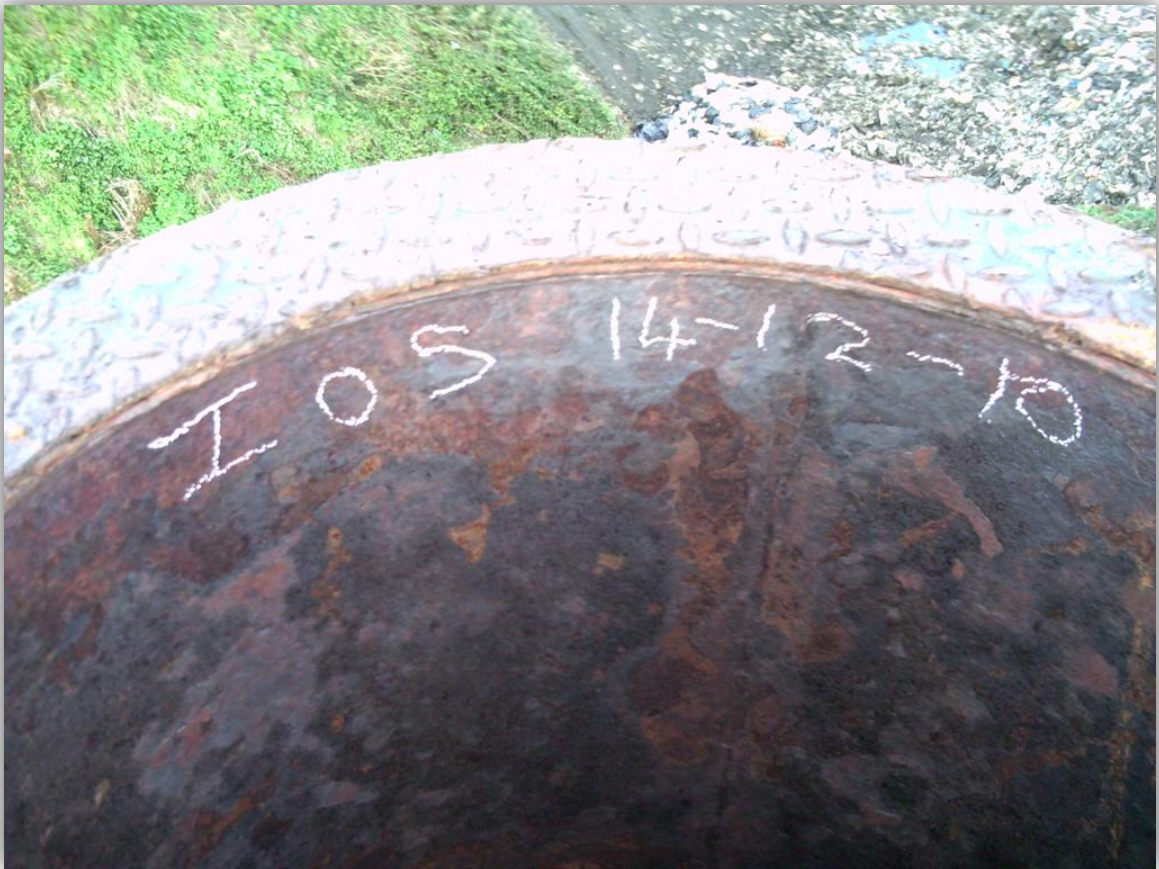
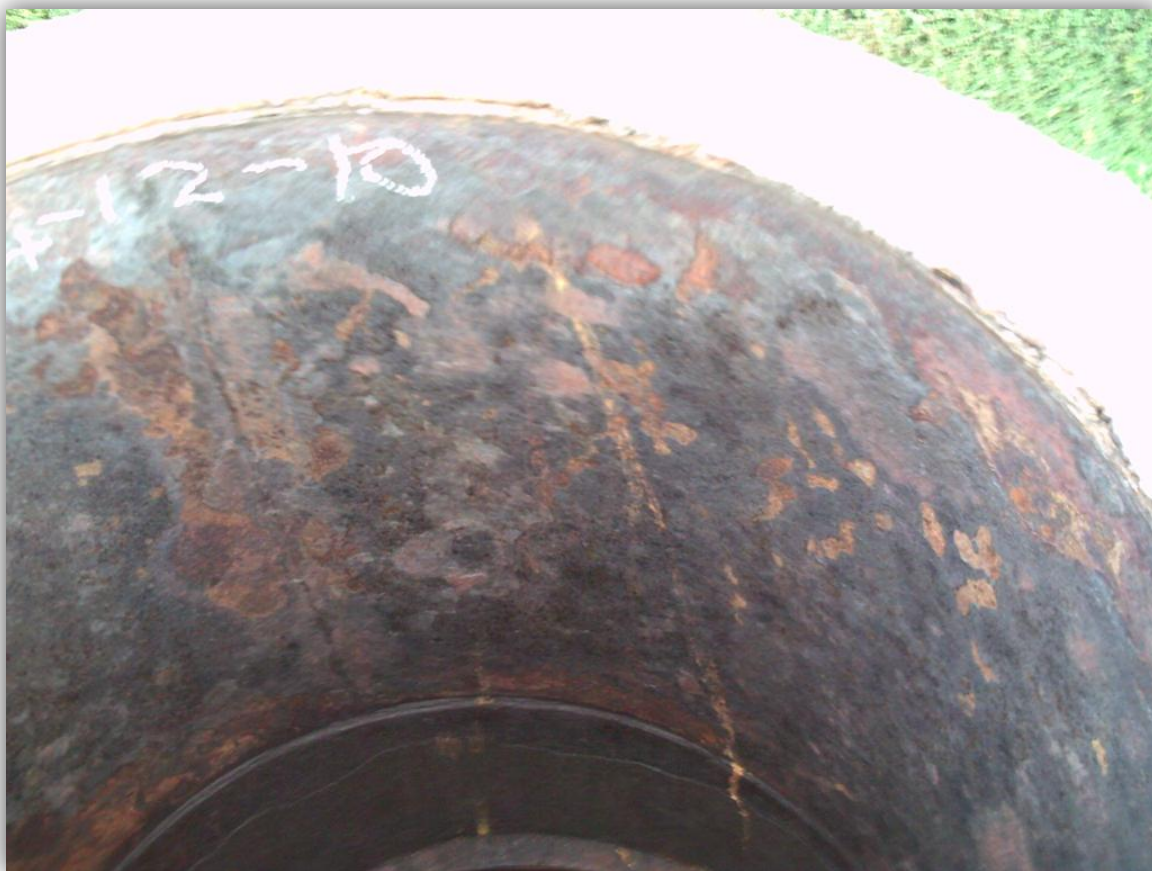
The chimney cope ring was found to be showing paint protection failure and minor surface corrosion.

Surface corrosion and minor shaling was in evidence throughout the full height of the stack internally.
