Inspection report

Client: Council of the Isles of Scilly

Site: Porthmellon Incinerator, Isles of Scilly

Chimney: Incinerator stack

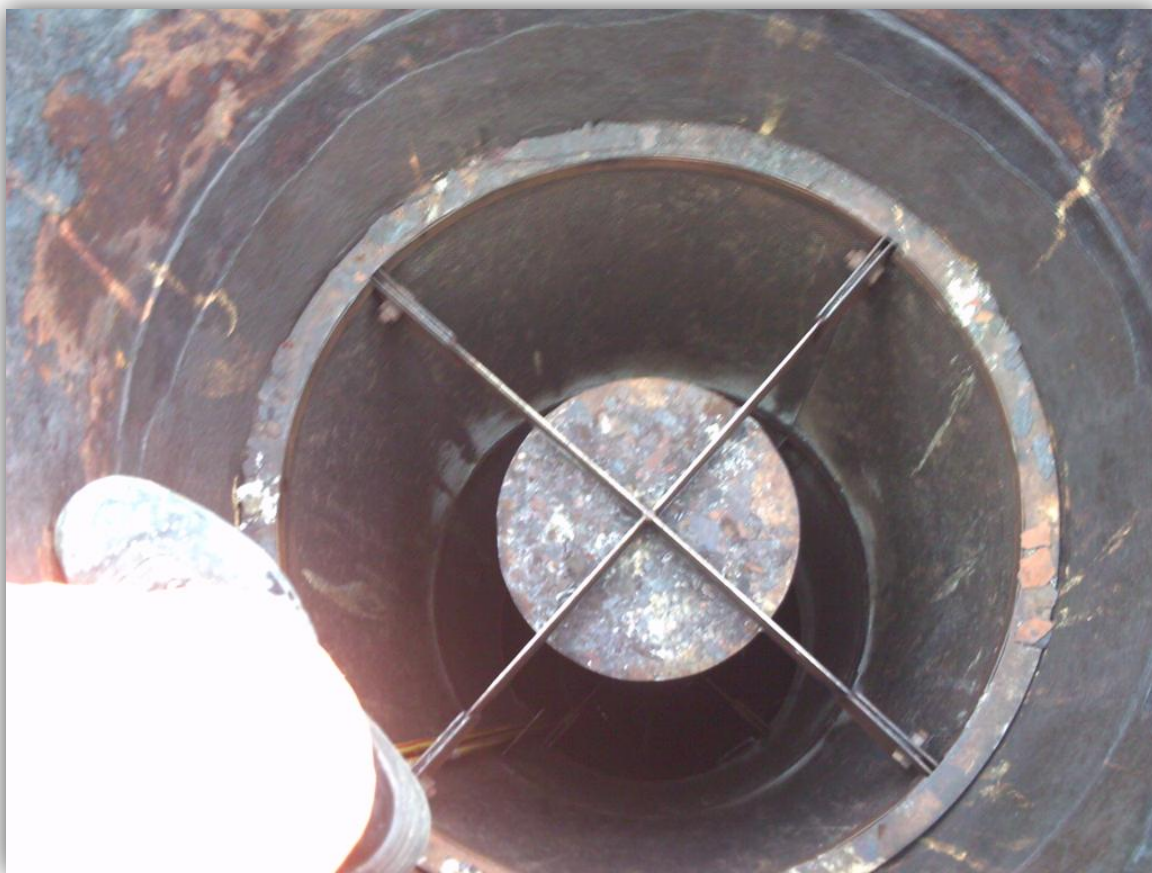
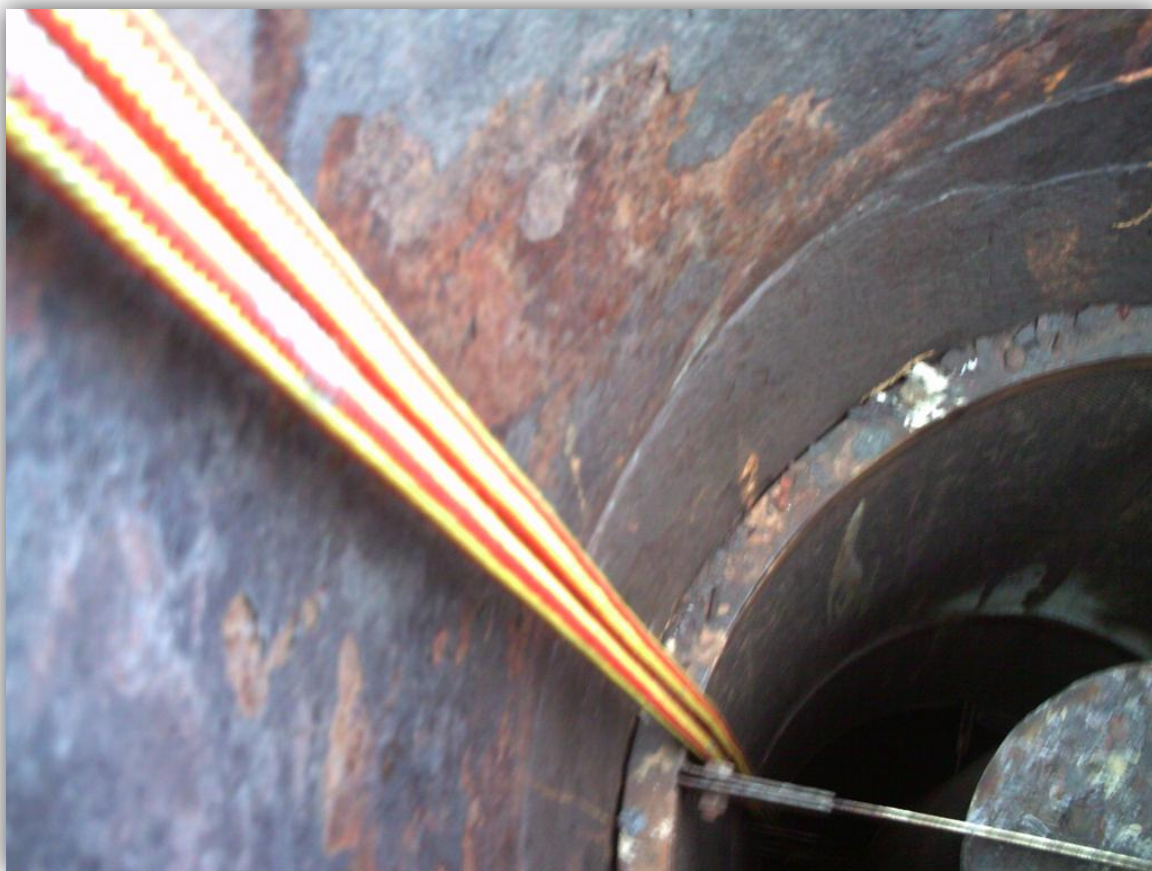
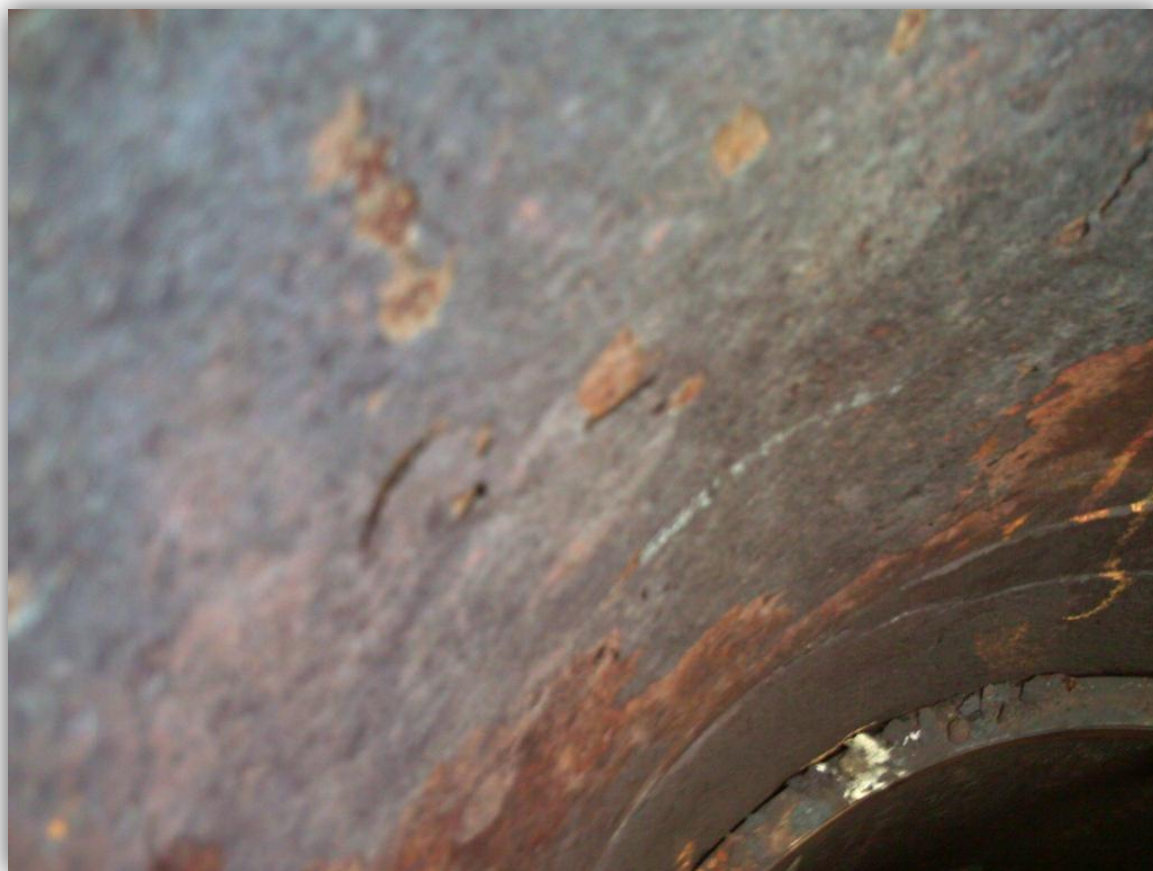
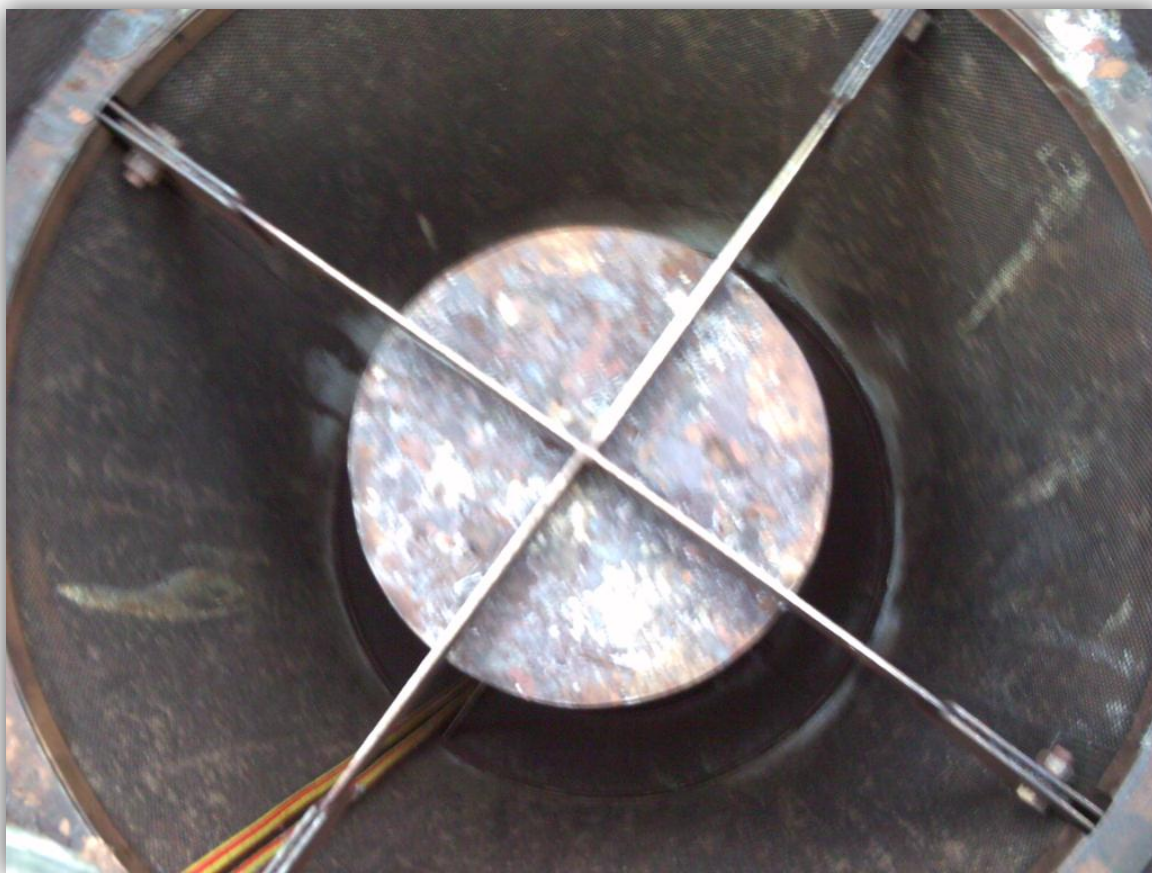
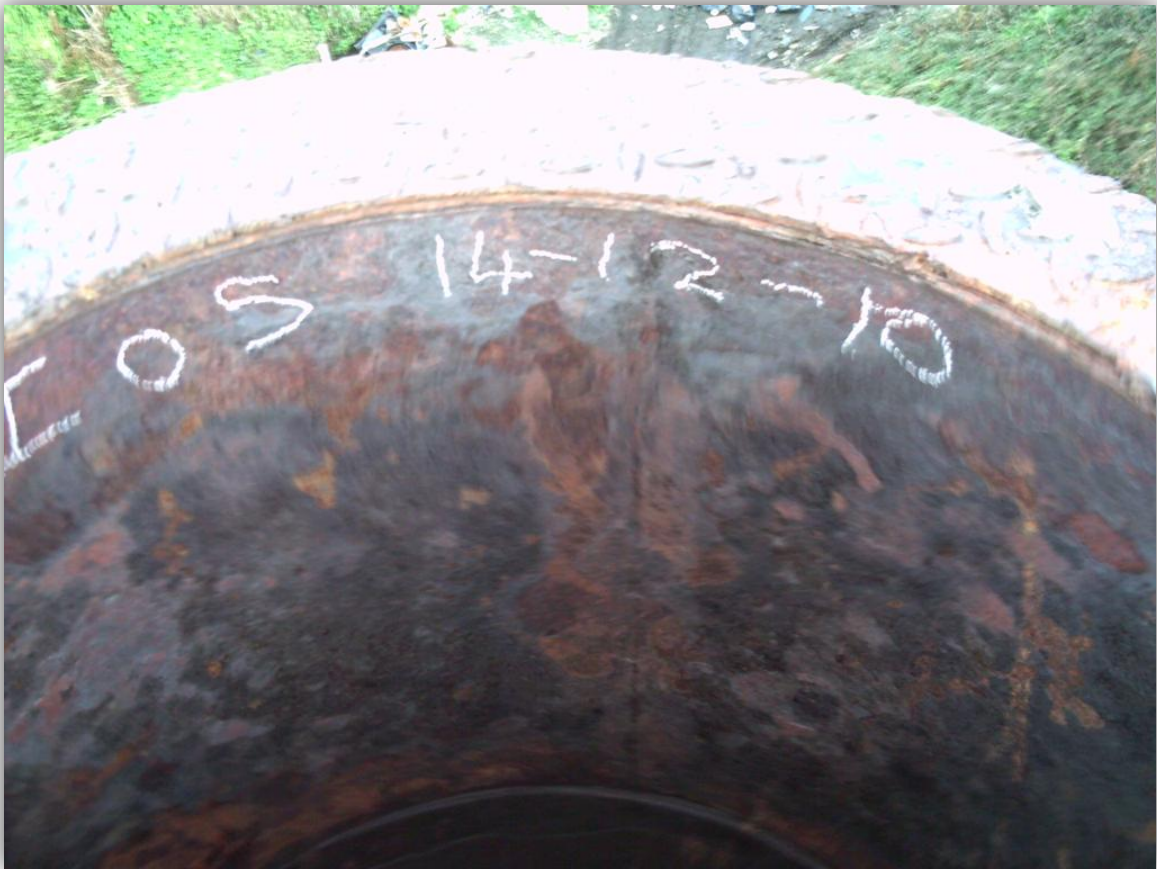
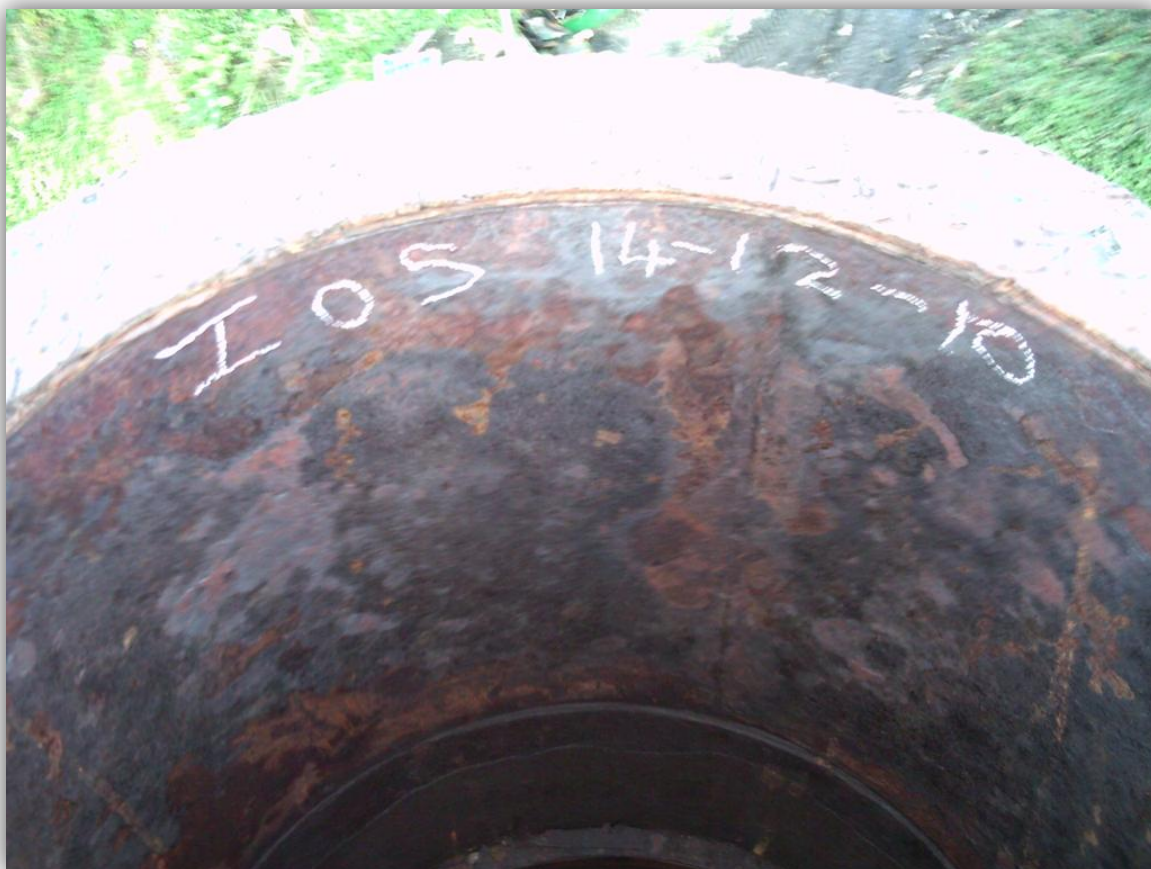
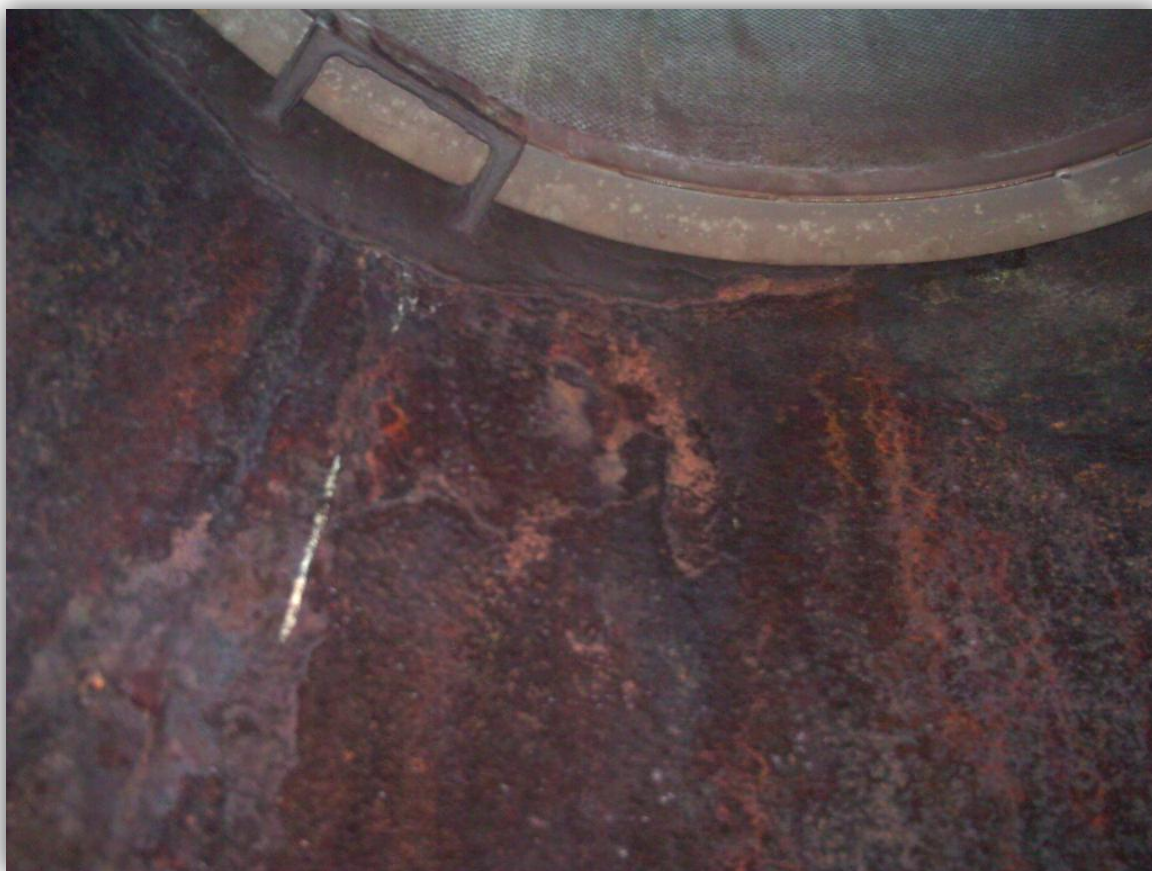
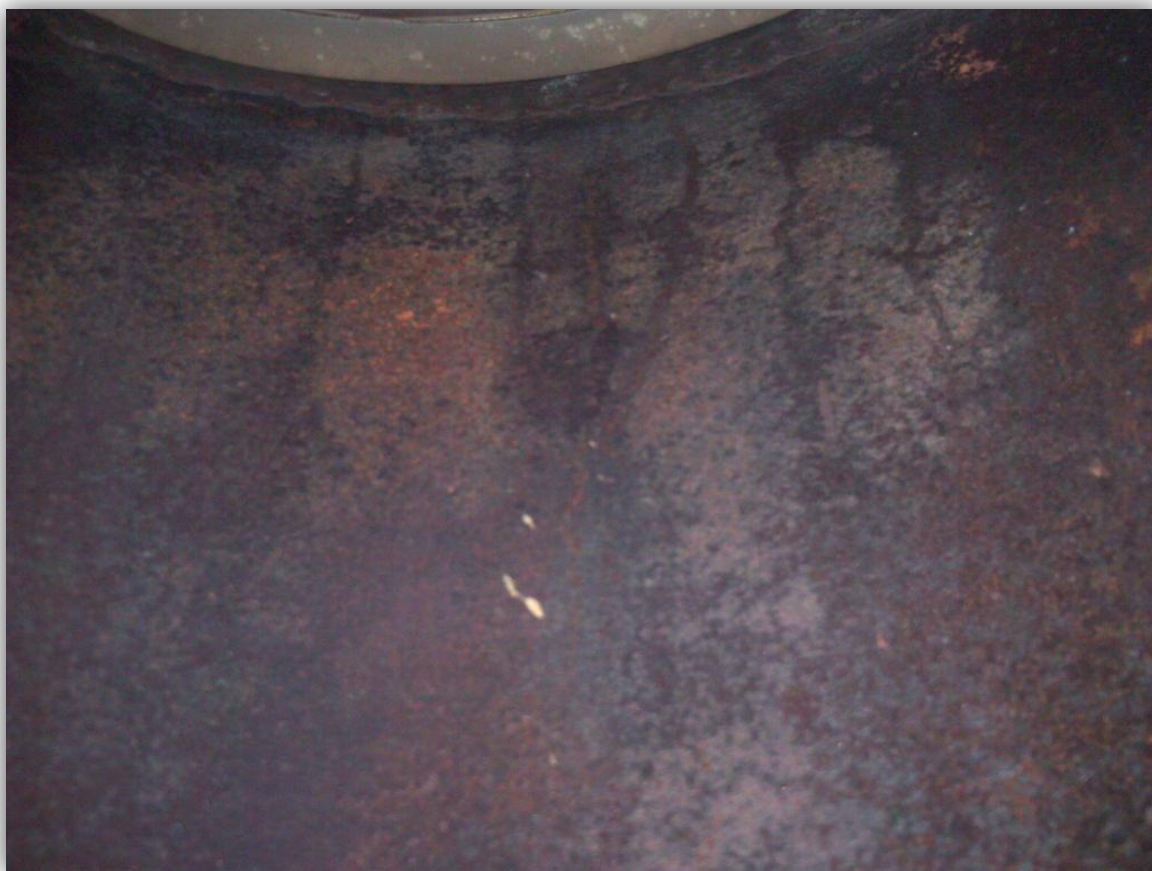
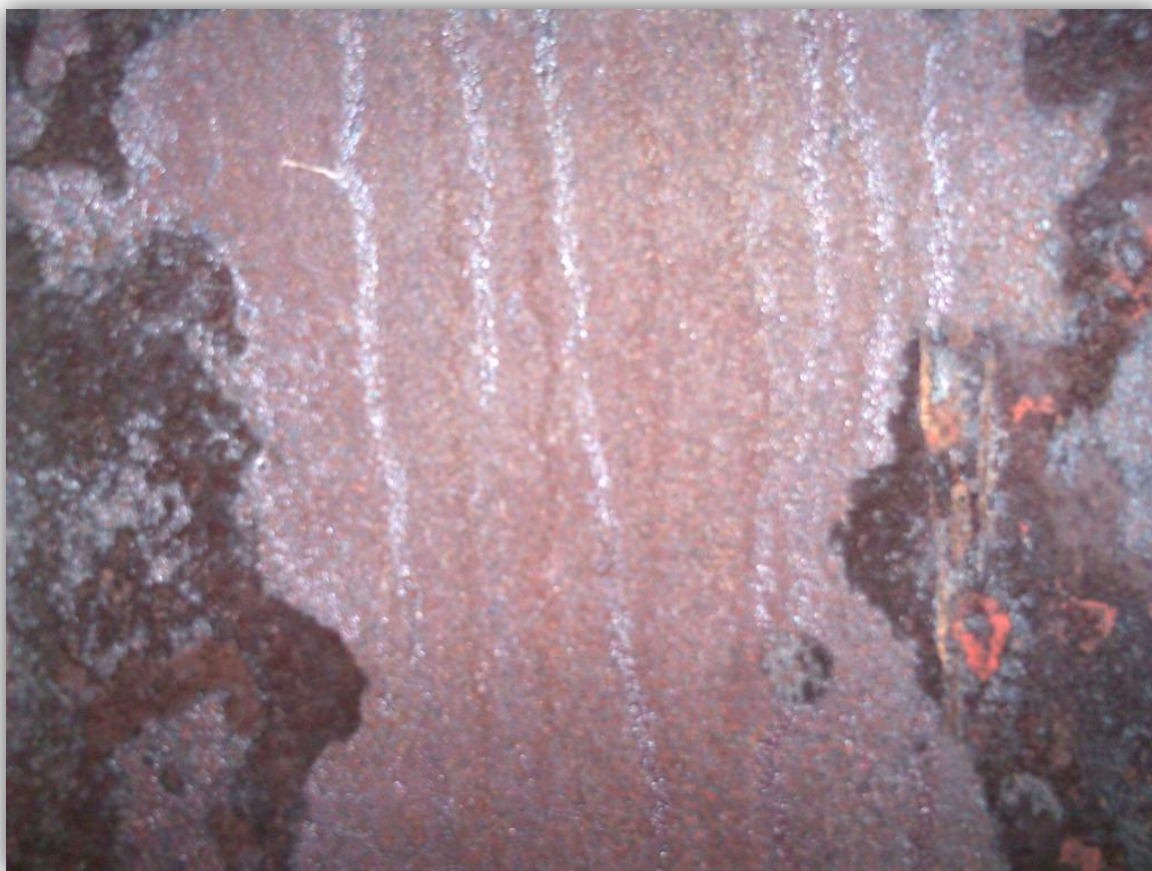
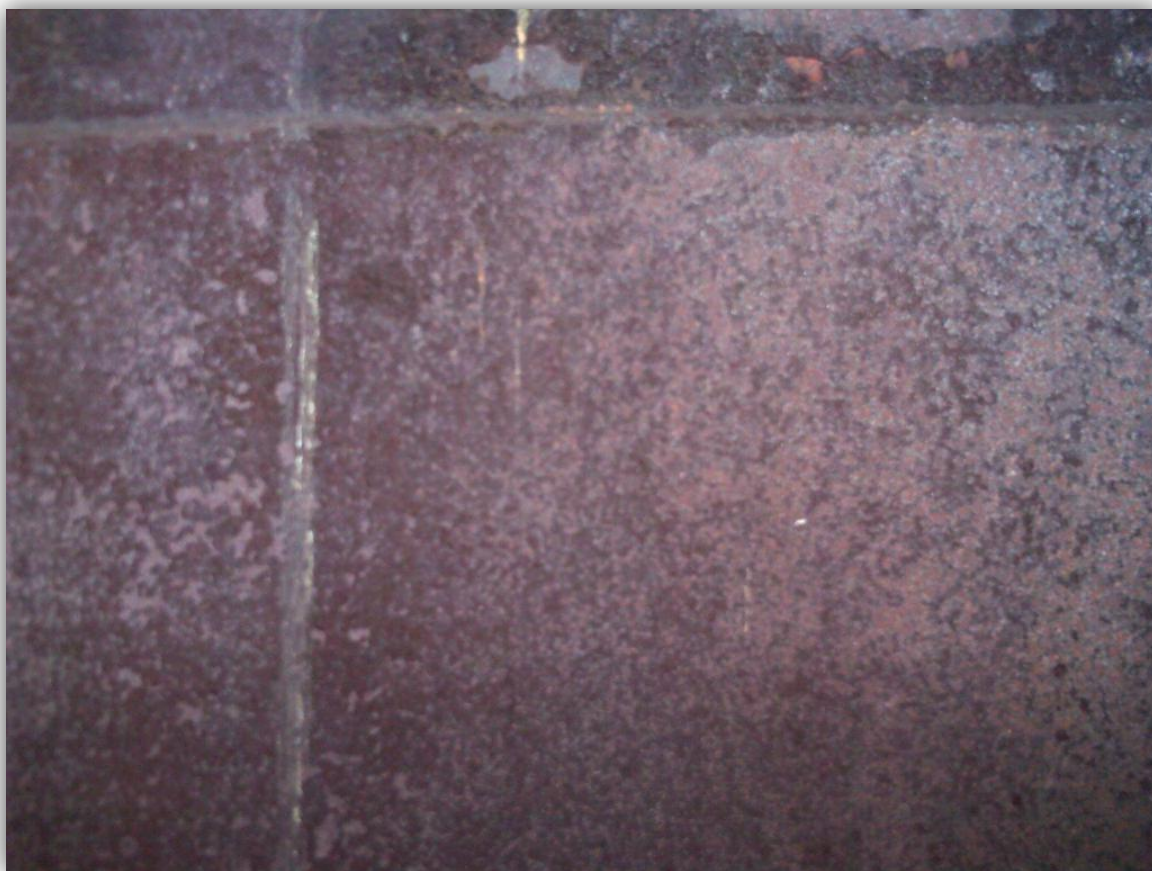
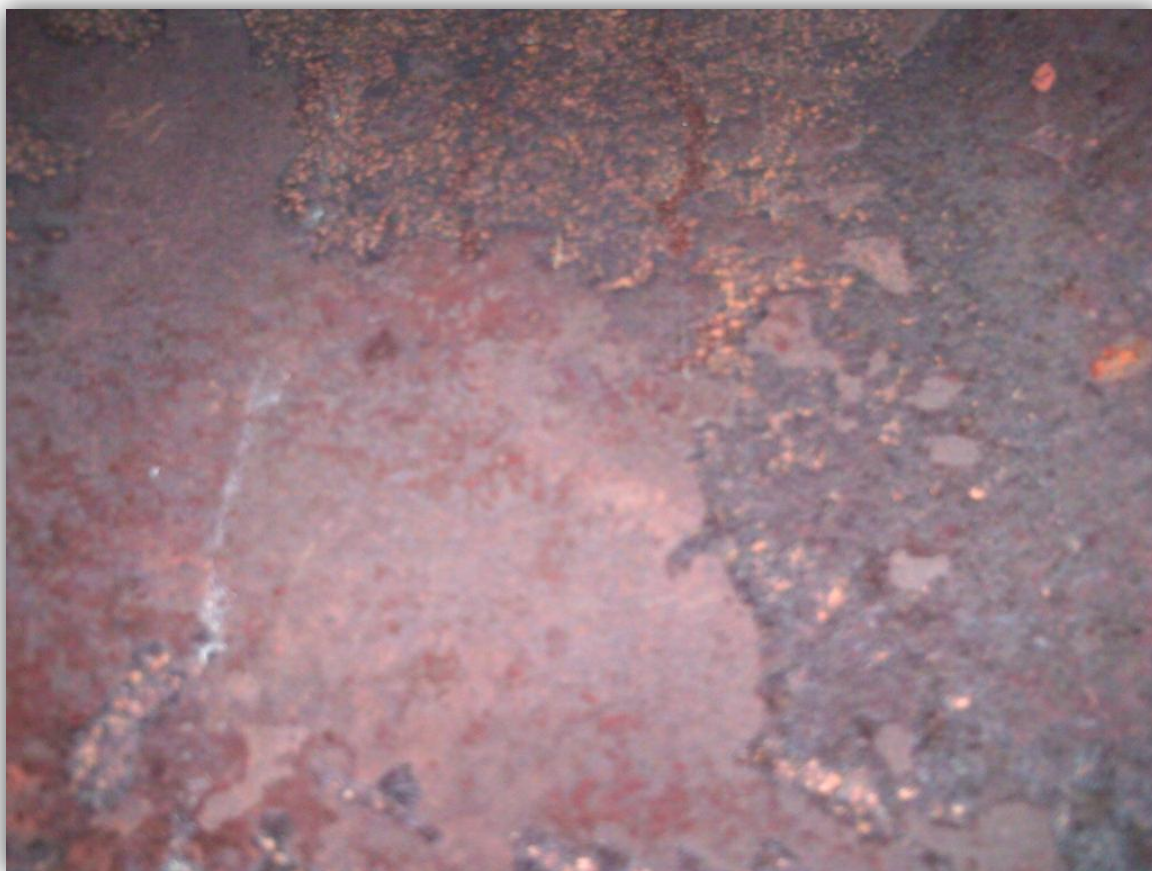
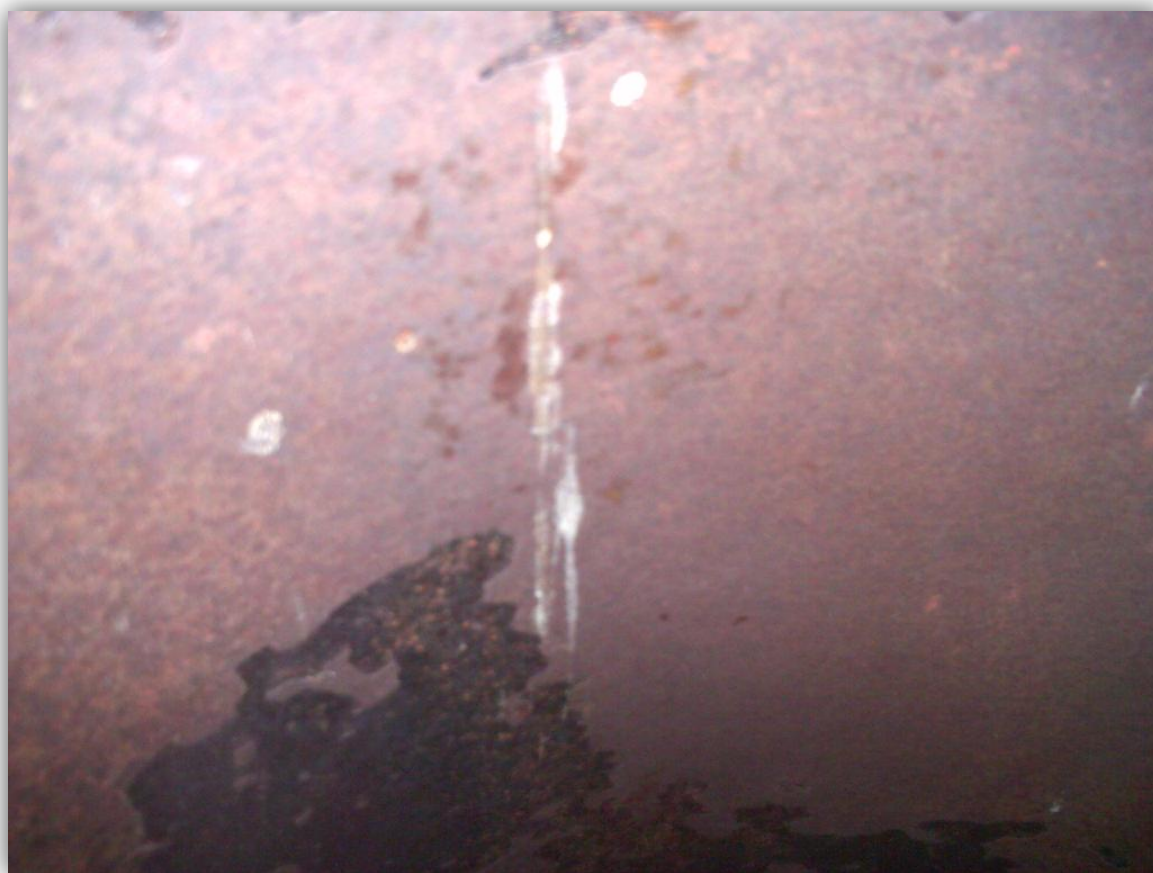
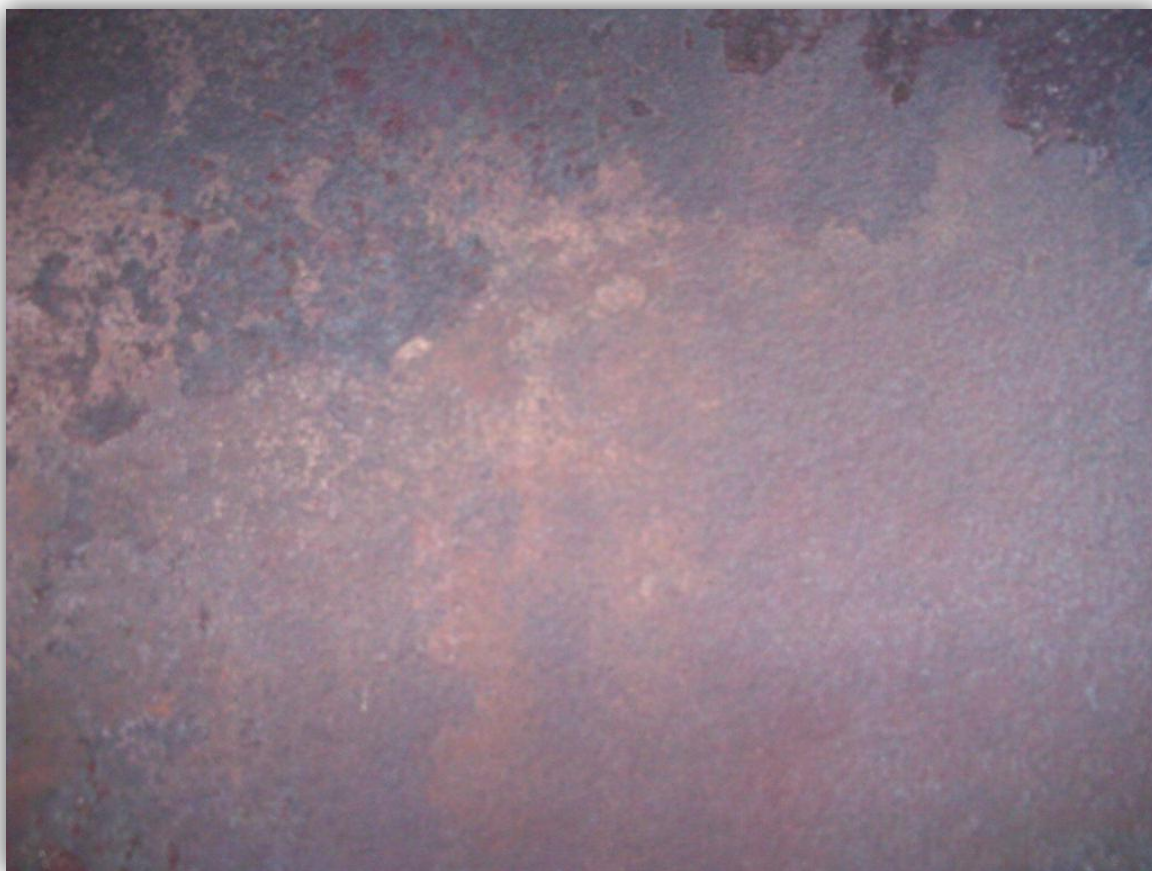
Surface corrosion and minor shaling was in evidence throughout the full height of the stack internally.

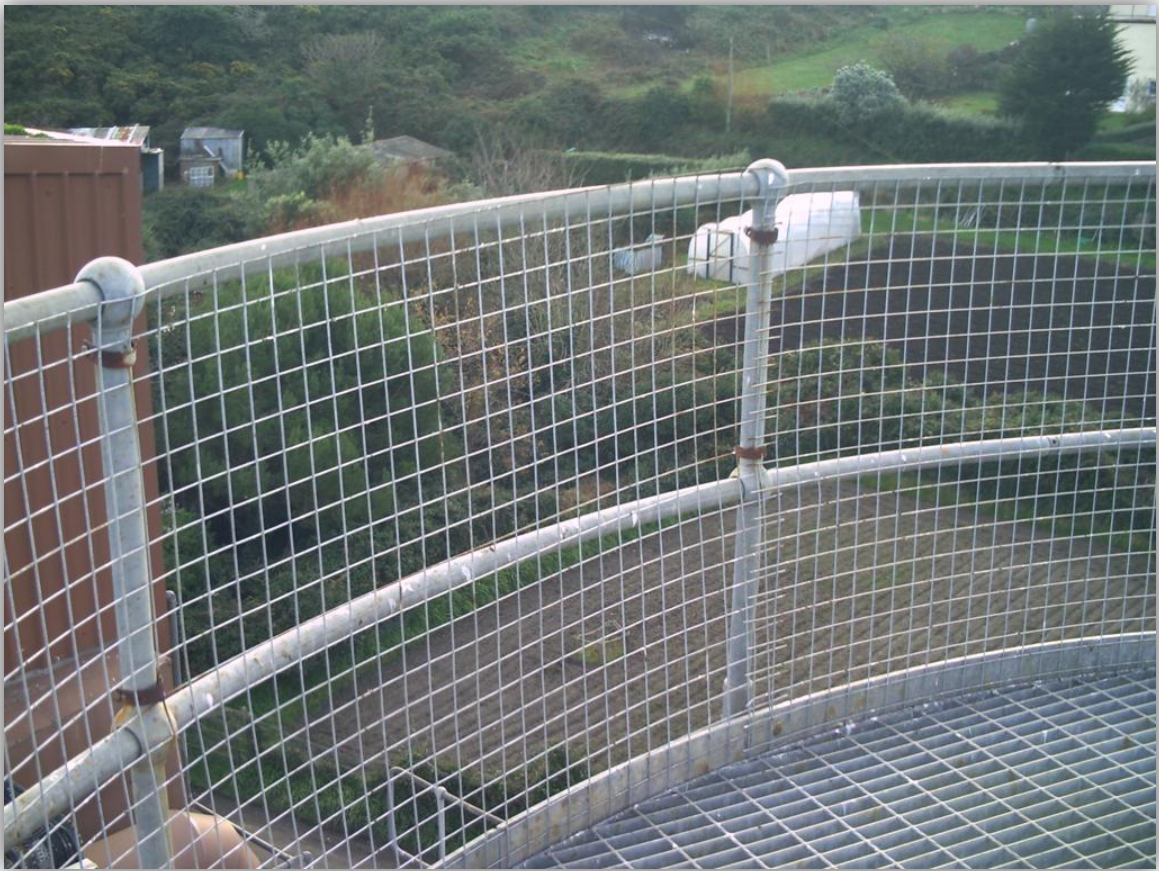
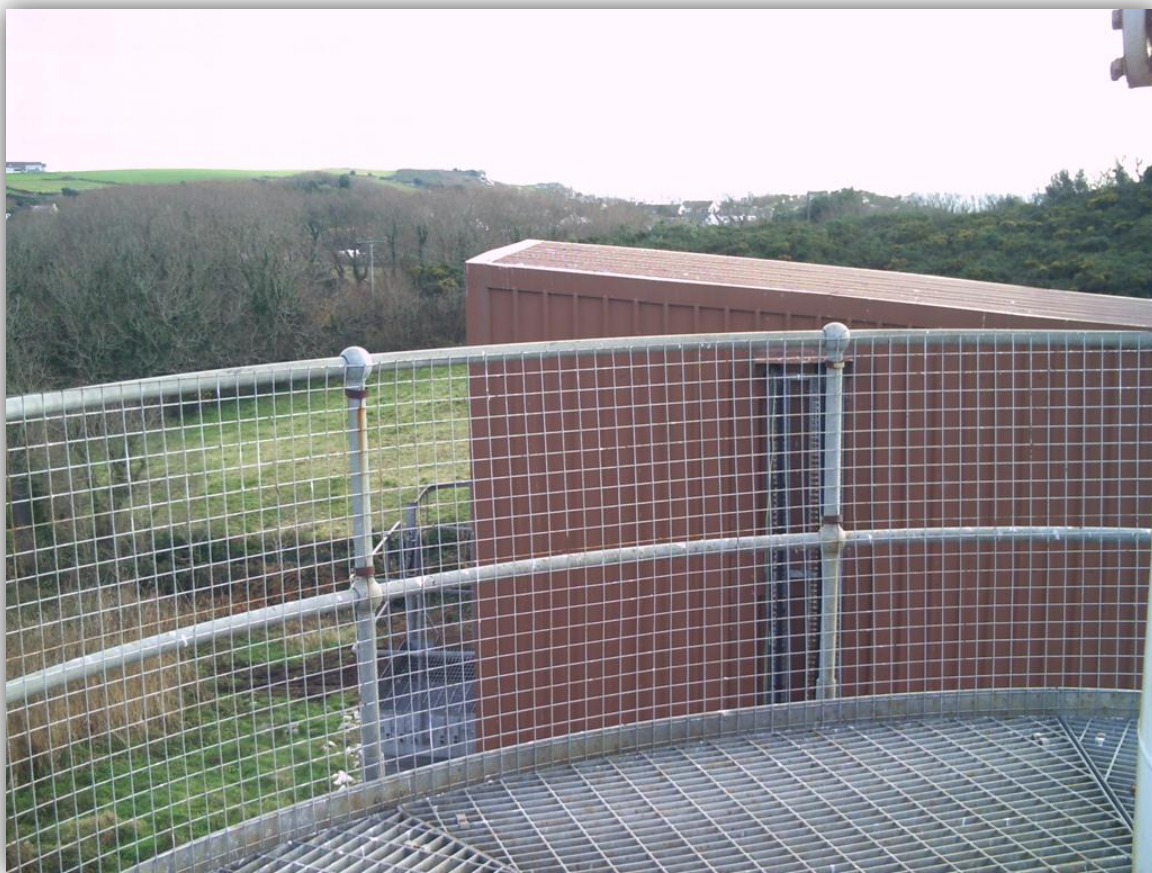
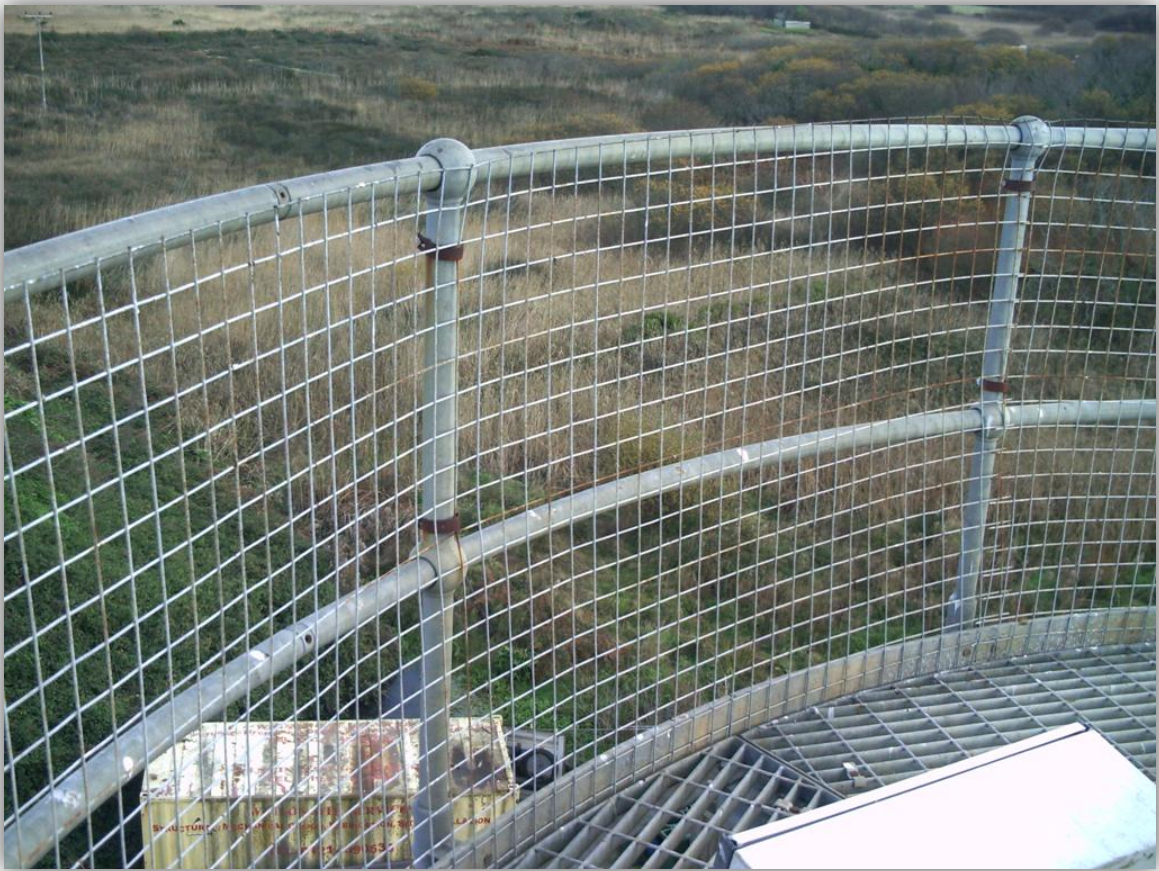
The galvanised mild steel gantry floors, handrails and support frames were all found to be in reasonable condition. Minor corrosion to handrail knuckle joints, mesh supporting straps and lindaptor grating fixings.

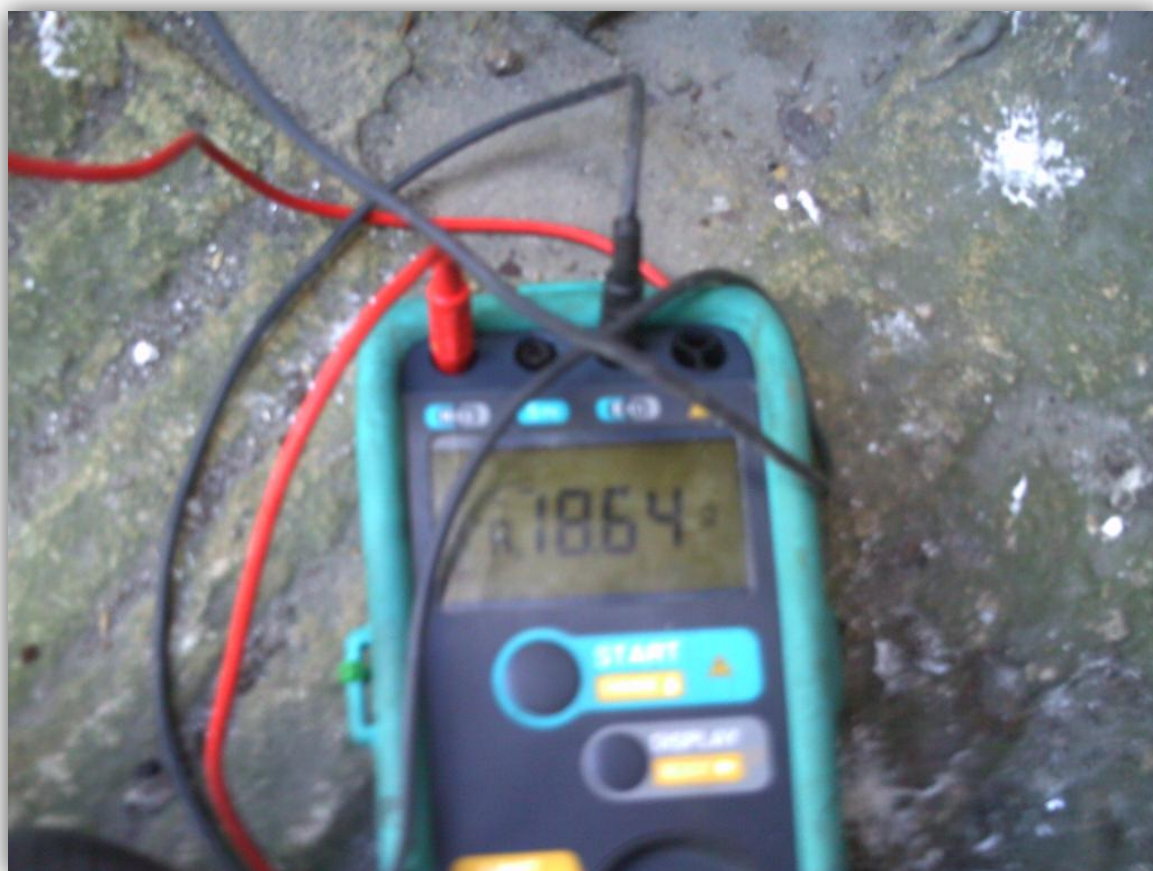
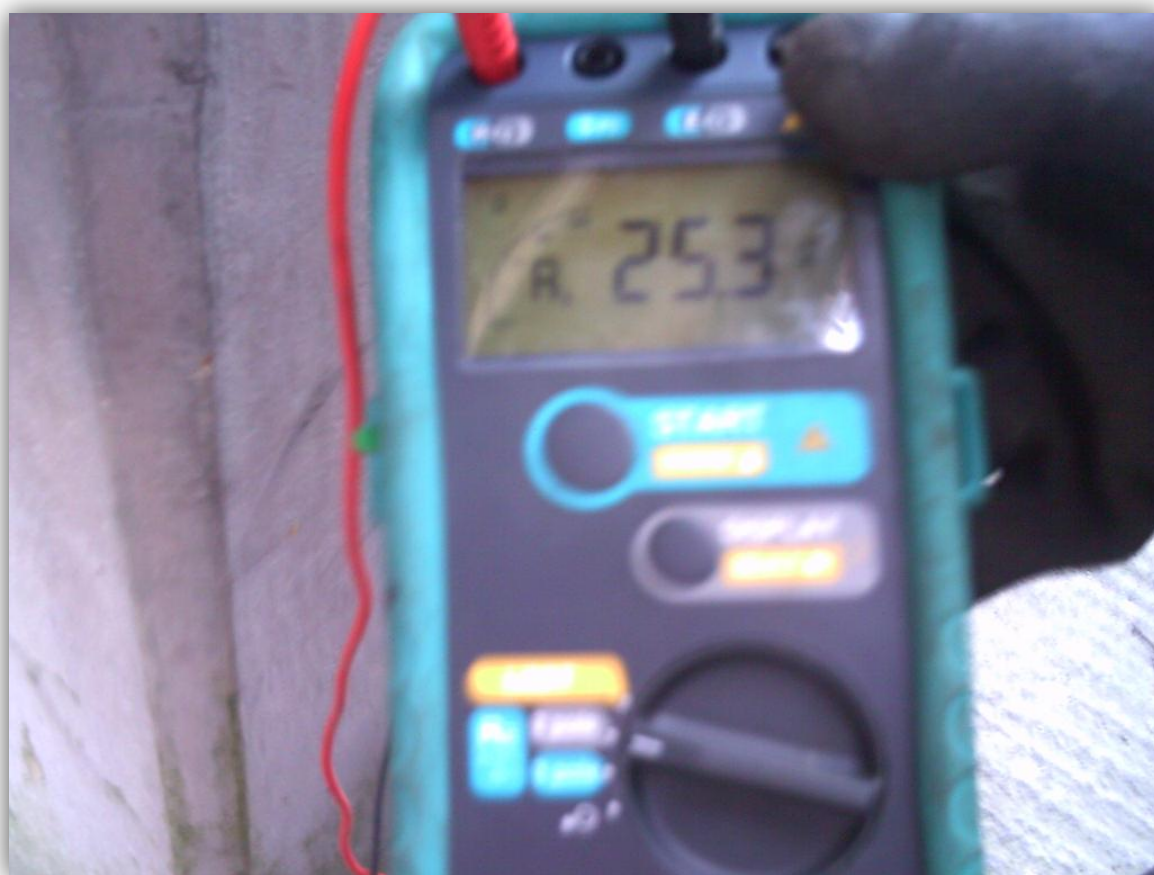
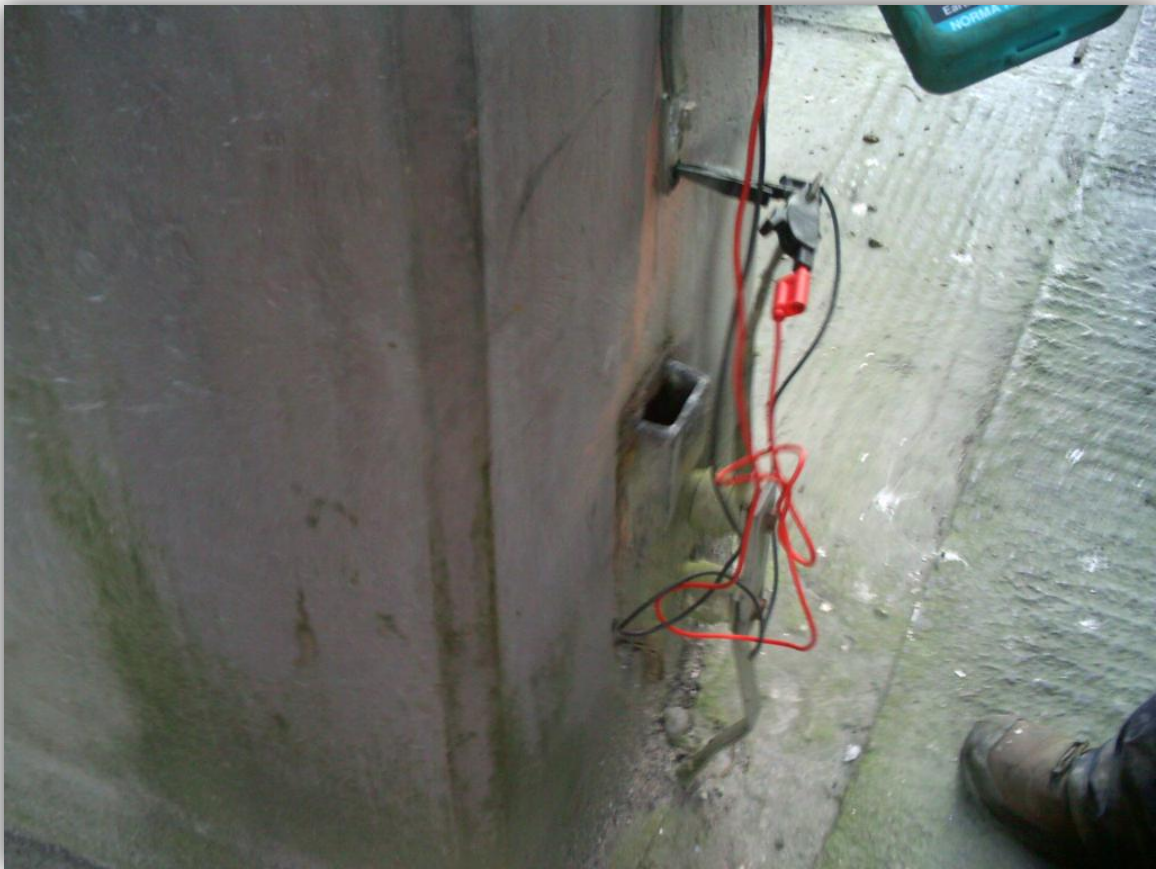
Report	Comment	Photo No.
The lightning conductor system was found to be in an unsatisfactory condition.	See attached test certificate.	40 - 42

This system does not comply with BS 6651:1999

Install additional earth rods to reduce the resistance to earth readings to acceptable levels.
