REFURBISHMENT AND DEMOLITION  
ASBESTOS SURVEY REPORT

Mundesley Boarding House  
Church Road  
St Marys  
Isles of Scilly  
TR21 0NA

JOB NO: J017965

HSG 264 Refurbishment Demolition survey of the  
SCOPE OF WORKS: areas affected by the proposed fire alarm upgrade  
works.

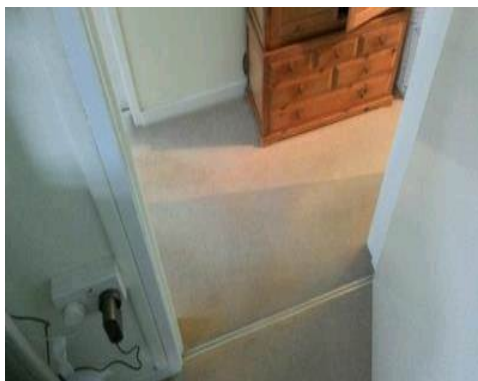
Item No.	Site Sample Reference	Location	Description of Material and Recommended Action				Area or Quantity	Photographs	
2	AJ002909	1st Floor.  Room 2 (Hall 120).	Beige vinyl floor tiles and adhesive beneath existing flooring.  Contains Chrysotile asbestos materials.  Materials can be removed by a non-licensed contractor in accordance with the Control of Asbestos Regulations 2012. <div>Recommended Action</div> <div>D</div>				3m²

Material Risk Assessment									
Product Type	Condition	Surface Treatment	Asbestos Type	Risk Factor	Risk Level	Accessibility	Material Classification		
1	0	(0) Completely Sealed	1	2	Very Low	Low	NNL

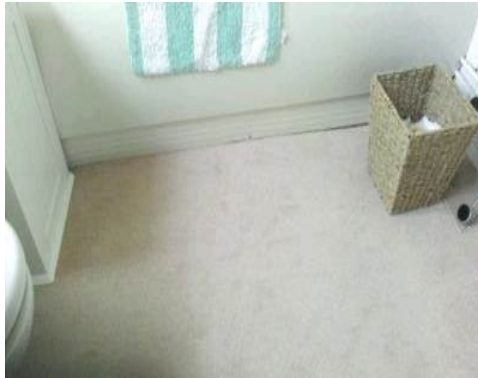
Item No.	Site Sample Reference	Location	Description of Material and Recommended Action		Area or Quantity	Photographs	
4	AS PER SAMPLE AJ002910	1st Floor.  Room 4 (Bathroom 119).	<p>Cream vinyl floor tiles and adhesive beneath existing flooring (as sample AJ002910).</p> <p>Strongly presumed to contain Chrysotile asbestos materials.</p> <p>Materials can be removed by a non-licensed contractor in accordance with the Control of Asbestos Regulations 2012.</p> <p>Recommended Action</p>		5m <sup>2</sup>

Material Risk Assessment							
Product Type	Condition	Surface Treatment	Asbestos Type	Risk Factor	Risk Level		Accessibility
1	0	(0) Completely Sealed	1	2	Very Low	Low	NNL

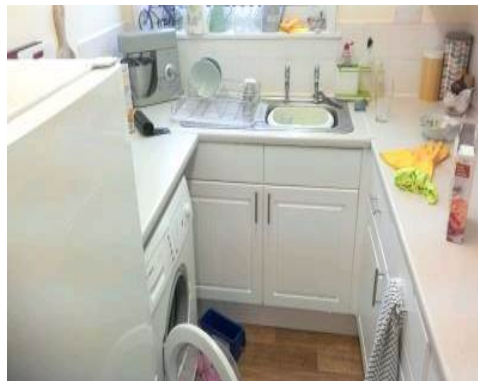
Item No.	Site Sample Reference	Location	Description of Material and Recommended Action				Area or Quantity	Photographs	
5	AJ002911	1st Floor.  Room 5 (Kitchen 116).	Sound pad to sink unit.  No Asbestos Detected.  No further action required.  <div>Recommended Action</div> <div>-</div>				1no.

Material Risk Assessment									
Product Type	Condition	Surface Treatment	Asbestos Type	Risk Factor	Risk Level	Accessibility	Material Classification		
-	-	-	-	-	-	-	-

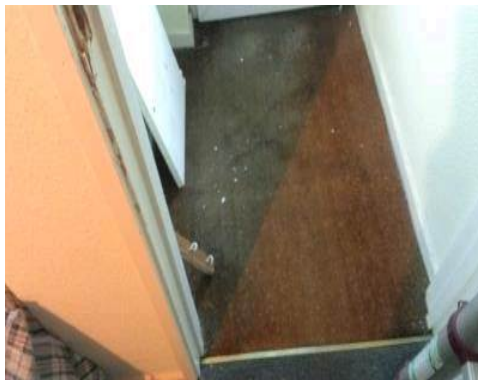
Item No.	Site Sample Reference	Location	Description of Material and Recommended Action				Area or Quantity	Photographs	
6	AJ002912	Ground Floor.  Room 1 (Lounge 021).	<p>Beige vinyl floor tile and adhesive remains underneath existing flooring within porch.</p> <p>Contains Chrysotile asbestos materials.</p> <p>Materials can be removed by a non-licensed contractor in accordance with the Control of Asbestos Regulations 2012.</p> <div>Recommended Action</div> <div>C</div>				1m²

Material Risk Assessment									
Product Type	Condition	Surface Treatment	Asbestos Type	Risk Factor	Risk Level	Accessibility	Material Classification		
1	1	(0) Completely Sealed	1	3	Very Low	Low	NNL

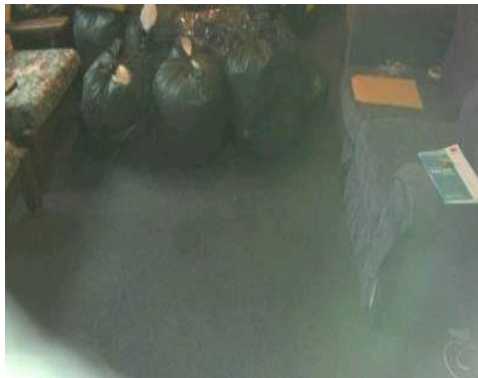
Item No.	Site Sample Reference	Location	Description of Material and Recommended Action				Area or Quantity	Photographs	
7	AS PER SAMPLE AJ002912	Ground Floor.  Room 1 (Lounge 021).	<p>Beige vinyl floor tile and adhesive underneath existing flooring (as sample AJ002912).</p> <p>Strongly presumed to contain Chrysotile asbestos materials.</p> <p>Materials can be removed by a non-licensed contractor in accordance with the Control of Asbestos Regulations 2012.</p> <div>Recommended Action</div> <div>D</div>				20m²

Material Risk Assessment									
Product Type	Condition	Surface Treatment	Asbestos Type	Risk Factor	Risk Level	Accessibility	Material Classification		
1	0	(0) Completely Sealed	1	2	Very Low	Low	NNL
