**Isles of Scilly Condition Survey**  
Council of the Isles of Scilly  
St. Marys

**Condition Survey Report**

**St Agnes Fire and Emergency Station**  
Revision P02

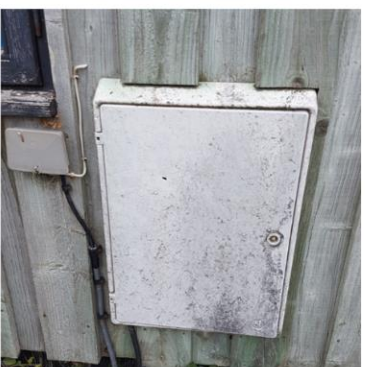
- 5.1.1 The Fire and Emergency Station is served from a WPD electrical supply system. The supply terminates in a GRP enclosure external to the building.

<p>E201: Incoming LV and data services terminating within GRP enclosure</p>	<p>E202: Incoming services cable sheathing degraded/ cracking.</p>	<p>E203: Distribution board, recommend changing to a metal fireproof board.</p>

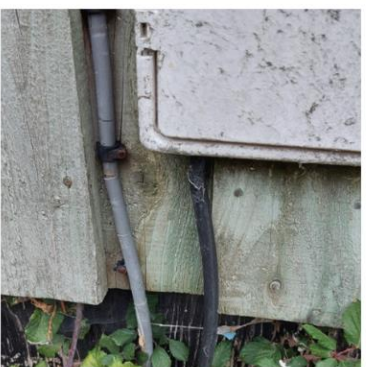
- 5.1.2 Incoming services cable sheathing degraded/ cracking. Further investigation required by BT Openreach to determine extent of degradation to avoid loss of services.

- 6.1.1 Lightning protection specialist to perform a risk assessment in line with BS EN 52306 and BS7671 to determine the need for a lightning protection system and surge protection.
- 6.1.2 BT Openreach engineer required to check BT incoming cable condition.

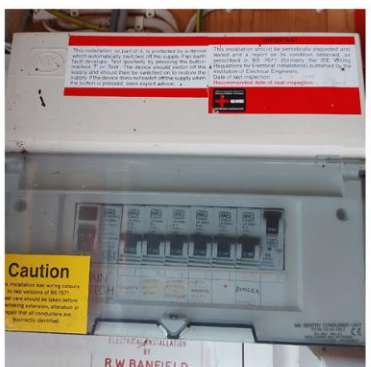
- 5.1.5 Main distribution board in working condition. It is recommended that the board is changed to a metal fireproof board in line with the current regulations.

B104	External Timber windows	External windows are showing signs of minor rot, water ingress and heavily weather externally - refurbish and redecorate all timber windows	C	2			£ 2,805.00		
B105	Timber Sills	Externally the timber sills and timber cladding below the sills are showing signs of damp and rot - Refurbish / re-decorate the sills and adjust so they are aiding the runoff of rainwater	C	2			£ 982.50		
B106	Main Floor	Concrete floor slab is scuffed and marked - reseal with a new surface finish	B	3				£ 2,002.50	
IMAGE REFERENCE	SERVICE TYPE & LOCATION	OBSERVATIONS	CONDITION GRADING	PRIORITY GRADING	STATUTORY COMPLIANCE	PRIORITY COSTINGS			
						P1	P2	P3	P4
ELECTRICAL ENGINEERING									
E201	Main Incoming Data	Incoming Data services cable sheathing degraded/ cracking. Utility Eng to investigate	C	1		£ -			
E202	Main distribution board	PVC Distribution board, recommend replacing with metal fireproof in line with BS7671	B	4					£ 600.00

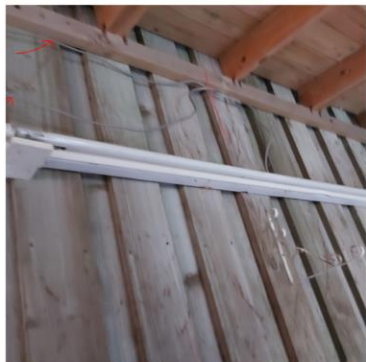
E204: Final circuit cables not supported.

- 5.1.7 Final circuit cables not supported. Cables to be supported using metal clips/ containment system.
- 5.1.8 Generally, the electrical installation is in a useable condition, however due redesign and upgrades to the latest BS7671 wiring regulations.

E203	Internal Lighting	Internal lighting missing diffusers. No Emergency lighting.	C	1		£ 3,000.00			
E208, E209	External lighting	External lighting and photocell diffuser degradation, replace.	C	2			£ 1,800.00		
E204, E205, E206	Final circuit cable supports	Final circuit cables not supported. Conduit required.	C	1		£ 375.00			
E212, E214, E215	Socket outlets	Addition of socket outlets within ambulance station	C	4					£ 720.00

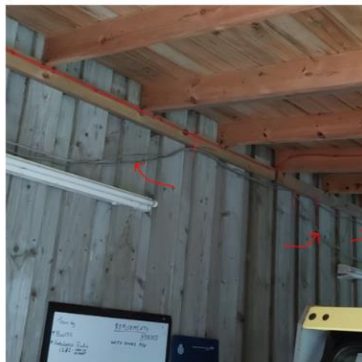
E205: Final circuit cables not supported.

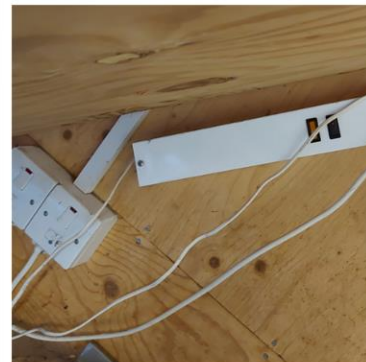
E206: Final circuit cables not supported.

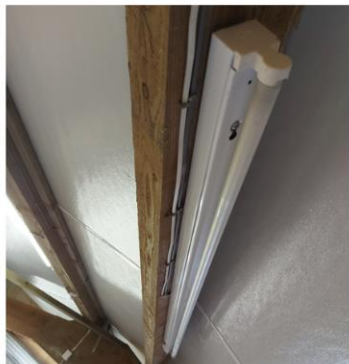
E207: Internal lighting missing diffuser and not working.

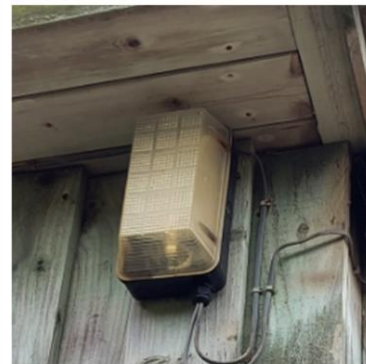
E209: External lighting diffuser degraded.

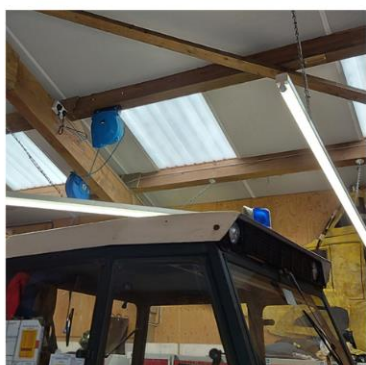
E210: Internal lighting working. IK rated diffusers required.

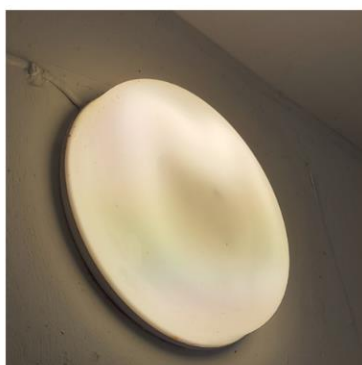
E211: Internal lighting, past economic life

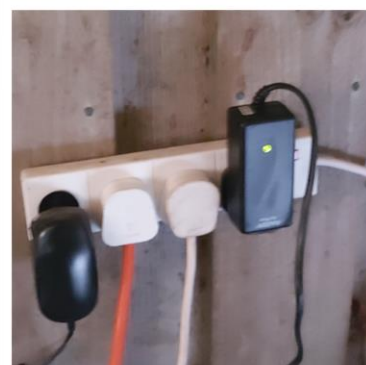
- 5.5.1 Majority of socket outlets in the station appear to be past their economic life.
- 5.5.2 Ambulance station fed from an extension cable from the fire station. Consider redesign to provide adequate socket outlets.
- 5.5.3 Sockets in close proximity to water sources.
- 5.5.4 A Periodic Test & Inspection should be carried out in line with BS7671.

E212: Ambulance extension from fire station. Consider redesign

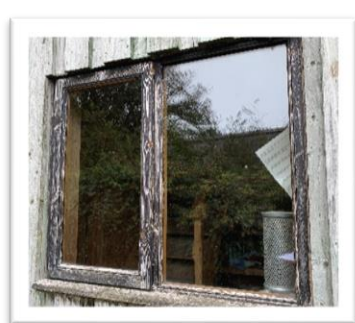
B104: External windows are showing signs of minor rot, water ingress and heavily weather externally

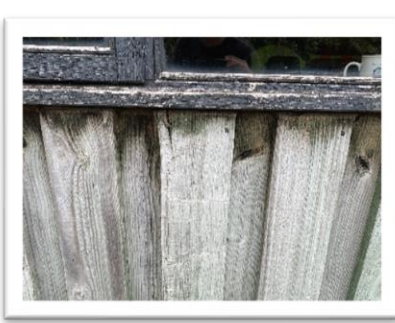
B105: Externally the timber sills and timber cladding below the sills are showing signs of damp and rot

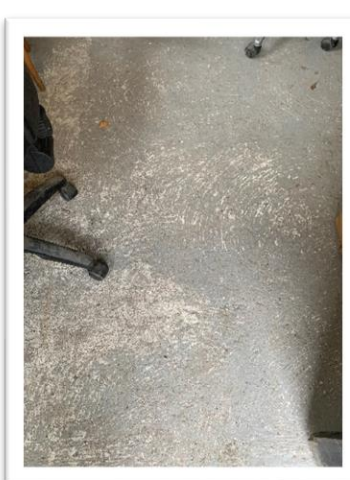
B106: Concrete floor slab is scuffed and marked - reseal with a new surface finish
