Isles of Scilly Condition Survey
Council of the Isles of Scilly
St. Marys

Condition Survey Report

St Agnes Public Convenience Revision
P02

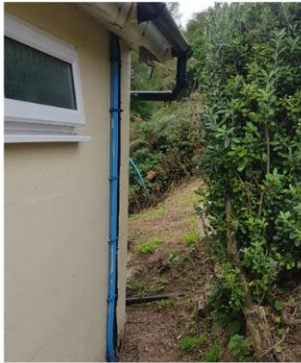
M101: Water inlet pipes.

-	Fire alarm risk assessment	Fire alarm specialist to perform risk assessment to determine the need for a fire alarm system in line with BS5839.	-	1	£1,800.00				
MECHANICAL ENGINEERING									
M101	Water Inlet Pipes	Water inlet pipe needs insulating from frost	C	1		£300.00			
M102	Flex Waste Pipe	Flex waste pipe is at a 90-degree turn - this will disrupt flow - needs replacing.	C	1		£300.00			
M103	Corroded Urinal Waste Pipes	Urinal pipes are corroded, need changing	C	1		£300.00			
M105	Disconnected Pipework	Pipes need securing and re-connecting	C	1		£300.00			
M106	Constantly Running Booster Pump	Needs servicing and maintaining correctly	C	1		£750.00			
M107	Decommissioned Sea Water System Pipes	Decommissioned sea water system pipes to be removed from site	C	2			£150.00		
M108	Decommissioned Pumps	Decommissioned pumps to be isolated and removed from site	C	2			£150.00		
M109	Corroded Filter	Filter is corroded, needs replacing and to be maintained	D	1		£450.00

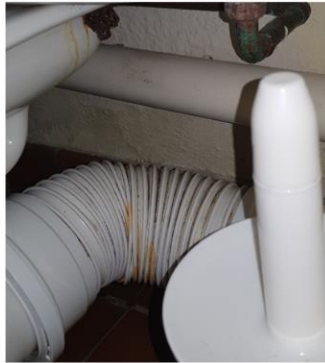
M102: Flex waste pipe + 90 degrees turn. Replace

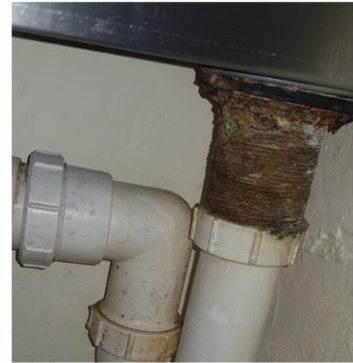
M103: Urinal waste pipes corroded.

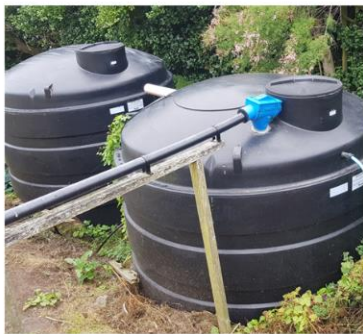
M104: Rainwater harvesting tanks.

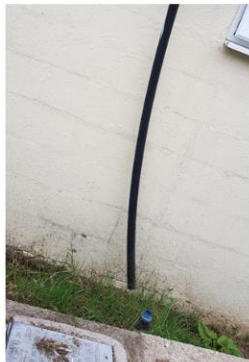
M105: Pipes not secured, disconnected.

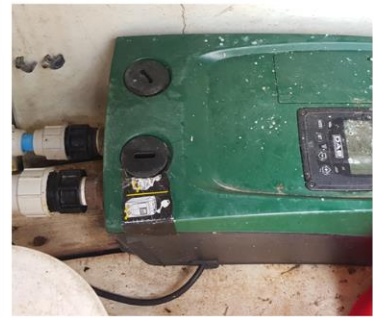
M106: Booster pump, constantly running.

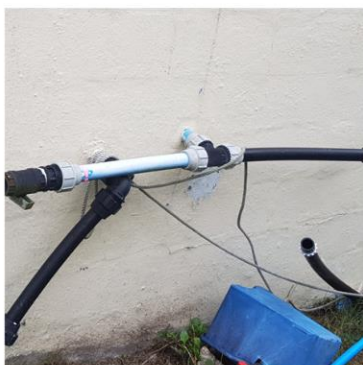
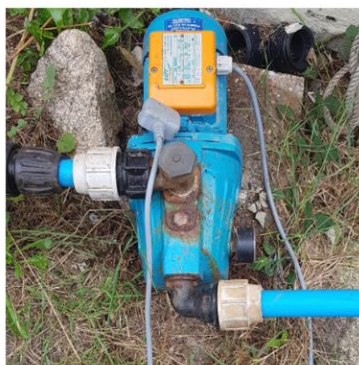
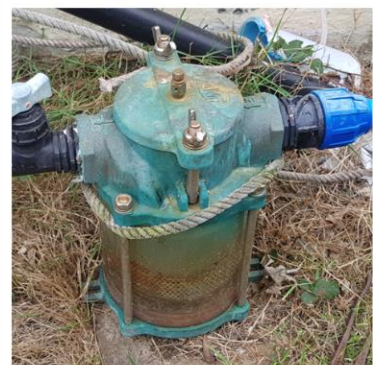
<p>M107: Decommissioned sea water system pipes to be removed from site</p>	<p>M108: Decommissioned pumps to be isolated and removed from site.</p>	<p>M109: Filter appears to be corroded and unmaintained, replace</p>

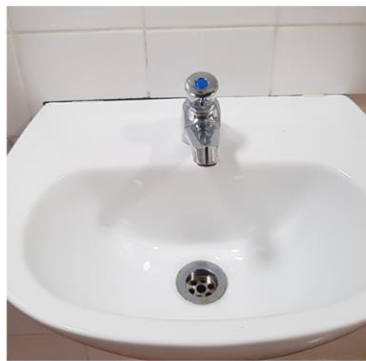
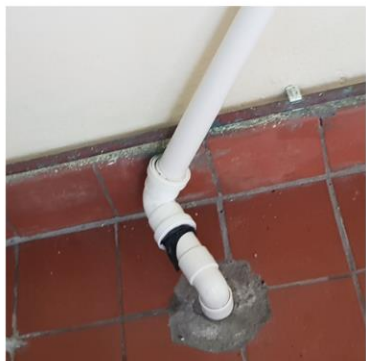
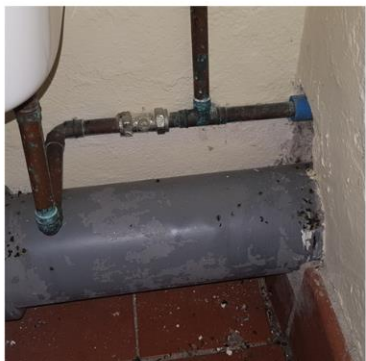
<p>M110: Recommend hot water.</p>	<p>M111: Waste pipe to be protected from mechanical damage.</p>	<p>M112: Wall to be sealed to prevent vermin access. Signs of vermin.</p>

M110	Wash Hand Basin - Hot water	Hot water recommended in wash hand basin	B	3				£2,250.00	
M111	Waste Pipe	Waste pipe needs protection from mechanical damage	B	1		£300.00			
M112	Wall to be Sealed	Signs of vermin - wall to be sealed to prevent vermin access	C	1		£150.00			
M113	Corroded Water Tanks	Signs of corrosion on water tanks, need replacing	C	2			£1,500.00		
M114	Pipework not Supported	Pipework to be insulated and supported properly	C	1		£300.00			
Total Costs					£ 3,600.00	£13,080.00	£ 9,930.00	£ 2,250.00	£ -

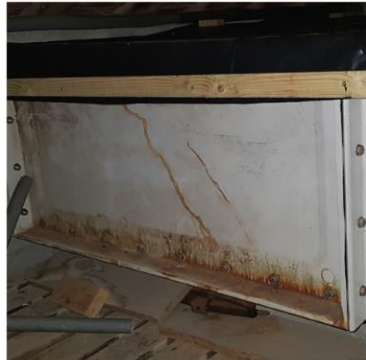
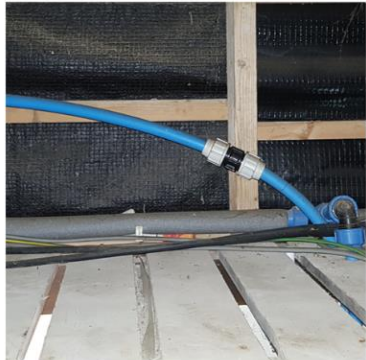
<p>M113: signs of corrosion on water tanks.</p>	<p>M114: Pipes not supported and not insulated.</p>

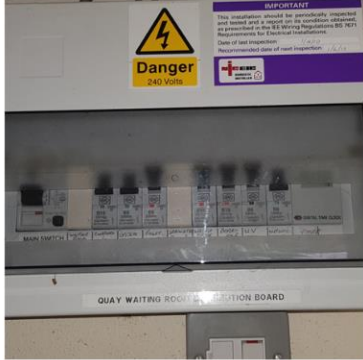
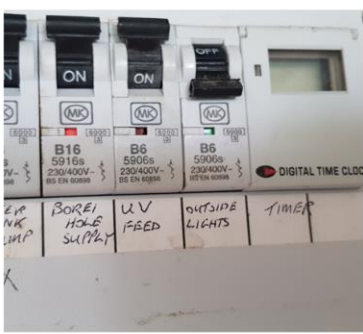
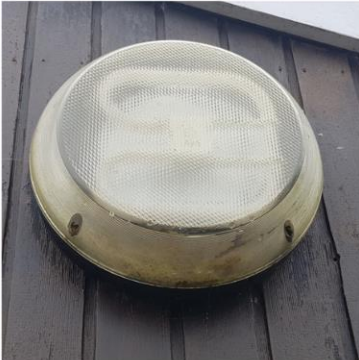
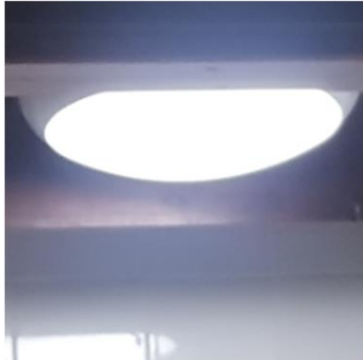
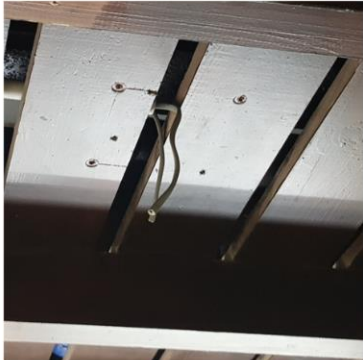
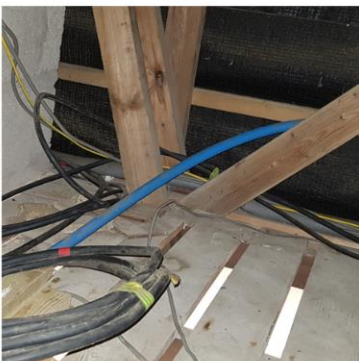
<p>E206: Cables in void not supported</p>	<p>E206: Cables to distribution board not supported.</p>

ELECTRICAL ENGINEERING									
E202	Main distribution board	Distribution board, recommend replacing with metal fireproof in line with BS7671	C	2			£600.00		
E203, E204	External lighting, WCs	Replacement of external lighting	D	1		£1,650.00			
E206	Internal lighting	Installation of internal lighting in WCs	D	1		£1,350.00			
E207, E208	Containment	Installation of cable support containment.	C	1		£600.00

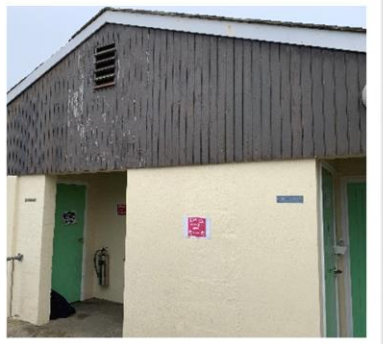
<p>B101: Heavily weather timber cladding, painted finish peeling</p>	  <p>B102: Heavily weathered timber soffits and fascias, painted finishes are peeling, rotten and corrosion stained</p>	  <p>B103: Minor expansion crack to lintel above the women's WC entrance</p>
  <p>B104: Minor deflection to timber shingle roof, curling up of edge verge tiles and small number of missing shingle tiles over the verge</p>	  <p>B105: Soiled quarry floor tiles and grouting</p>	  <p>B106: Corrosion to all door closers</p>

B103	Lintel to women's WC entrance	Minor expansion crack to lintel above the women's WC entrance - investigate further and repair / redecorate	D	1		£ 705.00

B104	Timber Shingle roof covering	Minor deflection to timber shingle roof, curling up of edge verge tiles and small number of missing shingle tiles over the verge - Investigate deflection in roof structure and replace shingle tiles	C	2			£ 2,100.00		
B105	WC Flooring	Soiled quarry floor tiles and grouting - deep clean floors throughout	C	1		£ 300.00			
B106	Door Closers	Corrosion to all door closers - replace	C	1		£ 480.00			
B107	Internal walls	Peeling, scuffed and marked paintwork to walls - Allow for redecoration throughout	C	2			£ 4,410.00		
B108	Roof Structure	Timber rafters are showing signs of active woodworm and damp - Treat rafters with woodworm treatment and investigate roof covering for the source of the water ingress and repair	D	1		£ 1,275.00			
IMAGE REFERENCE	SERVICE TYPE & LOCATION	OBSERVATIONS	CONDITION GRADING	PRIORITY GRADING	STATUTORY COMPLIANCE	PRIORITY COSTINGS			
						P1	P2	P3	P4

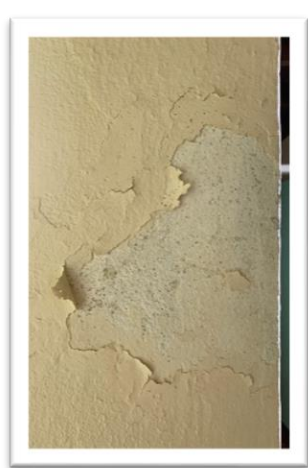
B107: Peeling, scuffed and marked paintwork to walls

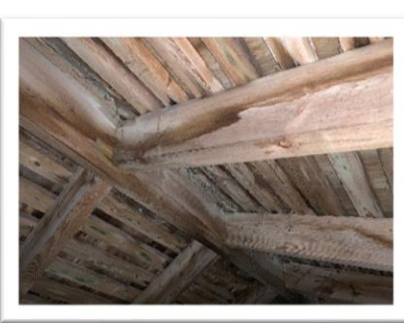
- 3.1.2 The pitched roof is finished with timber shingles over timber rafters, a limited roof void inspection found that there was no sarking felt installed, wet rafters, salt staining to the rafters and active wood worm. There were a number of missing and broken timber shingles to the roof which would benefit from being repaired/replaced imminently to prevent further water ingress. In the long term when the roof is down for replacement it would be prudent to install a sarking felt under the roof covering to help prevent water ingress and wood worm.

B108: Timber rafters are showing signs of active woodworm and damp
