Isles of Scilly Condition Survey
Council of the Isles of Scilly
St. Marys

Condition Survey Report

St Marys Fire and Emergency Station
Revision P02

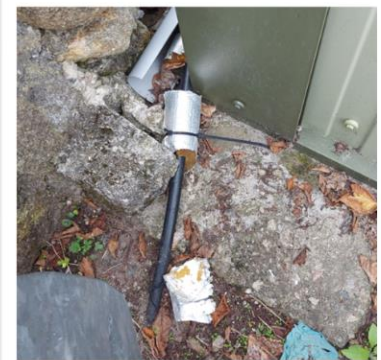
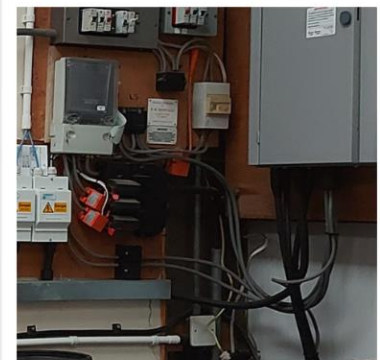
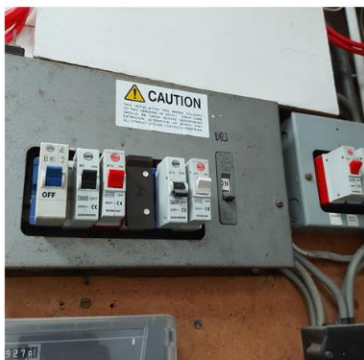
<p>E201: Incoming cable not protected from mechanical damage.</p>	<p>E202: Incoming supply terminated in vehicle store. Cables to be supported.</p>	<p>E203: Distribution boards, past economic life.</p>

- 5.1.1 The Fire and Emergency Station is served from a WPD electrical supply and a grid connected PV system. The supply enters the building via SWA cable and terminates within the main vehicle store area.
- 5.1.2 Incoming SWA electrical cable exposed. Recommend boxing the cable to protect against mechanical damage.

- 5.1.3 The installation has a mixture relatively old and new distribution boards. The majority of the distribution boards are past their economic life with no replacement parts and should be replaced.
- 5.1.4 The electrical services are distributed throughout the rest of the building via a network of SWA cables and PVC cables. A combination of MCBs and RCBO protection devices are installed to provide protection to the final small power and lighting circuits.
- 5.1.5 The distribution system should be tested regularly to BS7671.

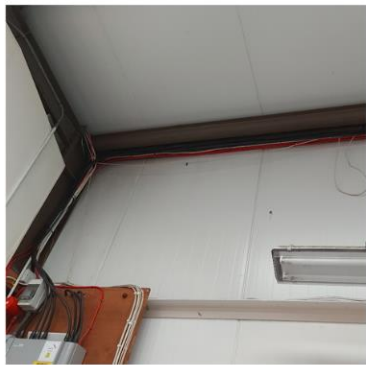
E204: Cables not segregated.

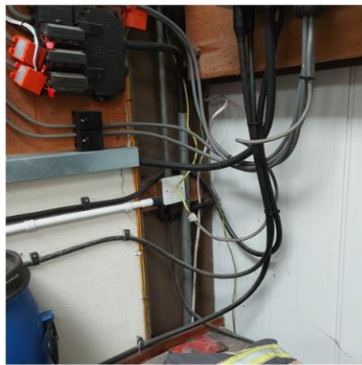
E205: Cable segregation required.

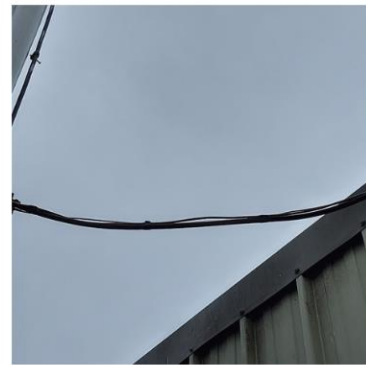
E206: External cables to be supported

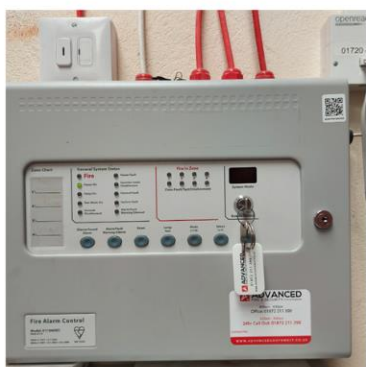
E207: Fire alarm panel in good condition.

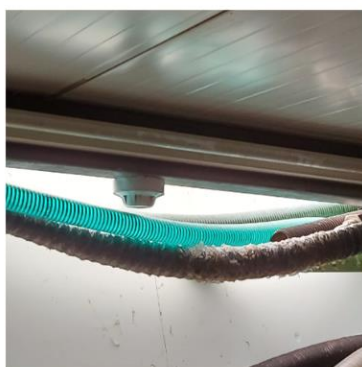
E208: Fire alarm detector heads – recommend repositioning.

- 6.1.1 Fire alarm specialist to perform risk assessment to determine the need for moving detector heads away from wall to comply with BS5839 - 1.
- 6.1.2 Lightning protection specialist to perform a risk assessment in line with BS EN 52306 and BS7671 to determine the need for a lightning protection system and surge protection.

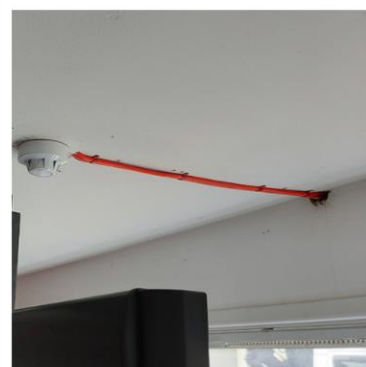
E209: Fire alarm detector heads – recommend repositioning.

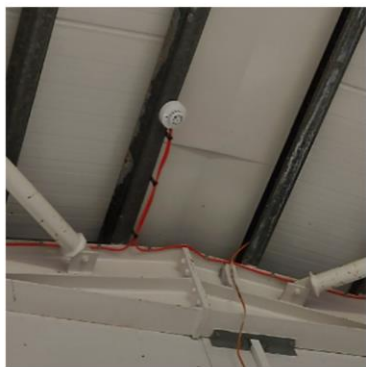
E210: Fire alarm detector heads – recommend repositioning.

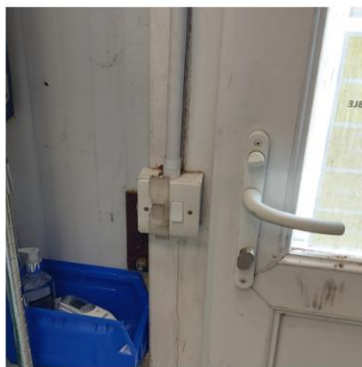
E211: Lighting control appears old and taped. Recommend testing/ replacing.

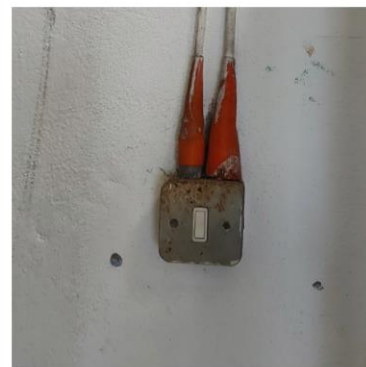
E212: Lighting controls appear to be past economic life.

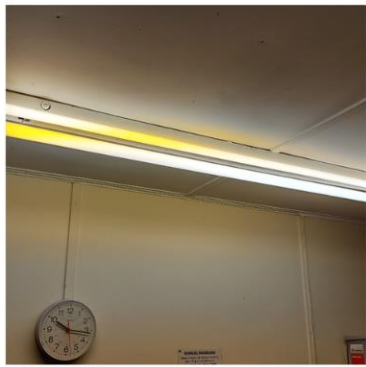
E213: Lighting appears reduced light output, diffuser missing.

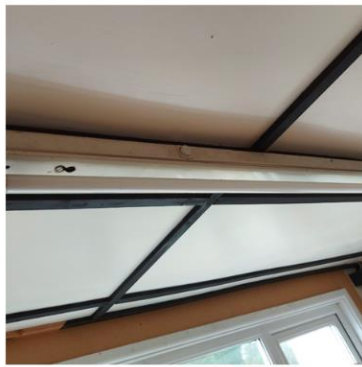
E214: Light fitting diffuser missing.

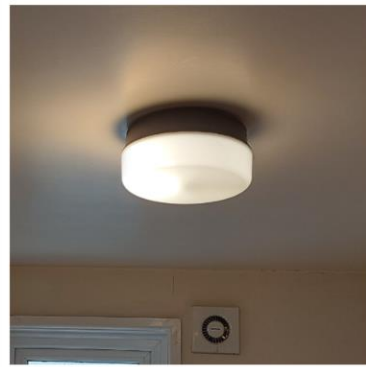
E215: Circular surface downlight, reduced light output.

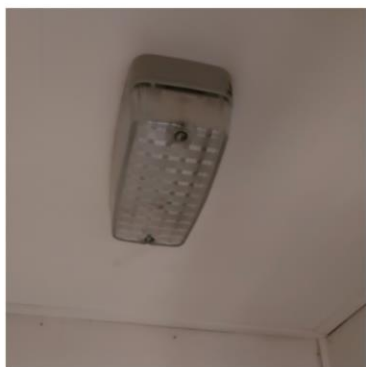
E216: Bulkhead fitting not working.

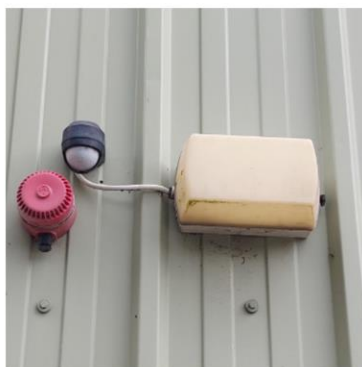
E217: External lighting degraded diffuser and PIR detector.

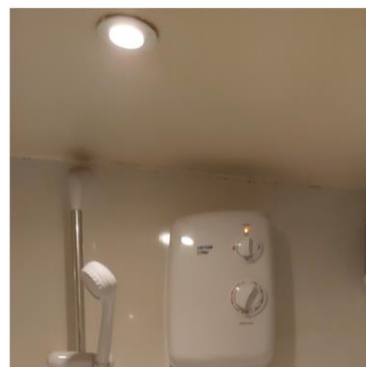
E218: Shower room light fitting - wrong IP rating, luminaire detaching from ceiling.

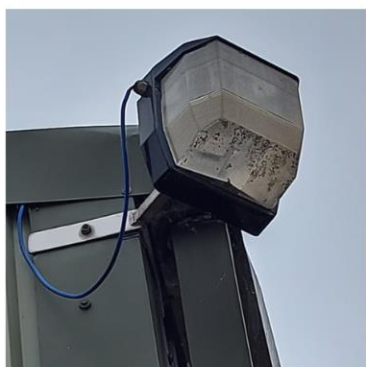
E219: External lighting with signs of water ingress.

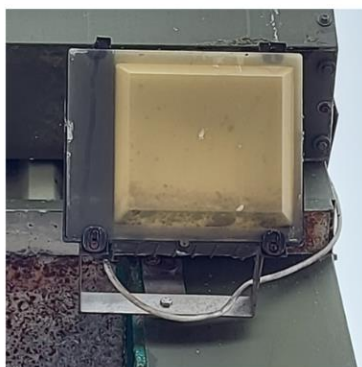
E220: External lighting degraded diffuser and internal algae growth.

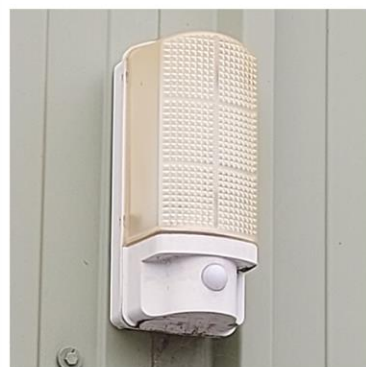
E221: External lighting degraded diffuser.

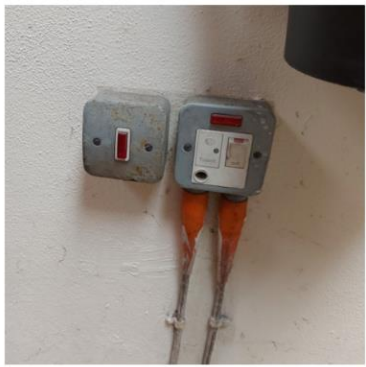
<p>E222: Exposed socket outlets. Protective blanking plate required.</p>	<p>E223: Socket outlets past economic life – replace.</p>	<p>E224: Socket outlets past economic life – replace.</p>

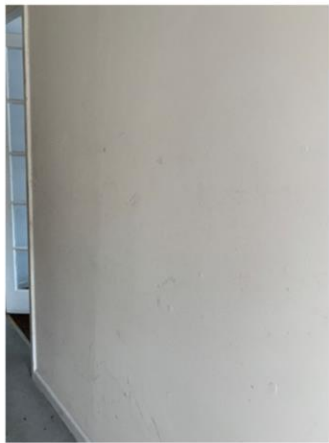
B104: Marked, scuffed walls and joinery throughout, minor making good

B103	Internal Doors	Broken ironmongery, worn and marked surface finishes - redecorate all doors and overhaul	C	1		£ 1,425.00			
B104	Walls / Joinery, GF & 1st FL	Marked, scuffed walls and joinery throughout, minor making good - allow for redecoration throughout the ground and 1st floor	C	2			£ 5,475.00

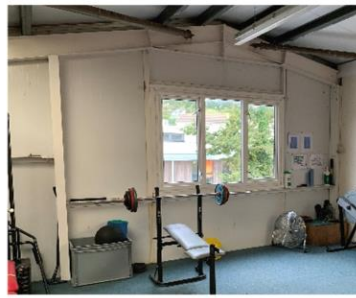
B105: Generally in good condition however would benefit from being eased throughout

B105	Windows	Generally in good condition however would benefit from being eased throughout	B	2			£ 360.00		
B106	Flooring	Concrete flooring pitted, worn and marked / Vinyl flooring worn and stained / markings faded - Replace all Vinyl flooring and re-seal floor to the vehicle garages and stores, renew markings	C	2			£11,550.00		
B107	Sliding Shutter doors	Corrosion to the top and bottom of all 3No. Shutters / Corrosion to the door frames and reveal - replace corroded sections / remove corrosion and treat areas - Overhaul and ease	D	1		£ 9,750.00			
B108	Mezzanine stair	Worn painted finish - renew	C	2			£ 315.00		
B109	External Area	Tarmacadam to the front and sides of the building are worn and breaking up - remove tarmacadam surface and replace with new	D	1		£33,000.00			
B110	Vegetation	Vegetation to the front of the building at ground level, rear box gutter, beneath rear exit grate, drains - remove	C	2			£ 307.50

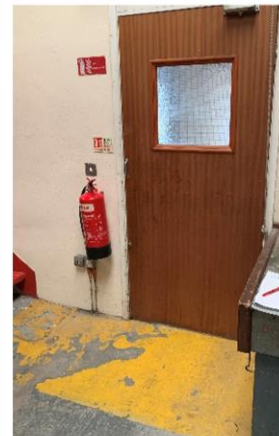
B106: Concrete flooring pitted, worn and marked / Vinyl flooring worn and stained / markings faded

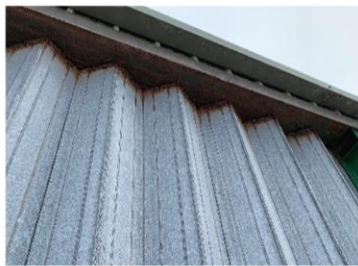
B107: Corrosion to the top and bottom of all 3No. Shutters / Corrosion to the door frames and reveal

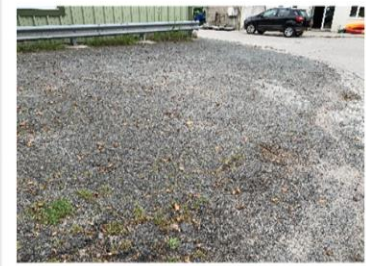
B109: Tarmacadam to the front and sides of the building are worn and breaking up

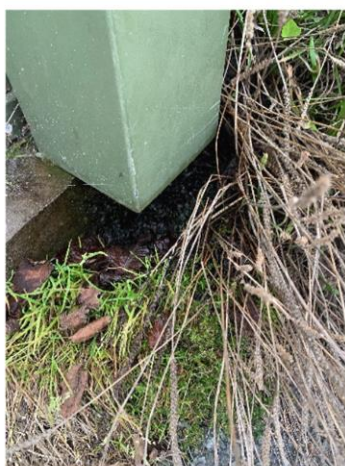
B110: Vegetation to the front of the building at ground level, rear box gutter, beneath rear exit grate, drains - remove

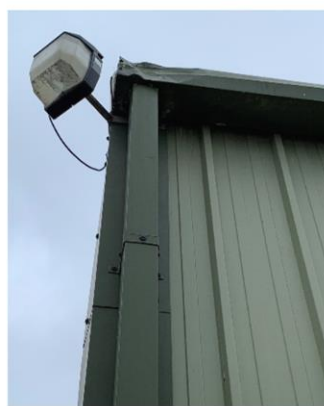
B111: Impact damage to 2No. Panel, Corroded rivets to cladding sheets

B111	Cladding	Impact damage to 2No. Panel, Corroded rivets to cladding sheets - repair panels and cover rivets with caps	B	3				£ 870.00	
B112	Roofing	Cut edge corrosion to the corrugated panel roof - Repair panels with cut edge corrosion treatment	D	1		£11,700.00			
IMAGE REFERENCE	SERVICE TYPE & LOCATION	OBSERVATIONS	CONDITION GRADING	PRIORITY GRADING	STATUTORY COMPLIANCE	PRIORITY COSTINGS			
						P1	P2	P3	P4
ELECTRICAL ENGINEERING									
E201	Main Incoming LV	Incoming LV cables to be protected from damage.	D	1		£1,800.00			
E202, E204, E206,	Main distribution	Main LV cables to be supported in cable containment.	B	2			£600.00

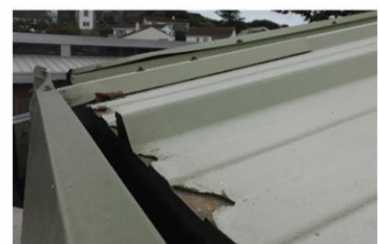
- 3.1.2 The pitched roof covering, has a coated profile metal sheet finish, powder coated pre-formed metal verges and powder coated box profile gutters with square downpipes. An inspection of the roof covering showed a high degree of cut edge corrosion throughout the roof and should be treated as a priority to prevent the corrosion getting to a stage where panels will have to be replaced rather than repaired.

B112: Cut edge corrosion to the corrugated panel roof
