**6 CONCLUSIONS****6.1 General**

**APPENDIX 1: LEEWARD AND SEAWARD SIDE WAVE WALL PHOTOS**

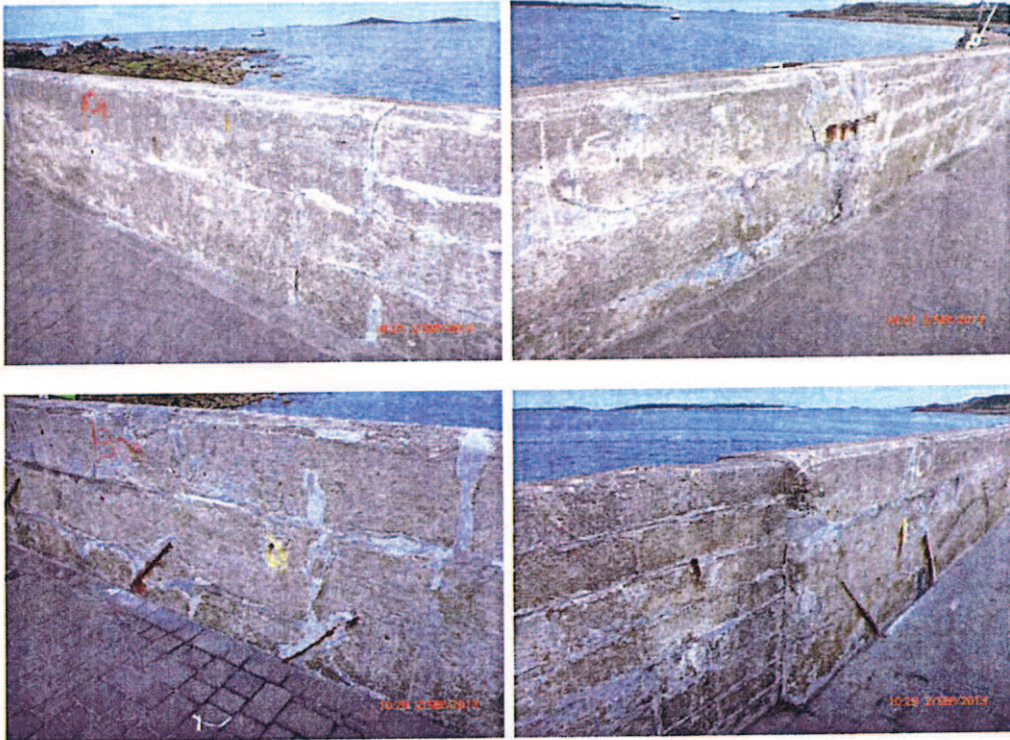
**Leeward Side**

The condition of the reinforced concrete works are heavily cracked and potentially delaminated from the existing masonry leading to the probability that the reinforcement within the section is either corroding or likely to commence corroding in the near future. These findings are substantiated from large areas of hollow sounding concrete and crack measurements from hammer sounding surveys and visual inspections respectively together with evidence of spalled concrete.

It is understood that a higher wave wall is proposed by the Duchy to improve overtopping resistance and, if this to be implemented, it is recommended that the existing wall is removed and a complete new wave wall is constructed.
