St. Mary's Quay – Wave Wall Inspection

Inspection Report

October 2013

Prepared for:
Duchy of Cornwall

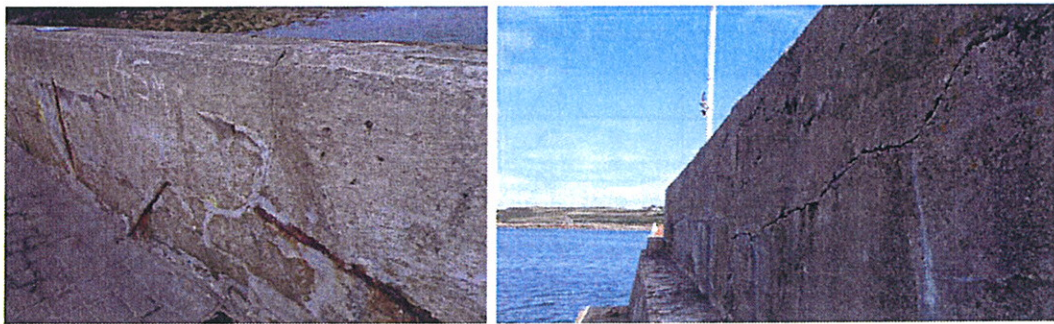
In general the structural condition of the wave wall is seriously deteriorated along the length of the leeward and seaward sides. There is considerable cracking in both the vertical and horizontal directions with crack widths ranging in sizes, examples are shown in Figure 3.

Evidence of remedial works to rectify zones of concentrated cracking is visible through large staples driven into the leeward and top of the wave wall. Areas where staples are present show concentrated cracking which is notably worse than other areas of the wall. It is unclear whether the staples are acting as a catalyst for further cracking by introducing discontinuities but it should be noted that cracking is evident which is discontinuous from the staples edges.

It is worth noting that in zones of concentrated cracking, evidence of spalling concrete is visible. The spalling of concrete ranges in sizes and is dependent on the magnitude of cracking at that location. Spalling is most notable in areas which are of a close proximity to staples from recent remedial works that coincide with the worst cracking, shown in Figure 3.

Figure 3: Evidence of Spalling and Cracking on Leeward Side (Left) and Seaward Side (Right)

Discontinuous cracking from the introduction of staples gives evidence that water ingress from these remedial works has led to the corrosion of reinforcement and further cracking.

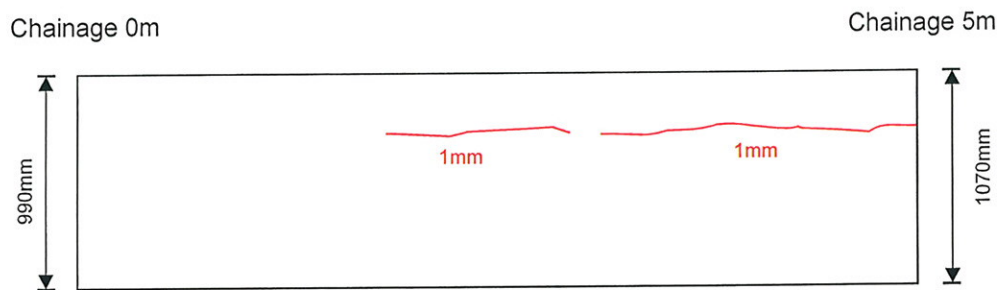
Figure 4: Wall Height, Crack Locations and Sizes for Chainages 0m to 5m

The following in Figure 4 shows the wall height, crack locations and sizes for chainages 0m to 5m from the south end of the wave wall on the leeward side only. Crack widths are averages.

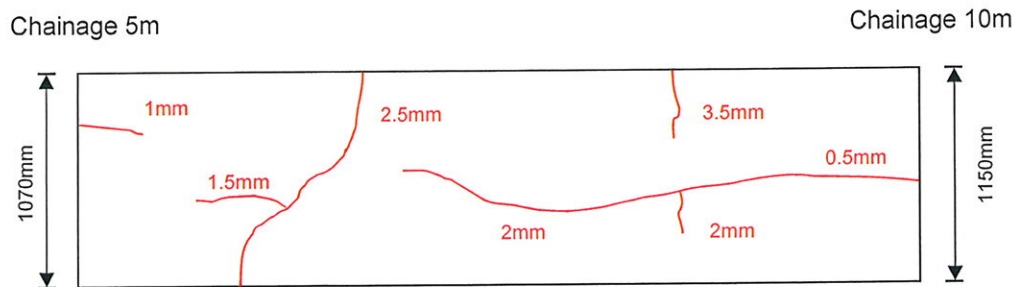
Figure 5: Wall Height, Crack Locations and Sizes for Chainages 5m to 10m

The following in Figure 5 shows the wall height, crack locations and sizes for chainages 5m to 10m from the south end of the wave wall on the leeward side only. Crack widths are averages.

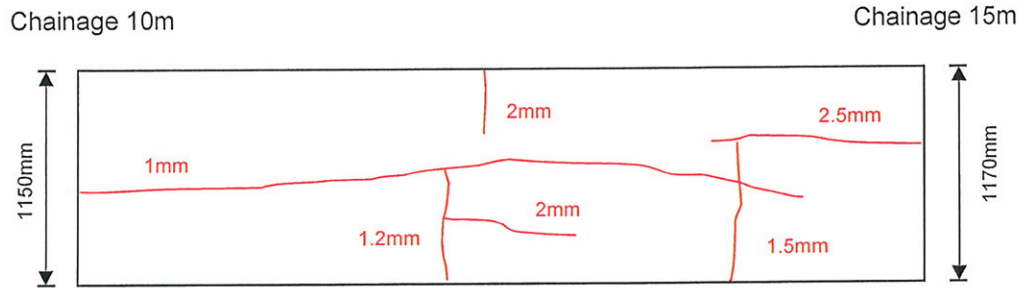
Figure 6: Wall Height, Crack Locations and Sizes for Chainages 10m to 15m

The following in Figure 6 shows the wall height, crack locations and sizes for chainages 10m to 15m from the south end of the wave wall on the leeward side. Crack widths are averages.

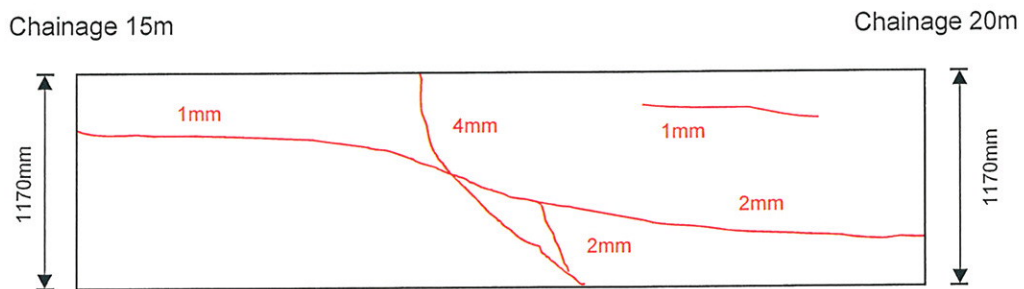
Figure 7: Wall Height, Crack Locations and Sizes for Chainages 15m to 20m

The following in Figure 7 shows the wall height, crack locations and sizes for chainages 15m to 20m from the south end of the wave wall on the leeward side. Crack widths are averages.

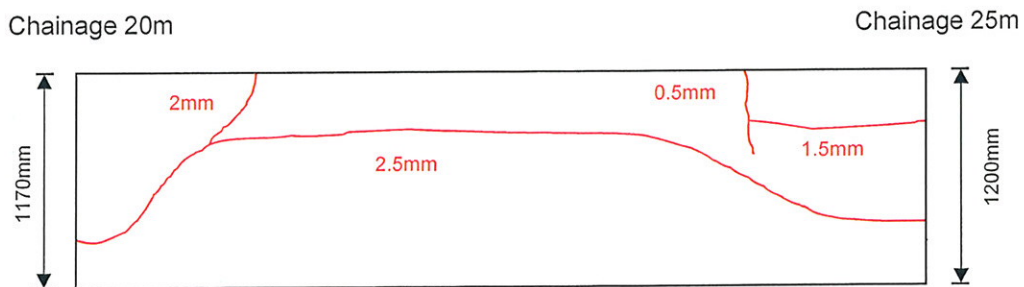
Figure 8: Wall Height, Crack Locations and Sizes for Chainages 20m to 25m

The following in Figure 8 shows the wall height, crack locations and sizes for chainages 20m to 25m from the south end of the wave wall on the leeward side. Crack widths are averages.

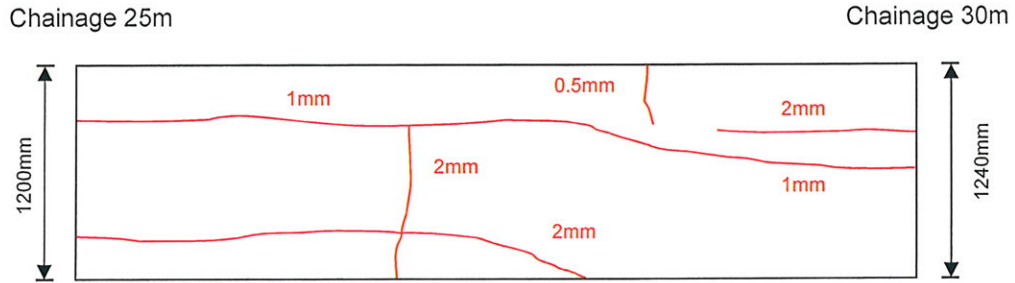
Figure 9: Wall Height, Crack Locations and Sizes for Chainages 25m to 30m

The following in Figure 9 shows the wall height, crack locations and sizes for chainages 25m to 30m from the south end of the wave wall on the leeward side. Crack widths are averages.

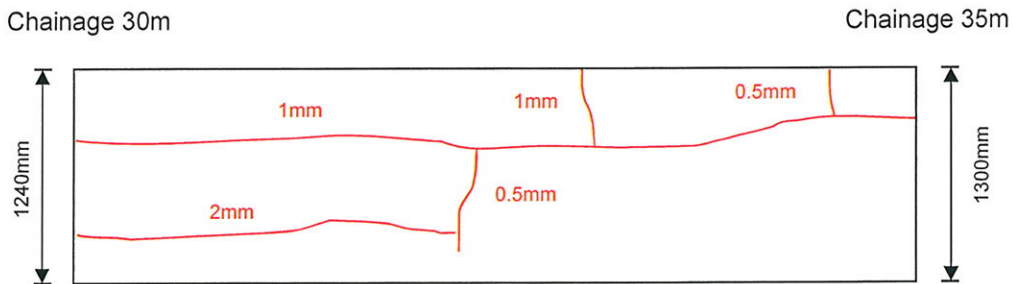
Figure 10: Wall Height, Crack Locations and Sizes for Chainages 30m to 35m

The following in Figure 10 shows the wall height, crack locations and sizes for chainages 30m to 35m from the south end of the wave wall on the leeward side. Crack widths are averages.

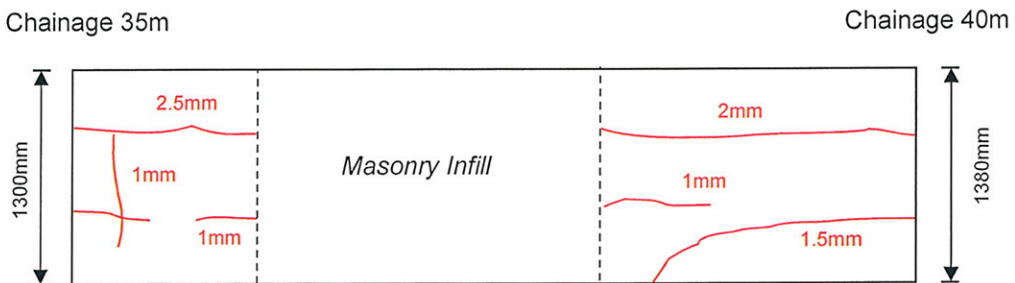
Figure 11: Wall Height, Crack Locations and Sizes for Chainages 35m to 40m

The following in Figure 11 shows the wall height, crack locations and sizes for chainages 35m to 40m from the south end of the wave wall on the leeward side. Crack widths are averages.

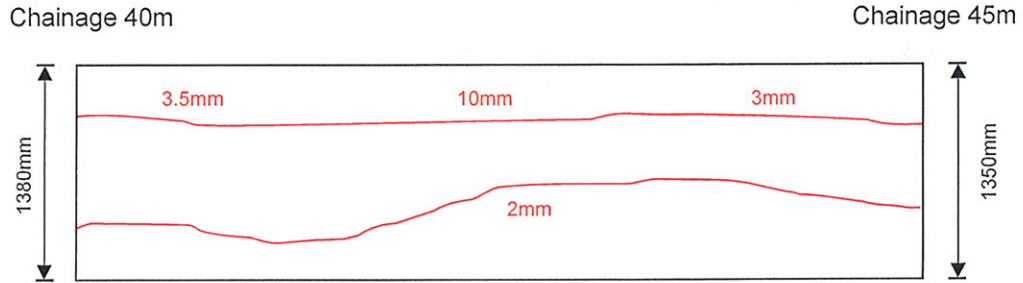
Figure 12: Wall Height, Crack Locations and Sizes for Chainages 40m to 45m

The following in Figure 12 shows the wall height, crack locations and sizes for chainages 40m to 45m from the south end of the wave wall on the leeward side. Crack widths are averages.

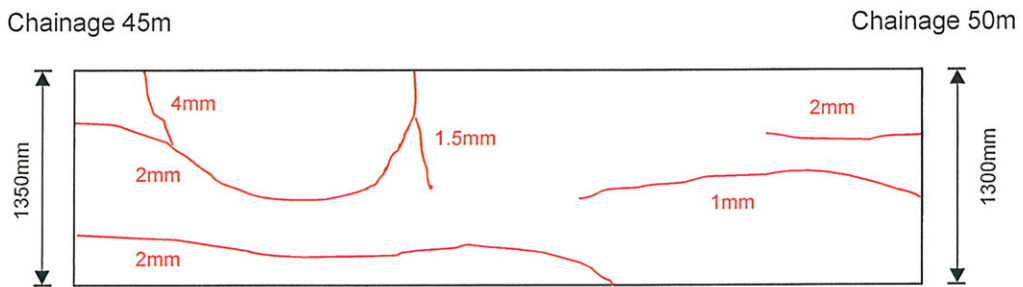
Figure 13: Wall Height, Crack Locations and Sizes for Chainages 45m to 50m

The following in Figure 13 shows the wall height, crack locations and sizes for chainages 45m to 50m from the south end of the wave wall on the leeward side. Crack widths are averages.

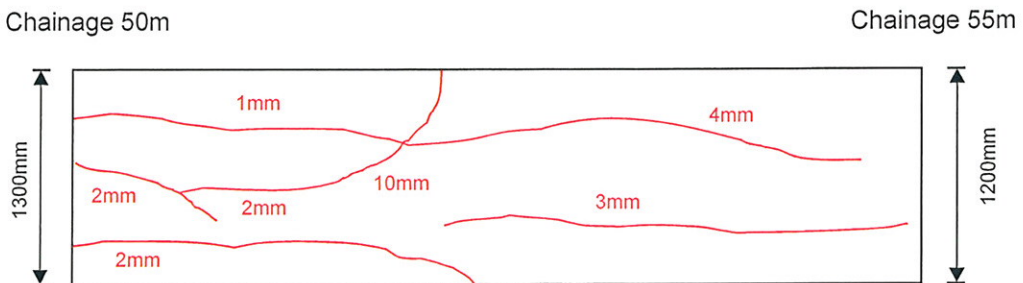
Figure 14: Wall Height, Crack Locations and Sizes for Chainages 50m to 55m

The following in Figure 14 shows the wall height, crack locations and sizes for chainages 50m to 55m from the south end of the wave wall on the leeward side. Crack widths are averages.
