## Heritage Impact Assessment – Shearwater House: Rebuilding of Right Chimney Stack

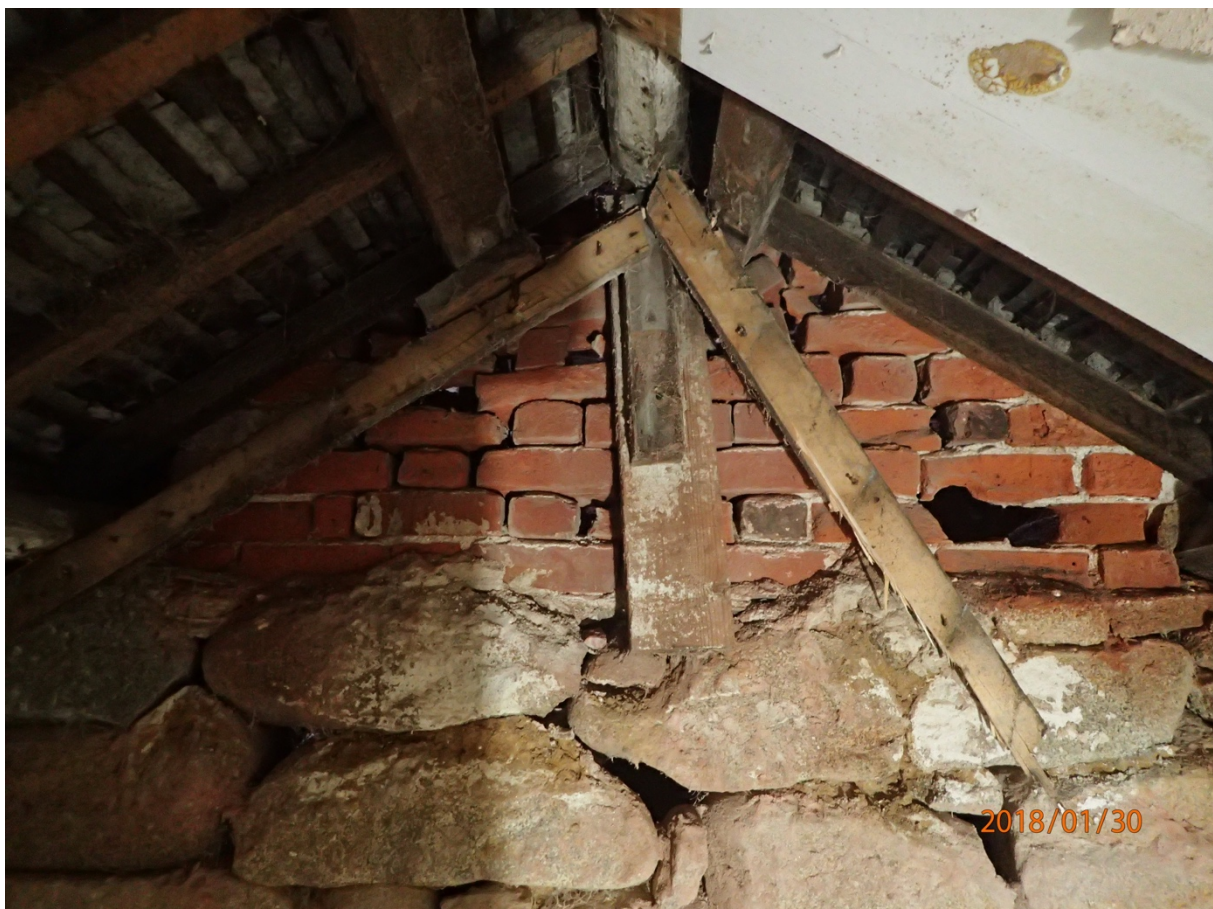
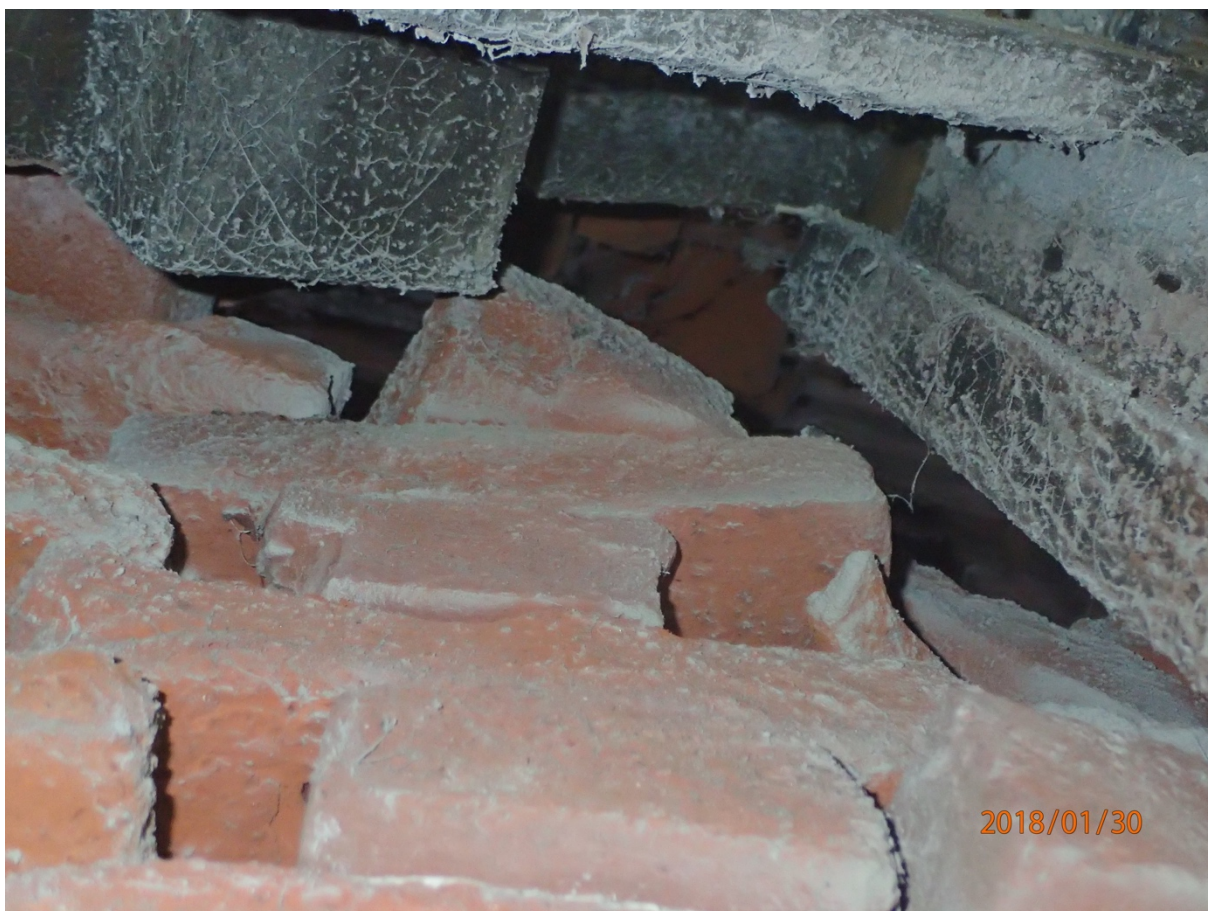
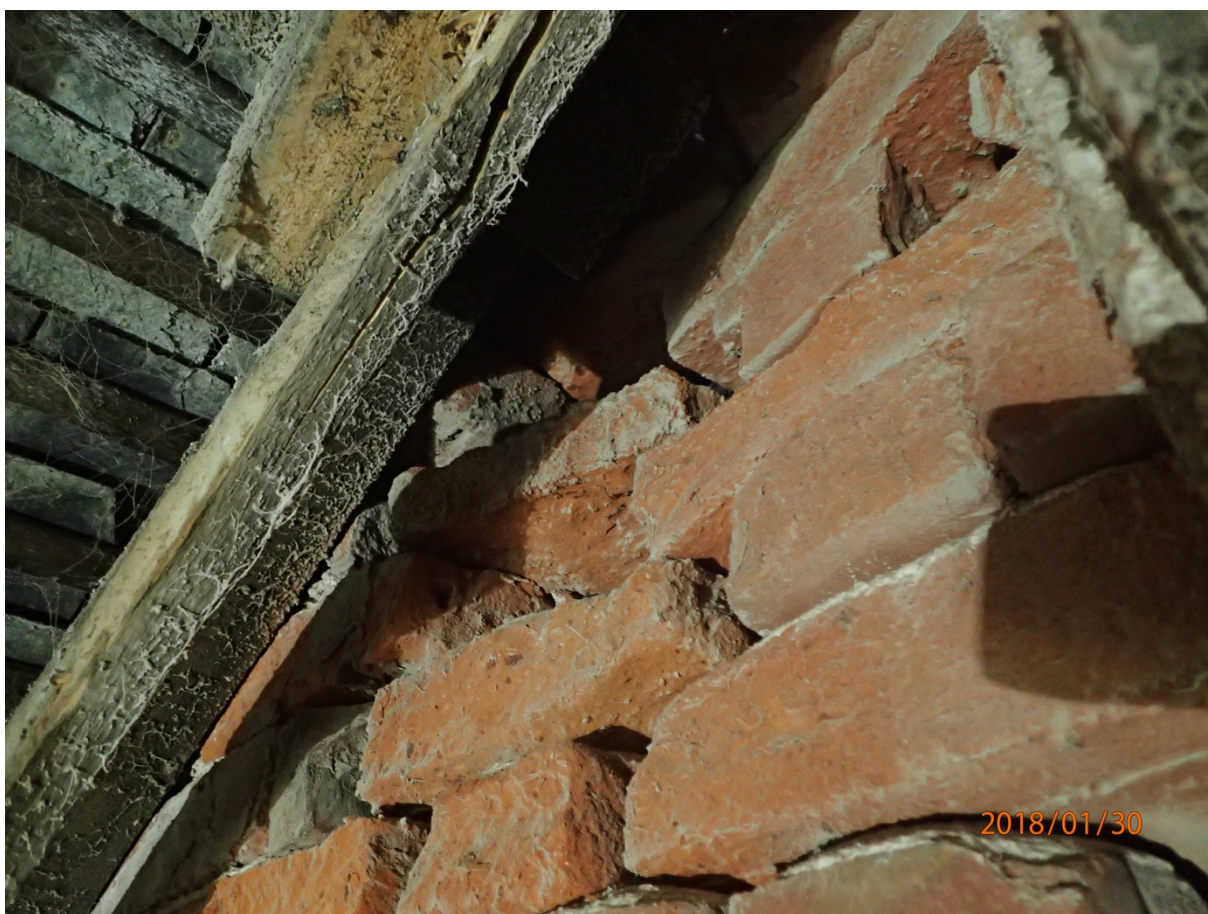
After consultation on site with Building Control, the managers of the adjacent adjoining property, and contractors, it was agreed that the condition of the top of the gable wall underneath the stack is vulnerable to collapse, and is therefore not satisfactory. The photos below shows the current condition of the supporting wall, indicating the loose or missing stonework/bricks, leaving the ridge and upper purlins not properly supported.

It was concluded that in order to ensure that the stack remains secure, it requires rebuilding as soon as is practical, along with the stack itself (as this would be required if the wall below is rebuilt).

- Based on advice from Building Control and experienced contractors, and also the Ian Sibley, the Chartered Surveyor acting as our local agent, we are proposing that there is an immediate need to rebuild the right hand chimney stack, along with the supporting wall immediately underneath it, in order to ensure the stack remains secure and safe, and that the rest of the listed property is appropriately protected from damage should the stack collapse.

- We would propose to rebuild the stack to its current design.
- Where possible, existing materials will be reused, and where they are found to be too damaged to be reused safely, they will be replaced with materials very closely matched to the original brick.
