Condition Survey – The Blockhouse 1-4, Tresco

Address	The Blockhouse, Old Grimsby
Survey Date	10th September 2020
Prepared by	Ky Cheal MRICS
Approved by	Paul Chamings MRICS

Version	Final
Date of issue	7th October 2020

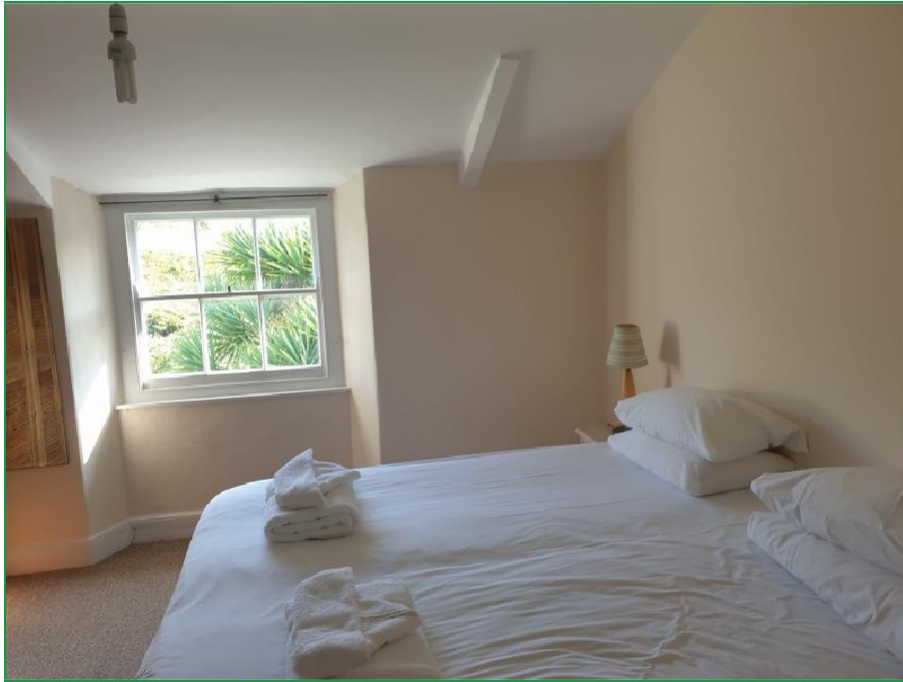
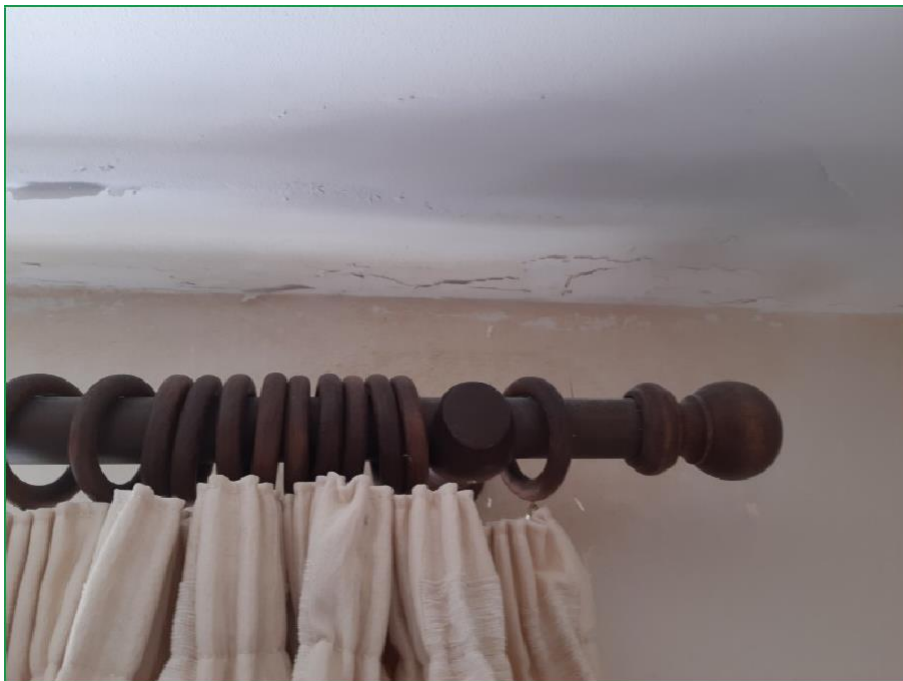
Photo 3Photo 4
External	Windows and Doors	Windows - Mix of single glazed timber casement and double hung sliding sash and UPVC double glazed double hung sliding sash	Poor	Timber sliding sashes are in a mixed condition with some broken sash cords, broken or missing latches and casements painted shut. UPVC framed double hang sashes are also in poor condition and difficult to operate. Allow to remove windows complete and renew with modern energy efficient but conservation approved casement / double hung sliding sash double glazed windows. Allow for 24 nr standard size double hung sliding sash, 12 no small casement windows.

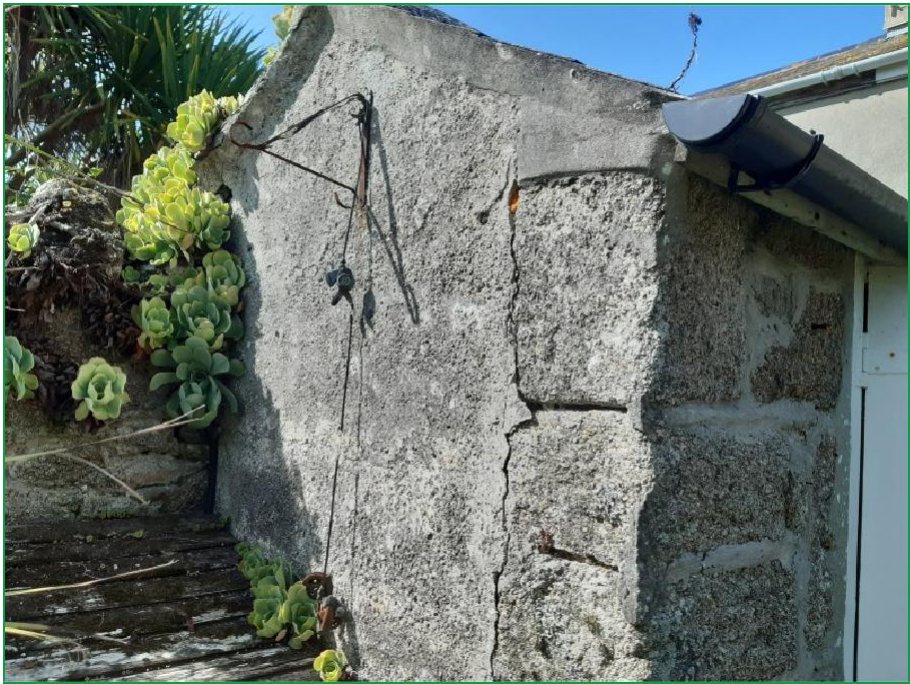
Photo 5

Area	Location	Element	Condition	Description	Photo
External	Windows and Doors	Doors - Timber external doors. 4 x external door per property for numbers 2,3 & 4. 5 x doors for No 1. 17 nr in total. Front doors are top section glazed panel doors.	Fair	Extent of required repairs dictates that it will be economic to allow to renew with modern timber double glazed energy efficient timber doors as part of refurbishment scheme. Allow for 17 external doors	
External	Structure	Main Walls - Granite block	Satisfactory	Granite block solid wall construction, no structural defects noted generally. No work required.	
External	Structure	Main Walls - Pointing	Poor	Solid granite block walls have been pointed with cement mortar. Where granite block is exposed there are some areas with missing or damaged pointing. Allow to hack out cement mortar pointing across the terrace and renew with lime mortar.

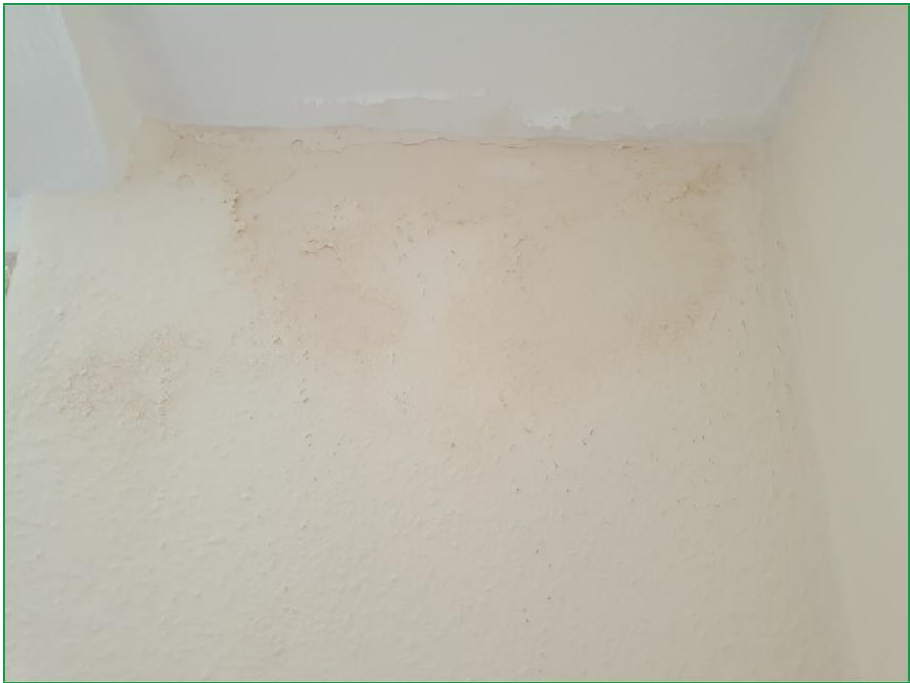
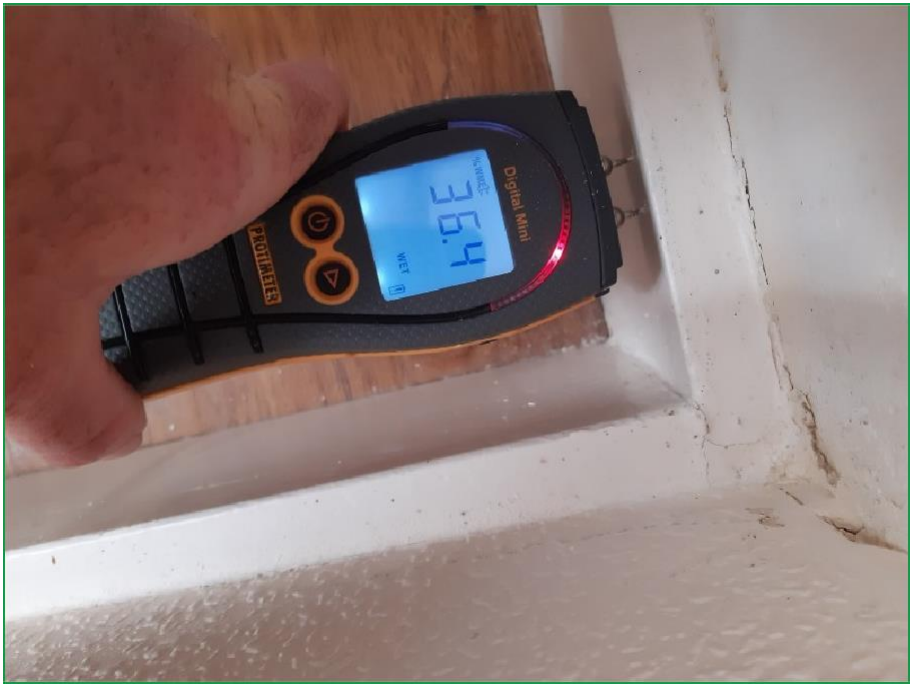
Area	Location	Element	Condition	Description	Photo
Internal	Structure	Internal Walls/ Partitions - Granite block to external walls and main internal walls, some assumed timber stud internal partitions.	Fair	External and internal walls to the ground floor appear to be of solid granite block construction and finished with a mixture of cement board, gypsum plaster and cement render. The walls are saturated in some areas and returning high damp readings in others. Damp readings correlate with adjacent joinery elements.

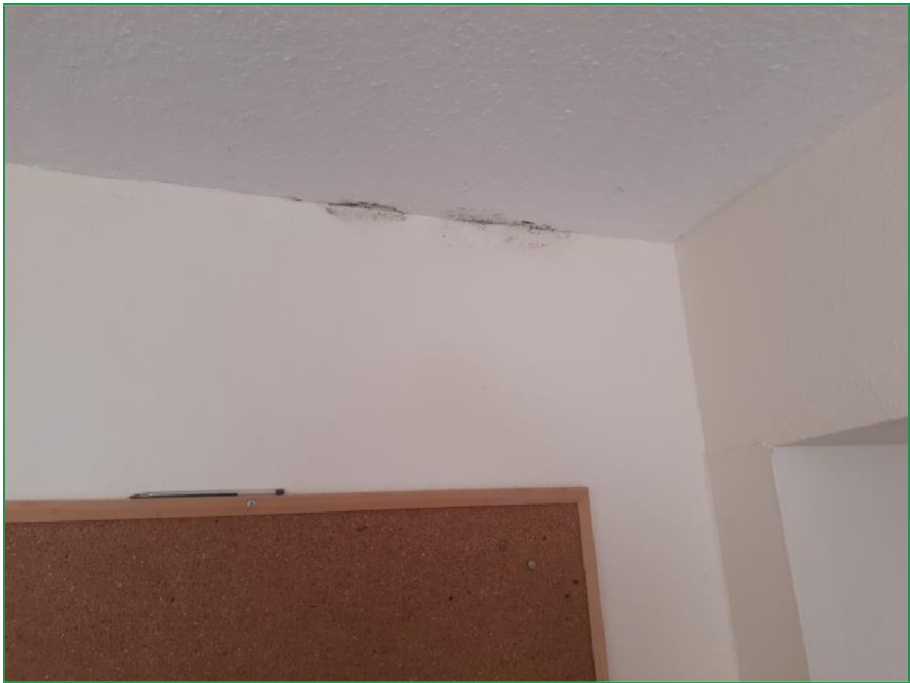
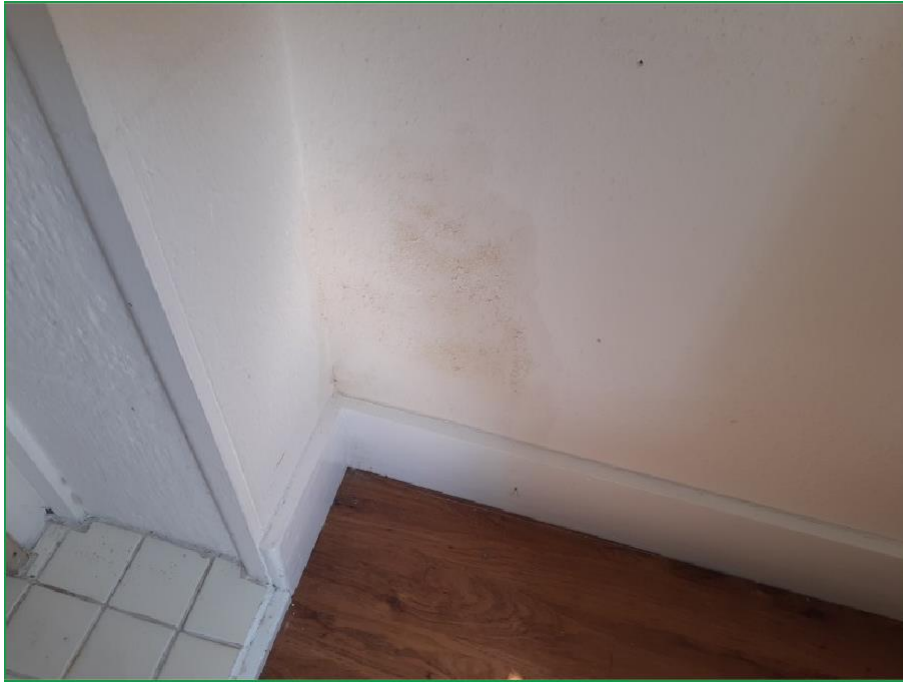
<p>Photo 8</p> <p>Photo 9</p>
Internal	Walls	Internal Walls/ Partitions - Solid/ Plastered	Poor	Internal faces of external walls and some internal walls subject to some significant dampness likely as a result of cement render and pointing externally and gypsum plaster internally. Allow to hack off gypsum plaster complete and renew with lime plaster.

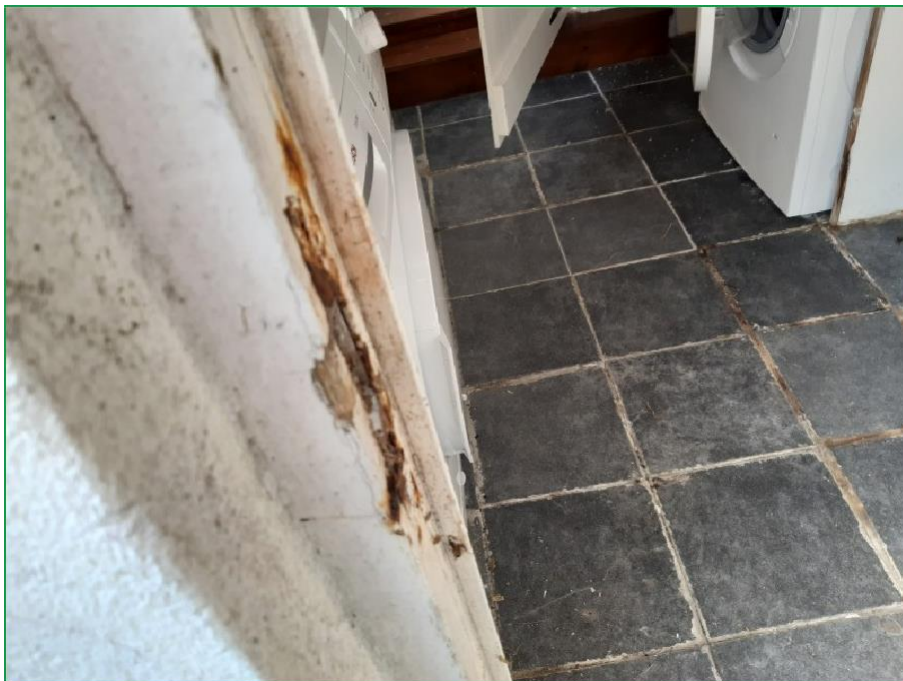
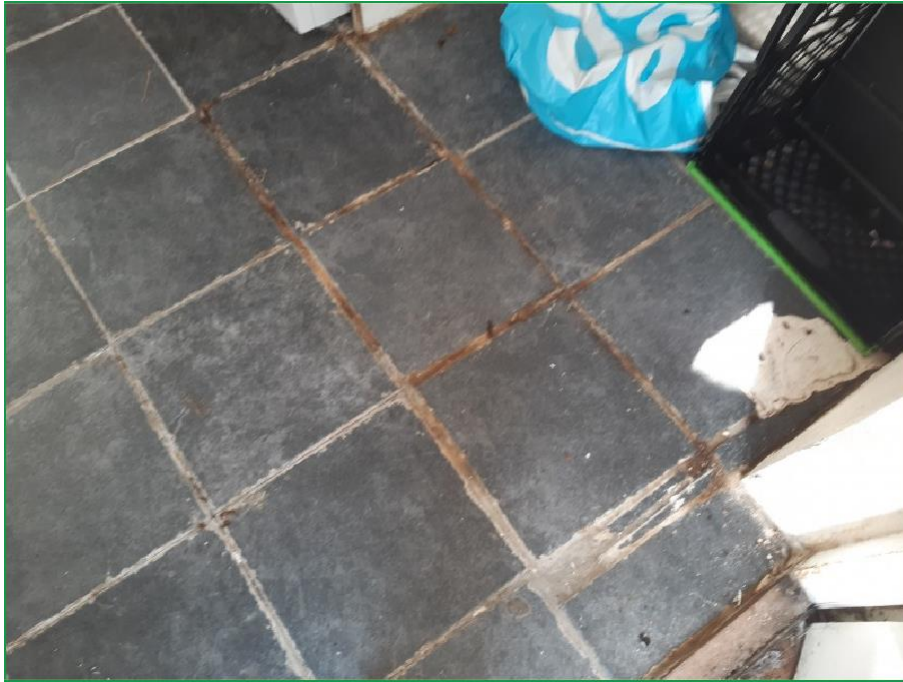
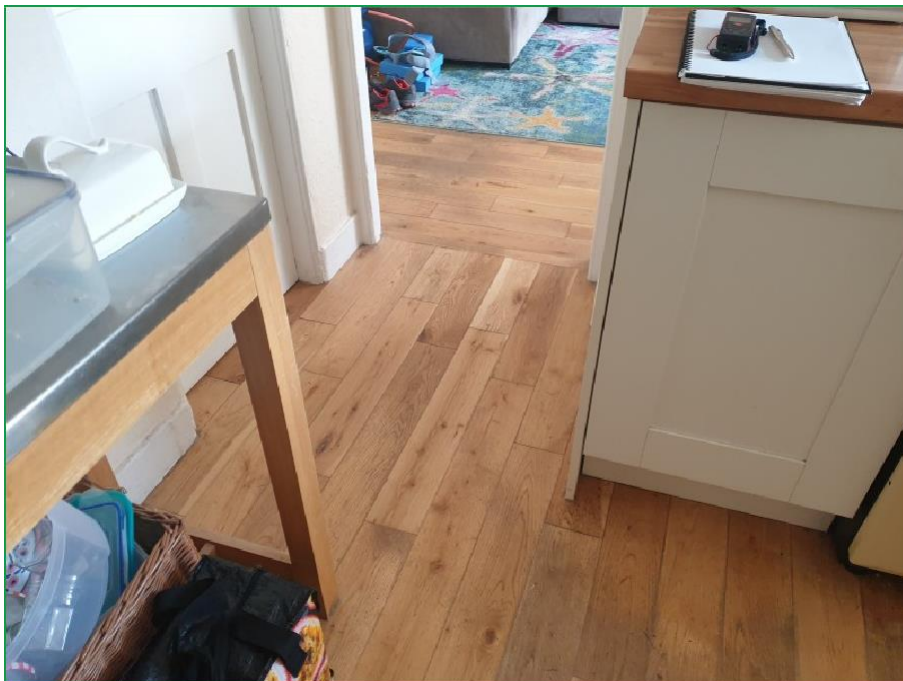
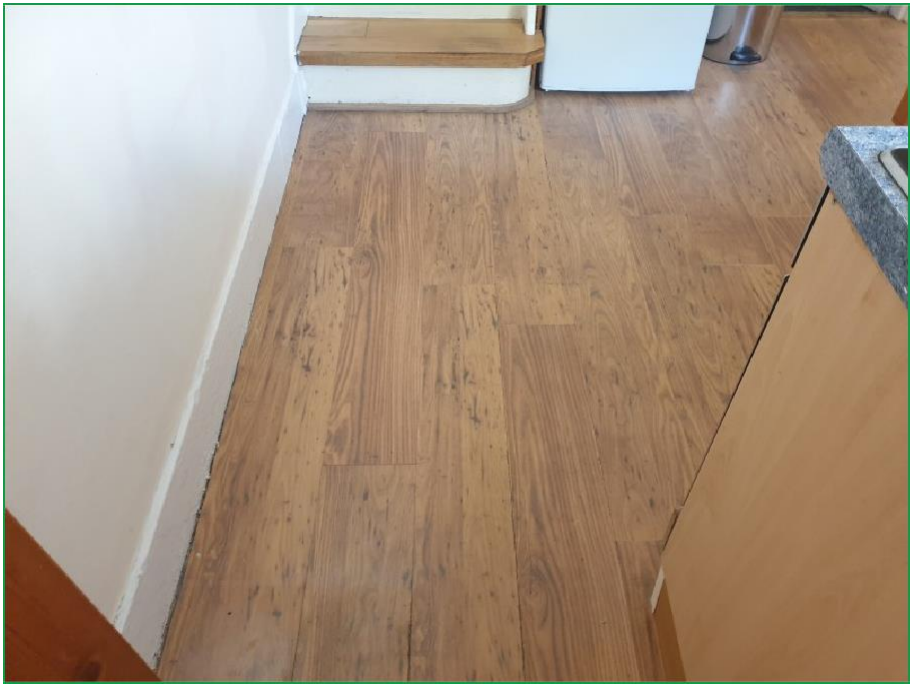
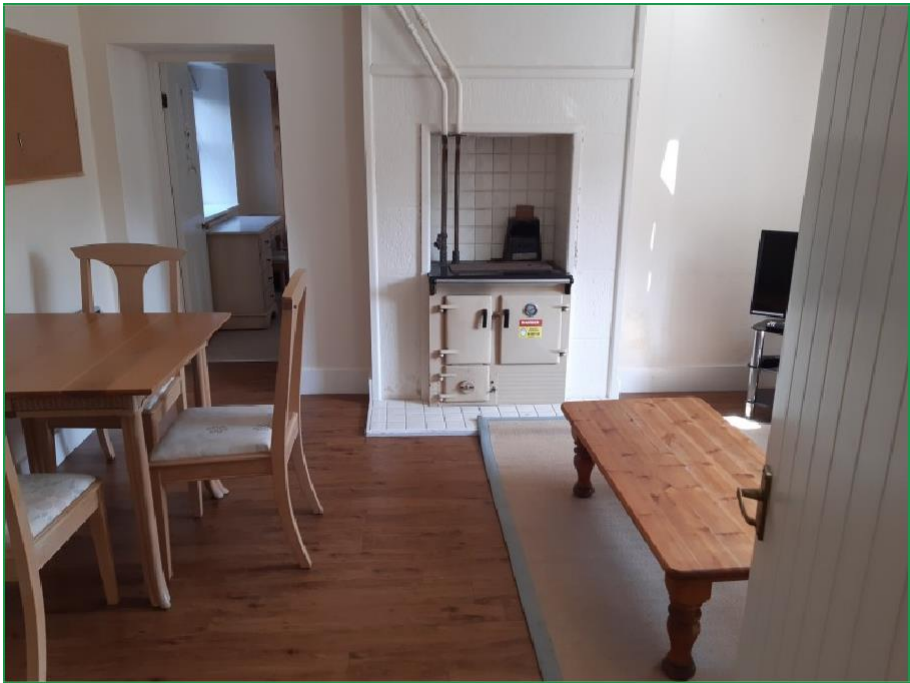
Area	Location	Element	Condition	Description	Photo
Internal	Ground floor	Floor Structure - Unknown - Assumed granite or slate slabs on ground	Poor	Extent of damp to internal walls indicates a risk of no concrete slab to the ground floor and no damp proof membrane. Allow to remove existing assumed slate or granite slabbing on sand and provide new insulated ground bearing concrete slab incorporating a damp proof membrane.	
Internal	Ground floor	Floor Finishes - Mixed finishes to ground floor including decorative tiles to porch, carpet to reception rooms and vinyl timber effect flooring	Fair	Mixed fair to poor condition but will require full replacement to accommodate holiday lettings. Damp readings were taken of timber flooring moisture content was recorded at 28%. Timber with more than 20% moisture is at risk of rot. Ceramic tiles were extensively debonding from substrate.	<div>

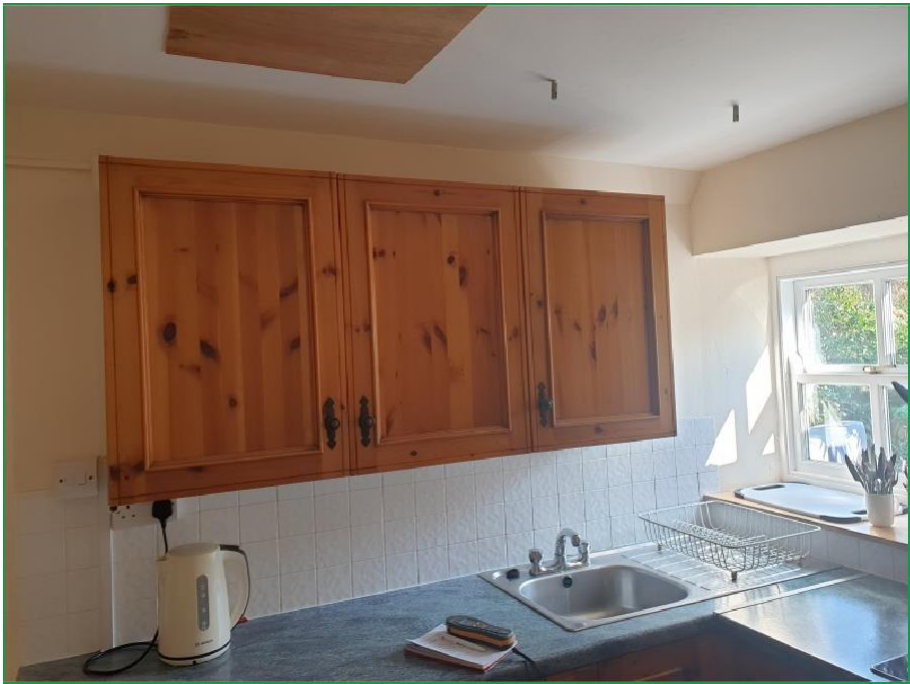
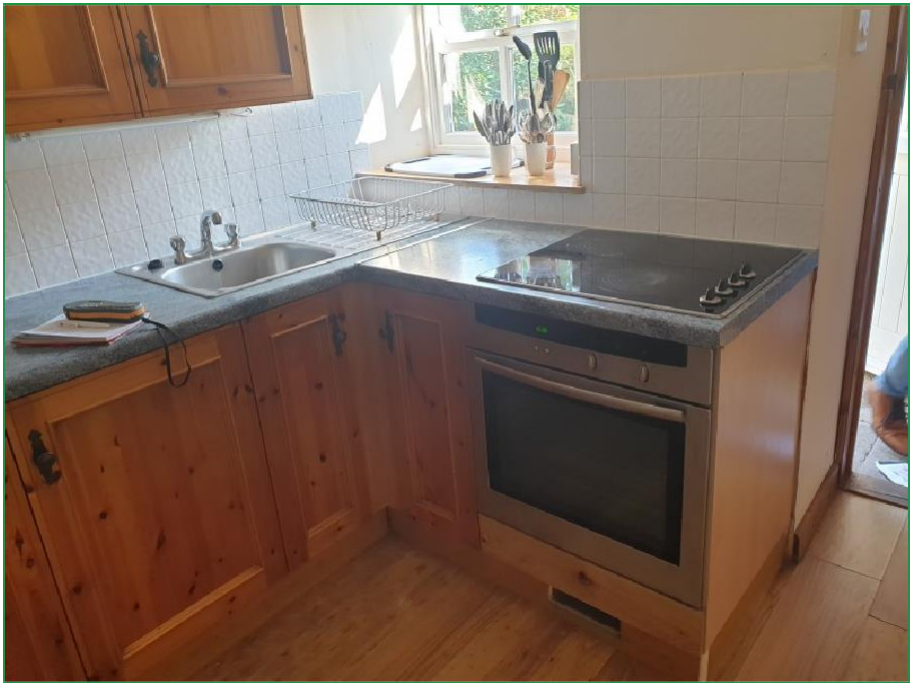
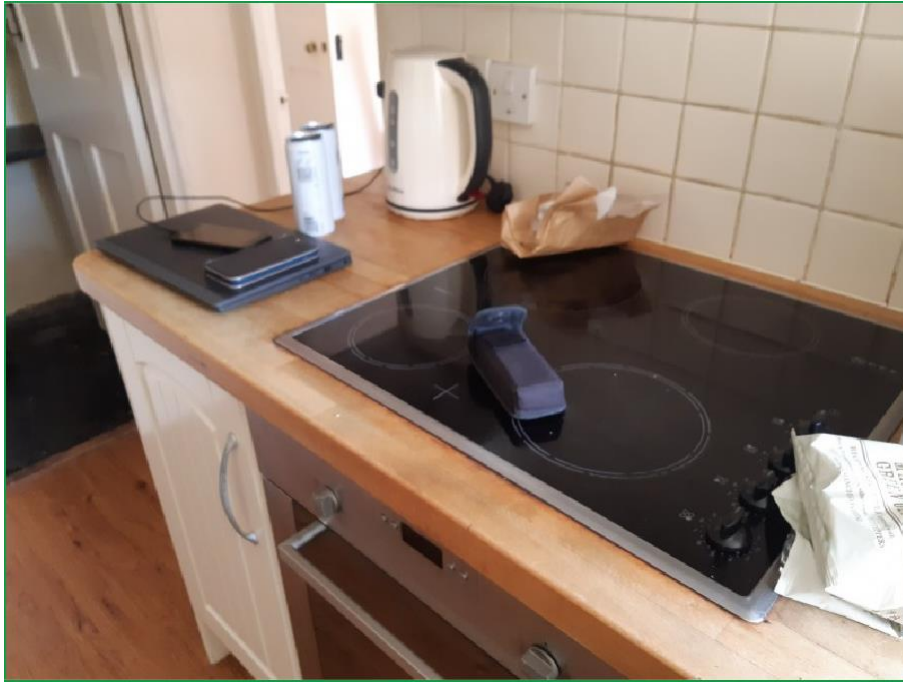
Area	Location	Element	Condition	Description	Photo
Internal	Ground & first floors	Decorative Condition - Gloss Paint	Fair	Internal decorations are currently in fair condition to all but No. 1 and will require redecoration following refurbishment works. Allow to provide new internal wall finishes and redecorations throughout.	
Internal	Ground floor	Kitchen Fittings - Base & wall units, doors and worktops	Satisfactory	Kitchen fittings are generally in a dated but satisfactory to poor (no 1.) condition with most cupboards and drawers functional, sink and taps working correctly. The extent of works required to the properties will require a complete strip out of internal fixtures fittings and finishes, therefore allow to renew kitchen installations.

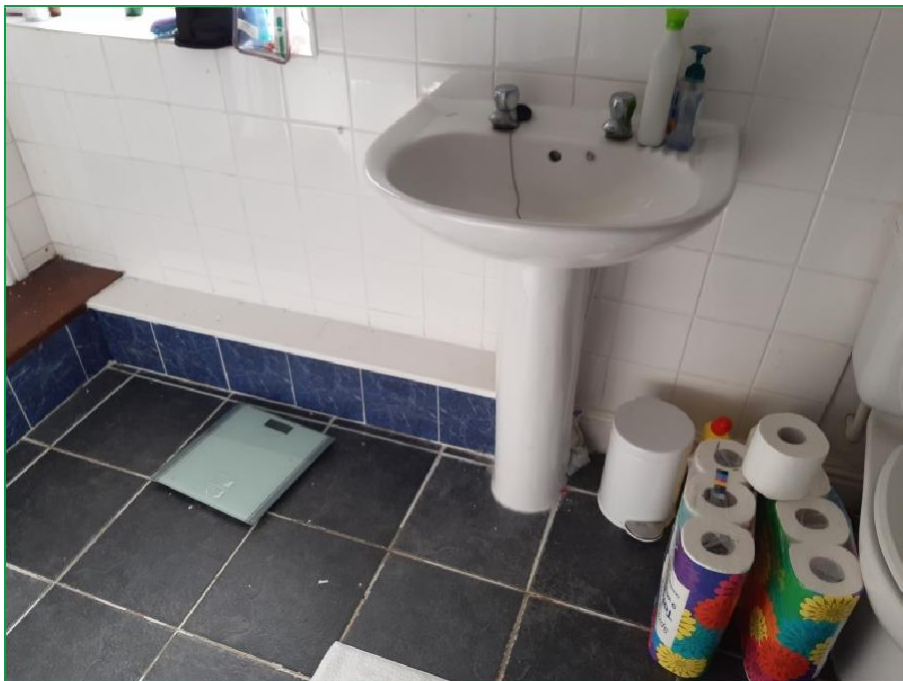
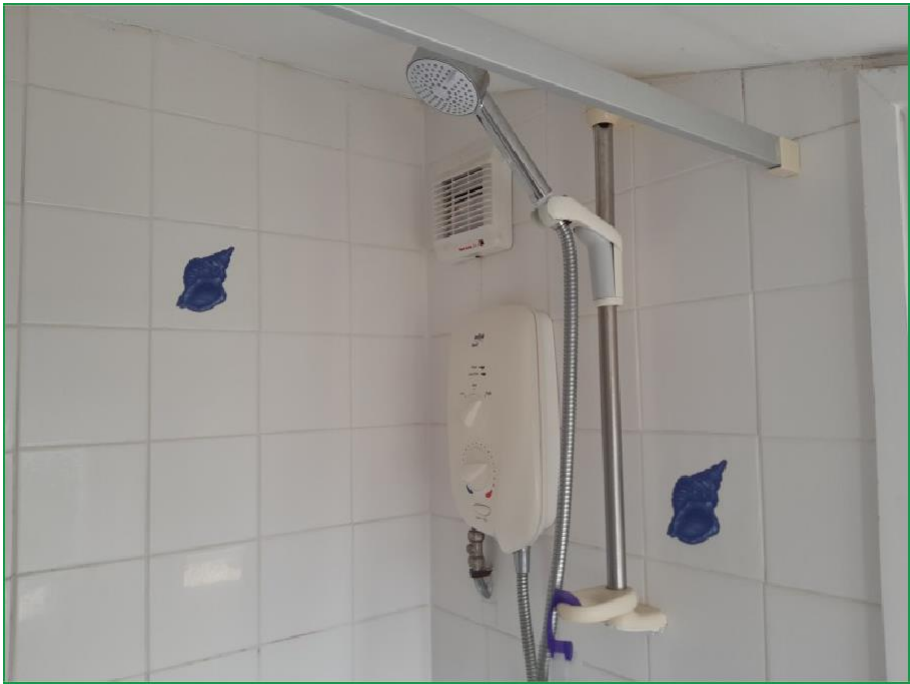
Area	Location	Element	Condition	Description	Photo
Internal	Ground floor	Sanitary Fittings - Baths with electric showers over, close coupled WC, pedestal wash basin	Fair	Bathroom fittings are in a satisfactory to fair condition with all elements functioning correctly. Silicone mastic joints are subject to some shrinkage and discolouration and require renewal. However, allow to strip out to facilitate suggested works to external and internal walls. Provide new high quality bathroom installation of a quality to suit 'tresco' holiday cottages.

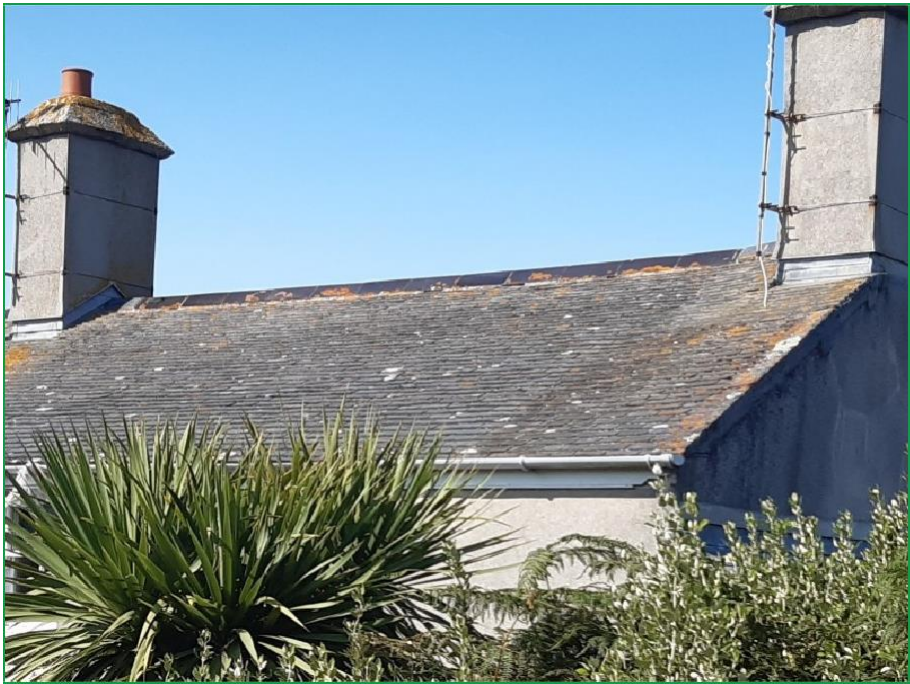
Photo 37

Area	Location	Element	Condition	Description	Photo
External	Roof	Chimneys incl. Flashings - Masonry chimney stack finished with rough cast render, lead flashings to roof	Satisfactory	<p>The chimney stacks extend approximately 1500mm above the roof surface and we would assume are constructed of granite block as per the external walls. They are finished with a cementitious render and capped with granite capping stones with a singular clay chimney pot in each. TV aerial poles are bolted and strapped to 4 of the 5 stacks and all subject to varying degrees of corrosion.</p> <p>The chimney stacks have a lead apron and cover flashing to an appropriate height above the roof of minimum 100mm.</p>

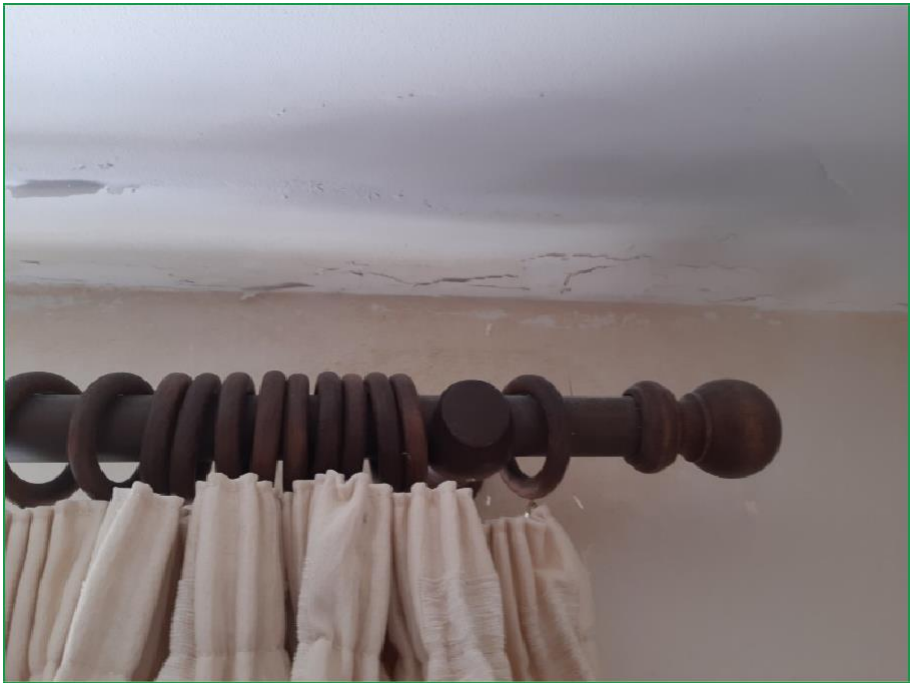
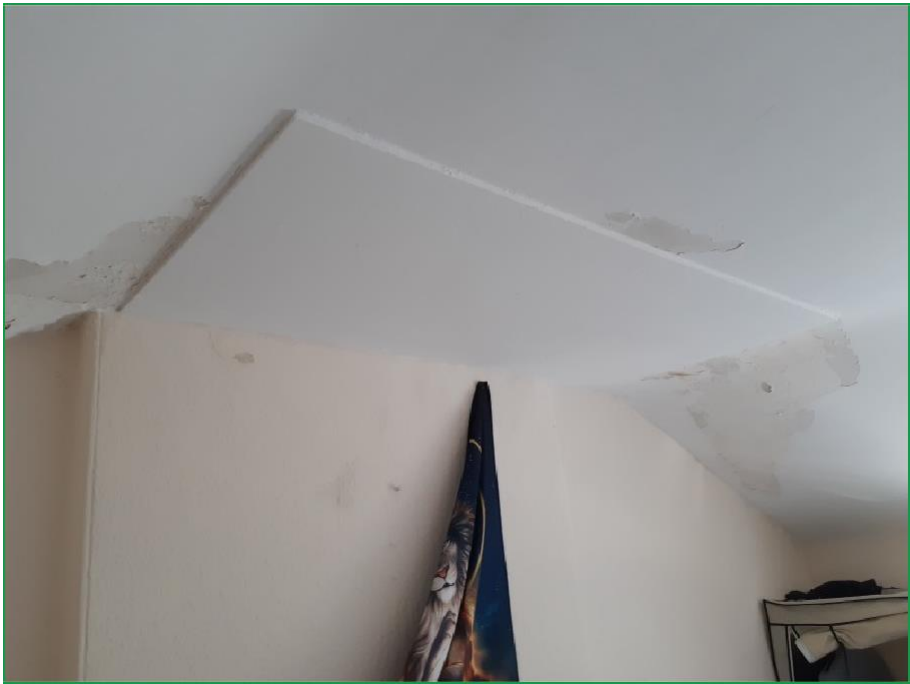
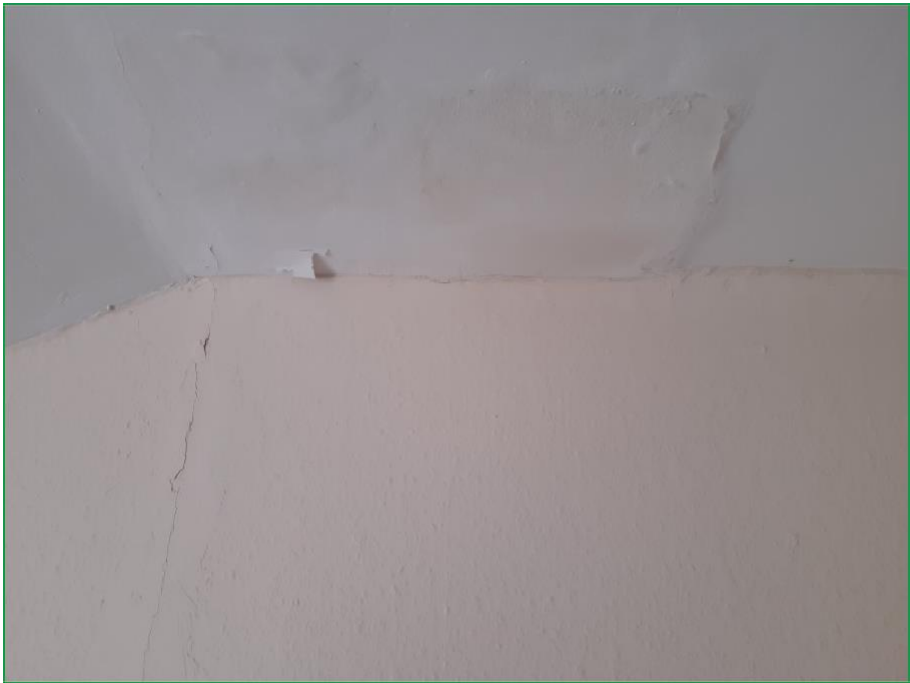
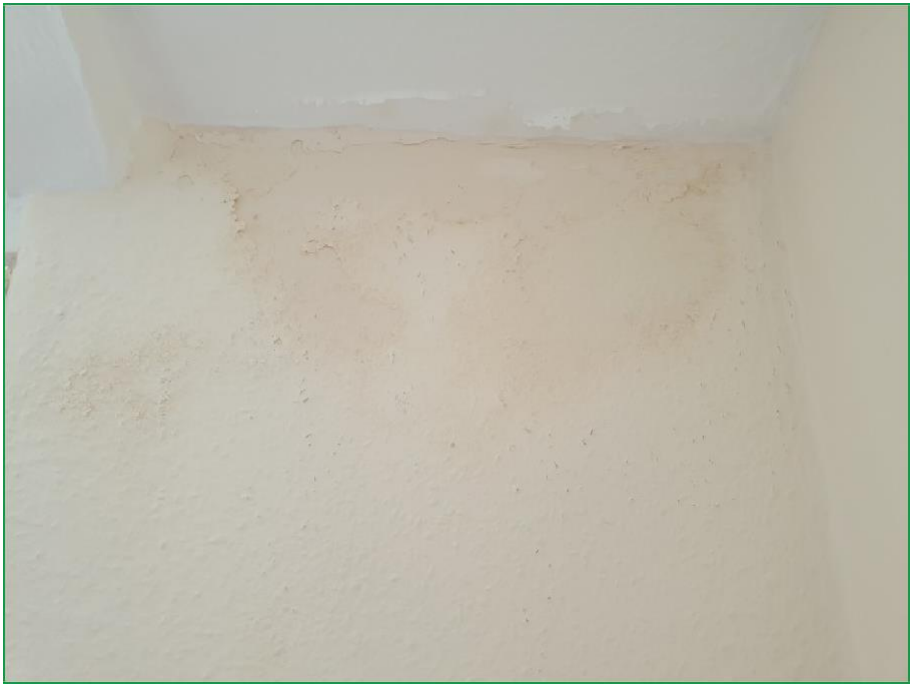
Area	Location	Element	Condition	Description	Photo	
Internal	Ceilings	Ceilings - Textured Finish	Fair	<p>Textured paper finish to ceilings on unknown board substrate. Generally sound and level but some areas where joints in paper are visible and cracks evident. There is some historic movement and cracking and areas damp were noted on ceilings throughout the terrace</p> <p>You should be aware that lining paper is often used to hide issues with substrates and therefore remedial works may be more extensive than apart from inspection of the surface. With extent of refurbishment required to make suitable for Tresco holiday accommodation we recommend removal of ceilings and renewal.</p> <p>Very similar condition of ceiling noted throughout the terrace.</p>

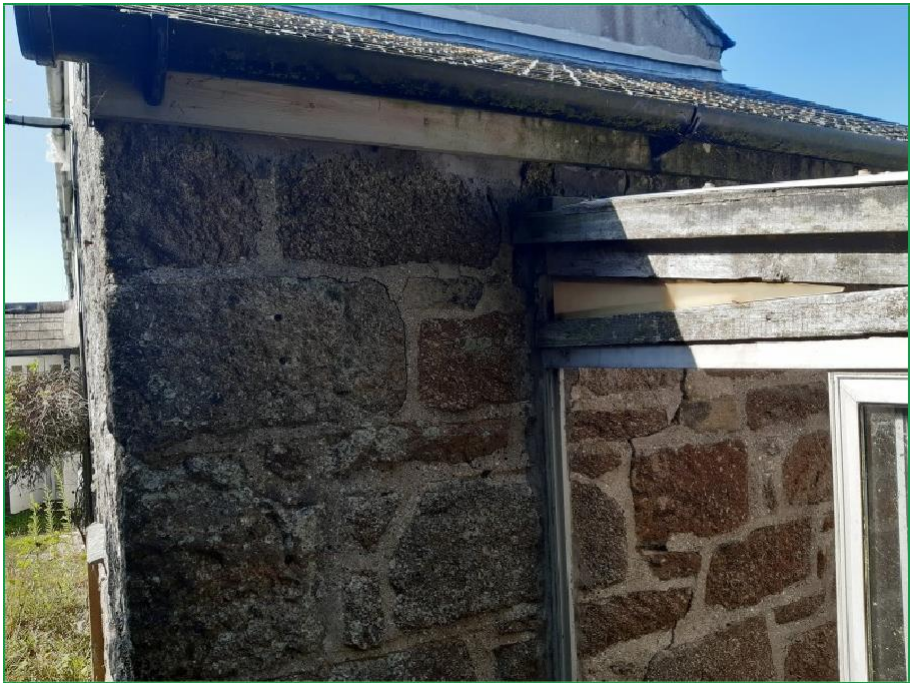
Photo 42

Area	Location	Element	Condition	Description	Photo
External	Structure	Main Walls - Granite block	Poor	East end extension. Granite block solid wall construction has a minor vertical crack running through the elevator. Allow to investigate cause of cracking.

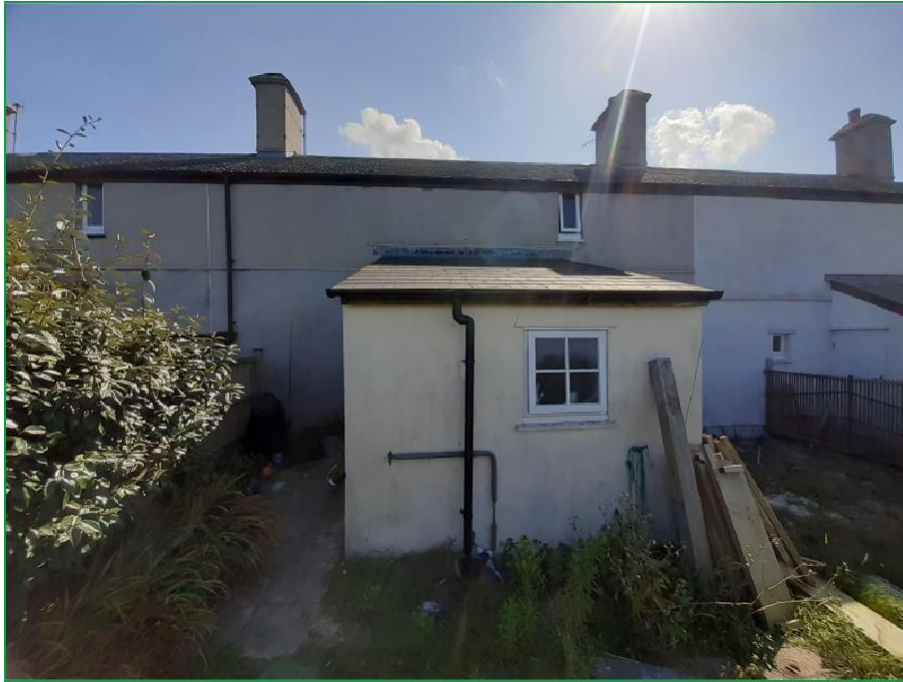
Photo 43

<p>Photo 42</p>
External	Roof	Roof covering - Fibre cement slates	Fair	Rear additions and some front additions have a fibre cement slate covering, it has been noted that some of these tiles are asbestos cement. We recommend these are removed and a new natural slate roof covering is provided in conjunction with recovering of the main roof.

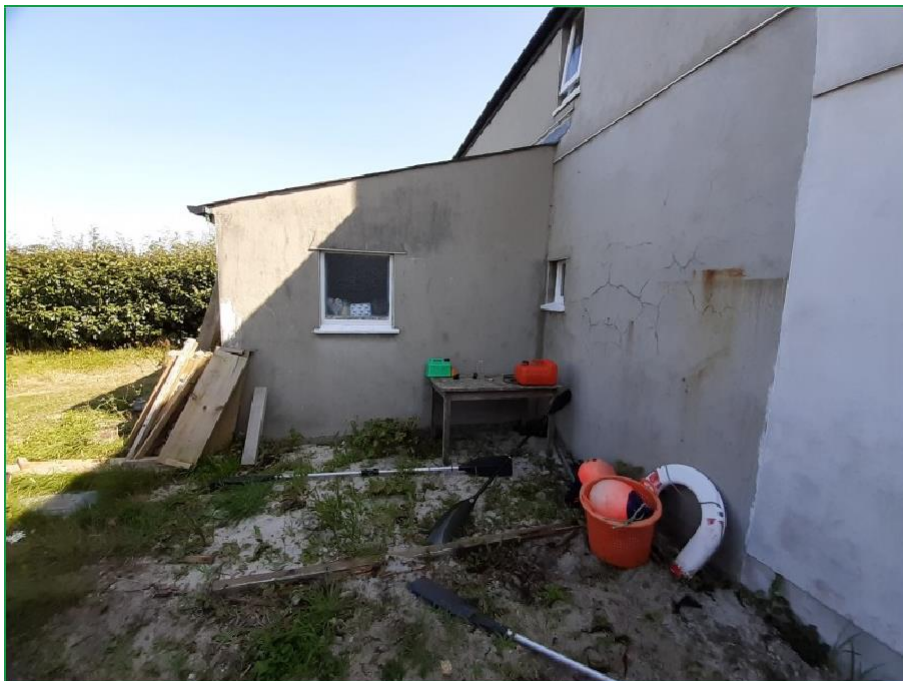
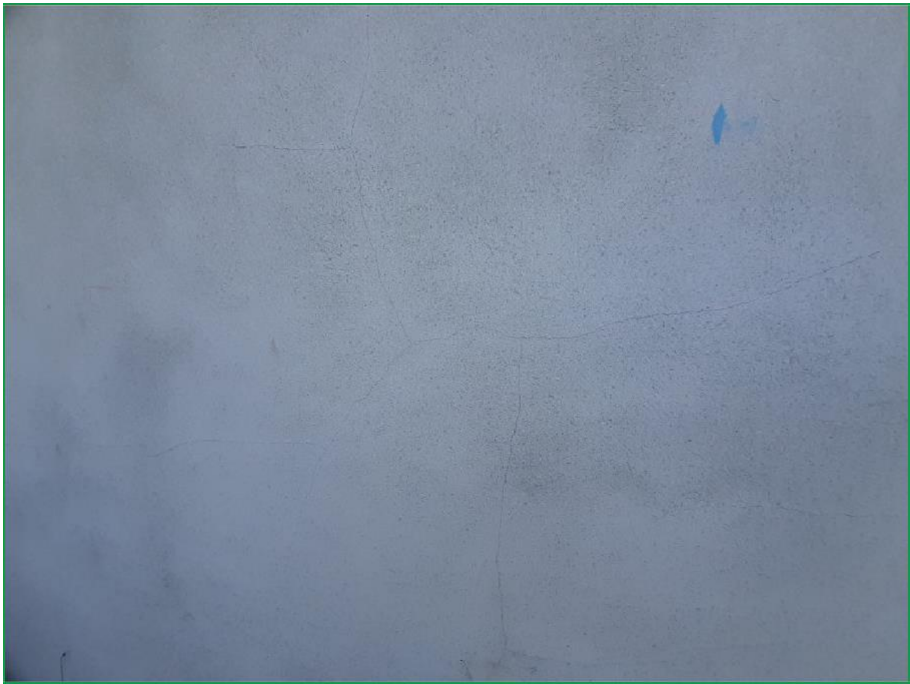
<p>Photo 43</p>
External	Structure	Main Walls - Smooth Render	Poor	Solid granite block walls have been rendered with cement mortar which is cracking and crazing extensively. Allow to hack off and renew with lime render.

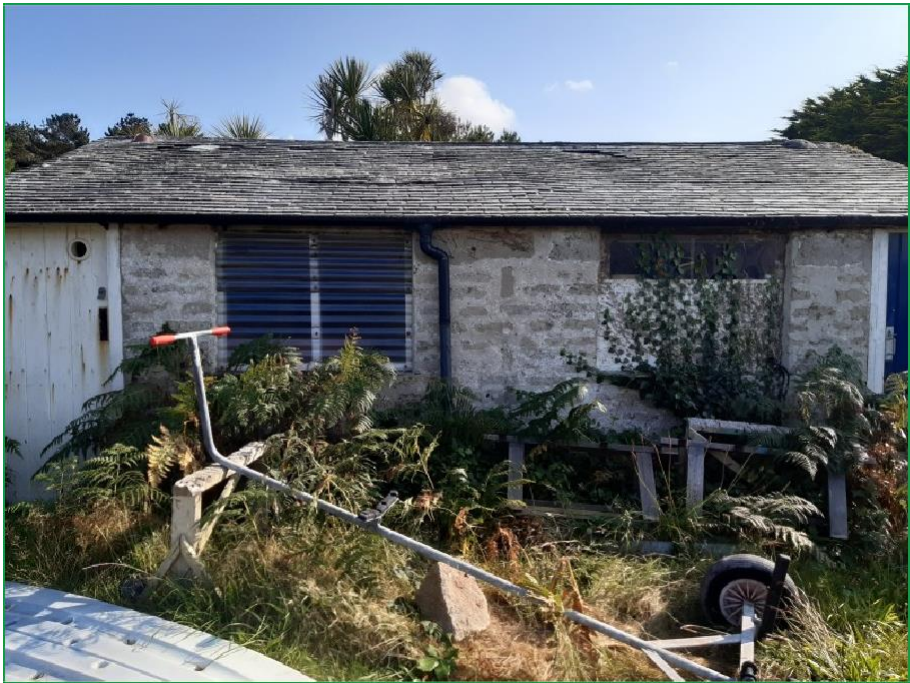
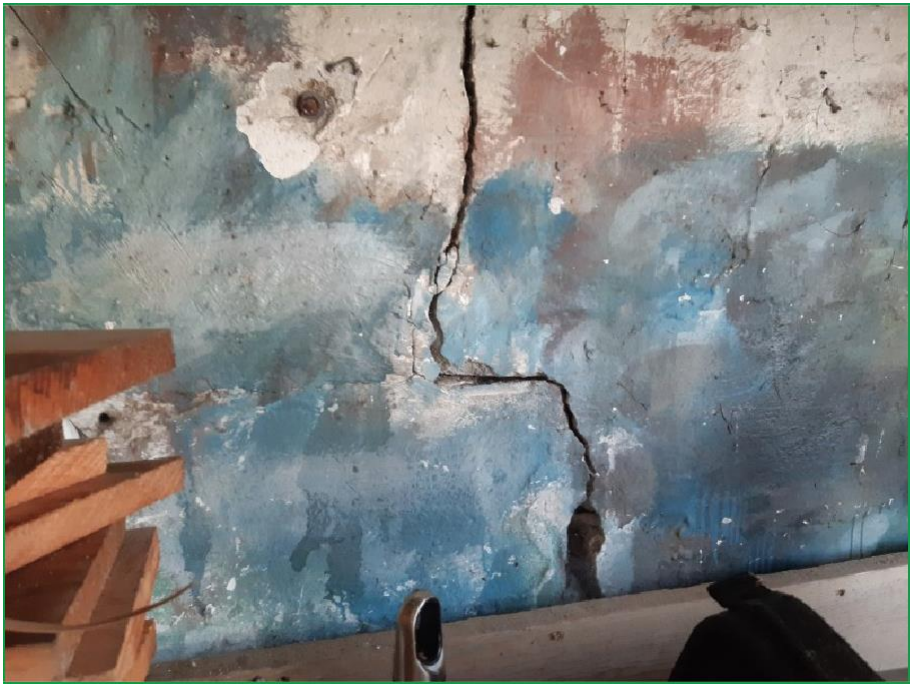
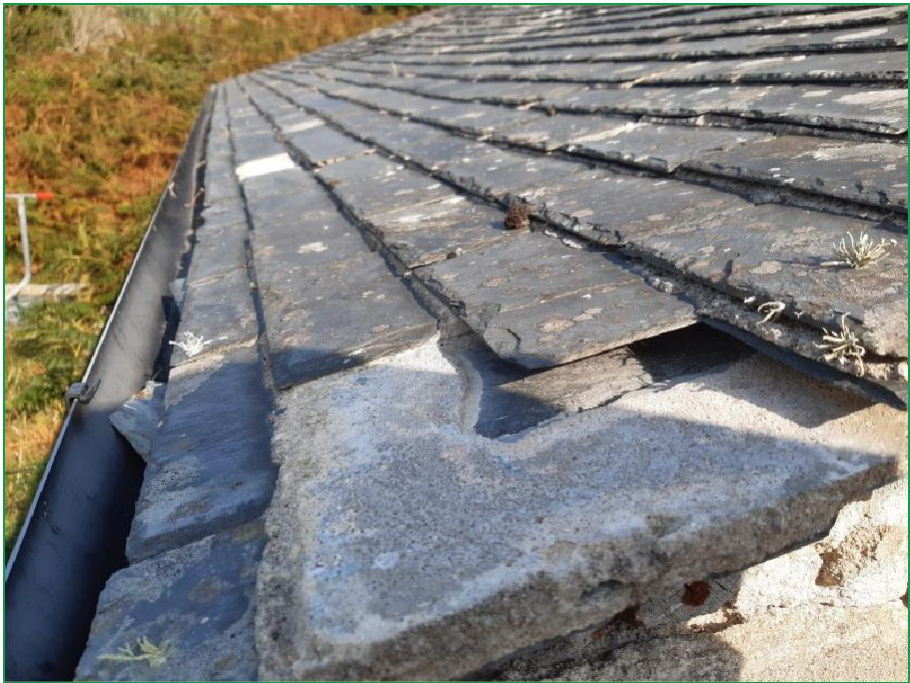
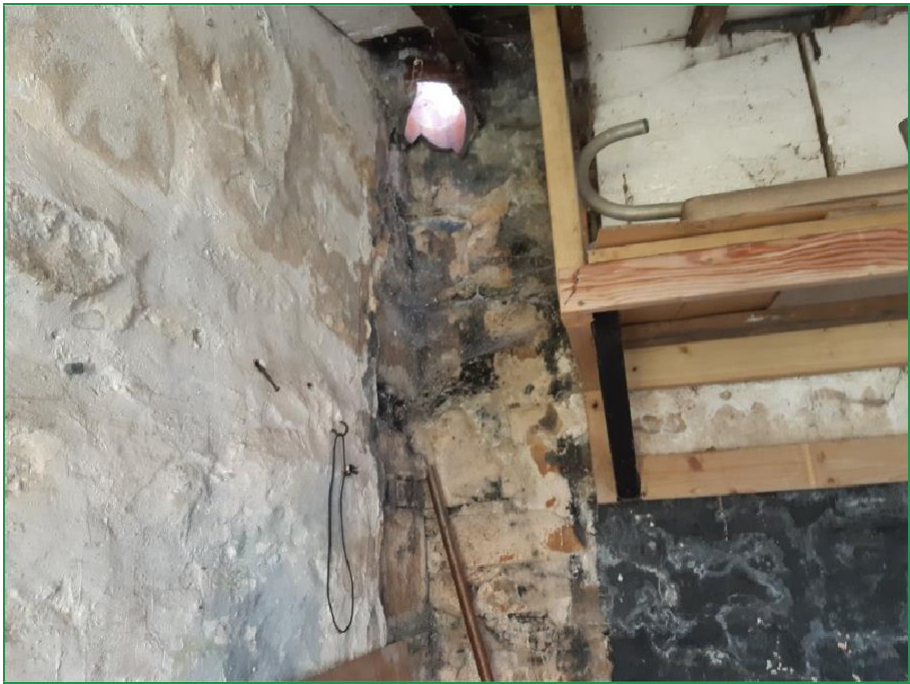
<p>Photo 44 Photo 45</p>
Internal	Roof	Roof Structure - Timber Purlin and Rafter	Satisfactory	Some damp staining to beams. Investigate condition of purlin / ridge beam ends where they penetrate stone gable and party walls. Allow provisional sum of £5k for investigation and scarf repairs if found to be rotten.

Area	Location	Element	Condition	Description	Photo
Internal	Roof	Roof Insulation - Mineral Quilt	Fair	Some loose laid mineral fibre quilt, some heat reflective boards, other areas none. Allow to provide 300mm mineral fibre quilt to 3 x roofspaces.	
External	Outbuilding	Complete - Outbuilding	Poor	Detached Masonry outbuilding some distance in front of terrace in poor condition. Failed scantle slate roof which is allowing water penetration. There is a moderate vertical crack in the masonry walls. Allow to demolish and remove from site in conjunction with major refurbishment of the terrace - being careful of the substation behind.
