Report on the Structure and Condition  
of  
The Town Hall and Museum  
Hugh Town  
St Mary's  
Isles of Scilly

## *1. Executive Summary*

A structural condition survey has been carried out on the Town Hall and Museum, St. Marys, Isles of Scilly.

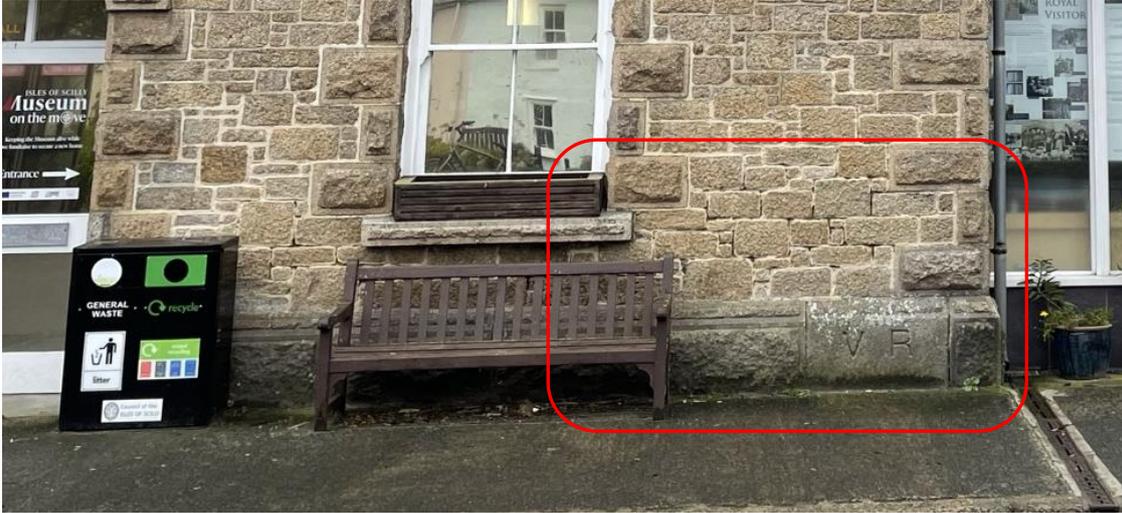
- A. There is slight loss of mortar from joints at the bottom west corner of the elevation. Recent repointing is evidenced by lighter shades of pointing. Photo 1

Photo 1 - mortar joint loss

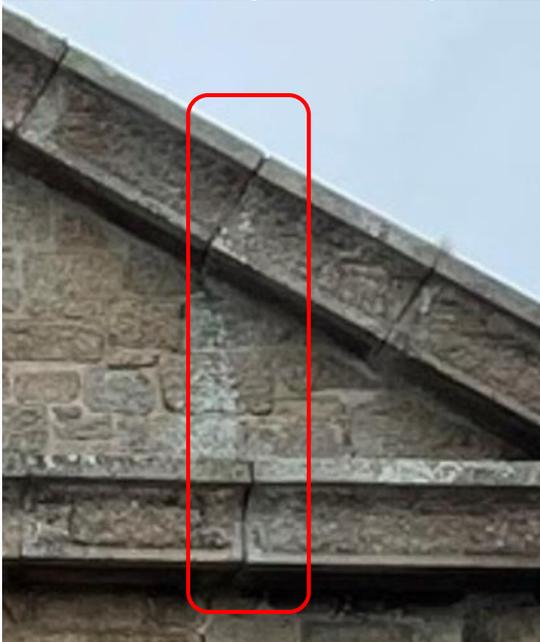
- B. The coping stones on the pediment are carved to a thin projection and joints in numerous places have washed out in the projection where such a joint would be vulnerable. Photo 2

Photo 2 - mortar joint loss in pediment coping projection

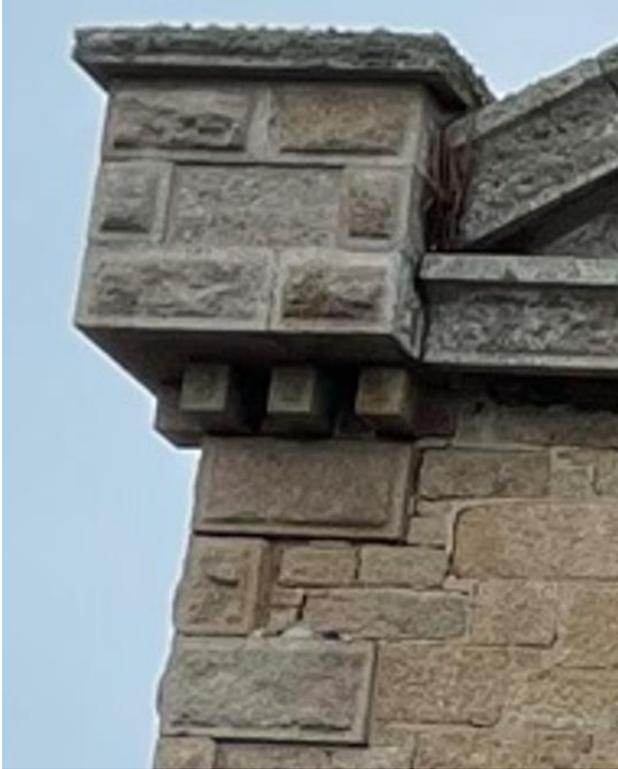
- C. There is a small crack between the string course at first floor level and the bottom corner of west-most first floor window. Photo 3
- D. Mortar joints around the eaves block on the pediment are open. The detail is exposed to weather and could be a source of water ingress. The dentil supported blocks have a large overhang. When viewed from the side the block is almost balanced at its centre of gravity compared to the supporting wall under. Photo 4

Photo 3 - joint washout round pediment block and washout under

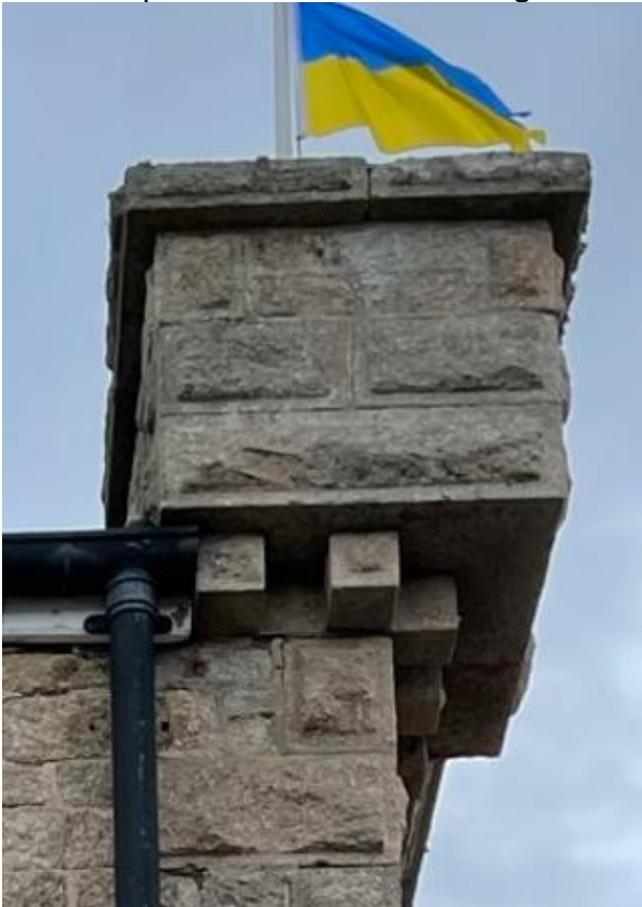
Photo 4 - pediment blocks over hang

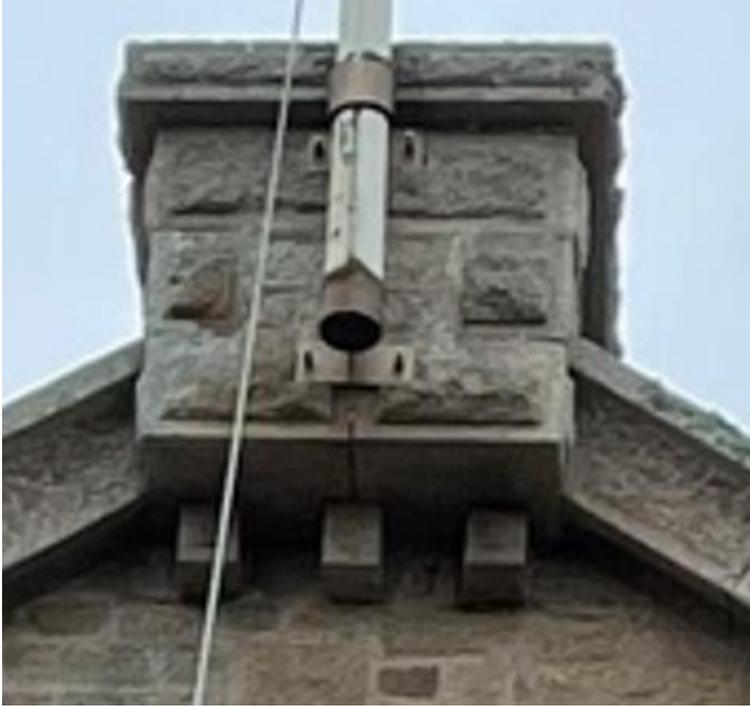
- E. The ridge block in the pediment is also balanced as the eaves level blocks. Additionally, the ridge block supports a flagpole cantilevered on brackets. This is not an ideal detail. Photo 5

Photo 5 - gable peak pediment block supports cantilever flagpole

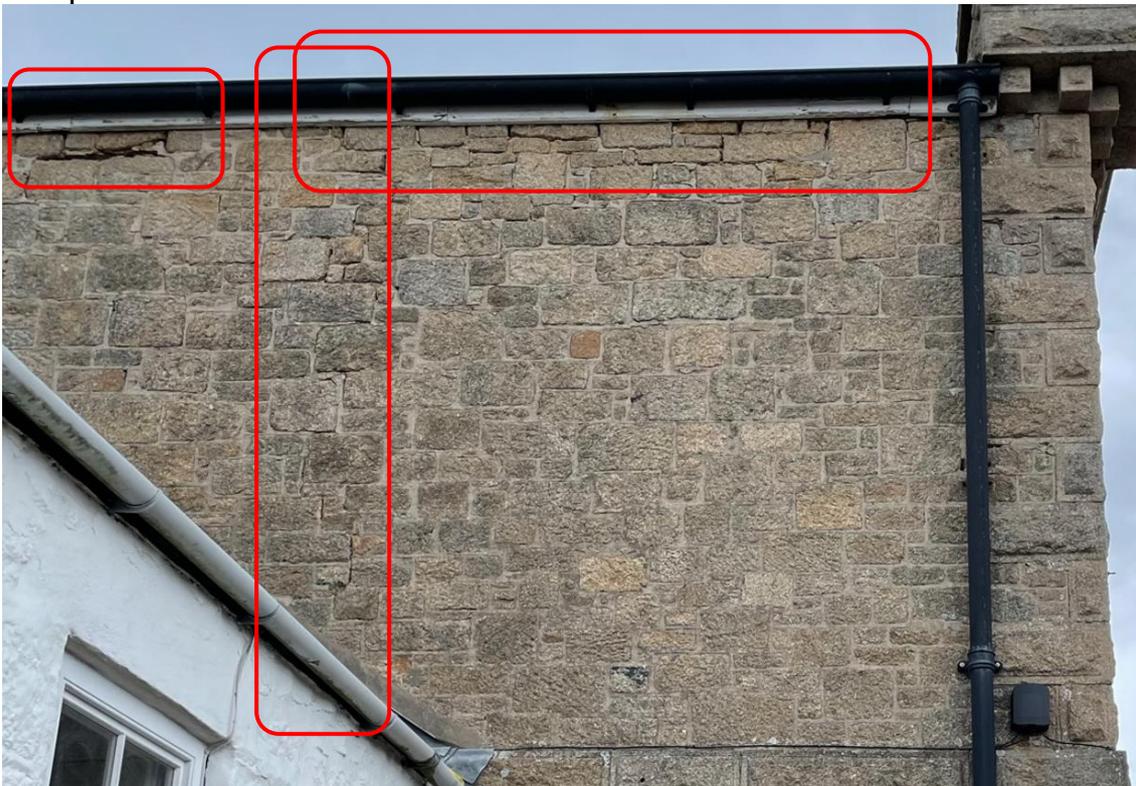
- A. There is loss of mortar at the north end of the elevation just below eaves level. Photo 6
- B. There is a vertical crack above the line of the cottage roof up to eaves level. Photo 6
- C. Close to eaves level above the ridge of the cottage a band of corroding steel/ironwork has blown the mortar. Based on its approximate position the steel/ironwork is likely associated with a roof truss bearing. Photo 6
- D. There are several small vertical cracks almost at eaves level along the length of the elevation. Photo 7
- E. The south end of the west elevation has been repointed. The colour of the mortar is consistent with mortar in the south elevation. We conclude the pointing on the west elevation was carried out at the same time. Photo 8

Photo 6 showing loss of pointing, vertical crack, and corroding steel/iron. See also photo 11

The wall defects listed by elevation in section 3 should be addressed. Larger cracks in the east elevation above the cottage should be stitched using stainless steel Helibar placed in bed joints spanning the crack. Embedded and corroding steel/iron should be removed where possible and treated for corrosion where removal is not possible. Consideration should be given to improving the coping stones on the south elevation gable.

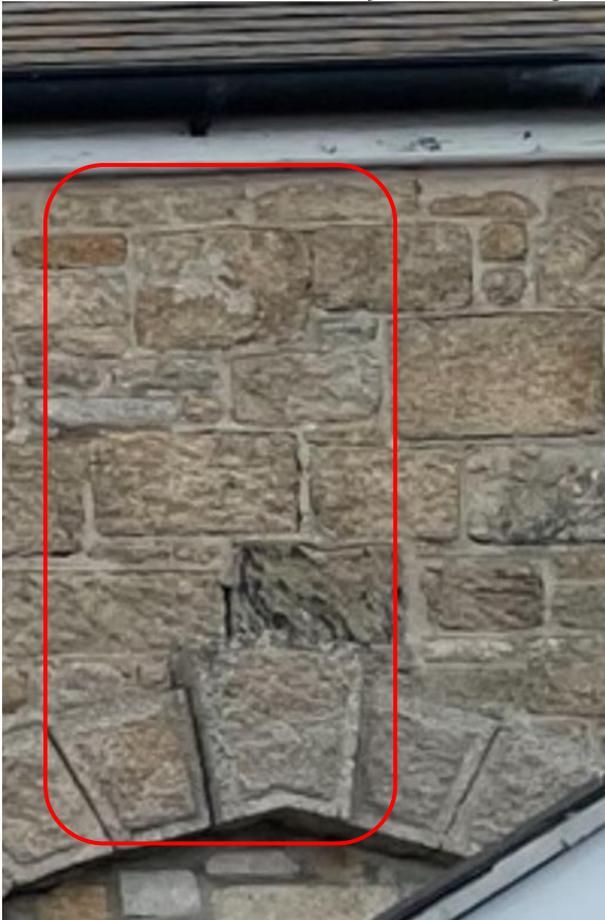
Photo 7 - vertical mortar joints missing

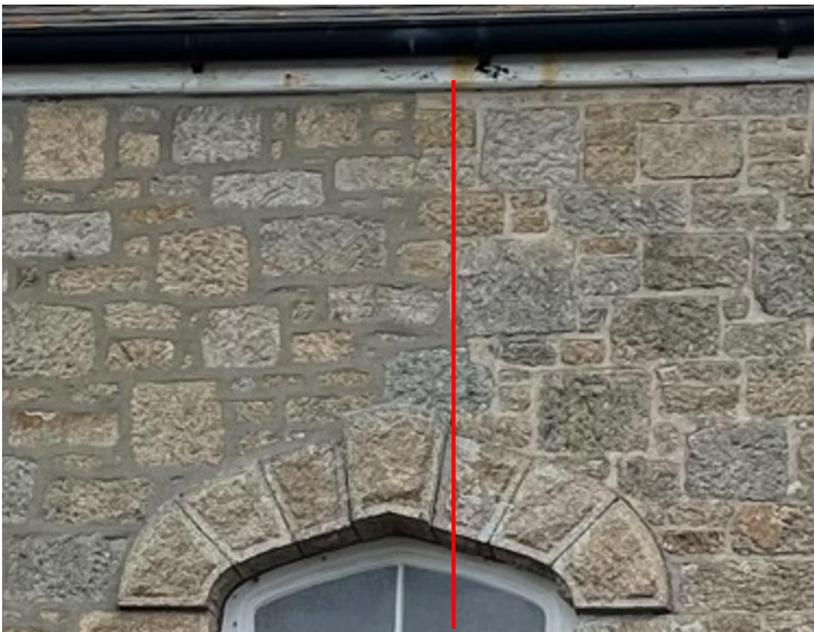
Photo 8 - change of pointing from lime to proud cement in east elevation over south most window head

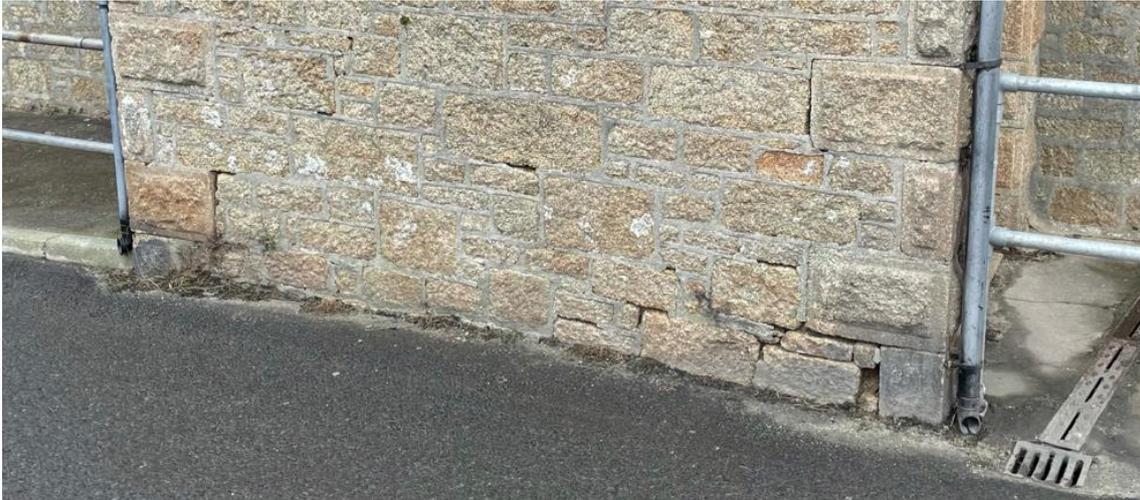
- A. The south elevation of the main gable has been re-pointed in the past. There is some mortar missing at low levels on the rear porch. Photo 9
- B. The copings to the south Gable have no overhang which does not help with weathering of the top of the wall. It is not clear whether the copings were made this way, or they did have an overhang, and this has weathered away. Photo 10

Photo 9 - mortar joint loss on rear porch at ground level

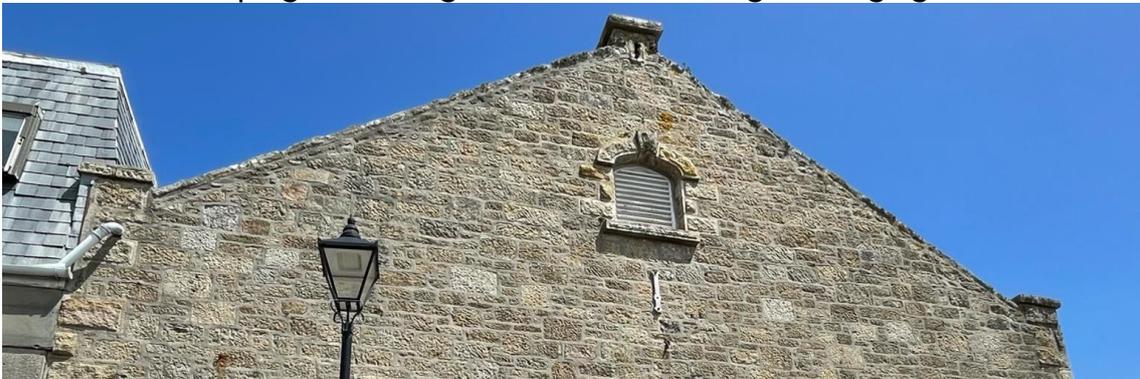
- C. The gutter on the west side of the roof discharges at the west side of the south gable through a pipe passed through a hole in the wall. Photo 10

Photo 10 - no coping on south gable. Gutter discharge through gable at eaves

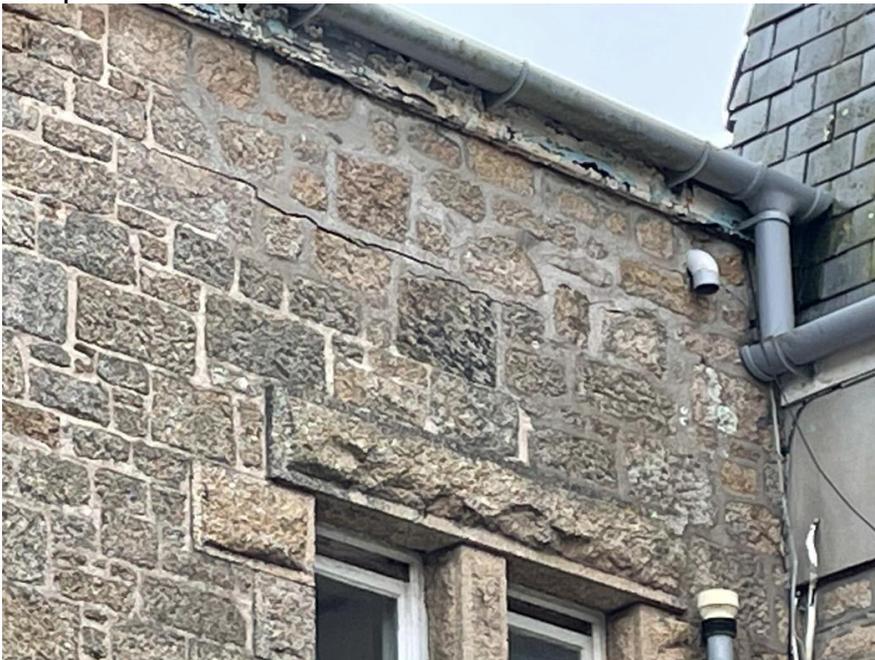
- A. There are cracks in mortar joints in the section of main wall above the foyer roof. These have previously been repointed in cement mortar but the crack has reopened suggesting some active mechanism. It is possible there is steel/iron corroding at this location in the wall. The position corresponds to a similar defect in the east elevation Photo 11 and Photo 6

Photo 11 - cracks over high-level window, note repointing and recurrence of crack. Possibly a mirror of the east elevation and buried corroding steel/iron. See photo 6

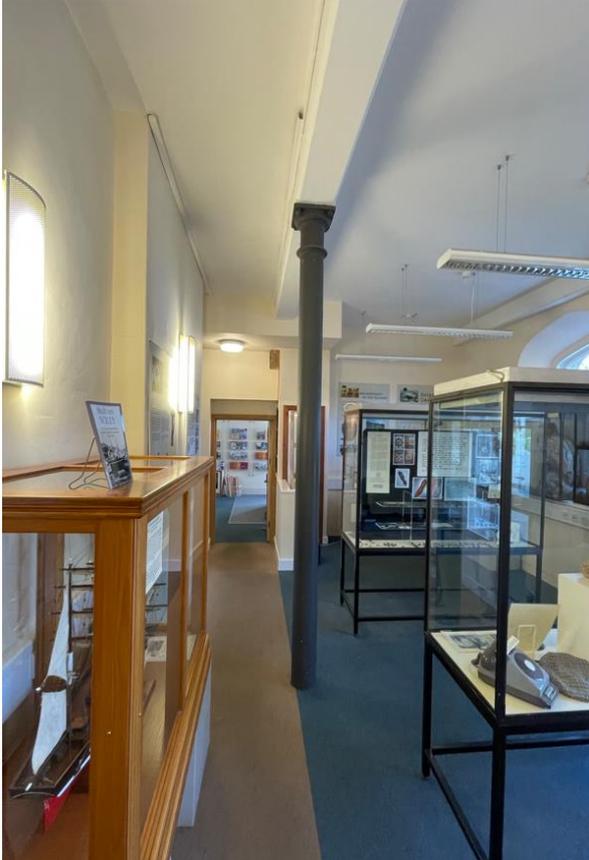
Photo 12 - cast iron columns supporting beam and FF over

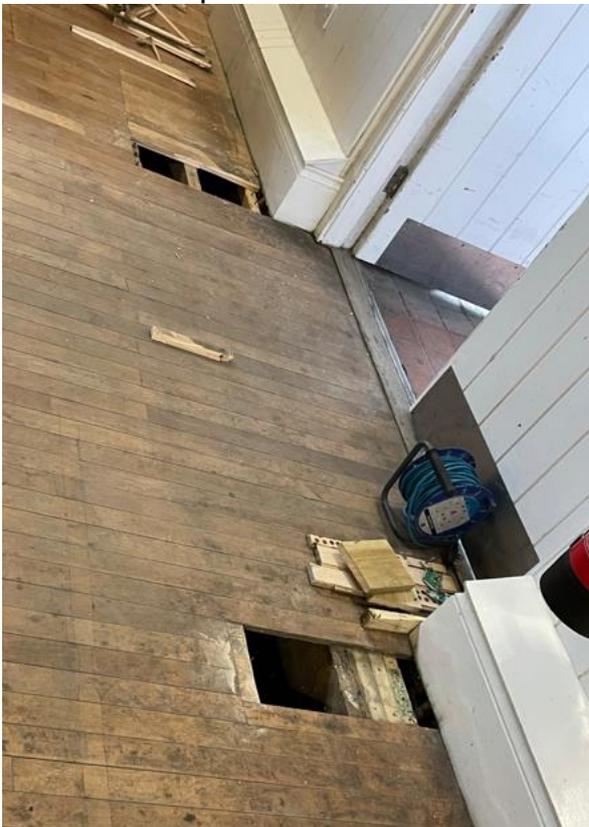
Two internal trial holes against the south elevation gable were made in the beech slat floor to determine the depth of void under the floor and the floor make up. Photo 13

Photo 13 - inspection holes in hall floor

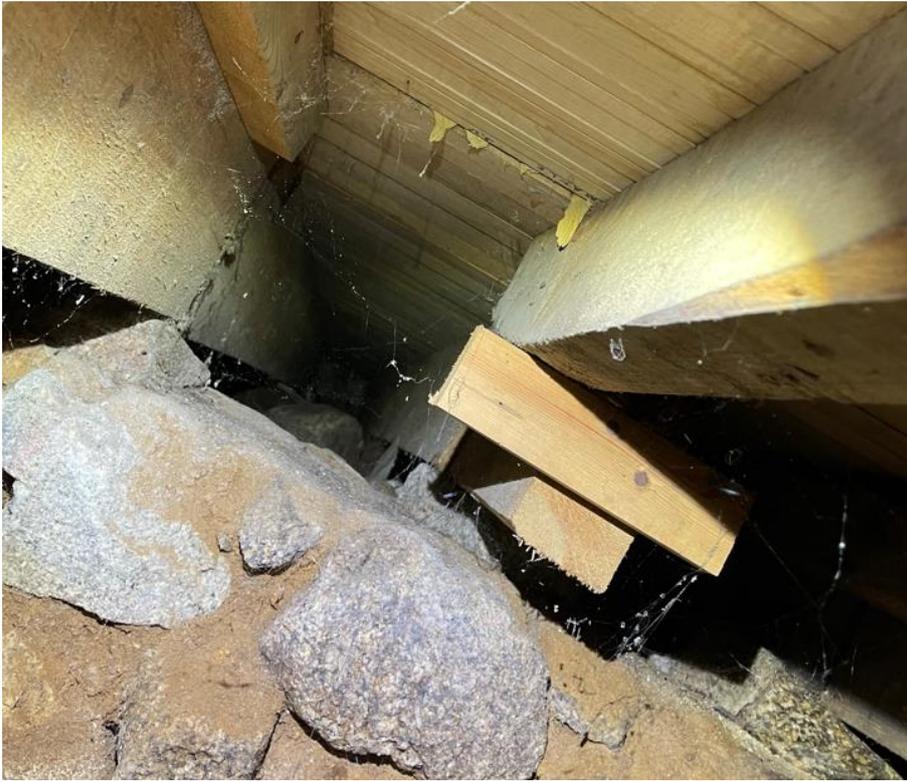
The floor of the main hall is a raised timber floor comprising floor joists running east-west (63x170mm at 400 mm crs) supported by roughly made dwarf walls approximately 200 mm high running north south at approximately 1.8m centres. The joists are wedged with stone and timber slips to provide direct contact with the walls. The dwarf walls are laid in mortar directly onto sand (Photo 14). The capacity of the joists with the existing dwarf wall spacing is in excess of 5kN/m<sup>2</sup>. (a typical live load capacity required for public spaces where crowding can take place). The joists that were visible through the hole positions were sound.

Photo 14 - dwarf walls supporting main hall joists - note poor contact support details

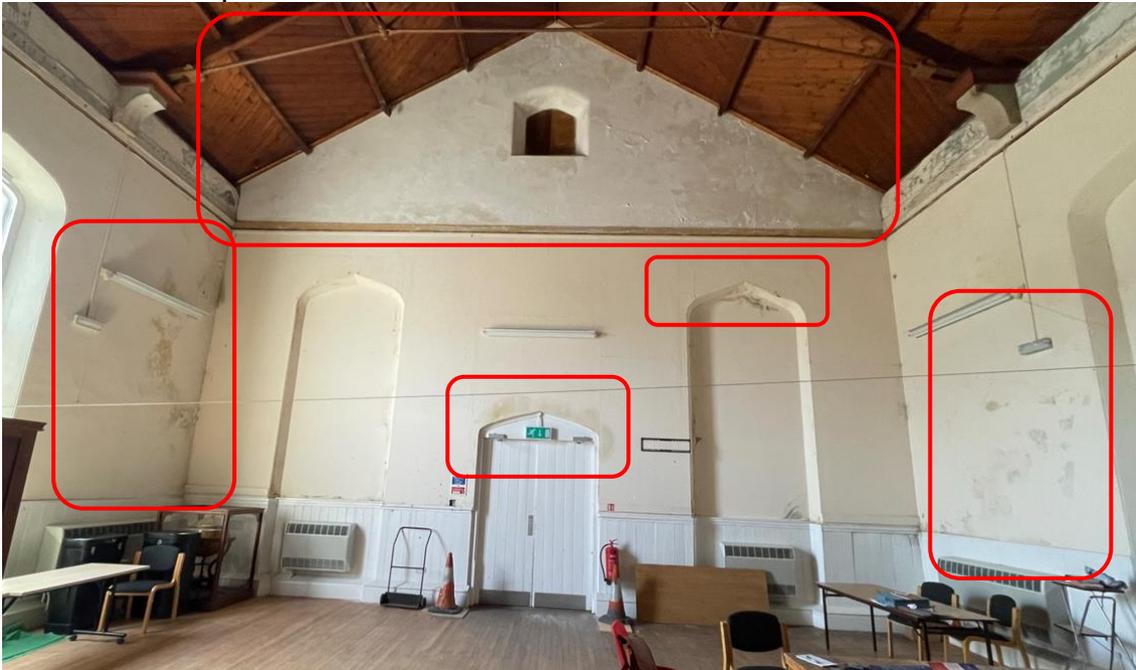
The walls of the main hall give clear signs of water ingress and damp especially at the south elevation and the east and west elevations where they are in close contact with the south elevation (Photo 15). Mould, paint distress and degradation of plaster can be seen over much of the wall. This is likely due to the extreme weather conditions the wall experiences year-round from the prevailing weather. Granite is a stone of low permeability and low porosity. While these are good qualities it means that the ability of a wall made with granite blocks to resist saturation and cycles of wetting and drying is highly dependent on the mortar used in its construction. Repointing in cement mortar is likely to prevent rapid drying of the wall and will have the tendency to lock in moisture. Moisture once in the wall will try to escape via convective drying from the mortar joints and in some cases the path of least resistance for liquid water and vapour will be inwards and not outwards. Salts can be transported to internal faces of the wall and deposit as damaging crystals on internal surfaces. Recent studies sponsored by Historic England (Drying response of lime-mortar joints in granite masonry after an intense rainfall and after repointing, Fusade et al 2019 published by Heritage Science) have shown repointing with lime mortars gauged with quicklime and wood ash additives are effective in very wet environmental conditions at resisting water absorption and had a good drying rate. It should be the goal of a mortar in these conditions to keep water as close to the surface of the wall as possible and allow it to dry quickly.

Photo 15 - damp inside south elevation

Of primary concern to the performance and use of the shell of the building is the damp found in the south elevation gable and the east and west walls where connected to the south wall. Consideration should be given to repointing the south elevation and connected side wall after a suitable period of drying is allowed. Internal plaster finishes where damaged should be removed, and breathable plaster finishes considered and the external cement pointing removed and repointing carried out in a suitable lime mortar. Where there is cement repointing but no apparent problem with damp internally, the walls could be left as they are unless it is preferred the walls are cosmetically uniform in appearance.

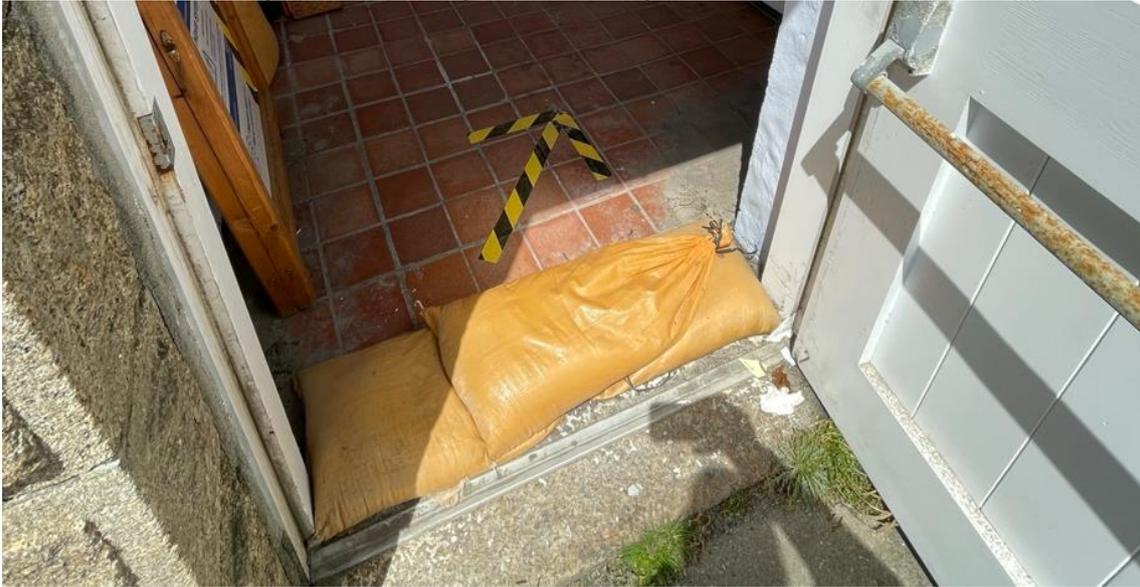
We understand that the rear of the hall floods with sea water during severe storms from the south. We understand the sea can crest the beach immediately south of the hall and the volume of sea water that lands on Silver Street falls towards the hall and temporarily overwhelms the drainage at the porch door. Sea water creeps inside and puddles on the beech slats. Sandbags are kept at the porch door to limit ingress. (Photo 16)

Photo 16 - sandbags inside rear porch to keep out water

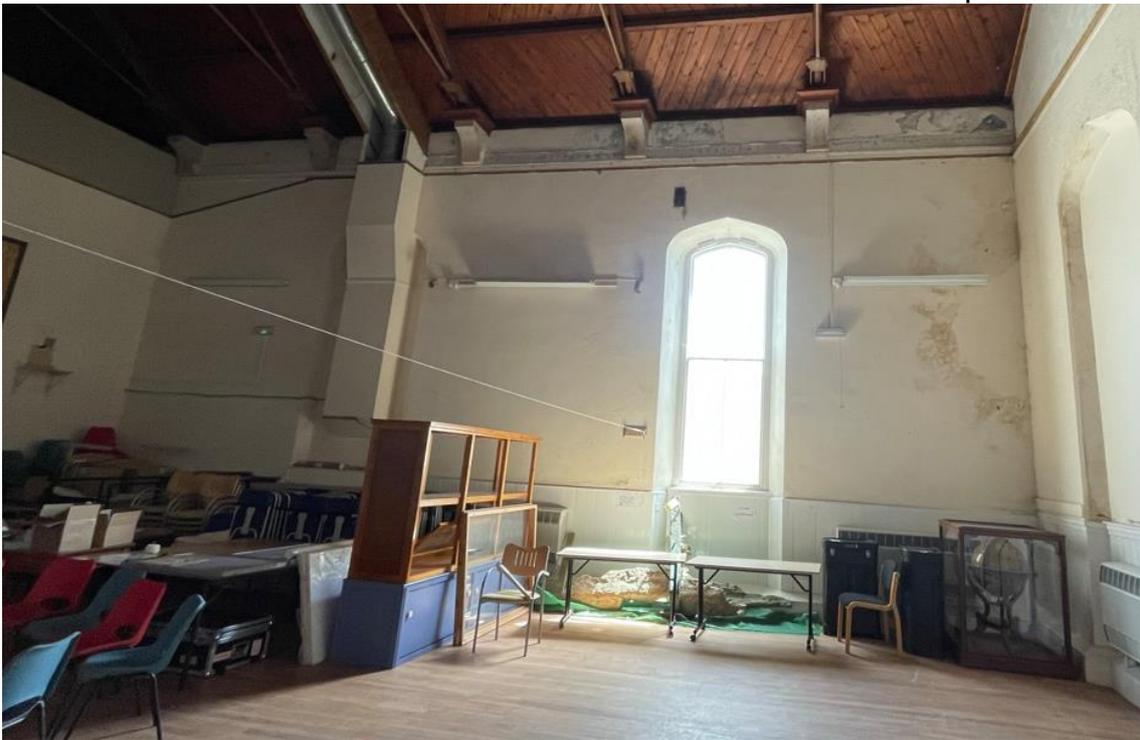
Aside from the damp in the walls there is little evidence of structural problems with the walls of the hall. There are three window reveals in the west elevation. The central window reveal has been blocked up to enable routing of a flu or air handling duct for the boiler. Only the southernmost window reveal on the west elevation has a glazed window in it. All other windows are blocked or never were windows and are false reveals. (Photo 17)

Photo 17 - Main hall west elevation - blocked window at boiler flu position

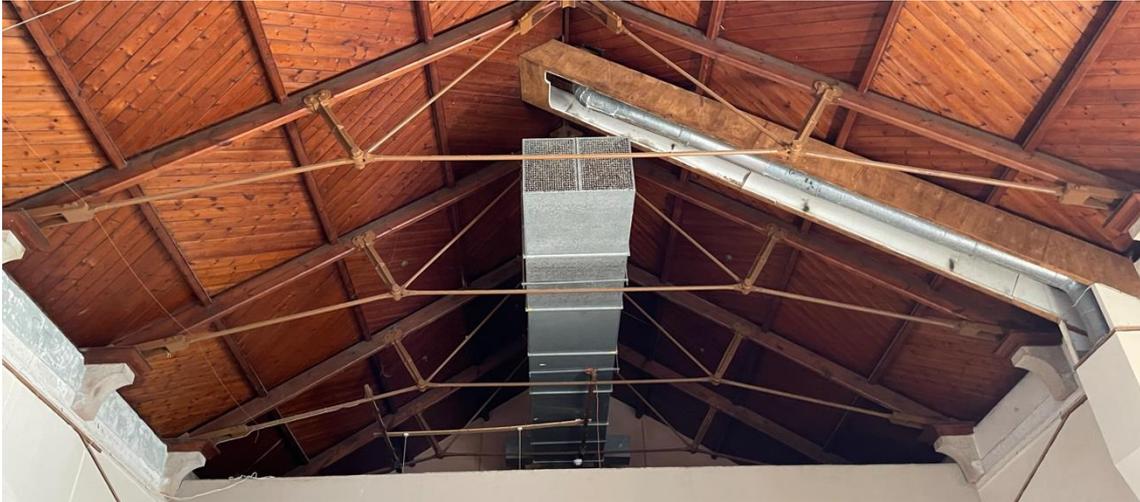
Air ducts for the main hall are currently supported on the central tension rods of the trusses at the north end of the main hall space. There is some deflection in the tension rods visible, but this is not considered detrimental. (Photo 18).

Photo 18 - Exposed roof trusses supporting air duct in main hall.

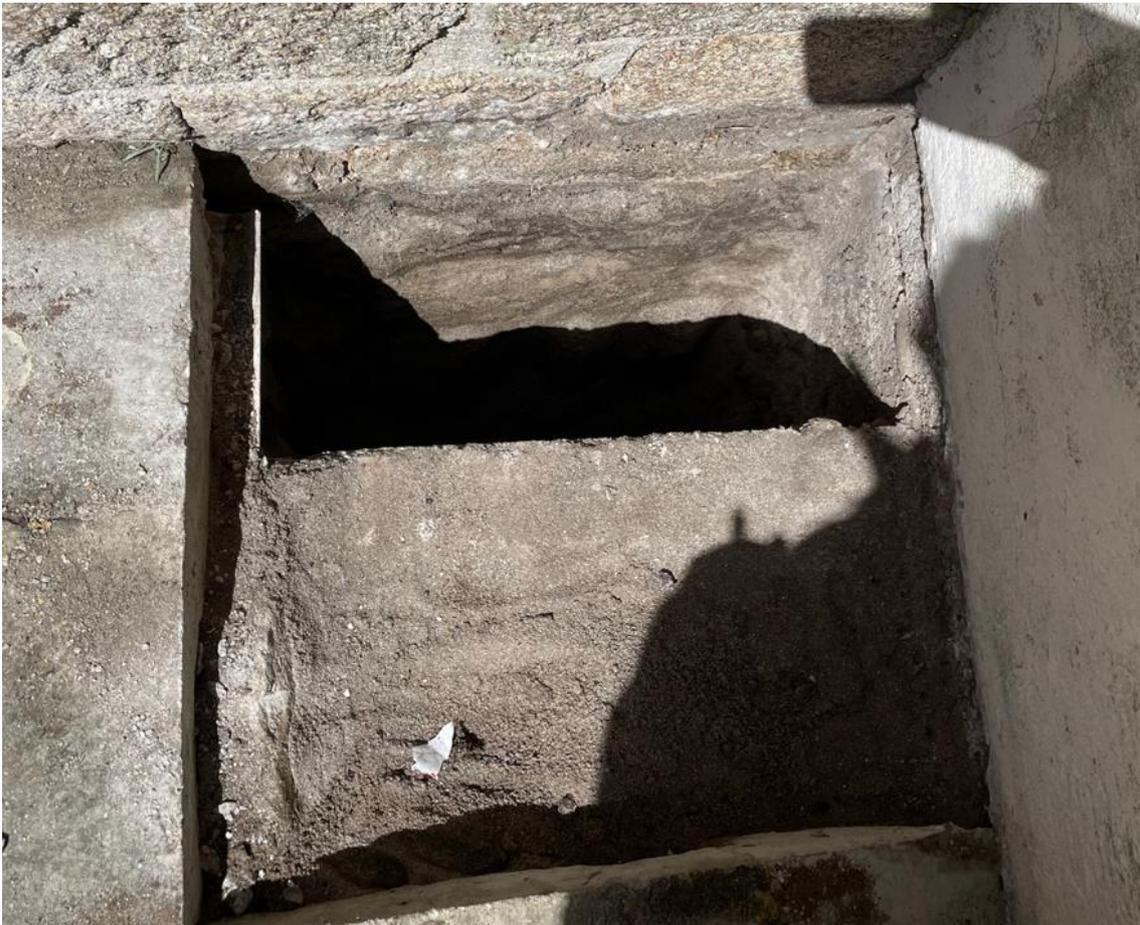
The pit adjacent to the boiler house on the east elevation showed random granite rubble stonework, not dressed, and not fixed by mortar, bearing directly on sand. Stones were established to a depth of 750 mm. This pit was made in the vicinity of a buried former oil tank bund for the boiler house. Asbestos was found immediately under the concrete capping on the bund wall construction. The bund appeared to have been backfilled with sand. It is likely this area is contaminated with asbestos under the concrete and tarmac surface. (Photo 19)

Photo 19 - trial pit west elevation against boiler house and main hall. Note asbestos sheet at left of hole under concrete cap and block wall top of bund and sand in bund

- New foundations where needed should be shallow.
- The presence of asbestos should be confirmed by testing where excavations will be required near the boiler house and the external sheathing at second floor level of the Mansard roof checked.

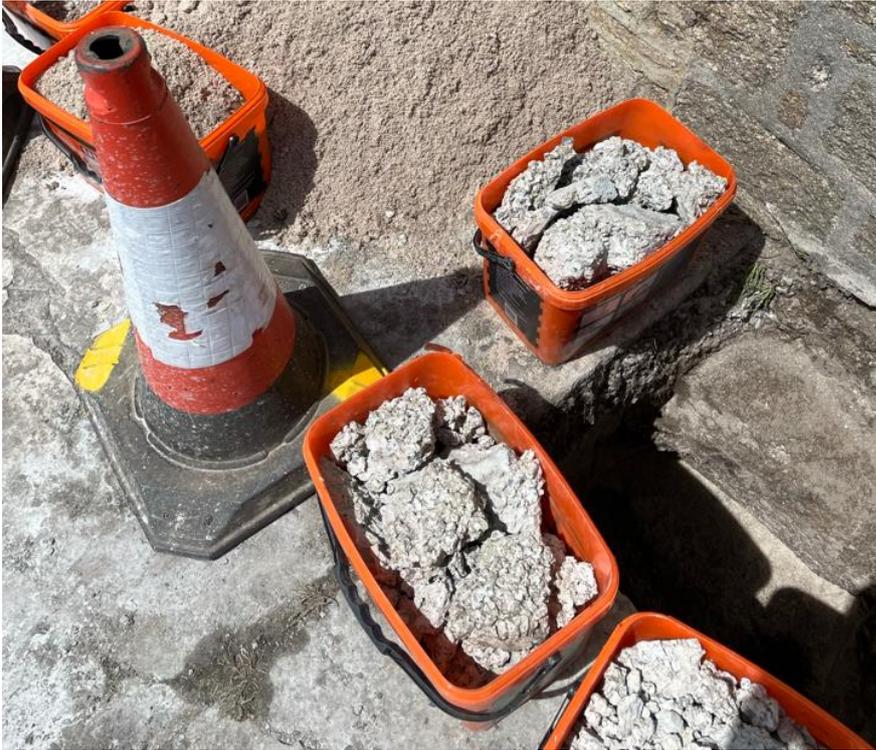
The second trial pit against the south elevation showed the wall was founded to a depth of 600 mm. The wall rested on a very large granite block which projected beyond the line of the dressed stone wall over. This is a typical detail of the area. (Photo 20)

Photo 20 - trial pit south elevation east of rear porch.

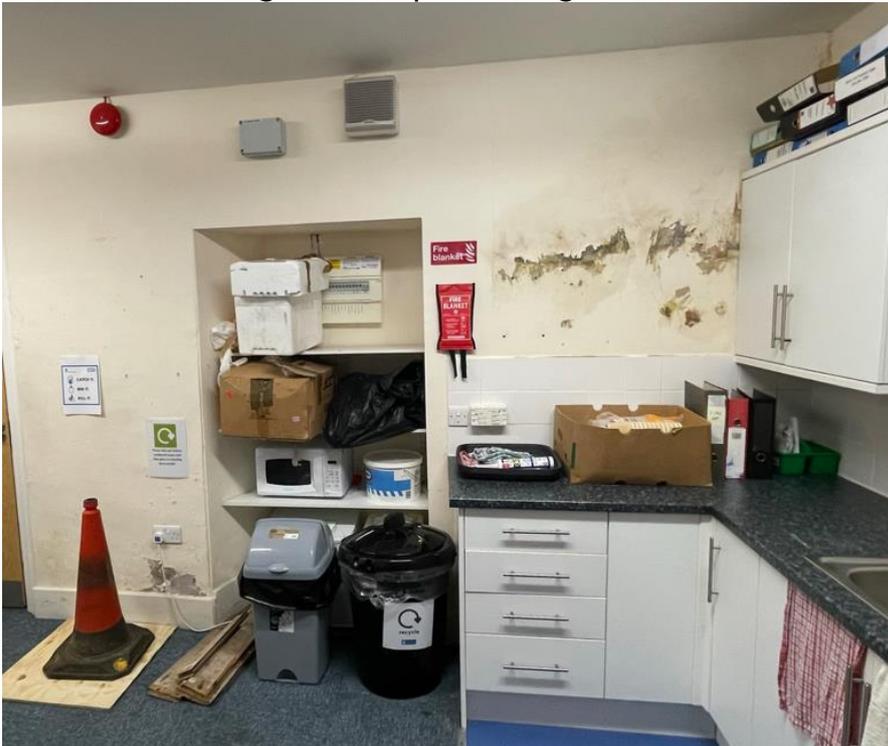
The original wall in the kitchen has a significant damp problem. (Photo 21)

Photo 21 - mould growth on plastered granite kitchen wall

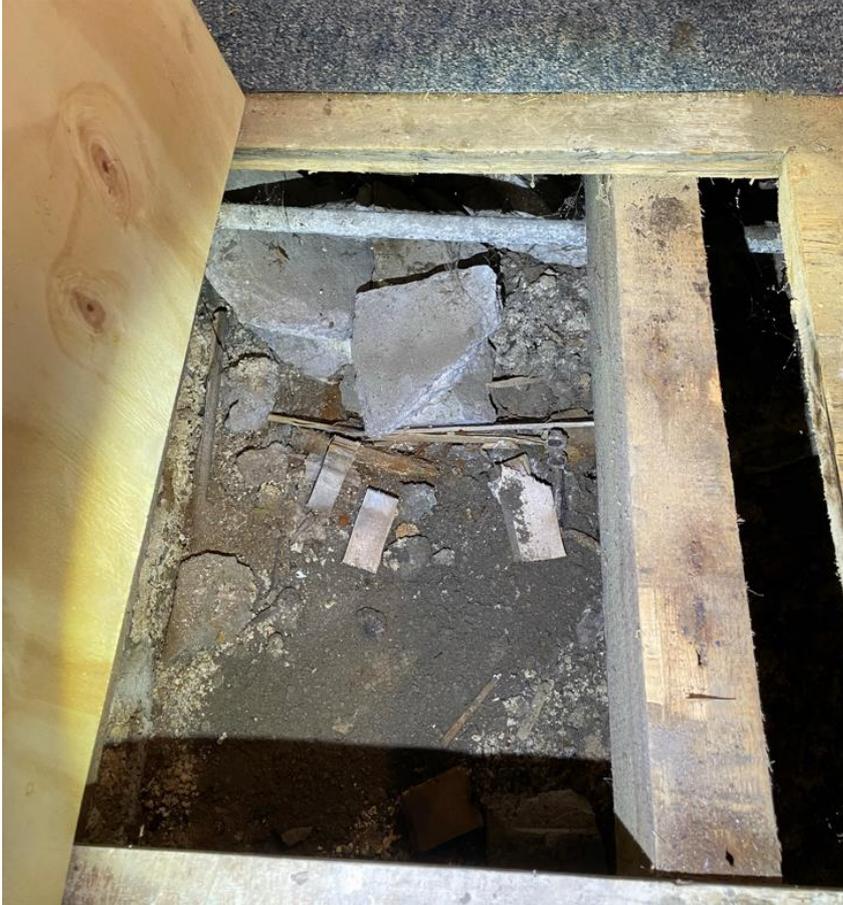
The floor to the stationery room and kitchen are timber joists spanning the width of the building. A trial hole was opened inside the kitchen floor. The joists were found to be 65x175mm at 400mm crs and the void under the joists to sand was 330mm clear. (Photo 22)

Photo 22 - trial hole in kitchen floor - sand under

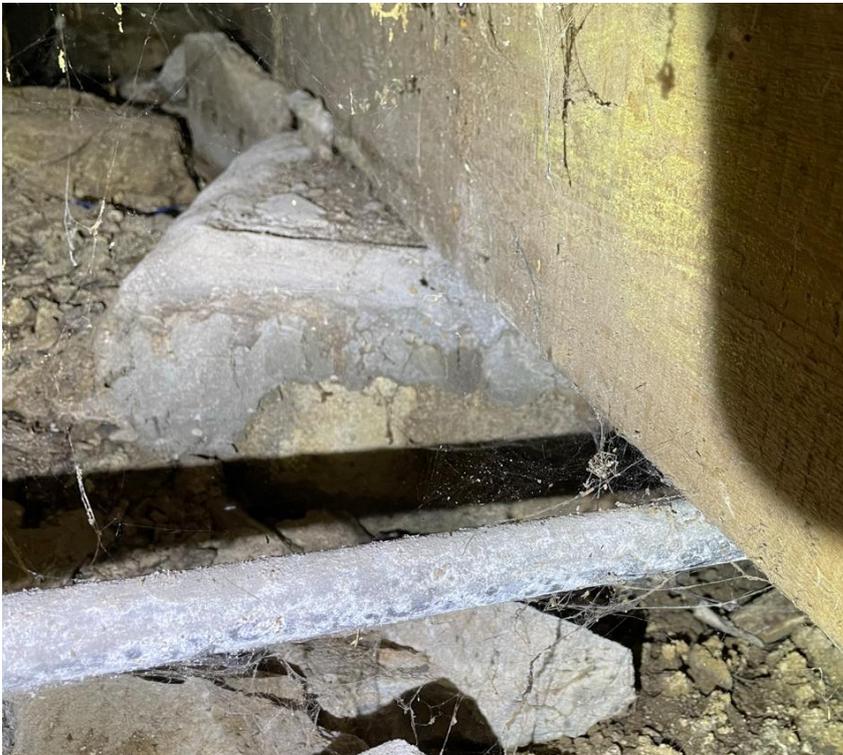
The kitchen floor void under the boards and joists contains a sealed manhole chamber which receives WC and kitchen waste from upper floors. (Photo 23) Suspended cast iron waste pipes can be seen in the void, these discharge to the manhole and then southwards under the building to Silver Street.

Photo 23 - foul drain access chamber under floor of kitchen

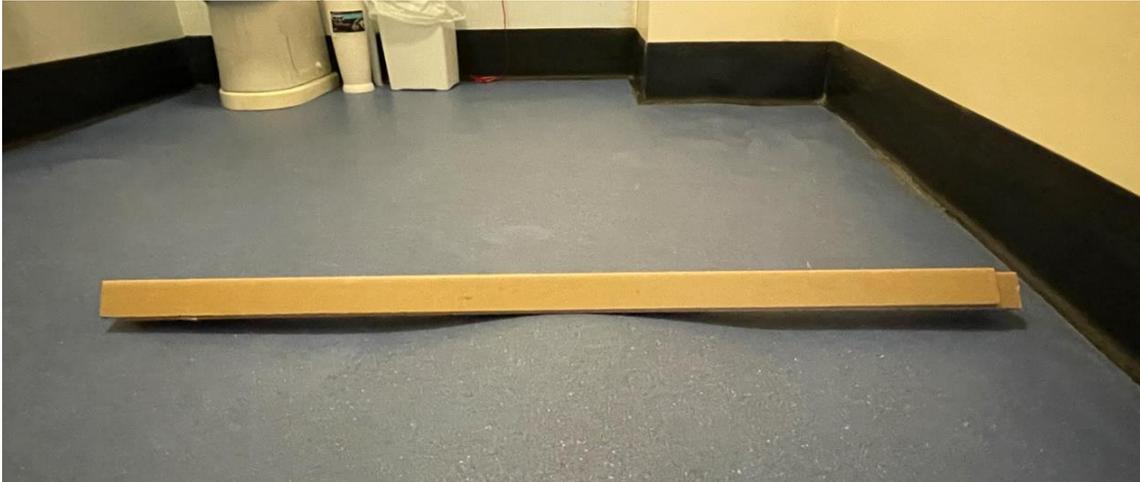
The ground floor of the toilets serving the main hall is solid. There is an odd bump in the floor of the disabled toilet which has been present for some time (Photo 24). There is not a logical explanation for why this bump is present, however, the area does suffer from water ingress higher up the building. It could be the bump is related to expanding corroded steel embedded in the slab.

Photo 24 - raised bump in disabled WC floor

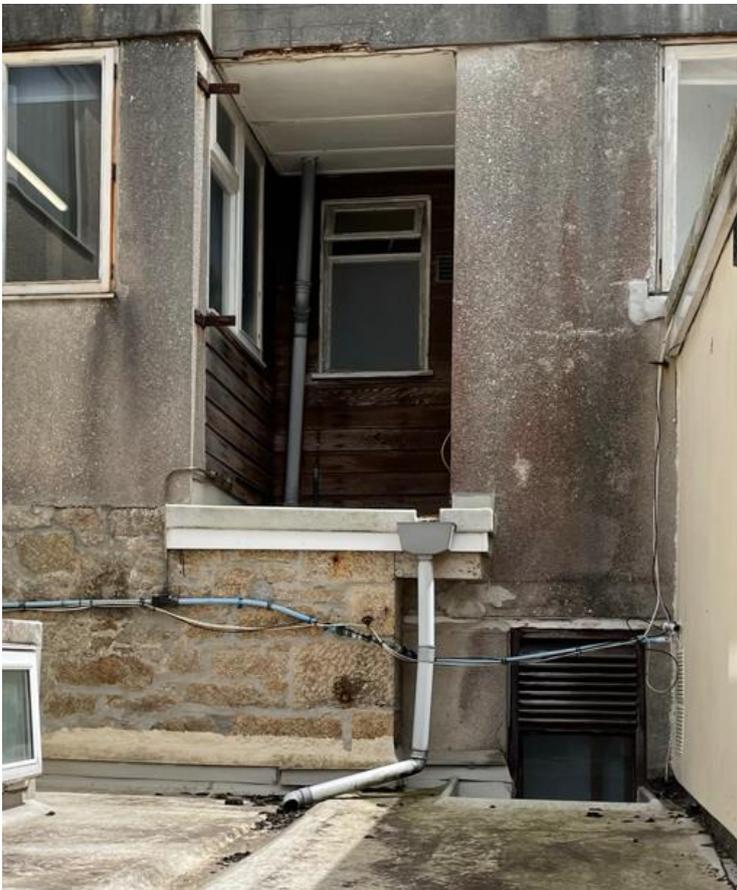
Windows for the two WCs central to the building plan open onto a recessed covered inset in the building footprint. The walls in the recess are timber clad studwork. The recess introduces a curious detail in the west elevation. A fibreglass “roof” protects the first-floor construction over the original thick wall under between the kitchen and WCs. (Photo 25) This roof evidently has leaked badly in the past and likely still leaks given the presence of active mould on the kitchen walls at ground level. Any timber in the first floor in this area is likely also affected by the water ingress and not just the masonry. Timber in this area and hidden from view is at risk of rotting.

Photo 25 - FF recess in elevation at WCs. Fibreglass roof in recess over original wall at rear of kitchen under

The three-storey office building is a mixture of construction types from several different eras. Structurally the building appears to be sound at present, however, the active damp problems associated with the first-floor inset recess could be causing hidden timbers to rot. The source of the damp should be established and eliminated and the condition of timbers in the vicinity of the damp investigated.

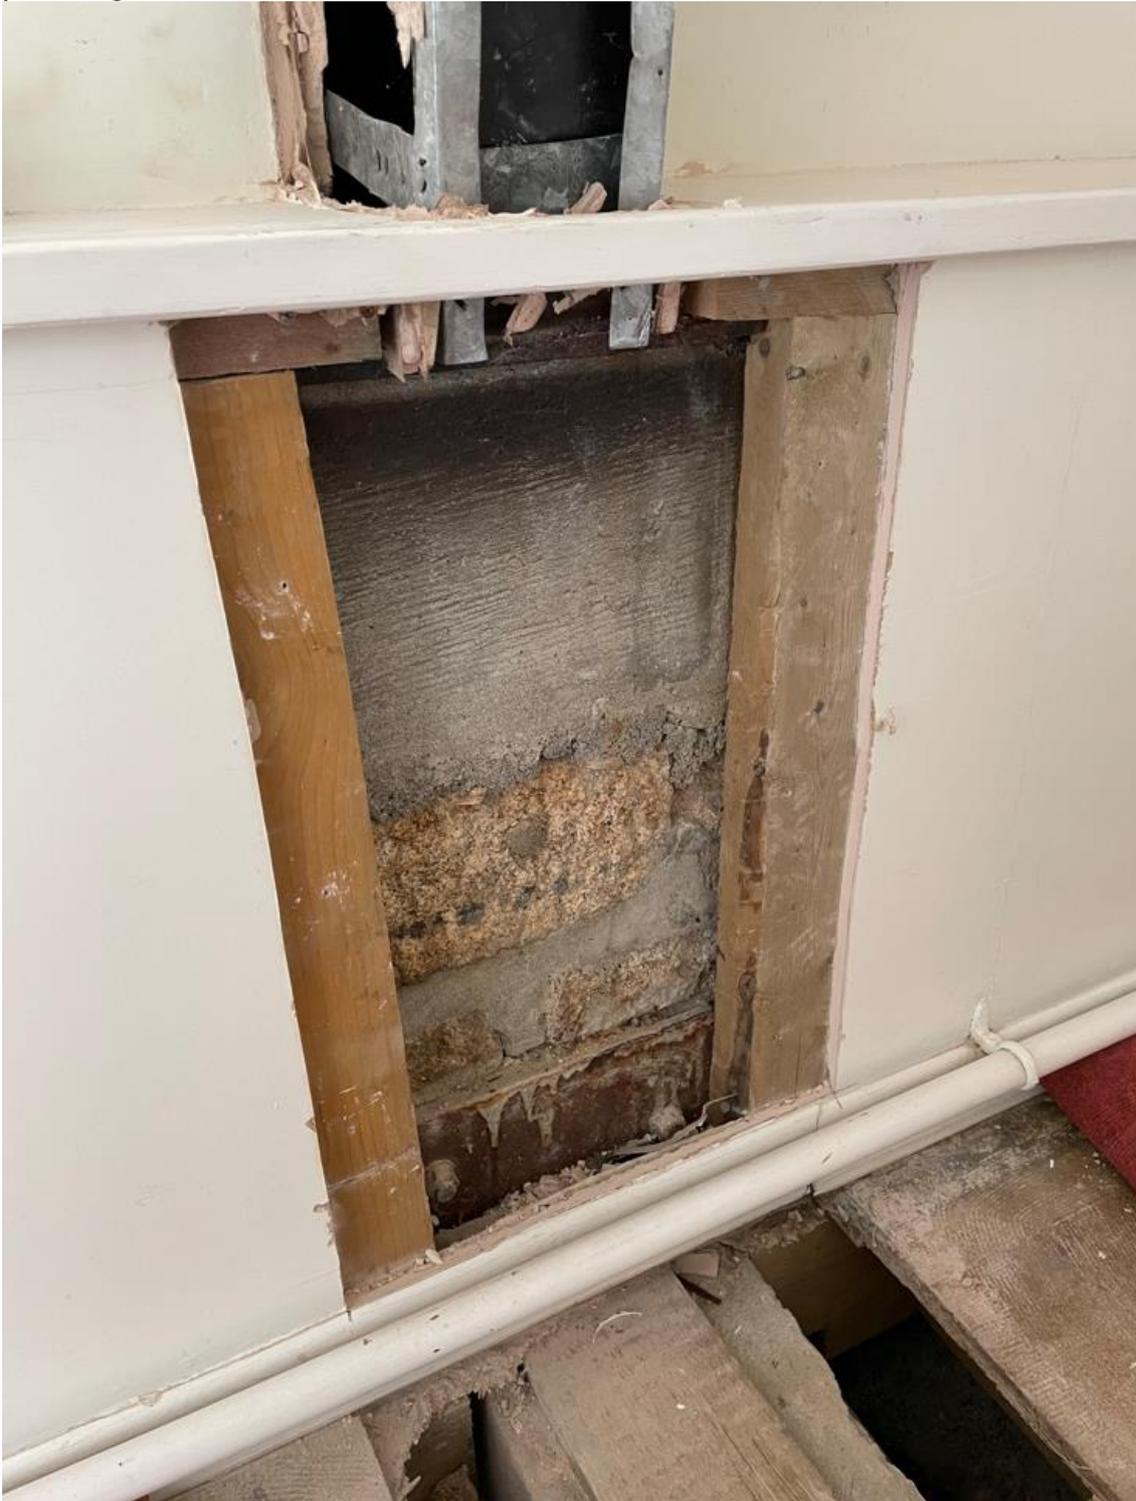
Photo 26 showing mansard steel on main hall wall on concrete ring beam or pad on granite and concrete T beam in the floor zone

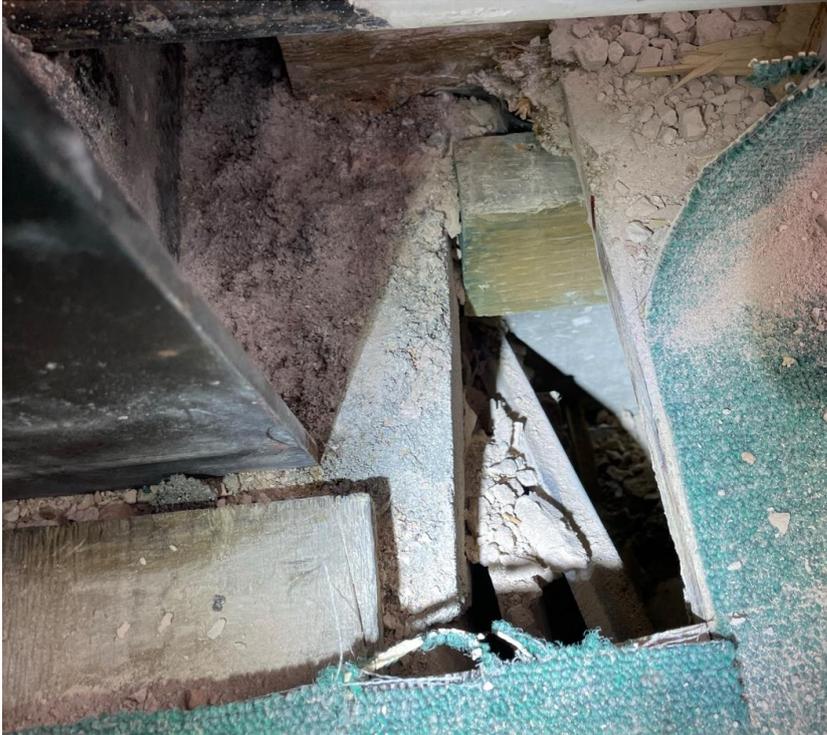
Photo 27 - mansard steel on west side wall cast into top of concrete T beam and T beam cast into ring beam, the face of which is seen under timber joist

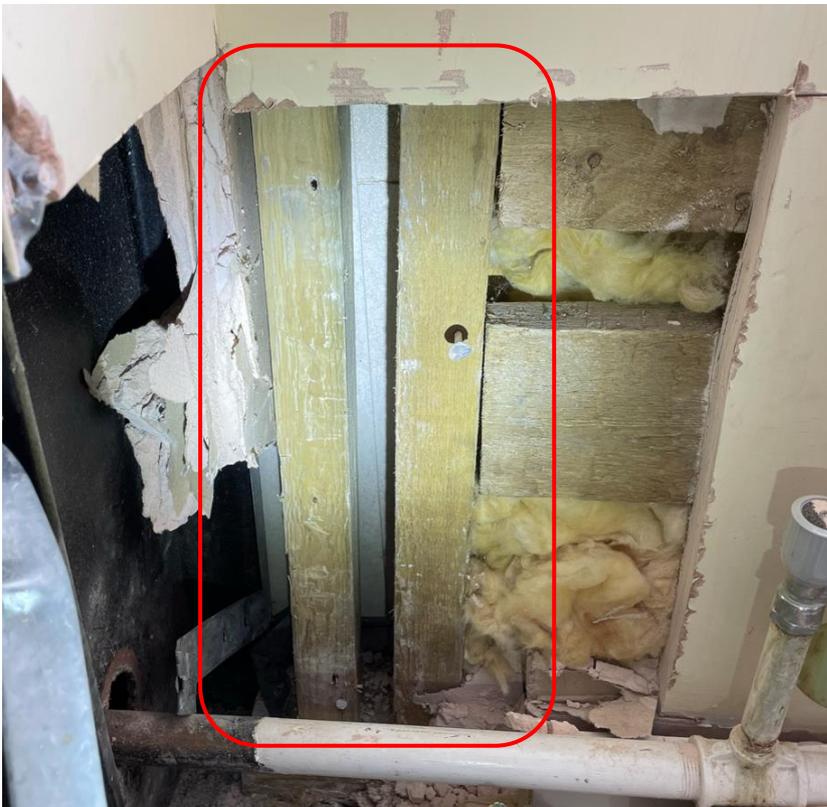
Photo 28 - cement board sheathing in mansard wall should be tested for asbestos
