Report on the Structure and Condition  
of  
The Town Hall and Museum  
Hugh Town  
St Mary's  
Isles of Scilly

## *1. Executive Summary*

A structural condition survey has been carried out on the Town Hall and Museum, St. Marys, Isles of Scilly.

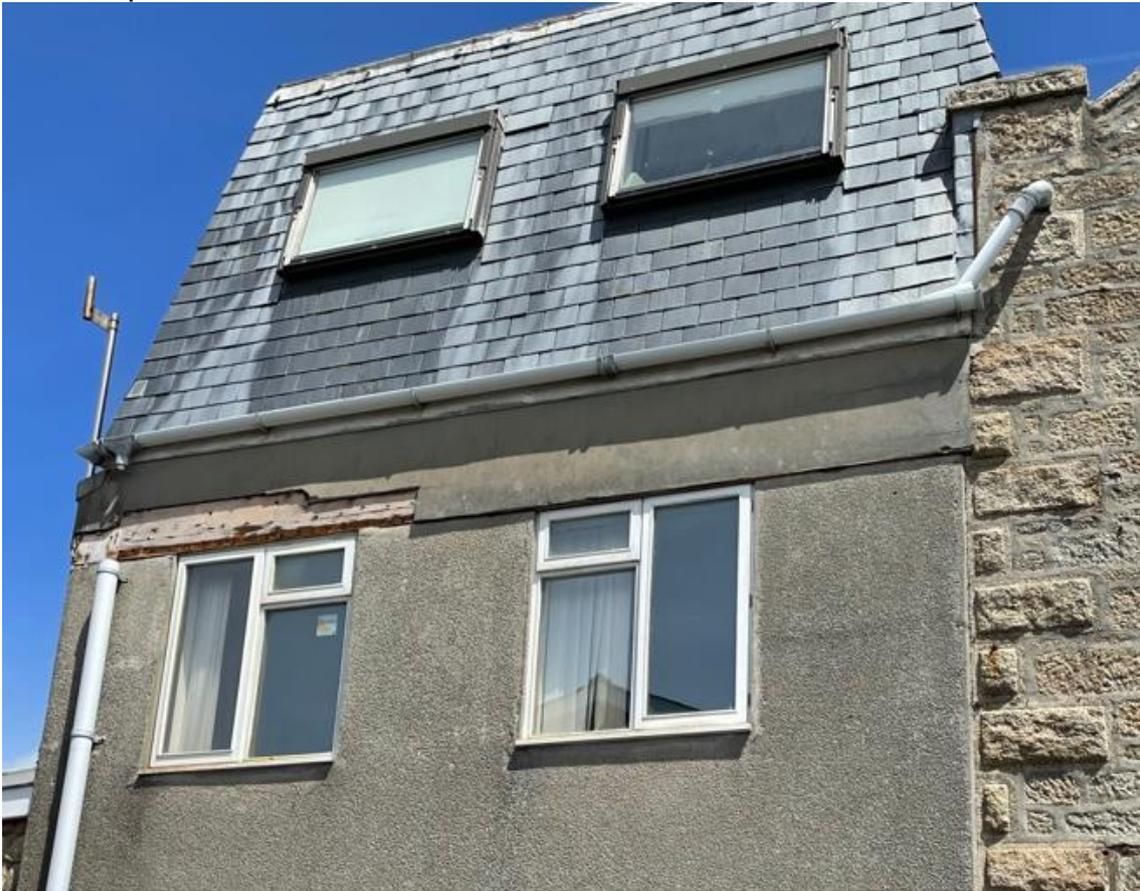
The south elevation is an unpainted render finish from ground floor to 2nd floor level. The render is in poor condition. A wide section of render approximately 450 mm high and 2m long has fallen off the building from second floor level where it was applied as a coating to plywood used in the Mansard roof extension construction. More render is at danger of falling off onto the pavement below and should be made safe (removed and repaired) as soon as possible. (Photo 29)

Photo 29 - loss of render over window and pavement below. Joint between render and stone likely allows water to track in creating damp conditions in side see photo 30.

Any high-level loose render on the rear elevation should be removed immediately as this poses a potential danger to all who walk under it. The render should be made good, or some temporary rain protection provided if a programme of wider repairs is not anticipated in the near future.

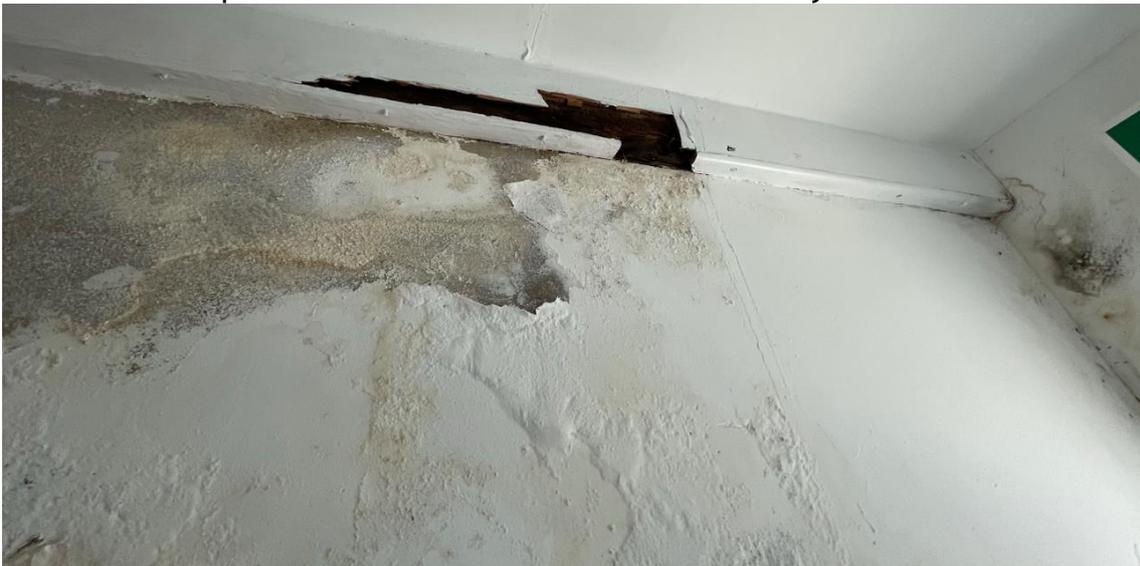
The south wall has visibly suffered from water ingress at ground floor and first floor level. This is evidenced by a decayed timber element above a stair at the rear of the building at first floor level and degradation of paint and plaster finishes on the main hall wall. (Photo 30 and 31)

Photo 30 - damp wall at GF rear of office section - decayed timber at FF level

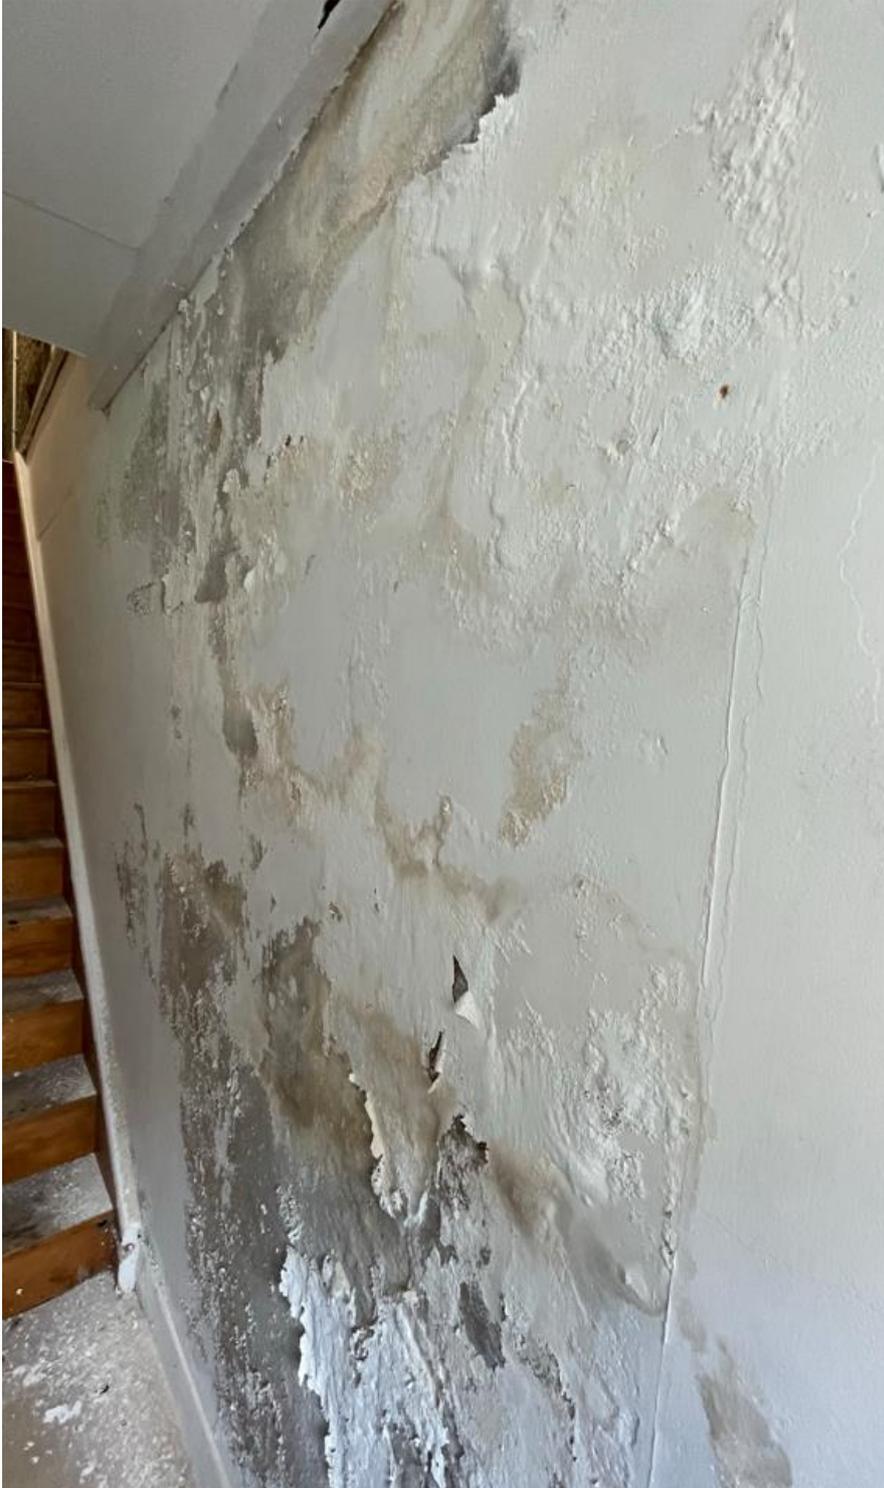
Photo 31 - severe damp in main hall wall - office side GF level

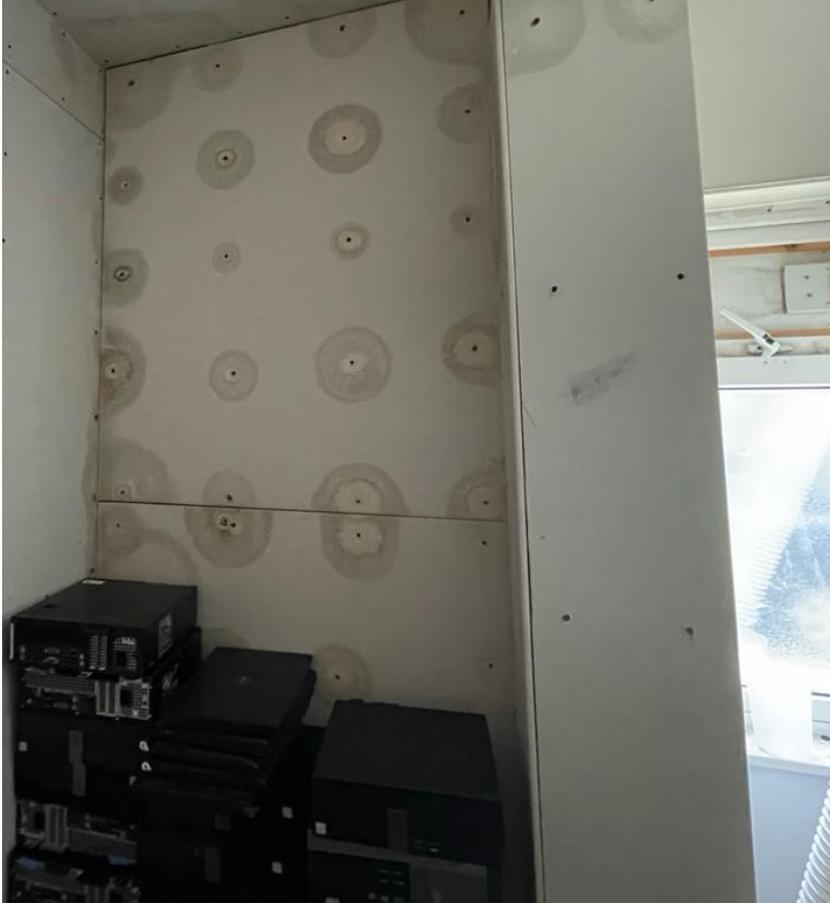
A rear storage room at ground floor level has been boarded out with new plasterboard but not skimmed. Screws in the plasterboard on the south wall can be seen to have served as conduits for moisture/condensation/damp leaving marks on the plasterboard where the screws are located. The room appears to be unvented, uninsulated, and unheated. It could not be worked out in the limited time of the inspection whether the damp issues associated with the room are generated by internal moisture or rain ingress. (Photo 32)

Photo 32 - GF rear storeroom - damp at plasterboard fixings in south elevation

The cause of damp in the ground floor rear storage room should be investigated and the problem eliminated.

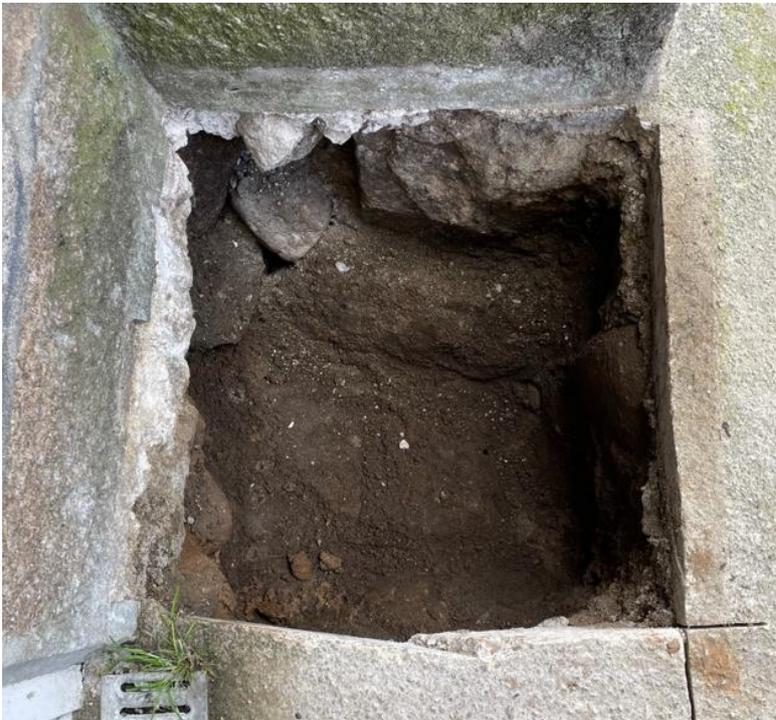
A trial hole was excavated at the front of the granite stone wall on the boundary with the neighbouring house on The Parade. This hole was made to verify the foundation depth of the wall. The hole was excavated to approximately 500mm deep. The wall below ground level was shown to be random granite rubble stonework, not dressed, and not fixed by mortar. A

Photo 33 - trial hole at boundary wall with adjacent house to the west on The Parade

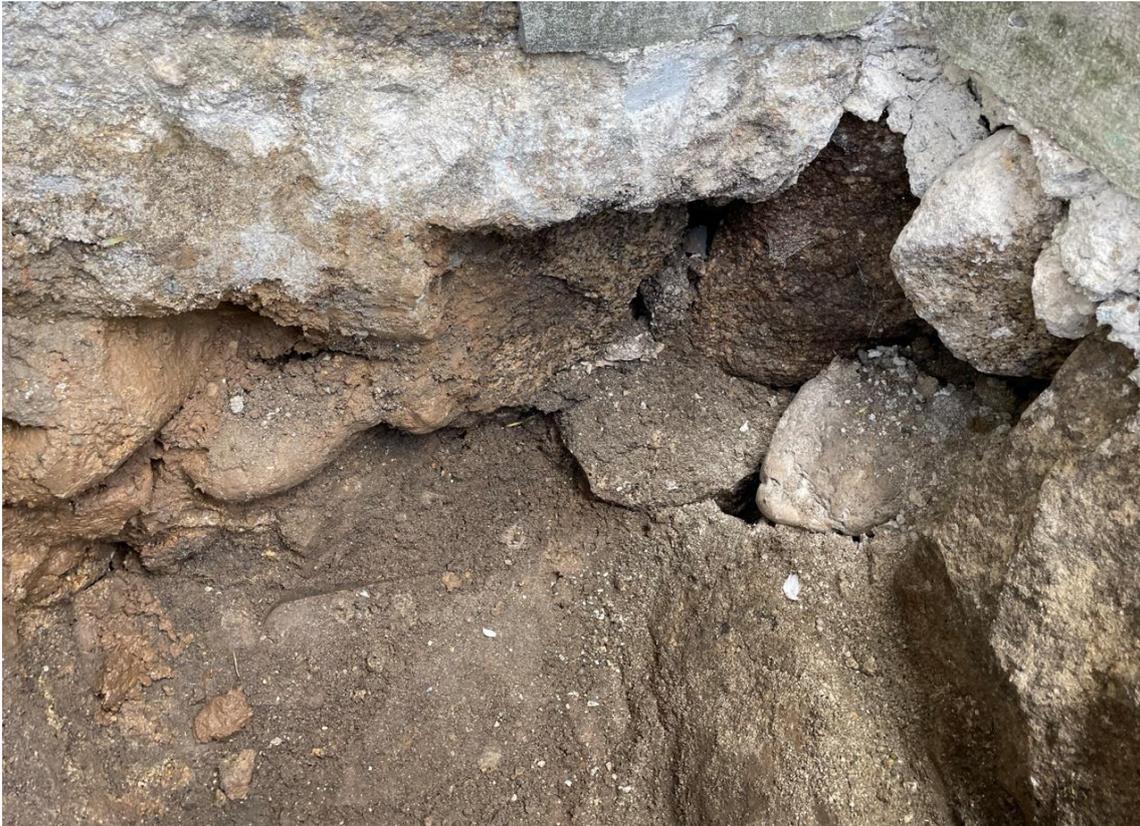
loose stone fell out of the wall so further excavation was stopped. There was further stone at the base of the hole. Despite not establishing the bottom of the foundation the detail is similar to the other two external holes excavated for the main hall walls. (Photos 33 and 34)

Photo 34 - showing loose stone makeup in foundation. Mortared joints commence at ground level

- New excavations must consider the shallow foundations of loose stone on sand. Care will need to be exercised when excavating near loose stone in the foundations and the sand under the foundations should not be undermined. It may be necessary to employ stabilising techniques on the loose stone and sand where new excavation will be made close to the walls prior to any works taking place.
