Climate Adaptation Scilly
Porthmellon Enterprise Centre
St Mary's
Isles of Scilly TR21 0LW

Information on the materials present in the Periglis embankment, St Agnes

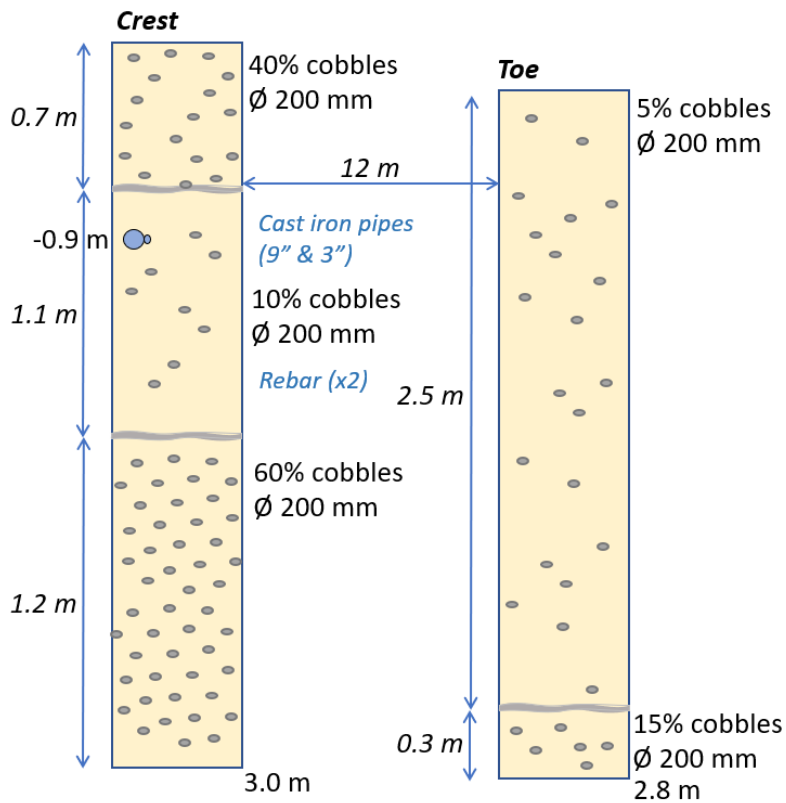
Figure 2: Trench 1 illustration

Trench 1: North of dispersal field

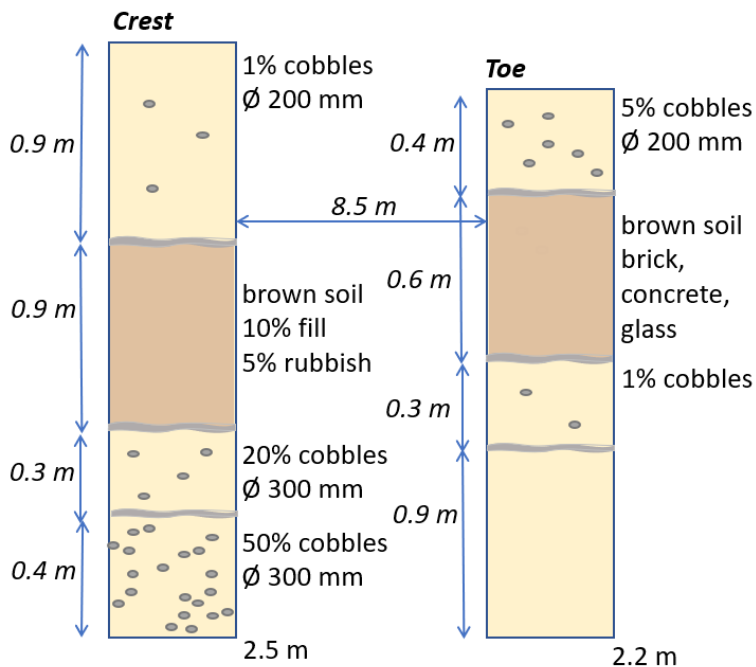
Figure 3: Trench 2 illustration

The locations of the trenches were chosen on the expectation that Trench 2 would probably intercept waste, because it was closest to the accessible end of the embankment.

Trench 2: South end near track

At the southern end of the embankment the brown soil present was probably placed where residents were disposing of rubble and other inert materials – there are up to 15% by volume bricks, concrete and glass mixed in with the soil. Residents recall ‘filling holes’ in the dune, rather than excavating a large volume then filling it again.

In places there is low proportion of general inert building waste such as bricks. Individual pieces of inert waste such as cast-iron pipe and what appeared to be the remains of a trailer were probably used for dune strengthening. Most waste was present at the southern end, closest to the buildings, as might be expected if waste was being deposited the shortest distance from the neighbouring track.

The volume of waste present is less than expected and all waste can be managed by removing it to the waste management facility on St Agnes and disposing of it.

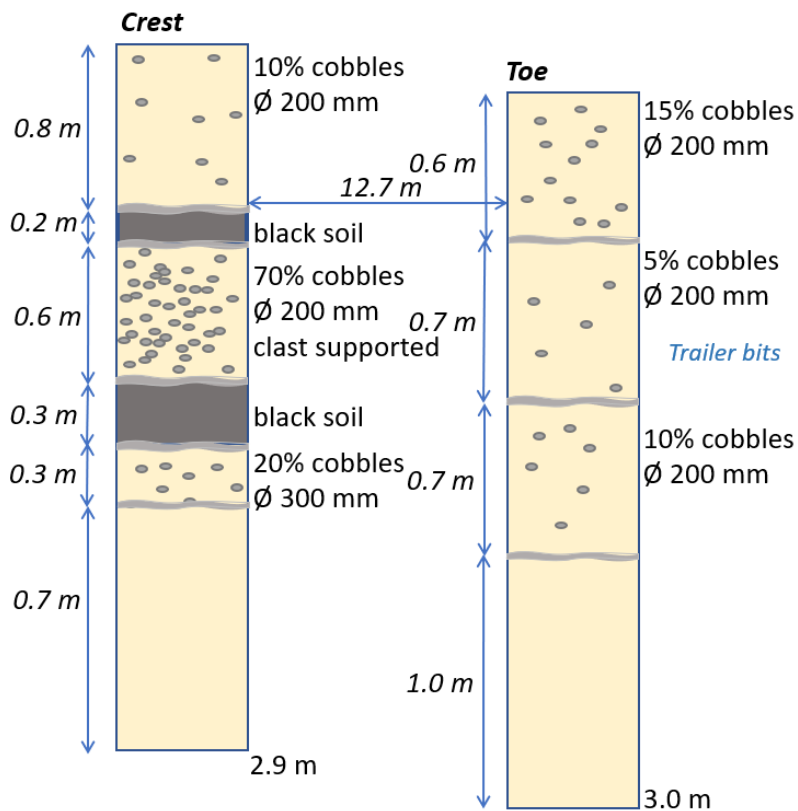
Figure 4: Trench 3 illustration

Trench 3: North end of cricket pitch

At most sites there is a basal unit with more cobbles present, except (notably) the trench north of the cricket pitch. This basal unit possibly represents an older beach unit that was covered by the overlying dune sand. The lack of cobbles at this depth north of the cricket pitch may represent the position of a cobble-poor section of the palaeo-beach as seen typically in present-day mixed cobble-sand beaches on the Isles of Scilly.

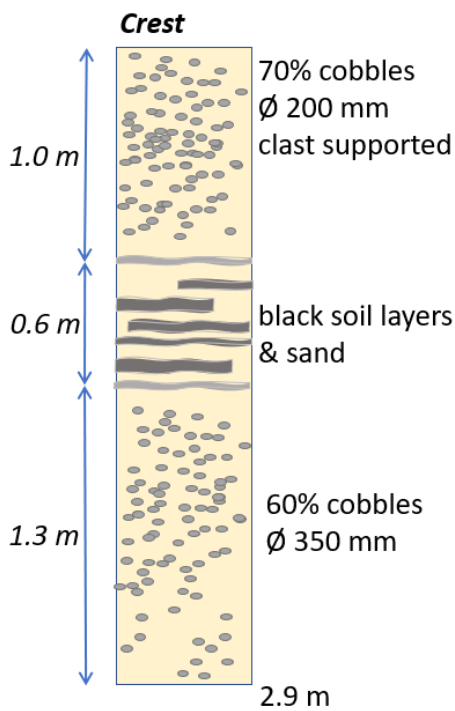
Figure 5: Trench 4 illustration

The stratigraphy of each trench was described at the embankment crest and at the toe at the eastern end of each trench adjacent to the low area of the SSSI. In the northernmost Trench 4, only a crest description was provided, since the trench was relatively short.

Trench 4: South side of leat
