# PRELIMINARY ROOST ASSESSMENT (PRA)

## COOTAMUNDRA, MCFARLANDS DOWN, ST MARY'S, ISLES OF SCILLY

*Client: Island Construction*

*Report date: 4<sup>th</sup> February 2023*

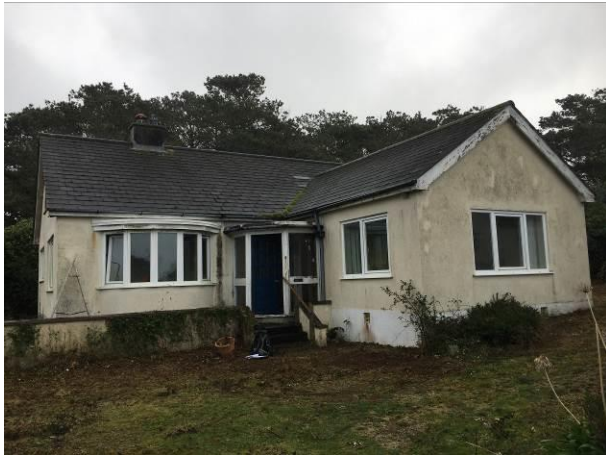
The main dwelling house is a dormer bungalow which is rendered externally in good condition. Occasional cracks are present, but these, are superficial only. The doors and windows comprise a combination of wooden and uPVC units which – whilst they are deteriorating in places – are well-fitted offering no gaps around the frames. There is a bay window and porch at the front of the property, both with flat roofs – no structural features offering roosting opportunities were noted associated with these.

**Photograph 1:** Showing the main existing dwelling on the site.

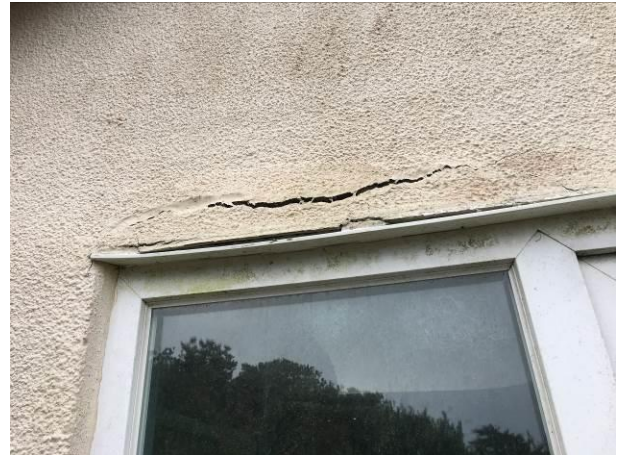
**Photograph 2:** Showing an example of the well-fitted window frames with no gaps or crevices. Cracks and damage in the render, as illustrated, are superficial and not suitable to support bats.

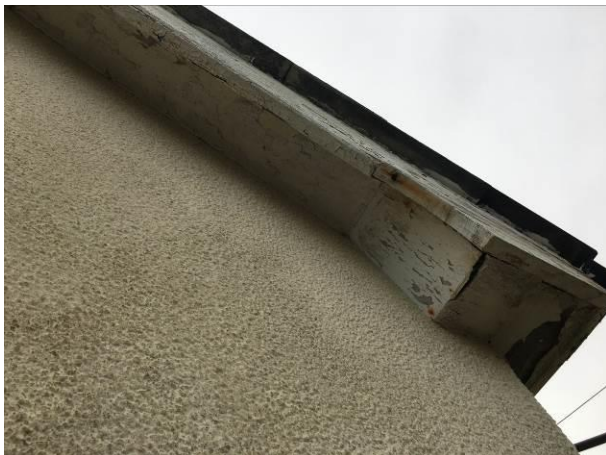
**Photograph 3:** Showing the good condition of the boxed soffits throughout the majority of the property.

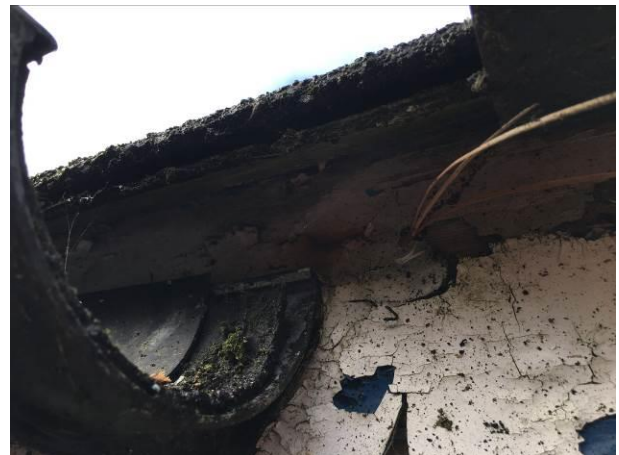
**Photograph 4:** Showing an example of the eaves where the guttering is displaced, demonstrating the lack of access for bats.

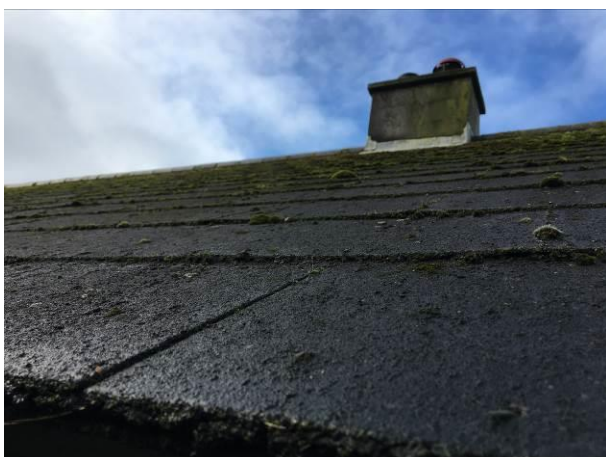
The roof is covered with slate-effect tiles which are thin but well fitted – no gaps were noted which could potentially provide a roosting opportunity for bats. There are rounded ridge tiles present – these too were well fitted with no gaps. The roof verge at the two gables were inspected and found to provide no gaps or access features; similarly the structure of the eaves permits no potential access. The valley between two roof pitches was well-sealed with no lifted flashing. The chimney is rendered and in good condition with no gaps in the flashing which joins the main roof. There are boxed soffits throughout the gables and eaves – these were all tightly fitted with the exception of a single location at the north-western corner. This would not provide access to the gable soffit due to the construction, but does support an old nest which was found during a video endoscope inspection. This entirely fills the gap along the eaves, indicating no current or recent occupation by bats. Video endoscope inspection confirms this.

**Photograph 5:** Showing the tight fit of the roof tiles, with no gaps noted throughout.

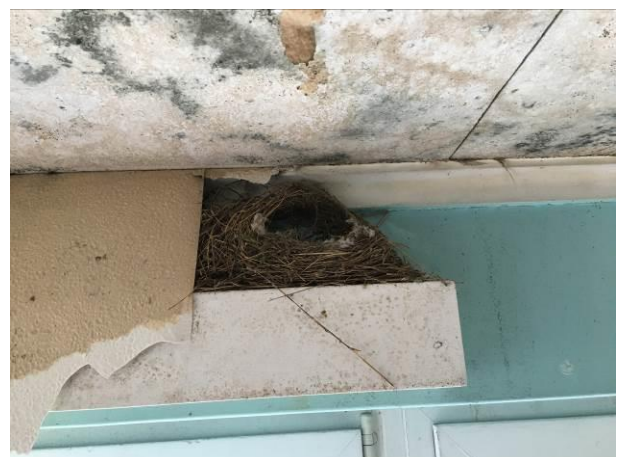
Internally, the property is in significantly poorer condition, arising from a long period without occupation and water damage caused by a leak during this time. There are occasional open or damaged windows which have permitted access for birds – a nest was located in the kitchen and another in the porch.

Nests were confirmed in the kitchen and porch of the dwelling house; and in the individual damaged sections of soffit on the dwelling house and the garage. No active nests were noted in the oil tank shelter or the glasshouse, but they are considered suitable locations.

**Photograph 6:** Showing an example of one of the birds nests within the property, resulting from lack of occupation.

If all access features are sealed before the end of February, this would ensure that breeding birds do not have opportunity to establish nests. Utmost care must be taken to ensure that no birds are present in the property at the time that the access features are sealed to prevent birds from being trapped. This would require a careful walkover of the property including all rooms and voids where birds may be present. Upon completion of this inspection, windows should be closed and sealed. In the case of soffits, the old nests should be carefully removed by hand and confirmed not to be in active use before these features are sealed. The presence of the dense nesting material and lack of access to further voids within the soffits would currently prevent use of these features by bats.

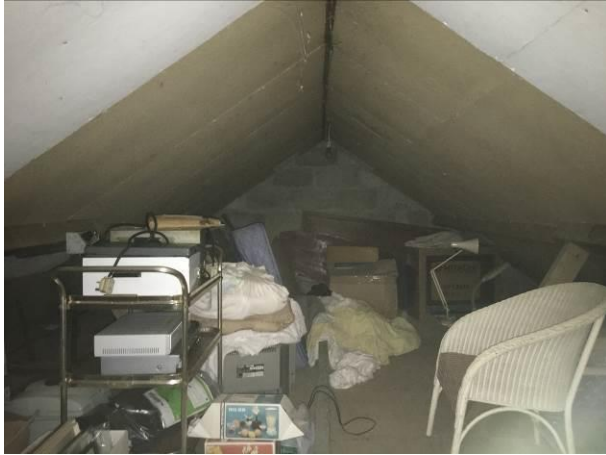
**Photograph 7:** Showing the interior of one of the boarded out loft components within the property – this example is at the apex but those at the eaves are of equivalent construction.

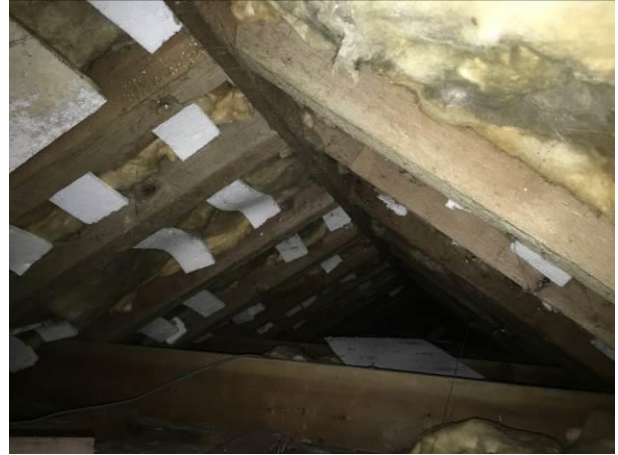
Loft spaces are present above the tie-beam of the A-frame roof timbers and also built into the eaves. The void at the apex was small and could not be accessed fully – however inspection from the loft hatch reveals well-fitted underfelted and insulation. Those voids built into the eaves were used for regular storage and were boarded out internally with insulation above. Occasional evidence of mice was noted, but a comprehensive inspection did not identify any evidence of bats.

It was not possible to fully inspect the apex loft space in the main dwelling; however the roof structure is remarkably tightly fitted and well-sealed given the overall condition of the property. No suitable access points for bats were identified anywhere within the roof structure making it highly unlikely that a bat would be able to access this void.

**Photograph 8:** Showing the main loft above the tie-beam in the main dwelling.

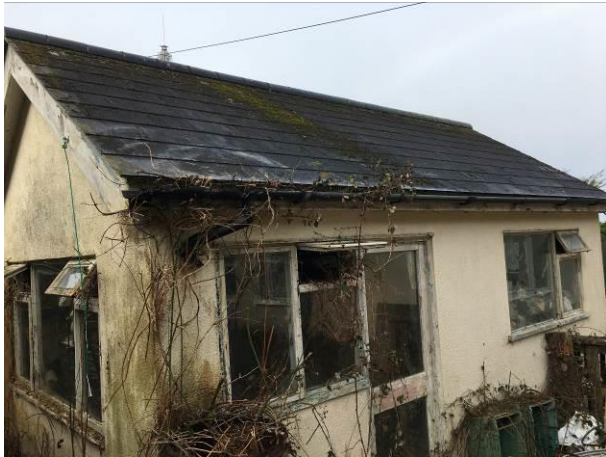
The garage unit is built using the same construction style and materials as the house – the pitched roof uses the same roof covering; the boxed soffits are equivalent; and the exterior is rendered in the same material as the house.

**Photograph 9:** Showing the single-storey garage.

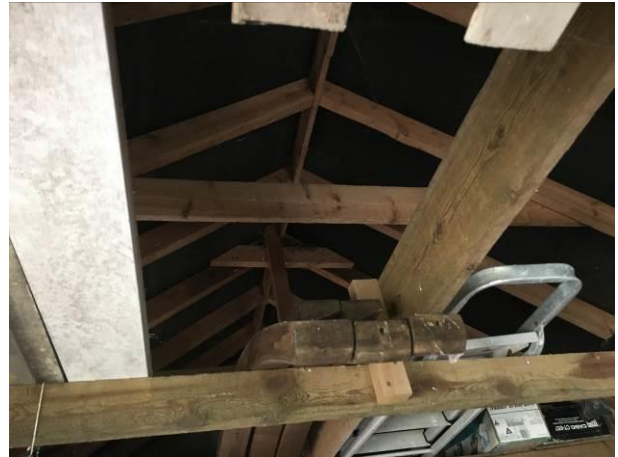
The roof is well-fitted with no gaps noted. Window and door frames are well-fitted with no gaps noted; however the windows were open in places. The internal A-frame roof timbers were well-fitted and in good condition – the terminal structures adjacent to the breeze-block walls were tightly adjoined to the wall with no gaps behind. A ridge board is present with underfelted in good condition above the timbers. A damaged soffit in the south-western corner would potentially provide access into the garage, but does not offer a roosting opportunity in its own right due to the lack of a suitable enclosed or terminal apex cavity. An inspection using a video endoscope did however identify the presence of a nest in this location. The remaining boxed soffits were in good condition with no gaps noted. There was evidence of mice in this building, but no evidence of access or occupation by bats was identified. The only potential features would be free-hanging from timbers, or use of idiosyncratic roosting features associated with stored garage items and equipment.

**Photograph 10:** Showing the interior of the single-storey garage with A-frame timbers and well-fitted underfelting.

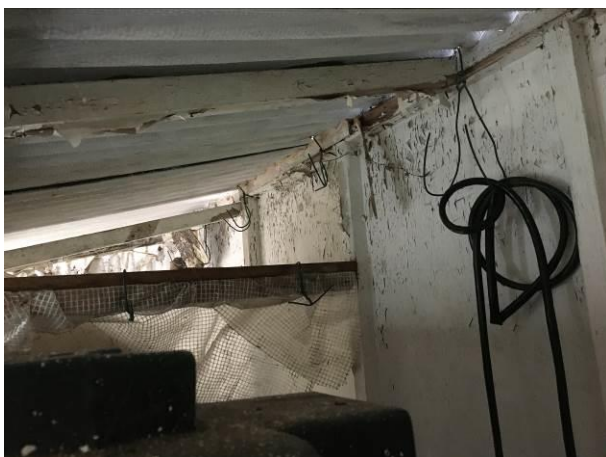
A shelter has been built around the oil tank adjacent to the glasshouse – this is a combination of ply and corrugated sheet materials around a wooden frame. An aviary is present at the eastern end of this structure. The shelter was fully inspected – no evidence of occupation by bats was noted and the structure did not appear to have suitable roosting features for the bat species present on the island.

**Photograph 11:** Showing the roof of the canopy sheltering the oil tank.

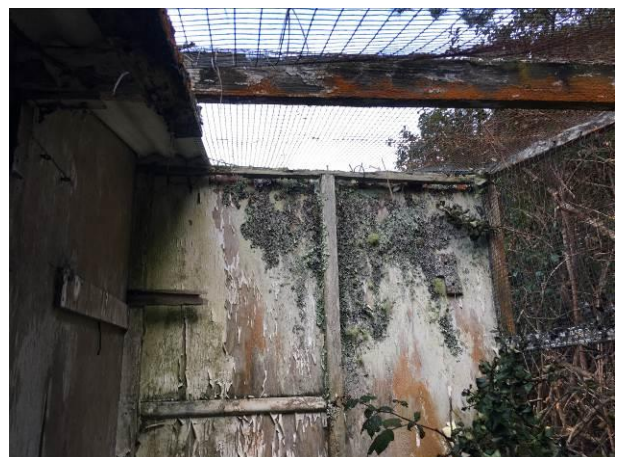
**Photograph 12:** Showing the aviary located at the end of the oil tank shelter.

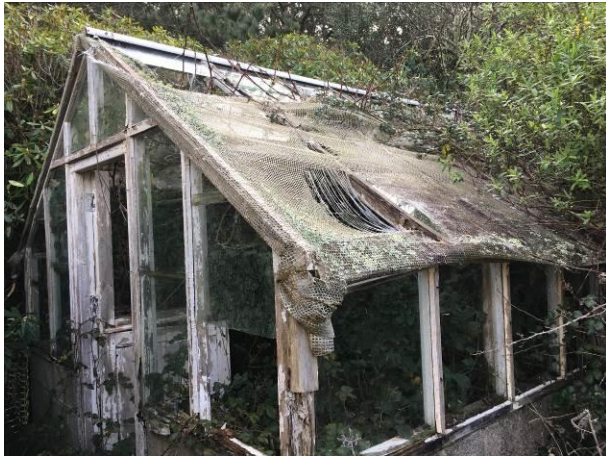
built onto a breeze block lower wall. The door was open and there are frequent broken panes allowing ease of internal access for birds. An old grape vine is present along the apex, with dense brambles in the base. No suitable roosting opportunities for bats were noted associated with this structure.

**Photograph 13:** Showing the glasshouse.

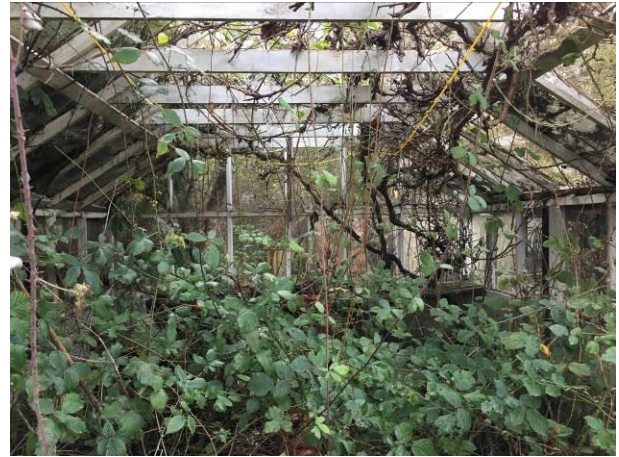
**Photograph 14:** Showing the interior of the glasshouse with overgrown grape vine and brambles.
