By Liv Rickman at 10:29 am, Jul 14, 2023

PRELIMINARY ROOST ASSESSMENT (PRA) JUNE 2023 UPDATE

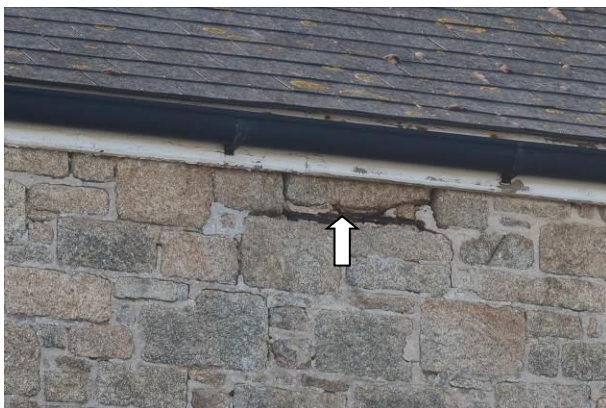
Photograph 3: Showing one of the cracks in the blockwork on the eastern aspect of the hall.

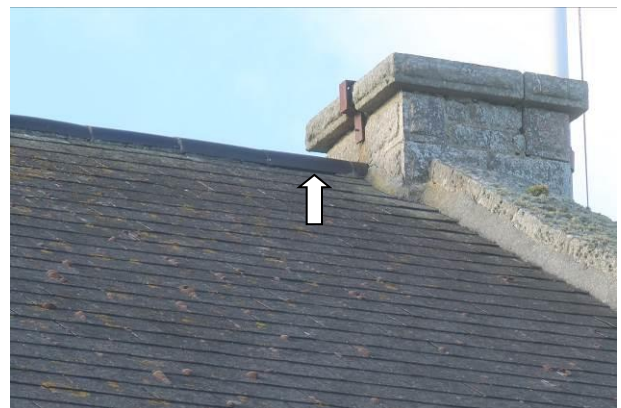
Photograph 4: Showing one of the minor gaps beneath the ridge tiles on the hall.

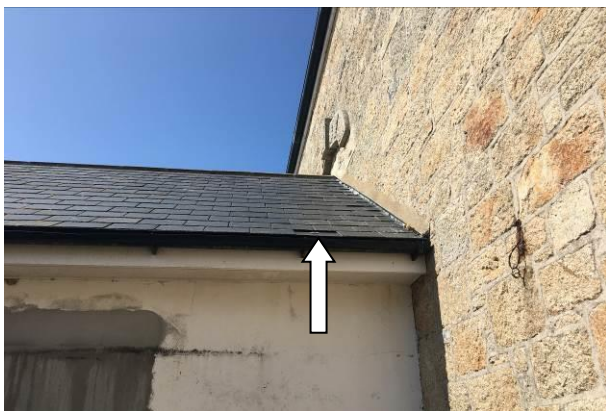
Photograph 9: Gaps under missing tiles on the Plant Room roof.

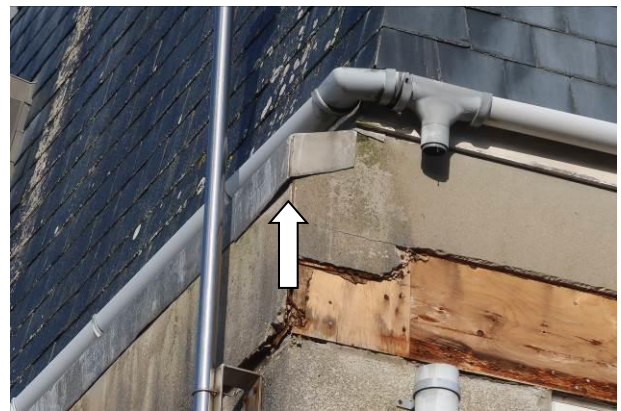
Photograph 10: Showing an example of lifted flashing between the slate tiles of the Mansard roof and the boarding beneath on the 1970's extension. **This photograph was taken in 2022 - the damaged boards have been repaired in 2023.**

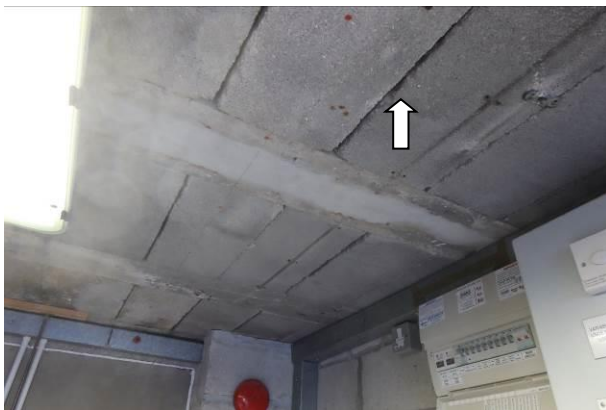
Photograph 11: Showing gaps between breeze blocks in the ceiling of the plant room.

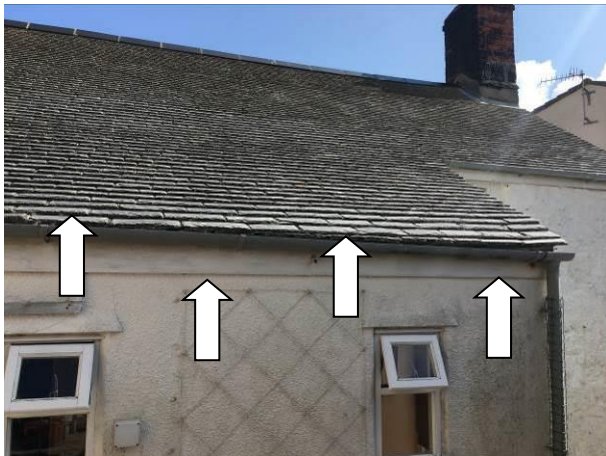
Photograph 17: Showing the northern aspect of the cottage – gaps beneath the tiles at the eaves as well as beneath the fascia boards were noted.

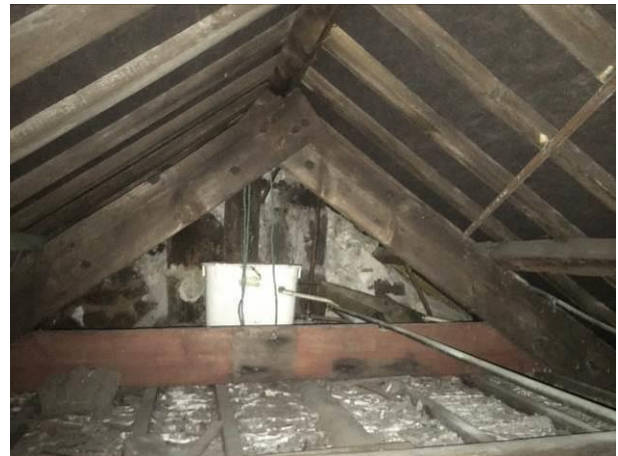
Photograph 18: Showing the loft space in the cottage, viewed from the access hatch.
