PRELIMINARY ROOST ASSESSMENT (PRA)

VERONICA LODGE, THE GARRISON, ST MARY'S, ISLES OF SCILLY

Report date: 17th August 2025

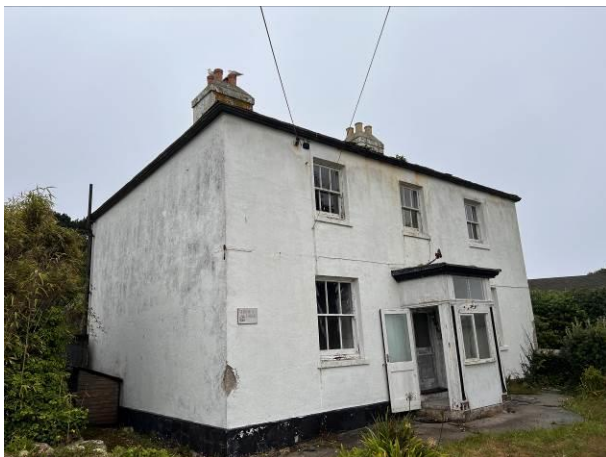
There is a glazed flat-roof porch on the front of the property – no potential roosting opportunities were identified associated with this structure.

Photograph 1: Showing the view of the property from south-east with the glazed porch visible on the front.

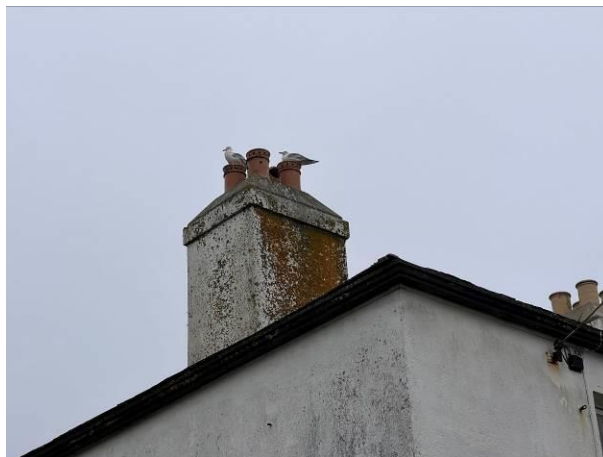
There are no fascias or soffits – the cast iron guttering is attached directly to the walls below the eaves and is tightly sealed – this structural feature does not appear to offer any roosting opportunities for bats.

The property has the potential to provide suitable nest sites for common bird species. This is associated with the roof, and may include use by gulls which were noted on the chimney pots at the time of survey. The ivy cladding on some walls may also offer nesting opportunities for species such as wren.

Photograph 2: Showing the cast iron guttering around the edge of the roof. The chimney with gulls on the pots can also be seen.

Works affecting the roof should be undertaken outside of the breeding season which runs from March – September inclusive, where practicable. This would provide the most robust means of avoiding risk of impact to nesting birds.

If the recommended timing of works is not possible, then contractors should visually inspect the work area internally and externally before they are affected by the works, in order to confirm that no nests are present. In the event that a bird nest is present, it must be left undisturbed until chicks have fledged the nest, at which point works can proceed.

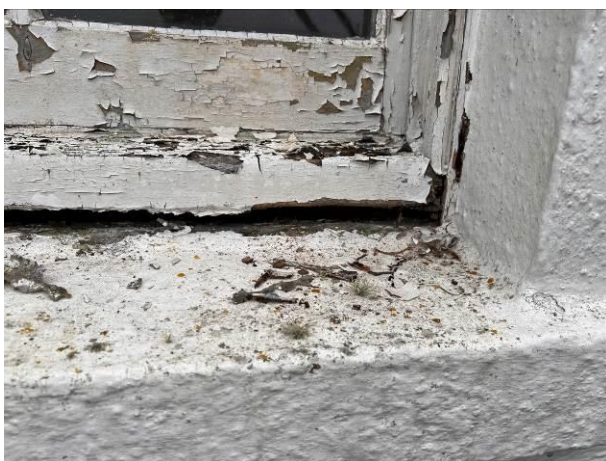
The exterior walls are rendered throughout with no cracks or other damage which might offer roosting opportunities. Timber window and door frames are well-fitted in their apertures. There are instances where there is rot in the timber frames but these do not currently offer

roosting opportunities in their own right, or offer access to further roosting opportunities associated with the walls or cavities. This could however develop with further deterioration in condition over time.

Photograph 3: Showing an example of the rot present in some window frames which does not yet offer roosting opportunities for bats but may develop in time.

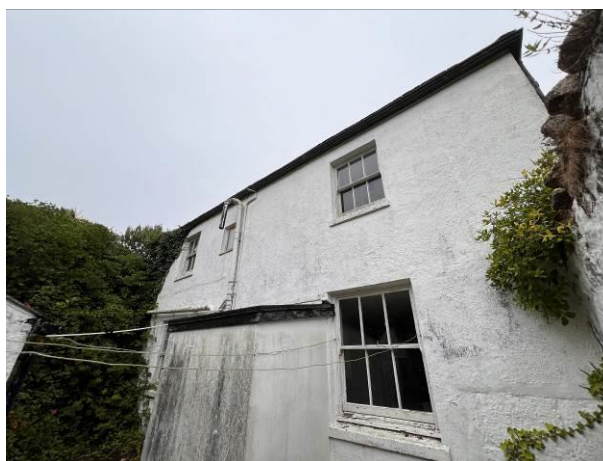
There is a further lean-to structure to the rear with a felted roof – this was similarly well-sealed with no access or roosting opportunities noted.

Photograph 4: Showing the rear of the property with the lean-to structure visible.

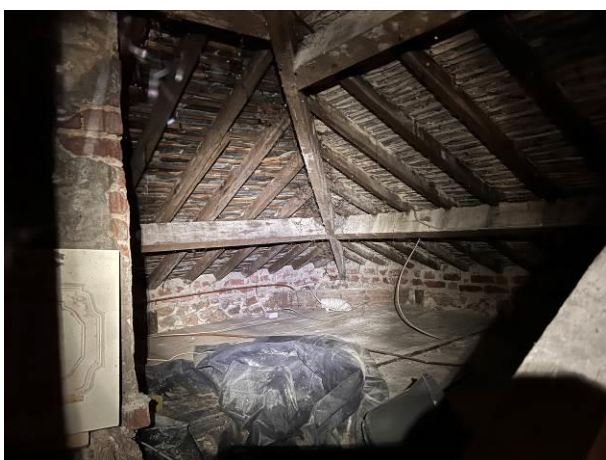
The hipped roof is lined with scandle tiles – these appear to be in relatively good condition externally though internal inspection of the loft space identifies potential gaps through light visible at the eaves. The chimneys are rendered in part and appear well sealed – the flashing at the junction with the main roof appears in good condition.

Internally, the loft is dusty with abundant cobwebs which appear to be of some age indicating no significant recent flight within the void. The roof is open to the scandle tiles above the battens with no felting or render. The roof is constructed around a timber truss framework which is well-sealed with no gaps or cavities at the joints. A ridge beam is present. The exterior walls rise around 30cm above the ceiling joists – the blocks are well pointed with flaunching in good condition around the top of the wall plate. No evidence of use by roosting bats was noted – however see access limitations as outlined below.

- The loft space of Veronica Lodge was surveyed from the vantage point of the loft hatch however concerns over the structural stability of the ceiling meant that full access to inspect the void could not be gained;
- Some features associated with the roof structure could not be safely inspected at height;
- There are locations within the building where evidence of bats, if present, would not have been apparent from a PRA survey, such as roosts which might be present associated with the wall plate.

Photograph 5: Showing the interior of the loft space of Veronica Lodge.

- 1x Presence/Absence Survey (PAS).

The PAS surveys should be led by a Licensed Bat Worker between mid-May and mid-September. A minimum of two surveyors with Night Vision Aid (NVA) cameras would be required to cover the relevant features and allow the results of the surveys to be reviewed and confirmed in

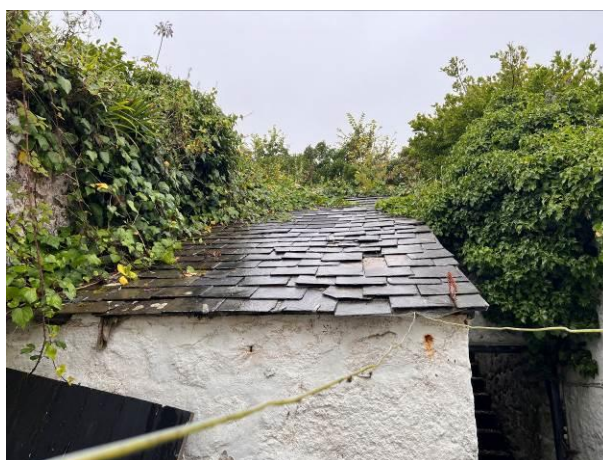
The slate roof has a number of slipped or missing tiles close to the eaves which could permit internal access; however there is no evidence of recent internal flight with abundant cobwebs which are dusty and debris filled indicating an extended period without disturbance.

Photograph 6: Showing Outbuilding B with the natural slate tiled roof. The gaps between slates close to the eaves practise can be seen.

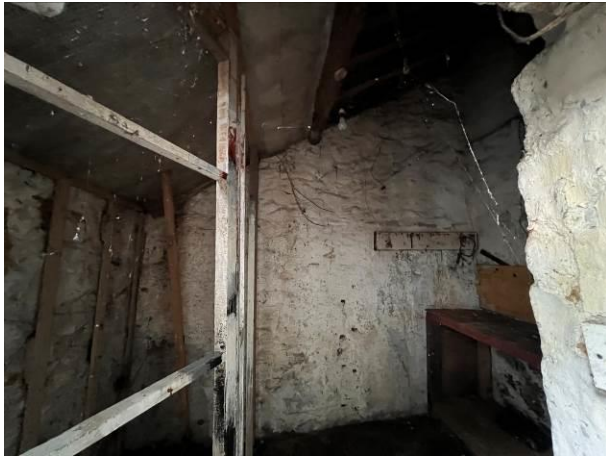
Photograph 7: Showing the interior of Outbuilding B.

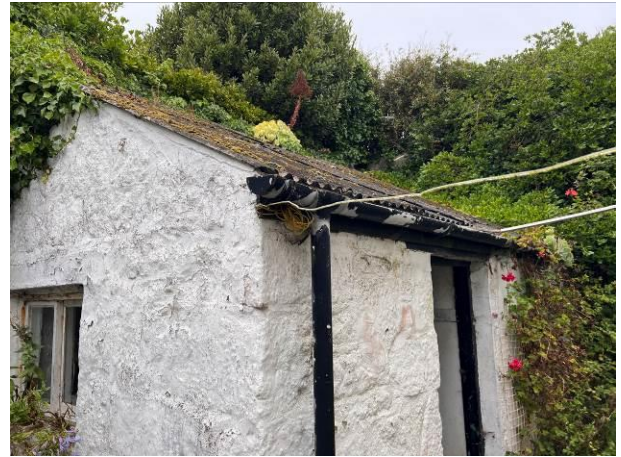
There is a fascia present on the front eaves of the roof – minor gaps are present but these could be fully inspected and were largely filled with debris or occupied by snails at the time of survey.

The corrugated roof sheets offer minor superficial niches where they overlap but these are likely to be of only negligible suitability for transient use.

Photograph 8: Showing Outbuilding A with the fascia visible along the eaves. The well-sealed verge on the gable is also illustrated.

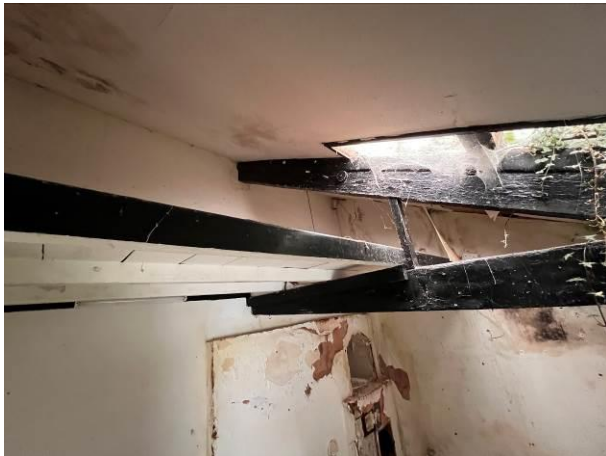
Photograph 9: Showing the interior of Outbuilding A where there is no void present.

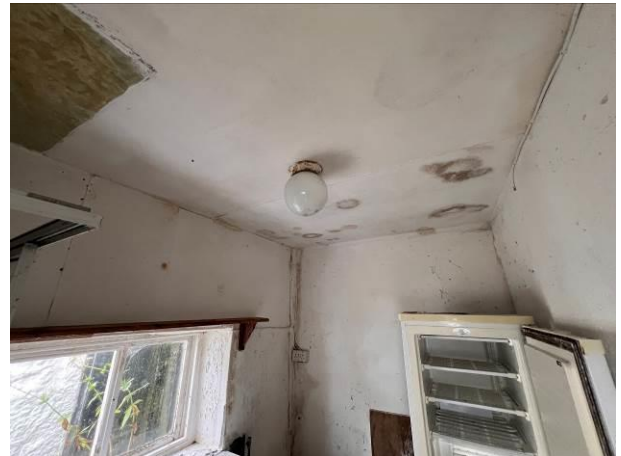
Internally, the main space does not offer any roosting opportunities for bats although a sealed void present on the southern edge could not be inspected. An external inspection however does not offer any clear means of access to this void for bats.

Photograph 10: Showing the portion of Outbuilding A where a sealed void is present.
