## PRELIMINARY ROOST ASSESSMENT (PRA)

### ROCK HOUSE & ROCK COTTAGE, HIGHER TOWN, ST MARTIN'S, ISLES OF SCILLY

**Report date:** 20<sup>th</sup> February 2025

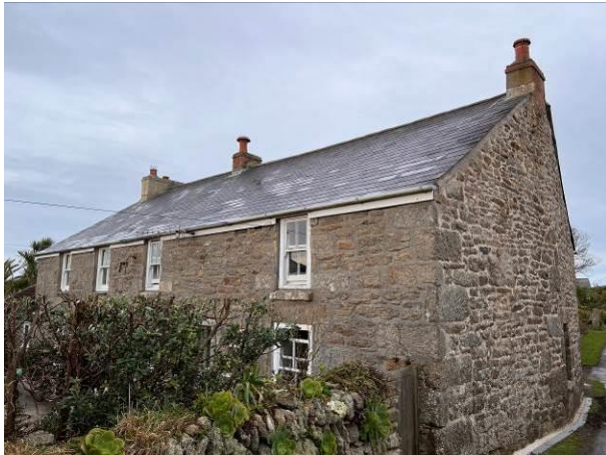
**Photograph 1:** Showing north-eastern gable and south-eastern aspect of the property

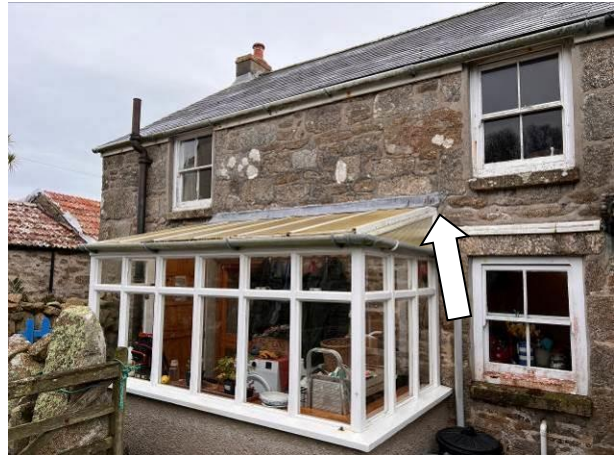
No potential roosting features are identified associated with the structure of the porch itself, though there are minor gaps beneath the lead flashing where the porch adjoins the main property.

**Photograph 2:** Showing the north-western aspect of the property with the porch visible. The minor lifted flashing at the join is indicated.

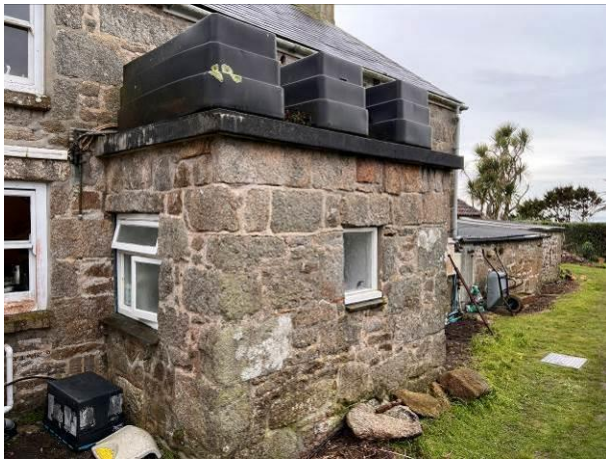
A flat-roof structure with water tanks on top is present on the north-western aspect. There is a superficial crack in the stonework though this is not considered sufficient to support a roosting feature for bats in its current condition. No other potential roosting features were identified associated with this part of the structure.

**Photograph 3:** Showing the water tank on the flat-roof structure.

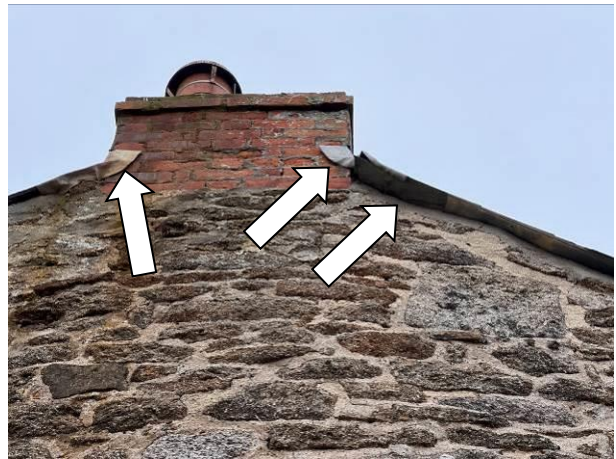
Three chimneys are present within the span of the roof under consideration – one at each gable whilst the third is positioned at the intersection between the two semi-detached properties. The eastern-most two are brick-built and partially rendered whilst the western-most is fully rendered. The pointing and rendering appear to be in good condition with flashing at the intersection between the chimney and the main roof in good condition, with the exception of lifted flashing on the north-eastern aspect of the chimney on the gable which could potentially provide access or roosting opportunities.

**Photograph 4:** Showing the north-eastern gable. Gaps beneath the chimney flashing and where pointing is missing at the verge are indicated.

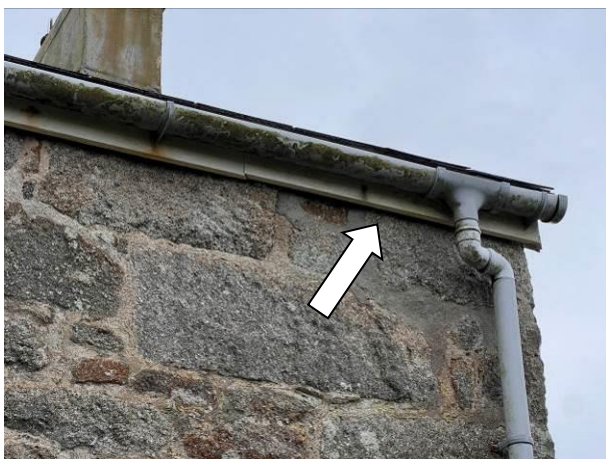
The main external features which may be suitable for use by roosting bats, or providing access to further roosting opportunities, occur at the eaves and gable where the walls and roof meet. These include gaps between the timber fascia board and the irregular granite blockwork on both eaves; missing pointing providing the potential for access beneath the terminal tiles at the verge of the north-eastern gable (where there is no fascia); and gaps behind the fascia board on the south-western gable.

Species such as house sparrows are likely to find nesting opportunities associated with the fascia gaps at the eaves and gable of the property. Further minor opportunities may also be found elsewhere within the structure.

**Photograph 5:** Showing the eaves on the north-eastern aspect with an example of the gap behind the fascias indicated.

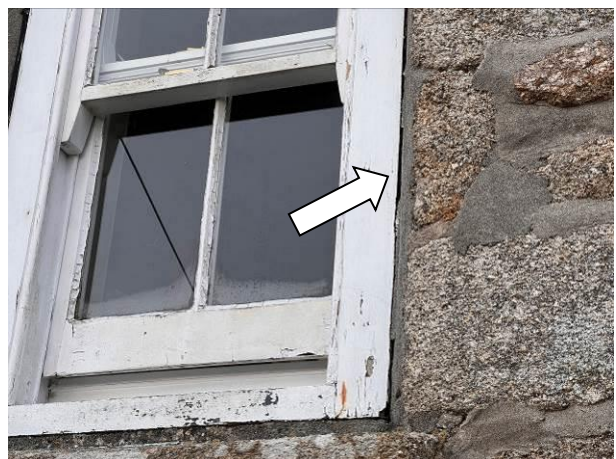
Timber window and door frames are generally well-fitted within their apertures though minor gaps were noted in places – these are largely superficial and relatively exposed without providing additional access to more suitable features for bats.

**Photograph 6:** Showing a window on the south-western aspect with minor gaps around the timber frame indicated.

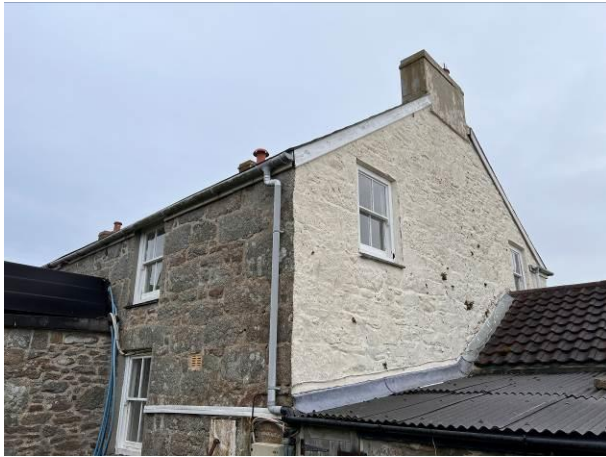
**Photograph 7:** Showing the south-western gable of Rock Cottage

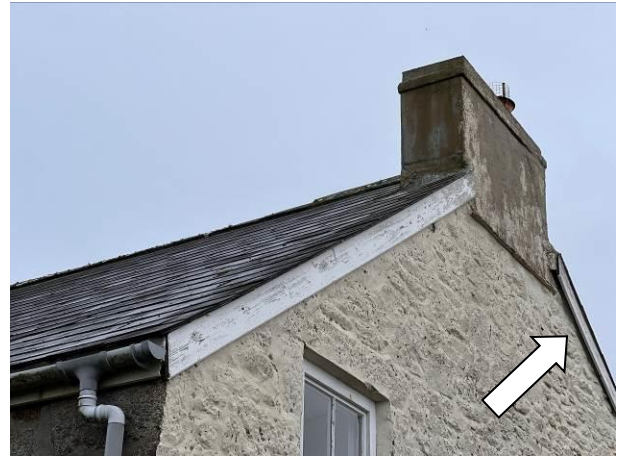
**Photograph 8:** Showing the south-western gable of Rock Cottage with the gaps behind the fascia indicated.

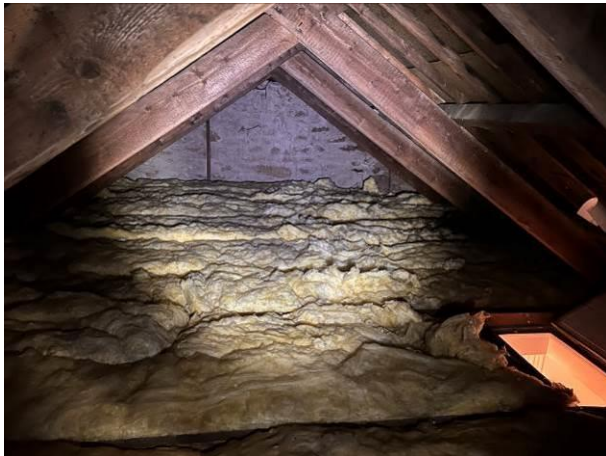
The internal timbers are in good condition with insulation present between the joints. The granite gable and internal dividing walls are well-pointed though gaps occur above the apex stones. The upper rooms of the property are built above the eaves line at the edges which means that the eaves are not directly visible from the loft space. The potential for roosting or access associated with gaps around the fascias visible externally cannot therefore be assessed internally.

**Photograph 9:** Showing the interior of the loft space with insulation visible above the joists

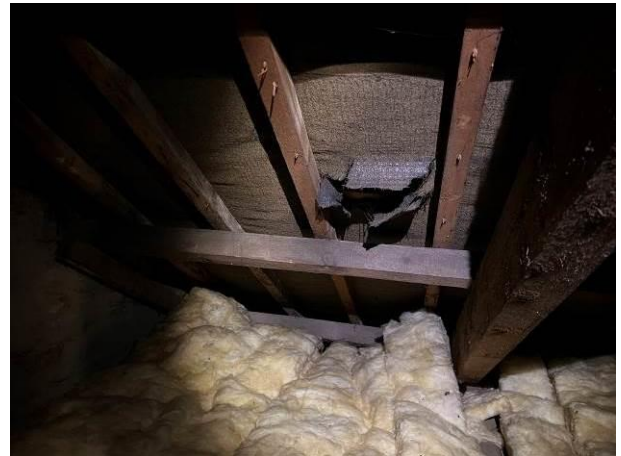
Internally, there is tar paper (Rock House) or underfelted (Rock Cottage) beneath the tiles which is mostly intact but tears in places could permit movement between the internal loft space and the space beneath the tiles.

**Photograph 10:** Showing an example of a tear in the tar paper which lies between the rafters and the battens/tiles above.
