EXTERNAL WINDOW GROUP 1 -
TIMBER VERTICAL SLIDING SASH WITH
ROUNDED HORN PROFILES

REV	DESCRIPTION	DATE	INS
CAD HERITAGE			
THE CONSERVATION DIVISION OF CAD ARCHITECTS LTD COURTLEIGH HOUSE, 74-75 LEMON STREET TRURO, CORNWALL, TR1 2PN CALL: 01872 630 041 MAIL: info@cadheritage.co.uk WEB: www.cadheritage.co.uk			
RIBA   Chartered Practice			
DATE	NOV 25	SCALE	AS SHOWN @ A1
CLIENT	PAUL GROVES	CHECKED	SM
DRAWING NO.	3528-1-500	STATUS	EXISTING

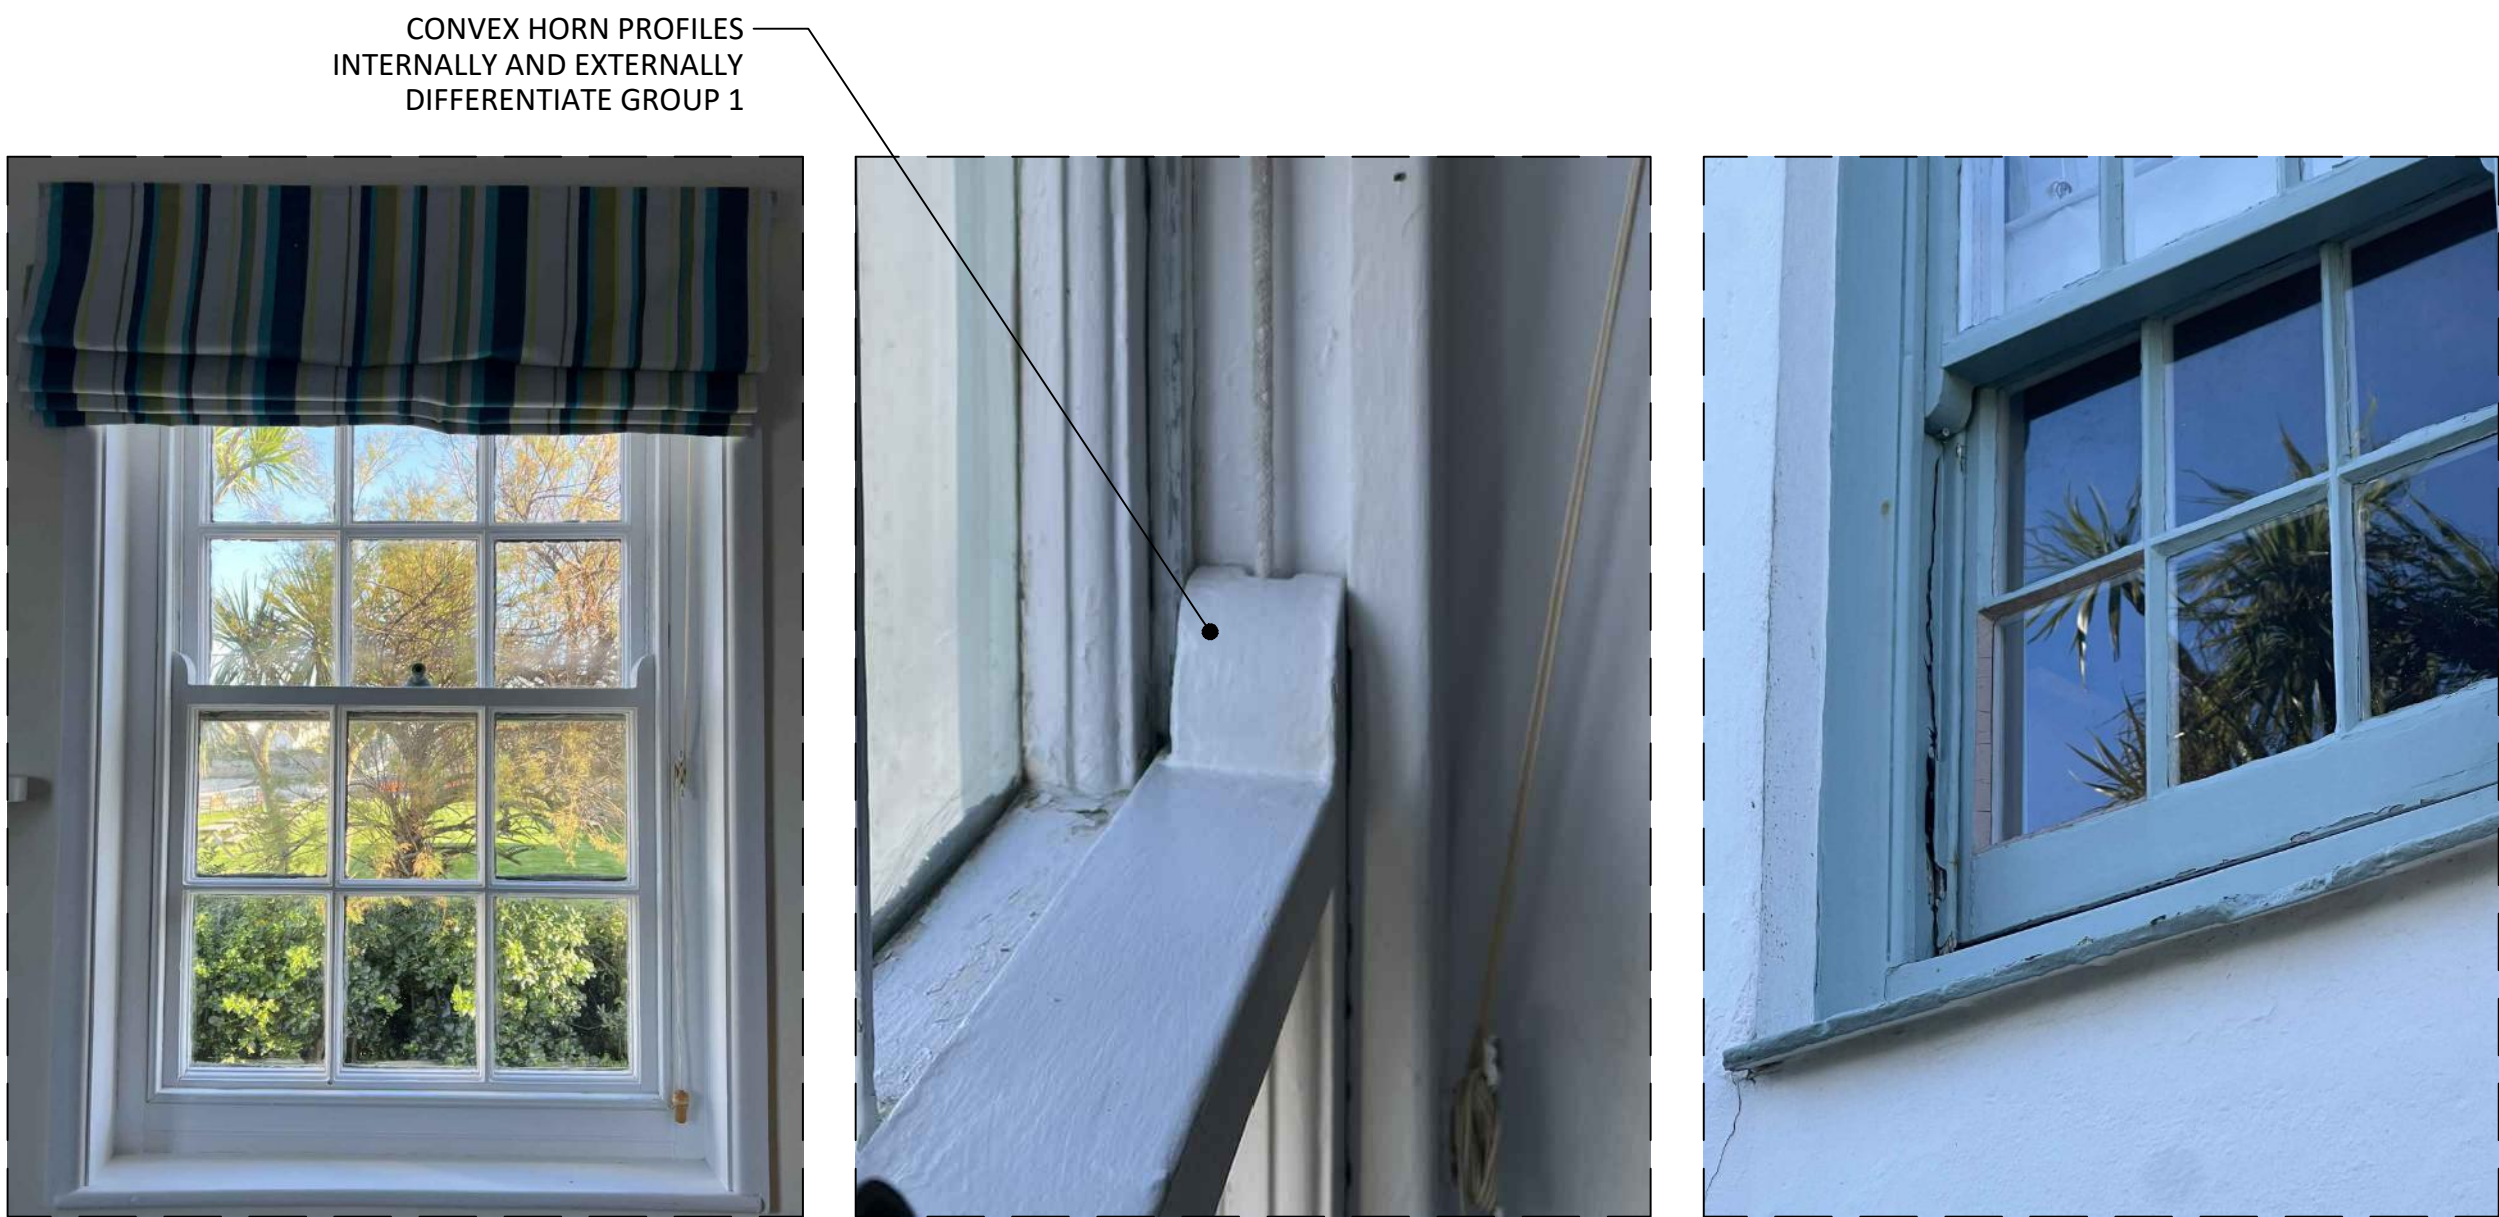
05 GROUP 1 TYPICAL PHOTOGRAPHS
REF 3528-1-500
SCALE N/A

Windows in generally poor condition, with evidence of rot, failed repairs, rusting fixings, and previously replaced timber elements.

Replacements to be heritage slim-line double glazed units as per specialist design - please refer to David Gilbert Joinery Ltd drawings for details.

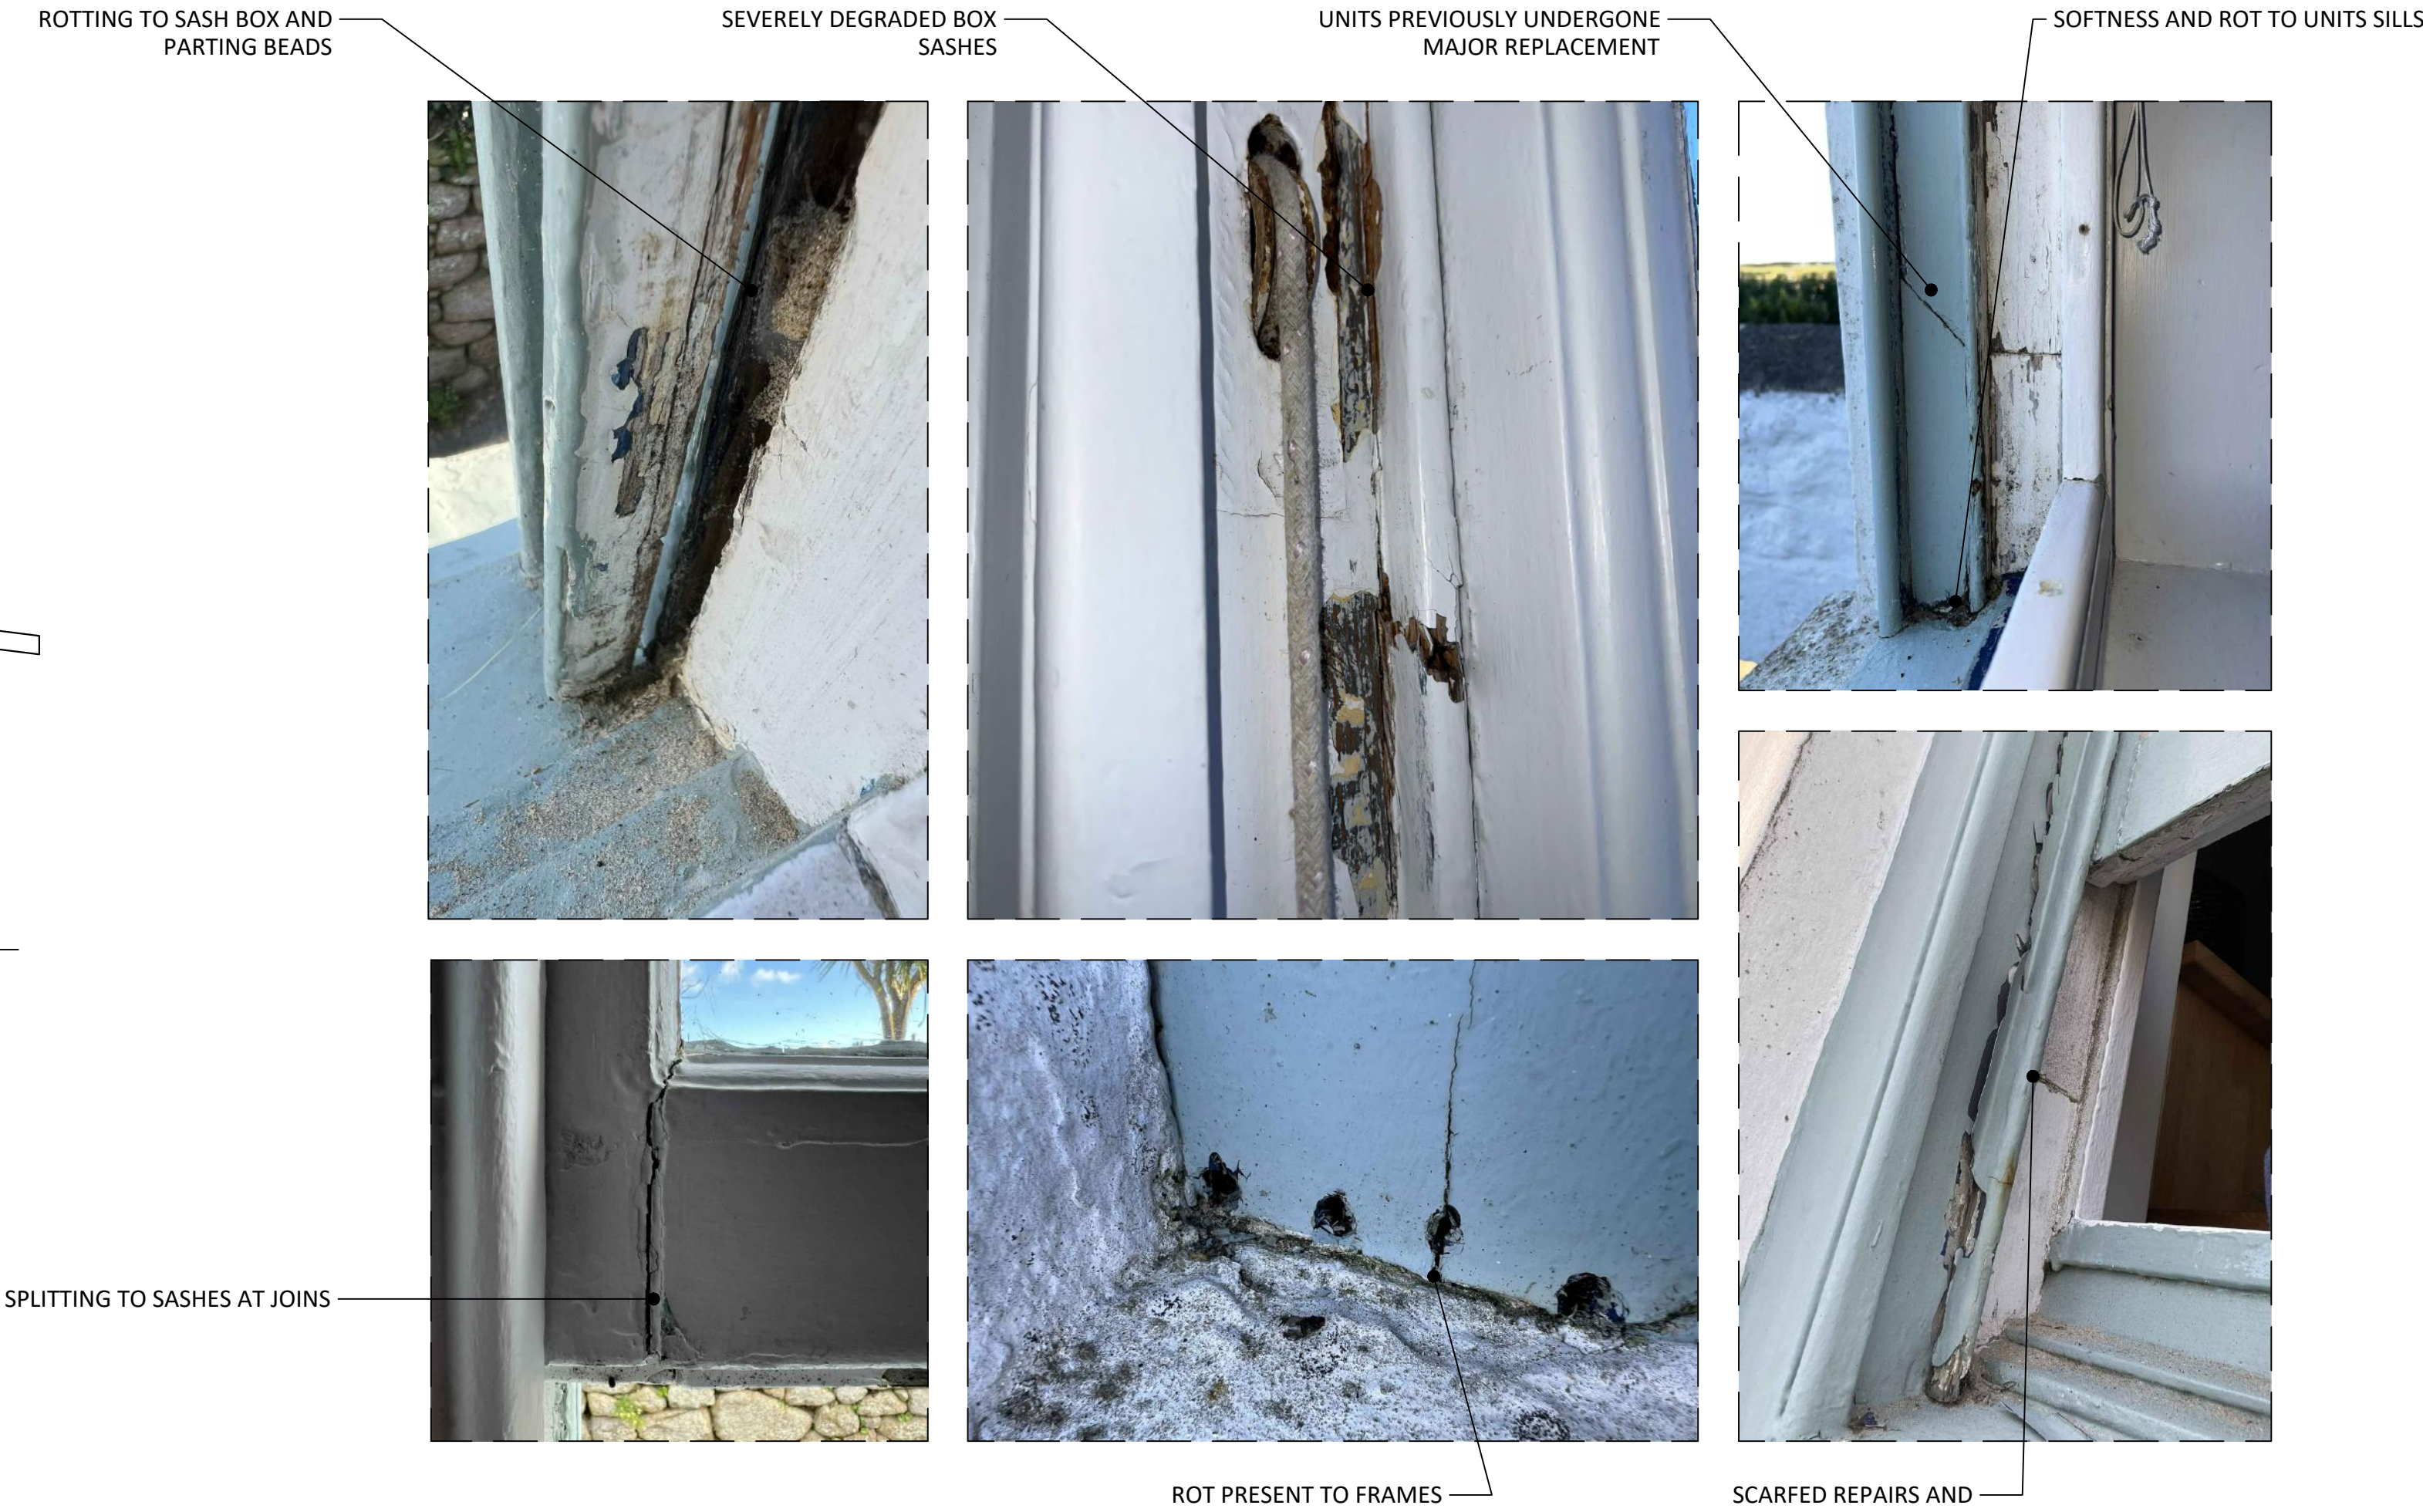
06 GROUP 1 TYPICAL DEFECTS
REF 3528-1-500
SCALE N/A

EXTERNAL WINDOW GROUP 1 DEFECTS

Rotting to sashes and box frames, with major replacements and scarfing attempts. Scarfed repairs clearly visible and numerous.

Large areas of previous repairs and alterations are now defective.

Rusting of parting bead pins, with complete separation of many parting beads, with persistent dampness.

Splitting and separation of sash frames at corner abutments.

Rotting of frame internally and externally, with softness to parts of unit's sills.
