## EXTERNAL WINDOW GROUP 2 DEFECTS

PROJECT  
ALTERATIONS TO FORMER CUSTOMS HOUSE  
LOWER STRAND, ST MARYS, ISLES OF SCILLY TR21 0PS

DETAIL  
AS EXISTING  
WINDOW DETAILS  
EXTERNAL WINDOWS GROUP 2 ANGULAR HORNS

DRAWING NO.  
3528-1-501

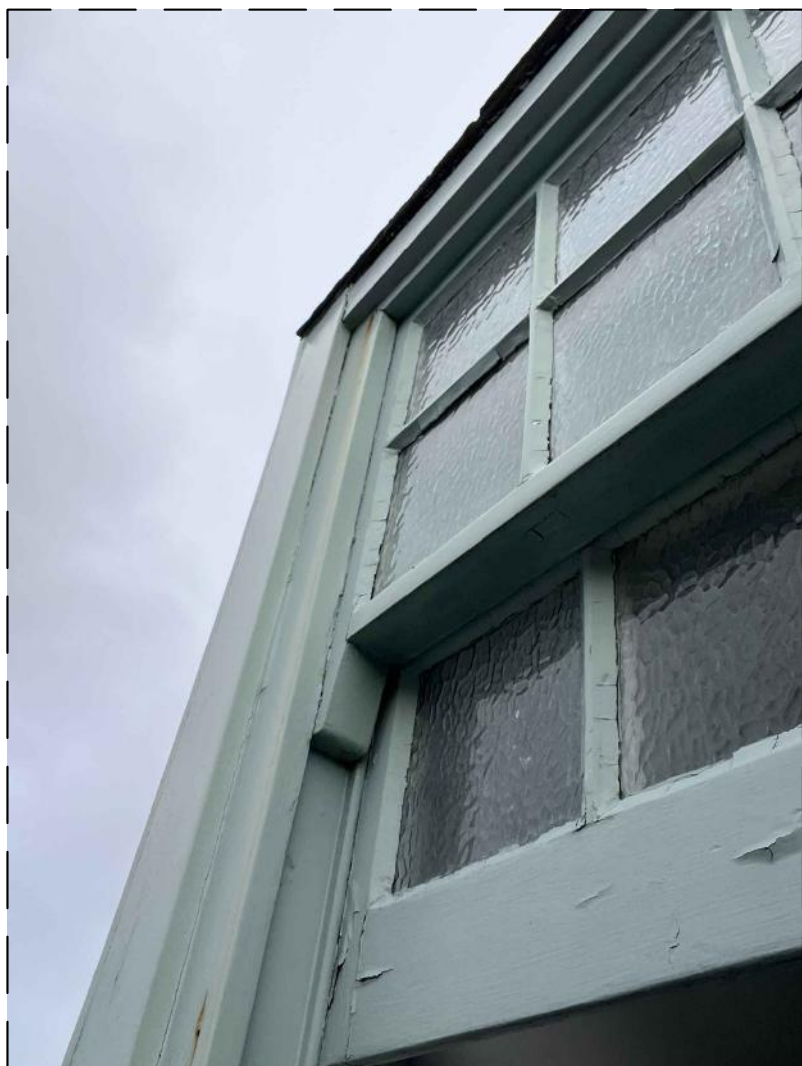
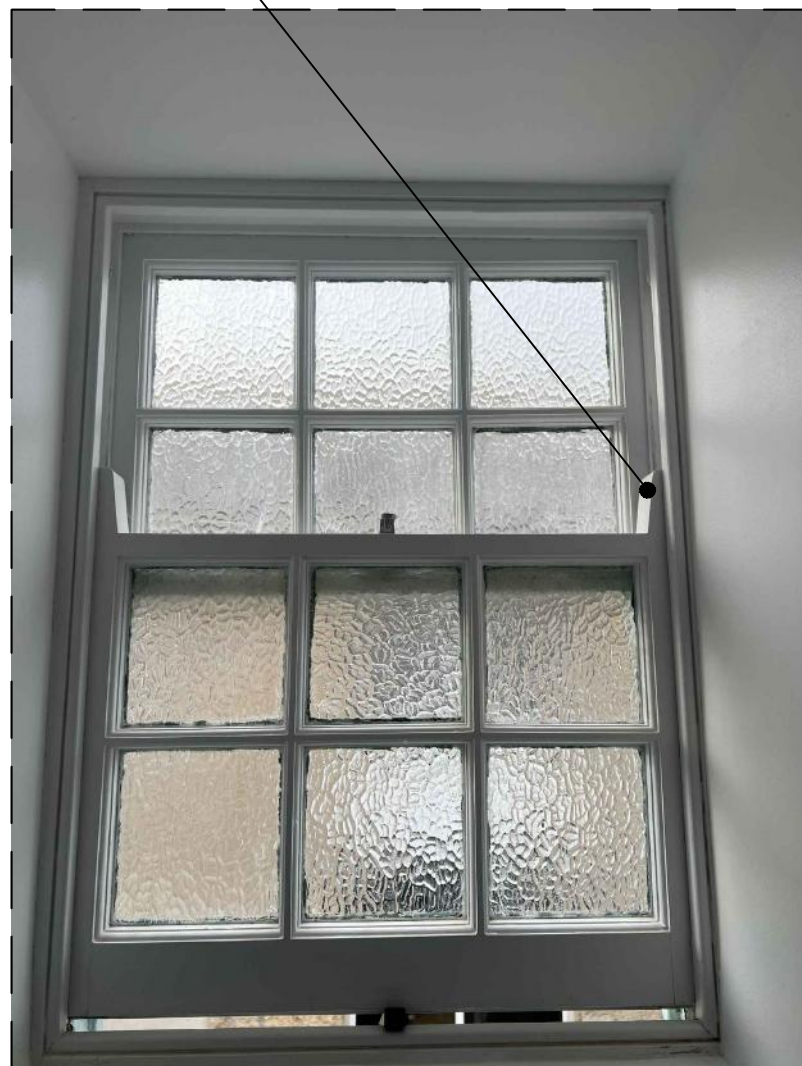
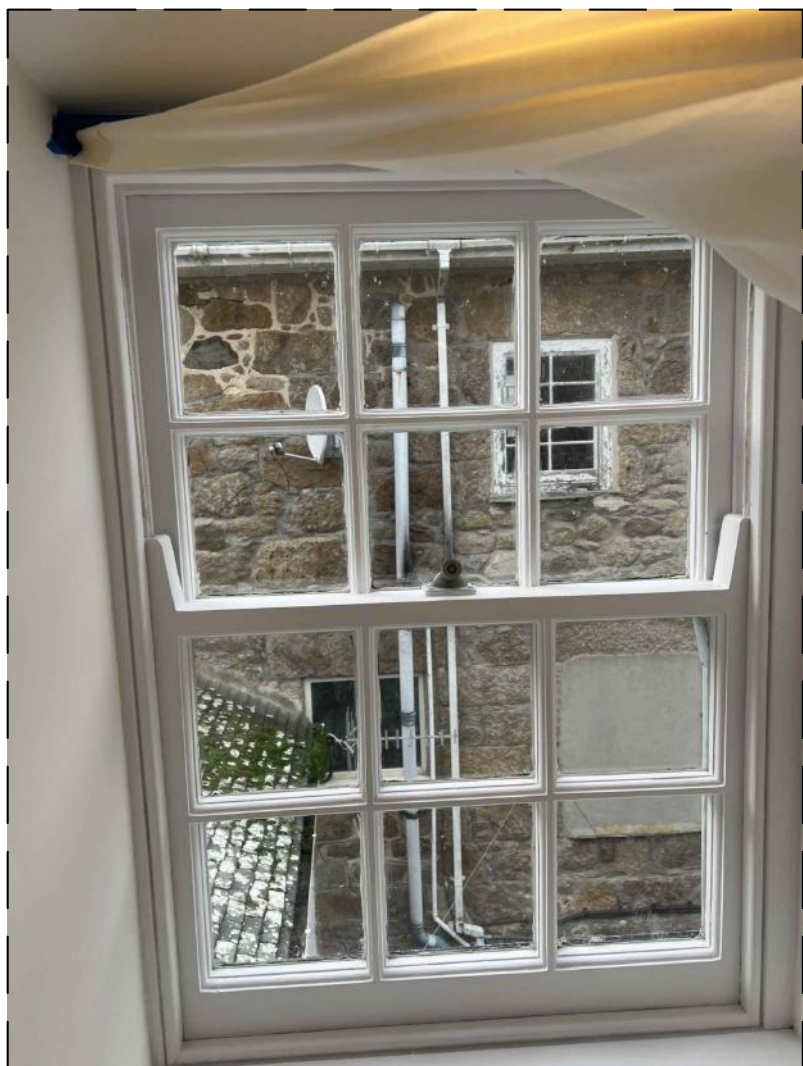
05 GROUP 2 TYPICAL PHOTOGRAPHS

Windows in generally poor condition, with evidence of rot, failed repairs, rusting fixings, and replaced timber elements.

Replacements to be heritage slim-line double glazed units as per specialist design - please refer to David Gilbert Joinery Ltd drawings for details.

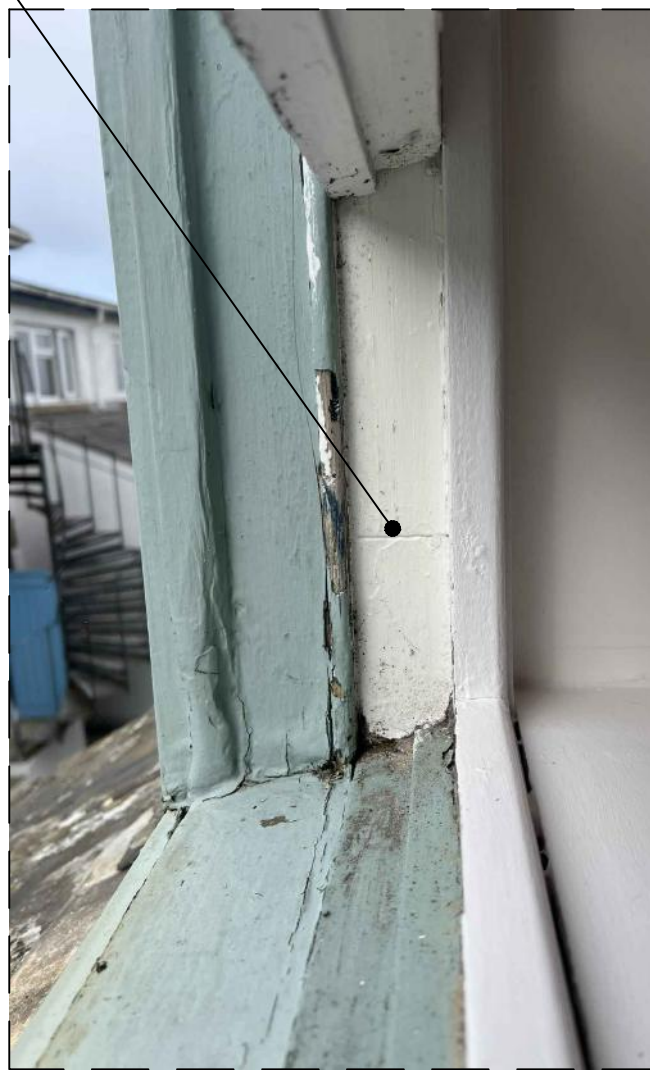
EVIDENCE OF SCARFED REPAIRS  
TO BOX FRAMES

Rotting to sashes and box frames, with removed areas of beading and scarfing attempts. Scarfed repairs clearly visible.

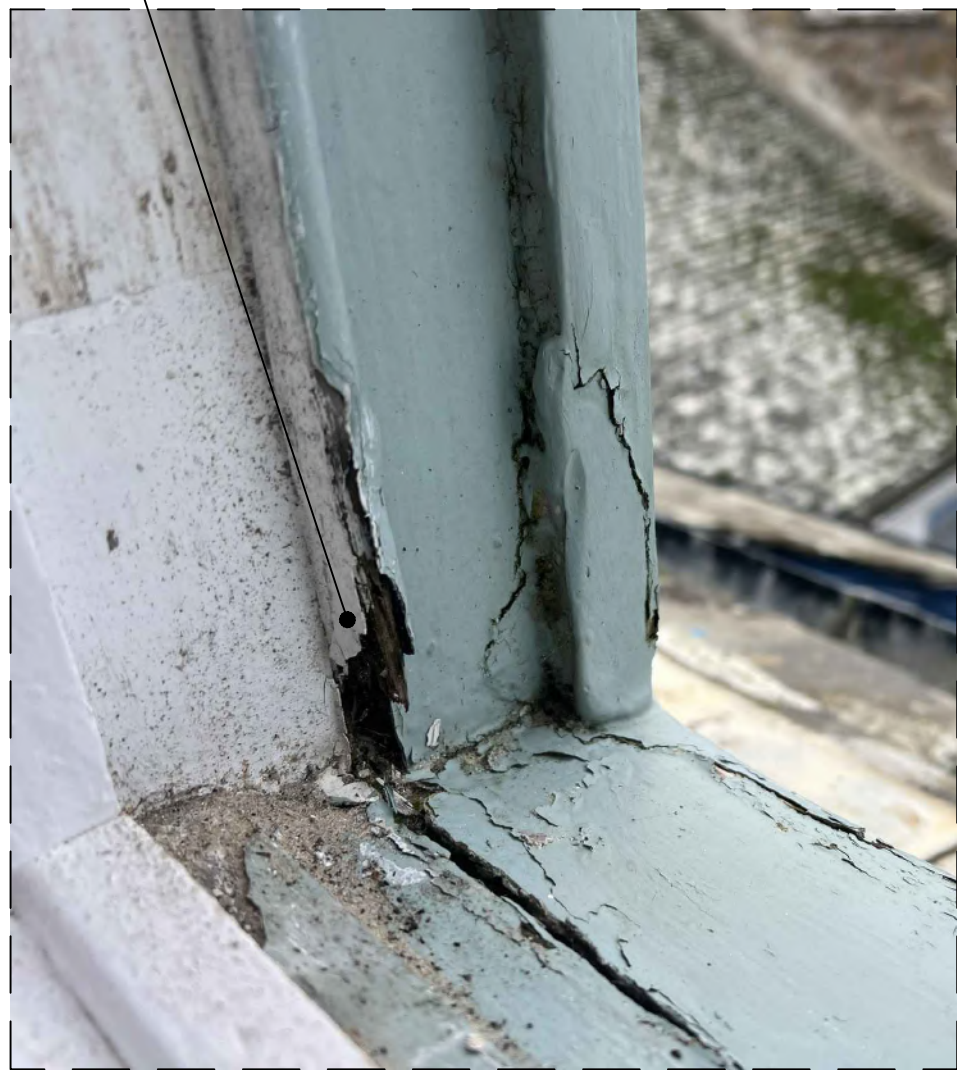
ROTTING OF PARTING BEADS AND AREAS  
OF SOFTNESS AND ROT TO SASH FRAMES

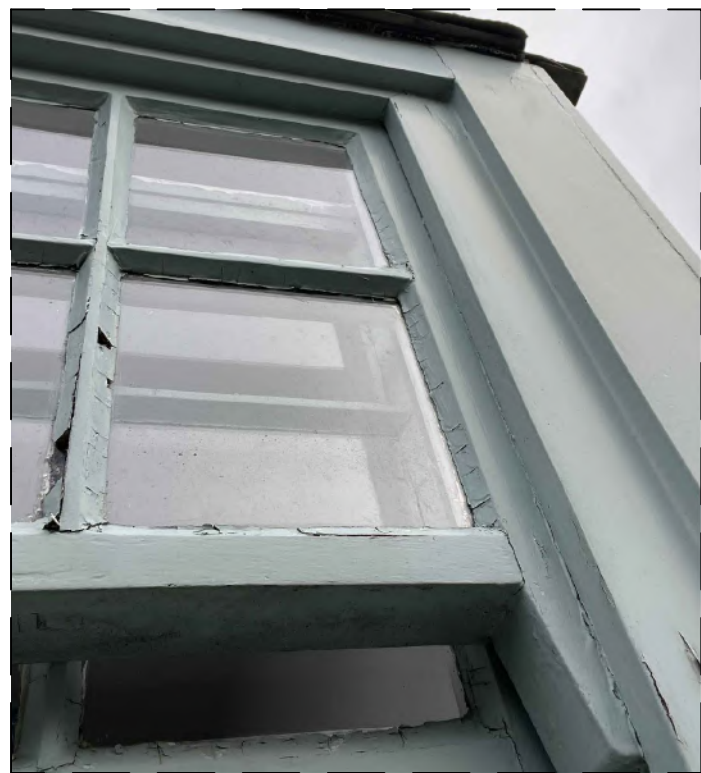
SPLITTING TO EXTERIOR BEADING  
AND PARTING BEADS, BEADS  
PREVIOUSLY CUT BACK AT LOW  
LEVEL

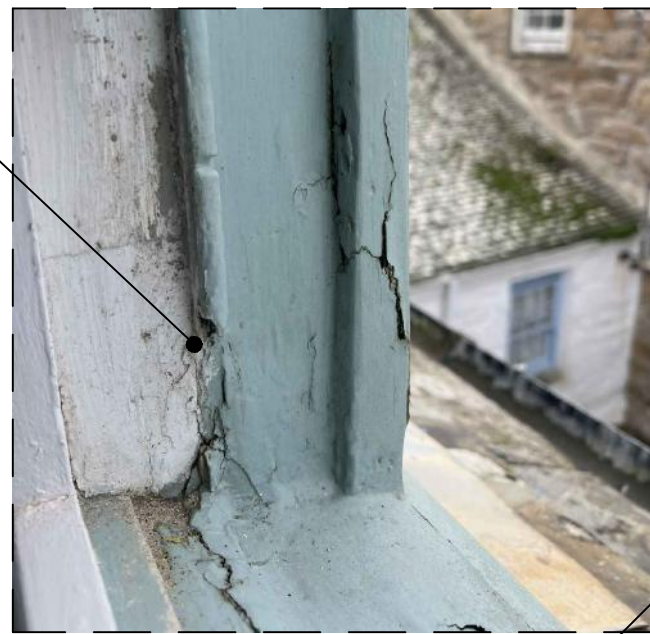
SPLITTING DEVELOPING TO  
SASH JOINS

Splitting and seperation developing to sash frames at corner abutments.

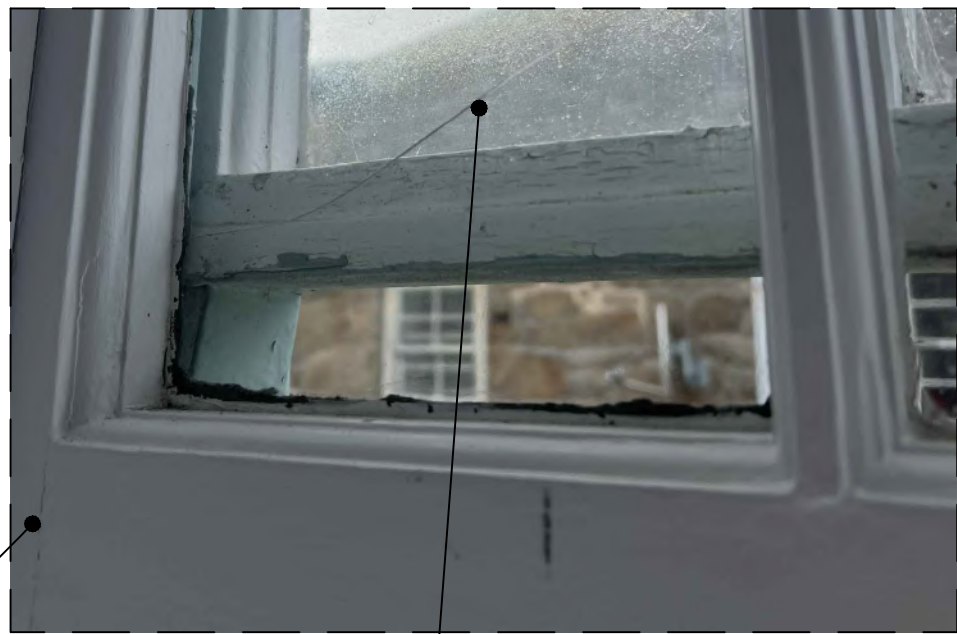
CRACKED GLAZING PANEL

SCARFED REPAIRS SPLITTING  
FROM FRAME

Many previous repairs and alterations have swollen and split.

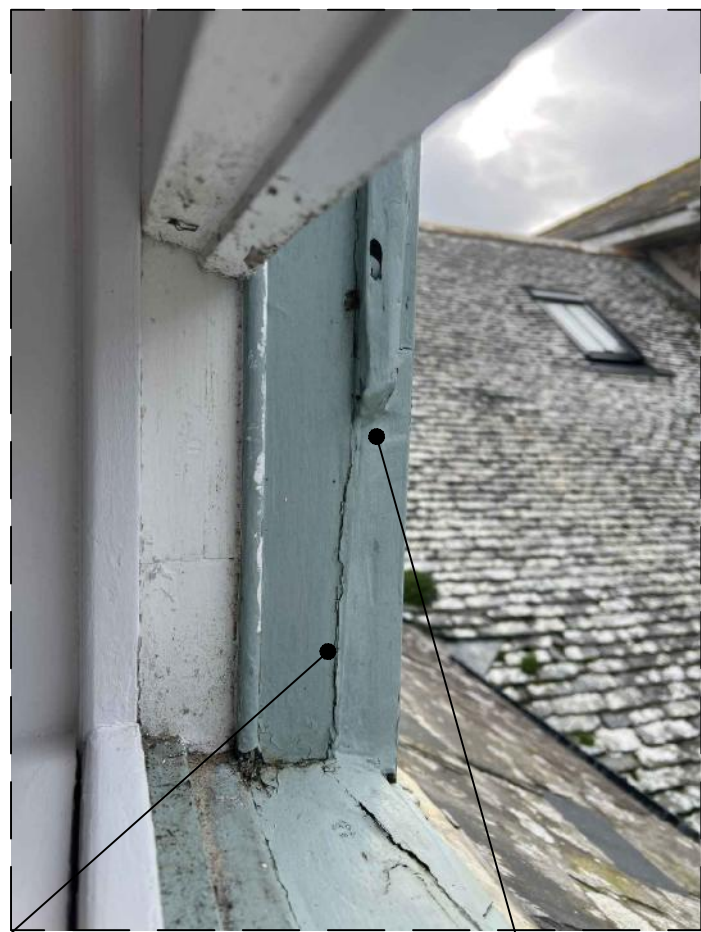
EXTERIOR BEADING ROTTING  
AND PREVIOUSLY CUT BACK

Rotting of frames externally and lower corners of sills showing deep areas of softness and rot. Large splits across sills indicate signs of failed partial sill replacements now defective.
