EXTERNAL WINDOW GROUP 3 -
TIMBER VERTICAL SLIDING SASH WITH
CONCAVE HORN PROFILES

EXTERNAL WINDOW GROUP 3 DEFECTS

REV	DESCRIPTION	DATE	INS
CAD HERITAGE			
THE CONSERVATION DIVISION OF CAD ARCHITECTS LTD COURTLEIGH HOUSE, 74-75 LEMON STREET TRURO, CORNWALL, TR1 2PN CALL: 01872 630 041 MAIL: info@cadheritage.co.uk WEB: www.cadheritage.co.uk			
RIBA   Chartered Practice			
DATE	ALTERATIONS TO FORMER CUSTOMS HOUSE LOWER STRAND, ST MARYS, ISLES OF SCILLY TR21 0PS	DATE	JM NOV 25
CLIENT	PAUL GROVES	SCALE	AS SHOWN @ A1
DRAWN	AS EXISTING WINDOW DETAILS EXTERNAL WINDOW GROUP 3 CONCAVE HORNS	CHECKED	SM
STATUS	EXISTING	DRAWING NO.	3528-1-502
		REVISION

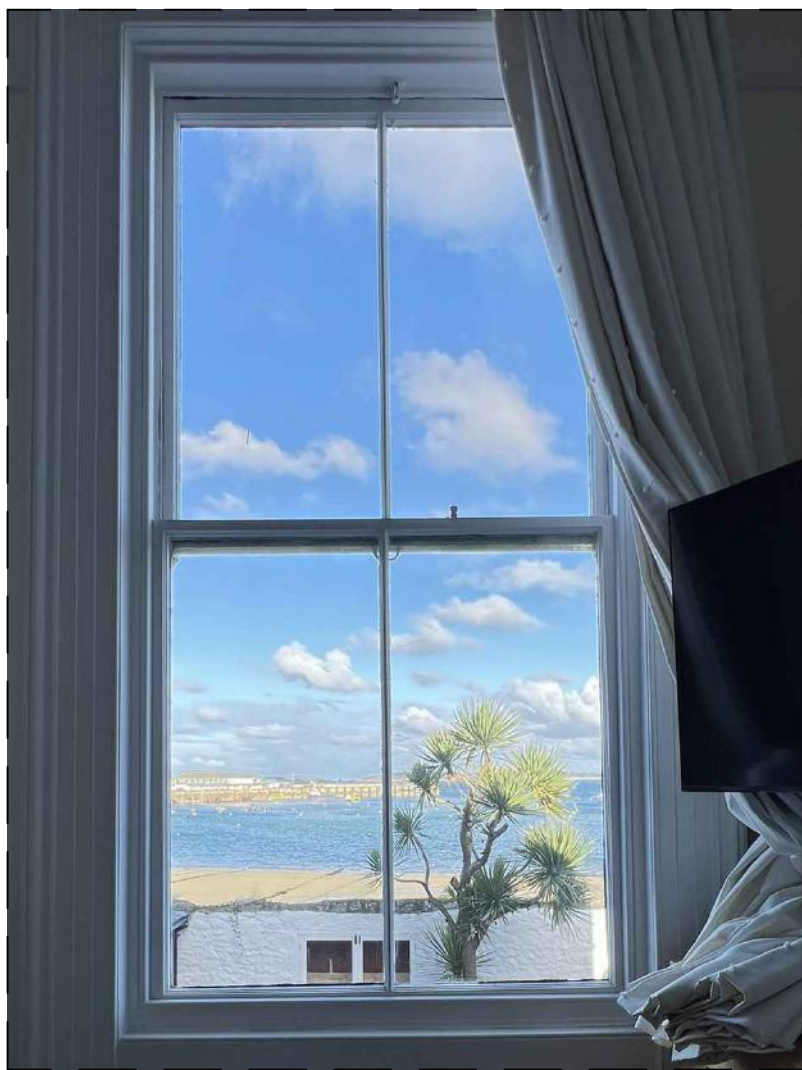
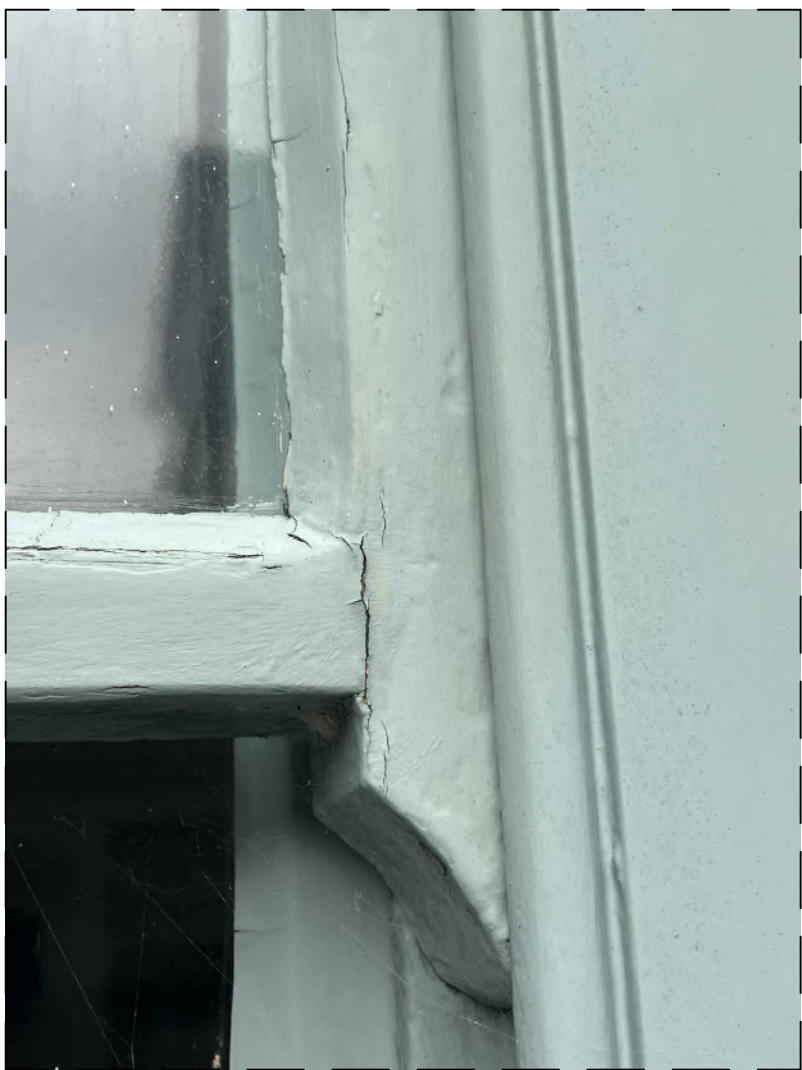
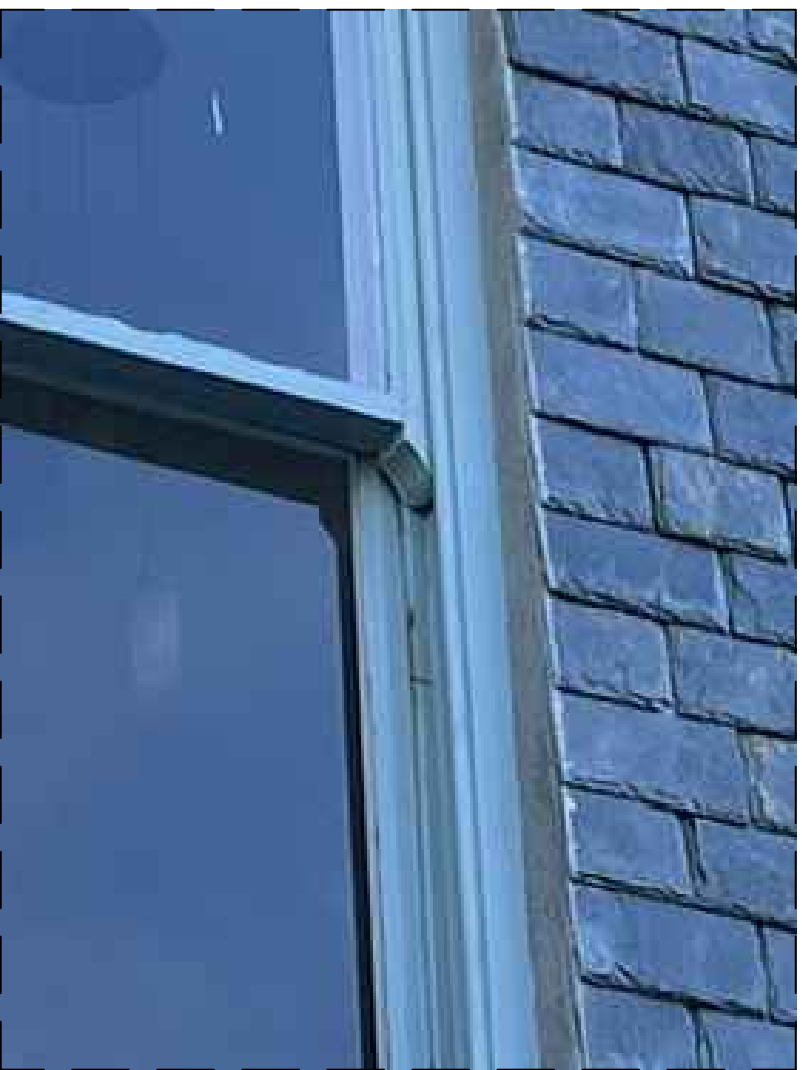
05 GROUP 3 TYPICAL PHOTOGRAPHS
REF 3528-1-502
SCALE N/A

Windows in generally poor condition, with evidence of rot, failed repairs, rusting fixings, replaced timber elements, and cracked glazing.

Replacements to be heritage slim-line double glazed units as per specialist design - please refer to David Gilbert Joinery Ltd drawings for details.

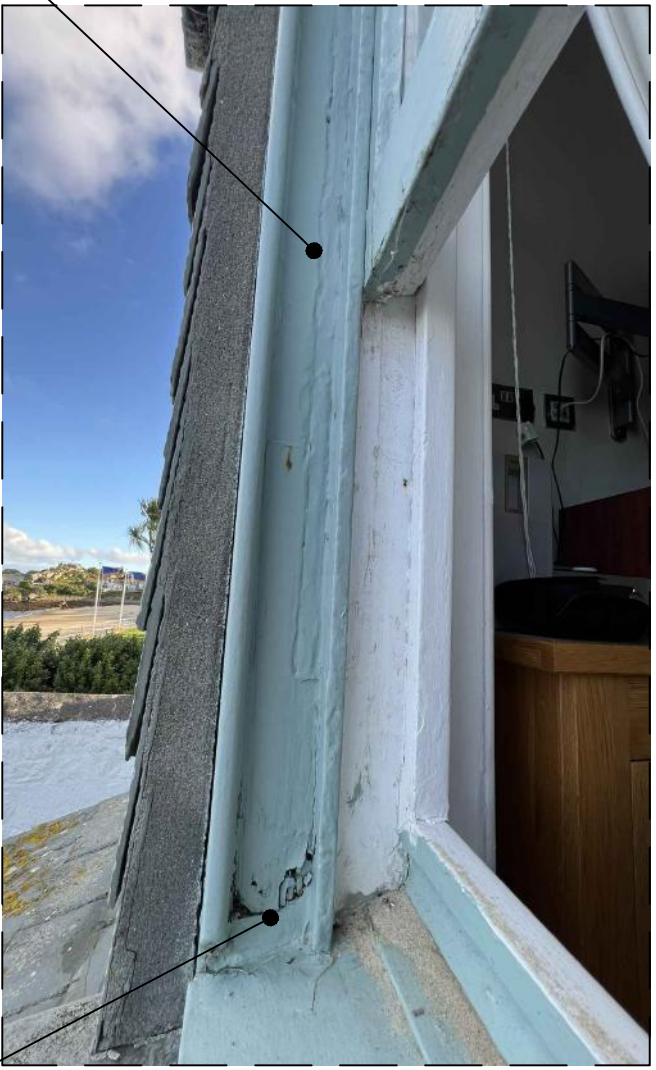
LARGE AREAS OF SCARFED REPAIRS

Large areas of previous repairs and alterations now defective, with previous scarfed repairs clearly visible where repairs are separating from sashes and frames.

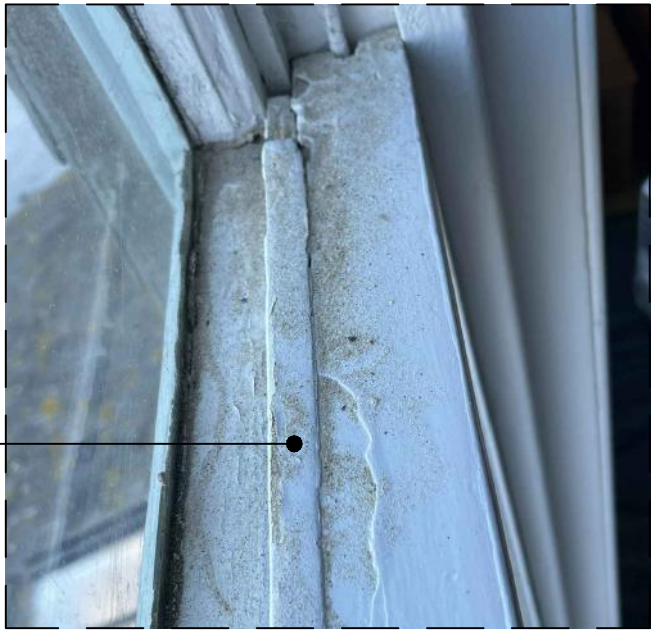
SOFTNESS AND ROTTING TO SASH BOX

Softness to lower areas of sills and frames. with significant areas of rot to sashes.

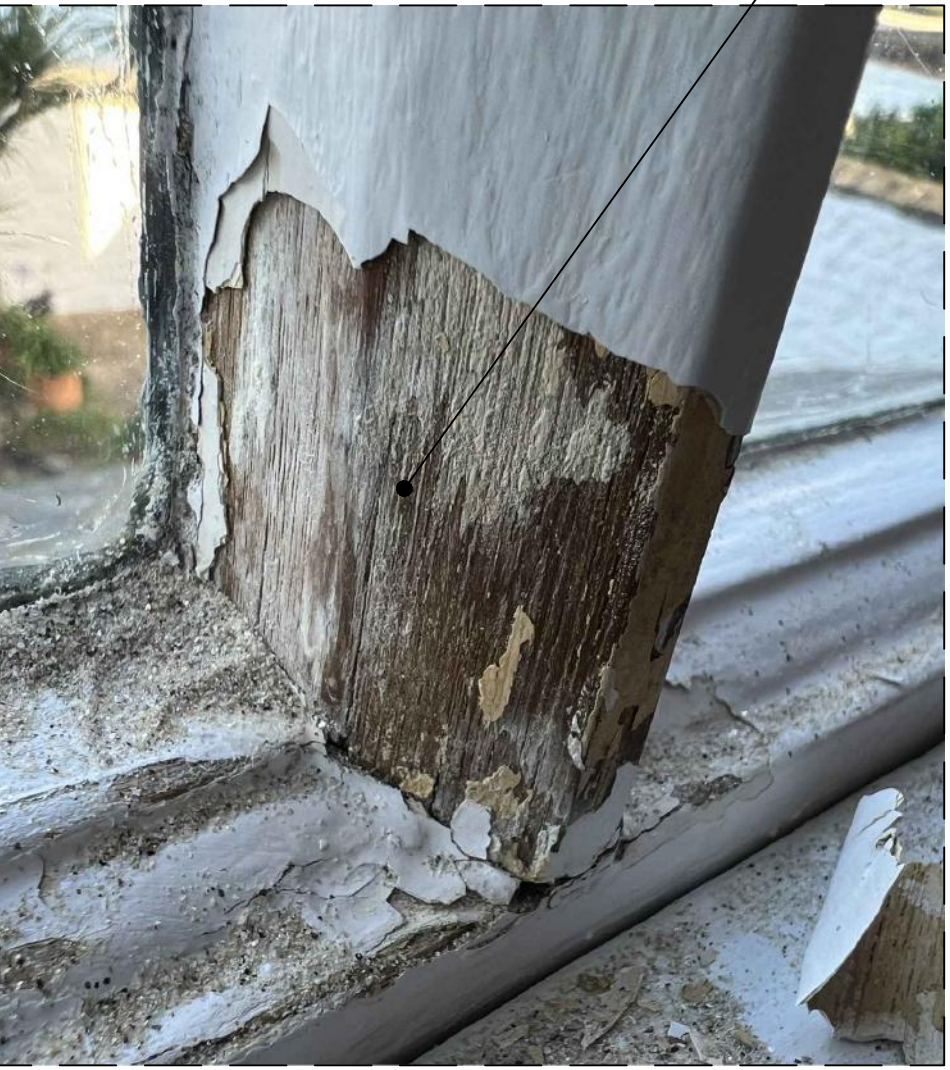
PREVIOUS SCARFED REPAIRS SPLINTERING FROM SASH

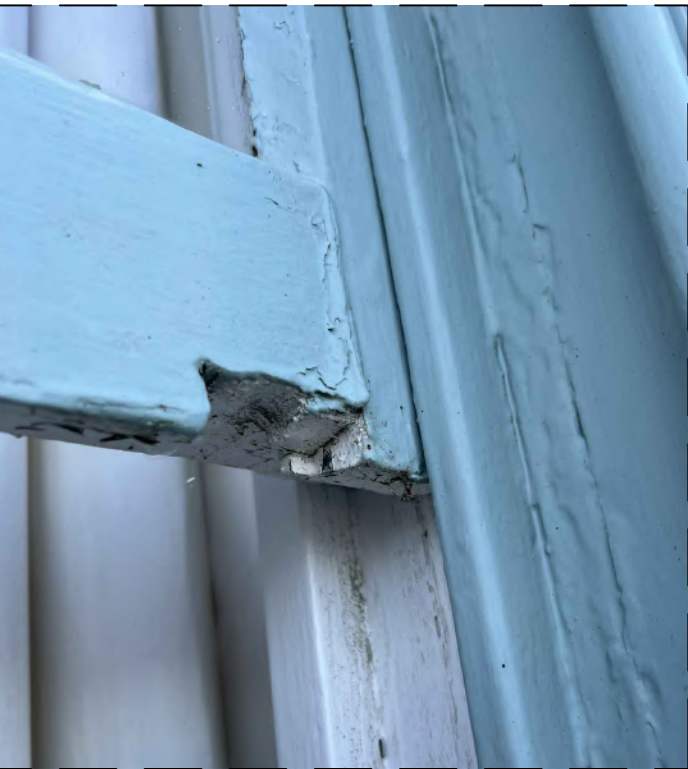
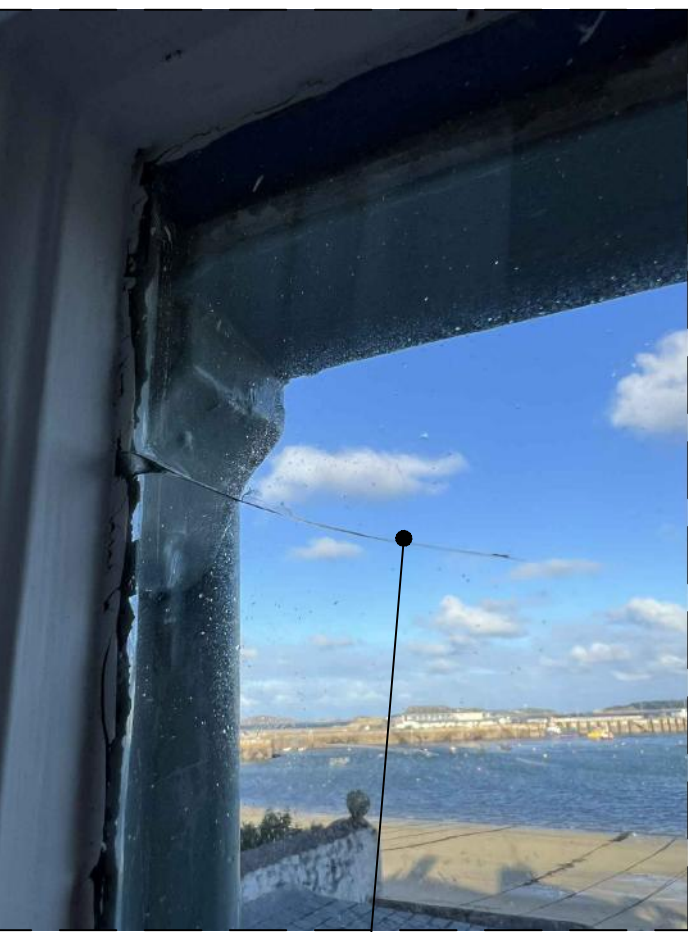
UNORIGINAL REPLACEMENT VERTICAL GLAZING BARS

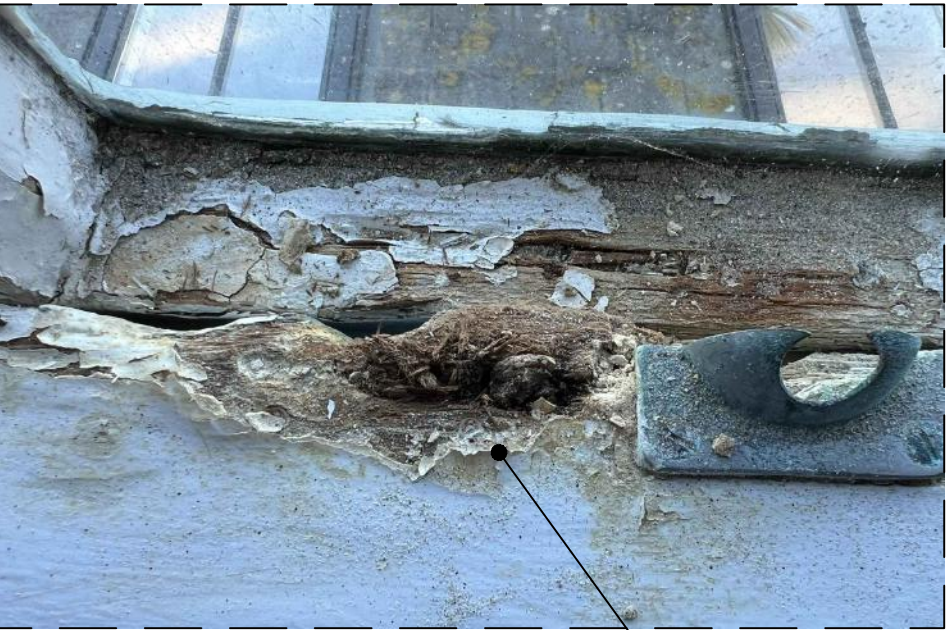
SEVERE ROTTING TO BOTH SASH MEETING RAILS
