Re: STEP COTTAGE, THE BANK, ST MARY'S, ISLES OF SCILLY

Further to our visit to the cottage on Tuesday 7th October 2025 and our limited inspection of the existing staircase and first floor structures, together with our various discussions with the client and yourselves, we report as follows.

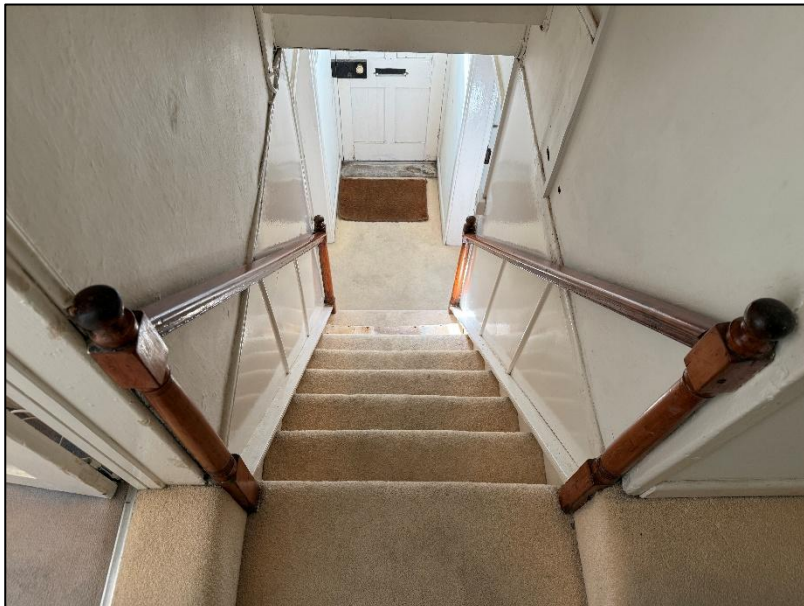
Staircase

The existing staircase, which is thought to be primarily original, including the stringers, treads, risers, newel posts and handrails, is steep with limited tread length and a high first riser. It is approximately 800mm wide, and set between two walls, the makeup of which varies, both of which have been altered in the past.

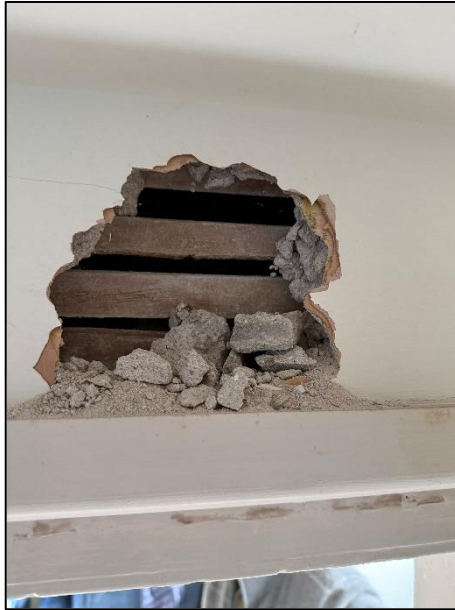
Investigation hole over dining room doorway showing timber lathes, with plaster overlaid with 12.5 plasterboard & skim.

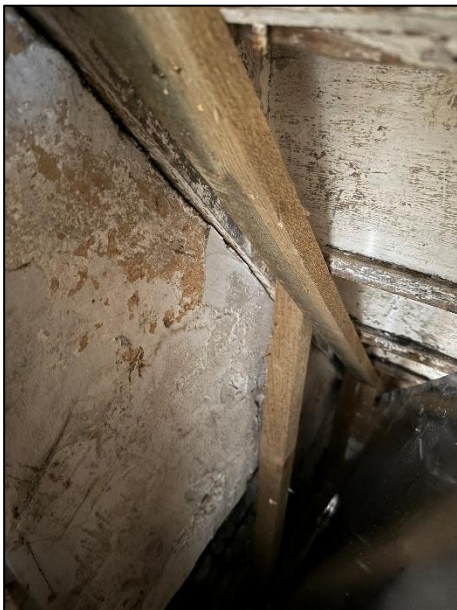
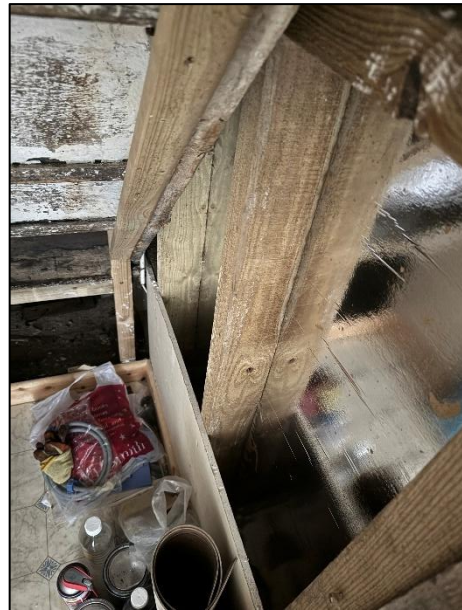
The later studwork construction under the stair has provided additional support to the stair flight, and as a result the robustness and structural adequacy of the original stair flight is reasonable.

Current added support timbers under stair flight which would benefit from tidying & enhancing.

Localised repairs are recommended, particularly checking connections between risers and treads, and repairing the second tread at the bottom end of the flight which is split.

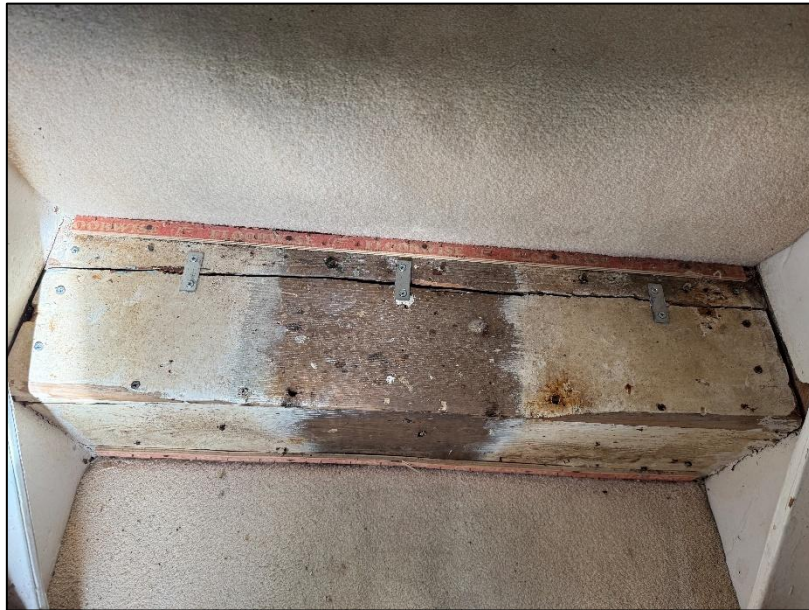
Split second tread requiring sympathetic repair.

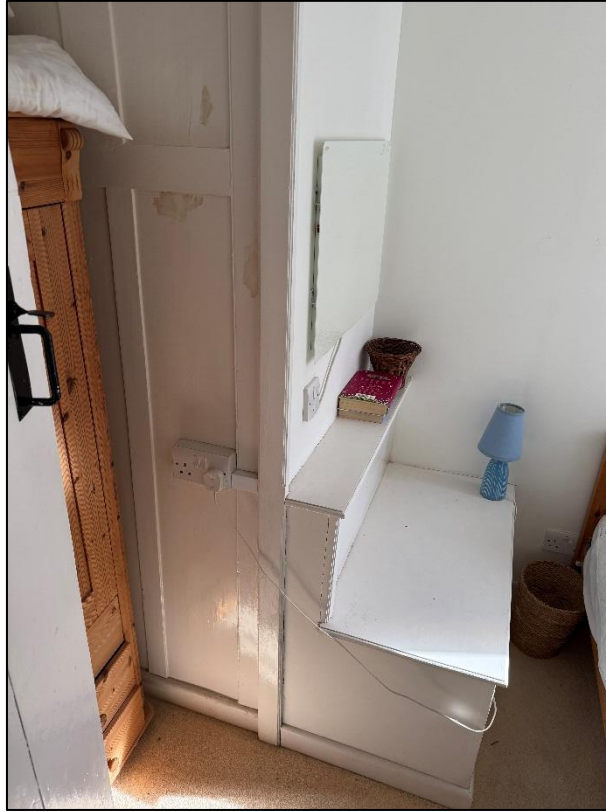
With respect to headroom above the flight, the current bulkhead has been altered and adjusted within C20, and would need to be further adjusted to allow for a larger stair void to provide acceptable headroom which in itself may not fully comply with modern building regulations.

Current bulkhead over the stairs altered in C20.

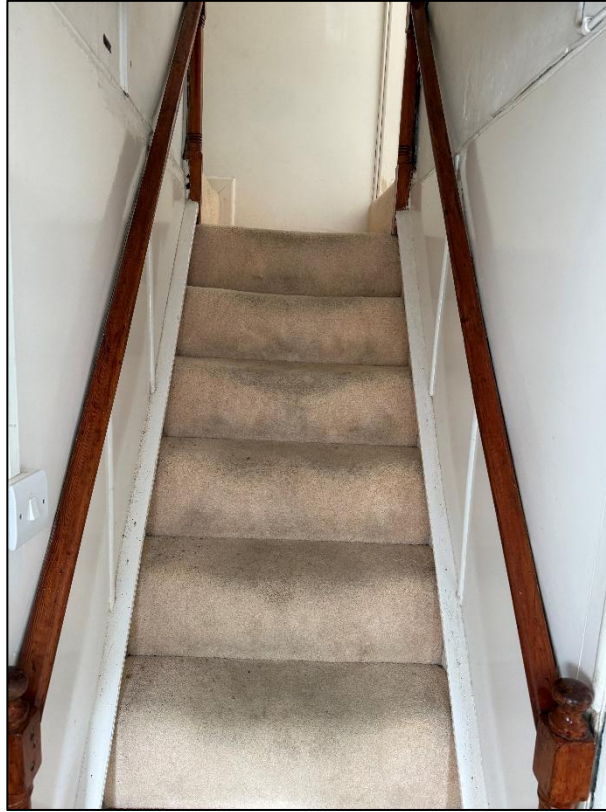
Existing original newel posts and handrailing to be adjusted and retained should a new 'over flight' be agreed.

3. The third option would be to allow for the retention of the existing historic stair flight and for it to be overlaid with a new staircase, introducing an additional riser and reducing the pitch of the stair, together with altering the ground floor doorways, enlarging the stair void, and adjusting the existing bulkhead and associated elements of first floor as may be required. Further discussions will be needed with respect to the optimum way forward with the existing original newel posts and hand railing, and whether these are adjusted with the hand rail extended or renewed at a pitch to marry with the pitch of the new adjusted stair flight.

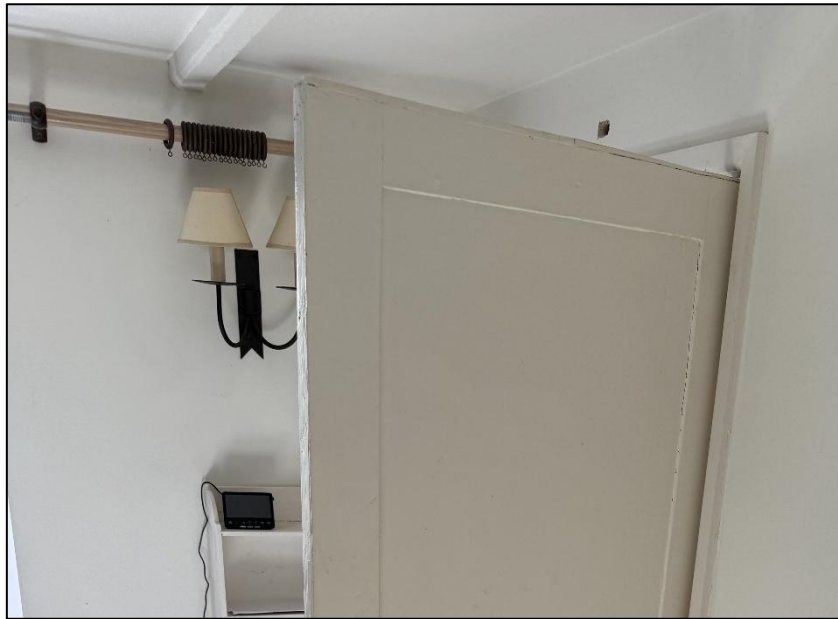
On the east side of the building, over the lounge, the joist and floor structure has more deflection and resonance, due to the weakness and under-sizing of the joists coupled with wide joist centres. There is a requirement by the client and the Conservation Officer to ideally retain the existing joists and the current painted ceiling arrangement allowing for the exposed original joists.

Existing painted ceiling appearance with exposed original joists to be retained.

We understand that, as part of the proposed works, the later C20 plasterboard will be taken down to accommodate new services etc. On this basis, we have prepared a sketch detail for strengthening the floor joists allowing for the ceiling to be reinstated in its current position and retaining the current appearance of painted joists and ceiling. This will not be a perfect solution but should stiffen the floor to a degree, making it more serviceable.

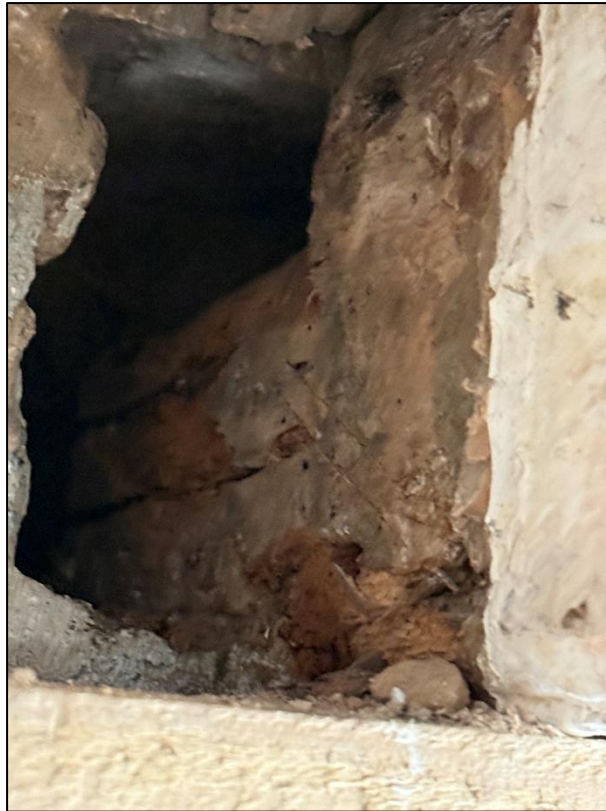
As part of the upgrading of the property, when later C20 finishes are removed for adding insulation and adjusting/renewing services etc., the condition of the joist bearings into the external southern wall should ideally be checked, as the initial opening up works has revealed that there has been some rot and deterioration to the joist ends. When probing and reviewing the exposed joist ends which have been exposed, the retained timber appeared quite hard and there was no sign of recent movement, or signs of serious structural distress. As a result, we believe this is not extensive, but it would be prudent to check and remediate as required but ensuring that any additional support is concealed behind the southern wall linings.

Exposed southern joist bearing showing some rot & longstanding decay.

We would advise that provided the retained timber is reasonable hard, and bearing on hard masonry, and that there has not been an overall loss of timber cross section of more than 1/3rd, repairs may not be required. The wall appeared to be reasonably dry at the time of our inspection.
