Our ref: FC26016
10th February 2026

RE: PIER HOUSE, THE BANK, ST MARYS, ISLES OF SCILLY, TR21 0HY – INSPECTION OF ROOF AFTER STORM DAMAGE

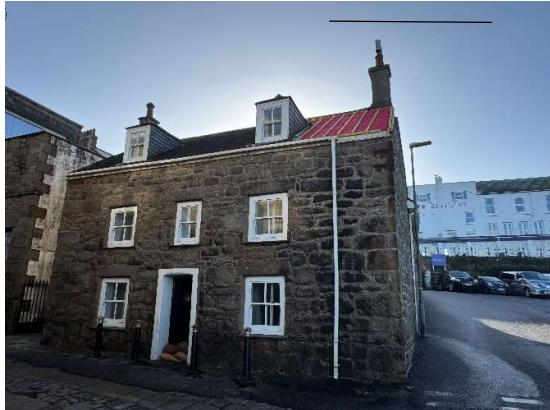
Front elevation showing storm damage

2. The existing natural slate roof was ripped from the roof structure in many locations. At the time of our visit, the roof had been temporarily repaired with some membrane and new battens to prevent further water ingress.
3. There was also damage to the slate roof covering on the east gable wall where wind has caused the slates to lift up and become dislodged. As the existing slates are wet laid, there would be a greater area requiring replacement as the surrounding slates may be damaged in the process.

9. It is proposed to replace the slate roof covering to both the front and rear elevations of the main property (the more recent rear extension was not damaged in the storm). As stated above, the existing slate roof covering is wet laid which means that each slate is mortared in place. This makes it very difficult to repair and often damages the surrounding slates. Given this, and the age of the roof covering, it is proposed to replace the entire covering of the main roof to both the front (north) and rear (south) elevations.

11. Given that the property is listed; consent will be required from the Council/Conservation Officer for the type of slate proposed to replace the existing roof covering. They will also confirm if a 'clipped' roofing system would be acceptable. In our opinion, given the exposure of the property, a clipped roof slate would give a greater resistance to future storm events.

12. New roofing membrane and treated timber roofing battens will also be required when replacing the roof covering. It is also envisaged that new lead flashings and soakers will be required as well as new lead valley gutters.

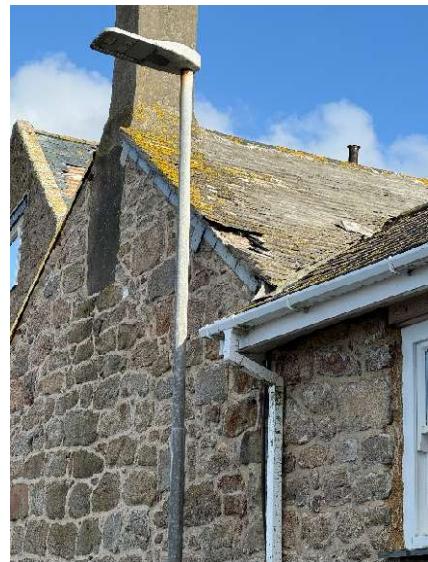
Rear elevation showing storm damage

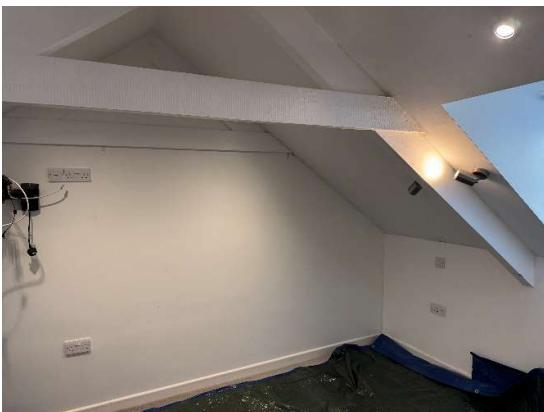
Main roof structure visible from 2nd floor bedroom

6. It can be seen that the main roof structure consists of 'A' frame principal trusses with timber purlins and common rafters over. There is a plasterboard and decorated finish to the underside of the purlins with the main trusses being exposed with a painted finish. This structural form is the same throughout the second floor.

7. There were no signs of structural damage to the principal trusses or the purlins/common rafters above. As expected, the storm had caused the slate covering and some of the roofing battens to lift off as these are the weaker elements of the roof. The purlins and common rafters are of a more robust nature and are able to resist such forces.

8. The main 'A' frame trusses show no signs of degradation and are in a good state of structural repair. There were also no further signs of any water ingress into the property and, therefore, the temporary protection works (roofing membrane and battens) are performing well.
