SCOPING-LEVEL HYDROLOGICAL ASSESSMENT OF LOWER MOORS SSSI, ISLES OF SCILLY

1575_r1_final, January 2015

Isles of Scilly Wildlife Trust

Dr. Rob Low (Rigare Ltd, Abergavenny)

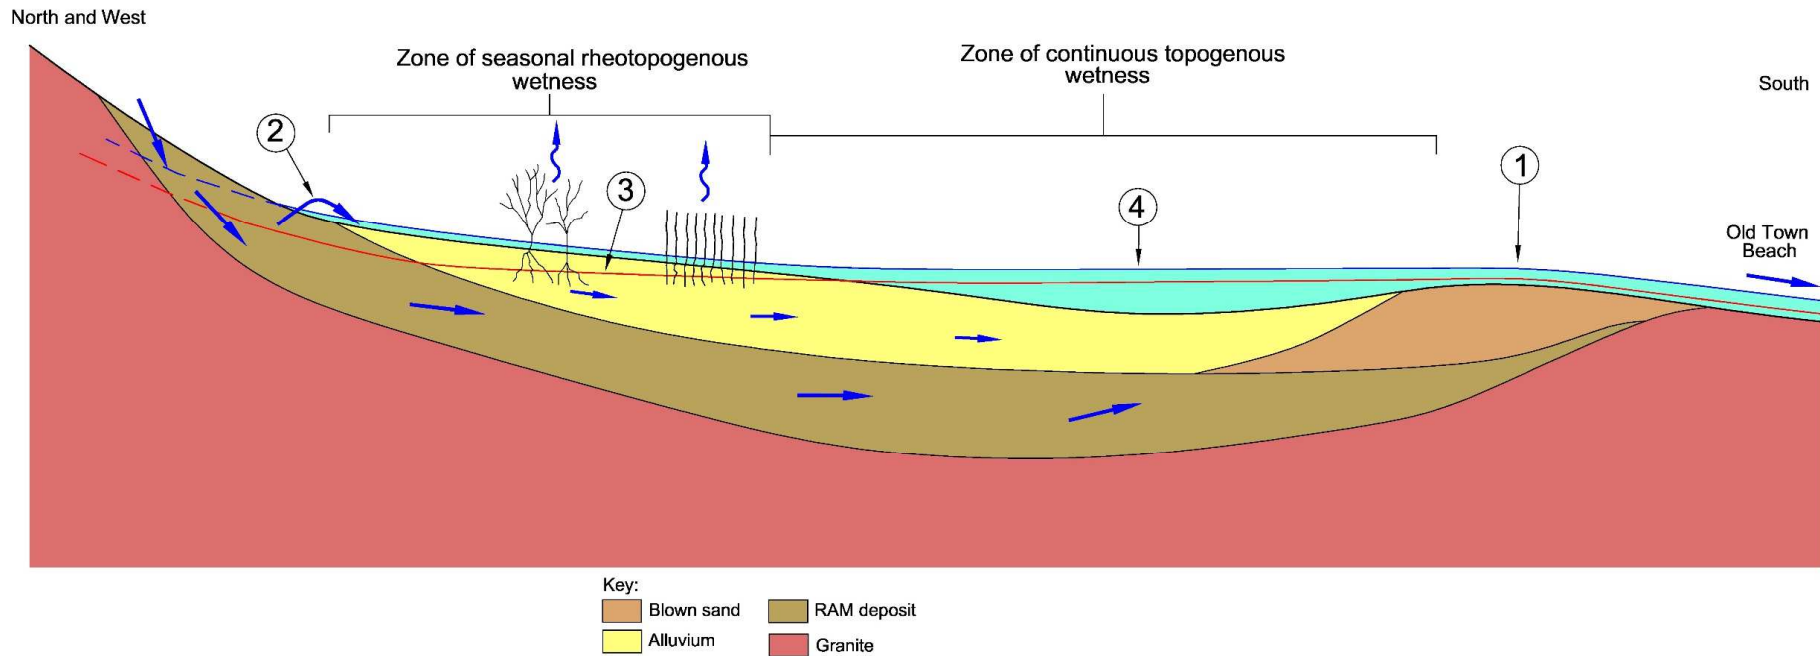
Figure 4.1-1 Schematic diagram of the hydrological conceptual model. The higher winter water levels are shown in blue whilst the lower summer water levels are shown in red. A topographic barrier at the southern end of the site (1) retains water at a similar level in the central and southern area of the site, resulting in an area of topogenous wetness. Further north and west within the site, water levels are high when maintained by rainfall, groundwater (from peripheral springs (2)) and surface water flow during the colder months, but have a tendency to fall below the surface (3) when not supported. Relatively high transpiration from vigorous reedbeds, scrub and willow will exacerbate lowering of the water table during the warmer months. The expressions of topogenous wetness in the central and southern areas of the site (4) are deeper water-filled ditches and episodic more extensive flooding.

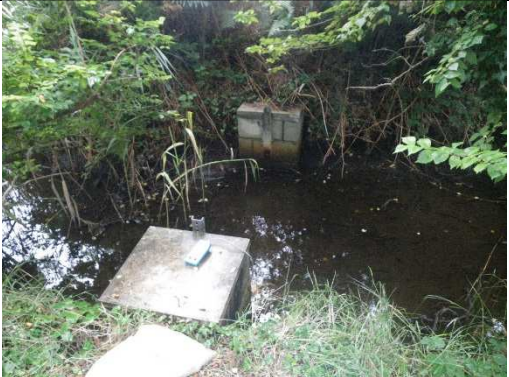
#	Easting	Northing	Feature/comment	pH	EC ($\mu\text{S}/\text{cm}$)	Temp (deg C)	Photo
1	91293	10443	Water control structure on outlet channel. Facility for stop-logs, but none in place. No channel restriction.	6.9	o/s	17

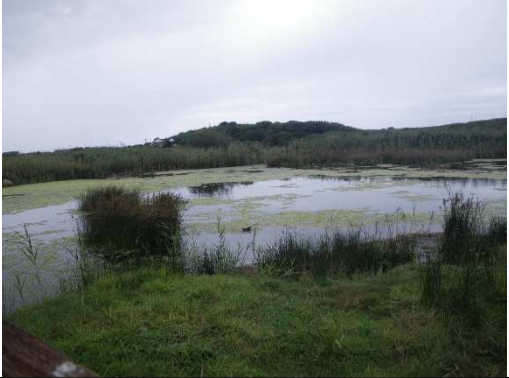
2	91236	10523	Bird hide and photograph of bird scrape.

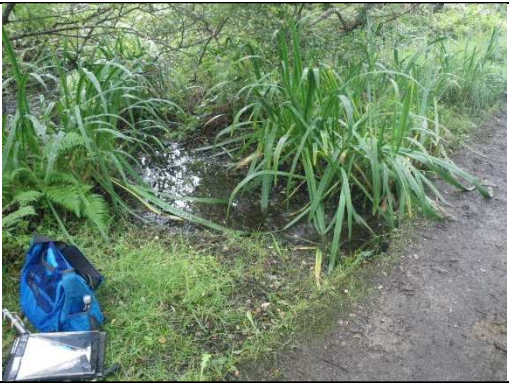
5	91291	10581	Confluence of eastern peripheral ring ditch with axial channel - springflow. Very small flow observed under one footbridge, but not others.	7.2	780	15

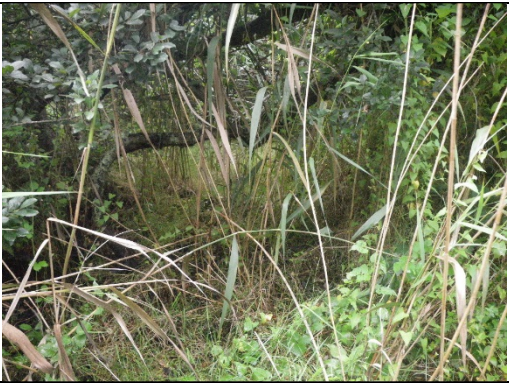
9	91104	10674	Dry channel bed, sloping to W? Very overgrown.

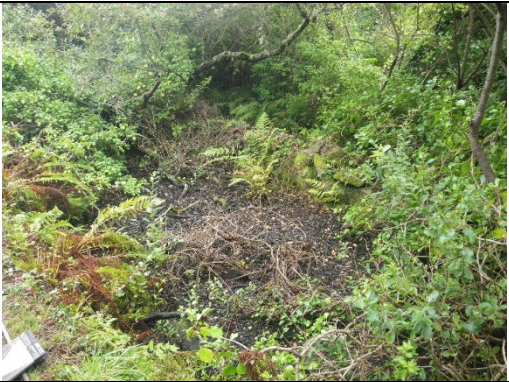
10	91105	10662	Auger hole #2 0-10 cm Damp, brown SILT 10-40 cm Damp, black-brown, dense, silty coarse SAND Area generally dry, water table @ 40 cmbgl 40-120 cm Damp, brown, soft organic-rich SILT				
11	91201	10780	Northern area of site dry, with areas which are clearly routinely wet (wide channels, swales, etc)

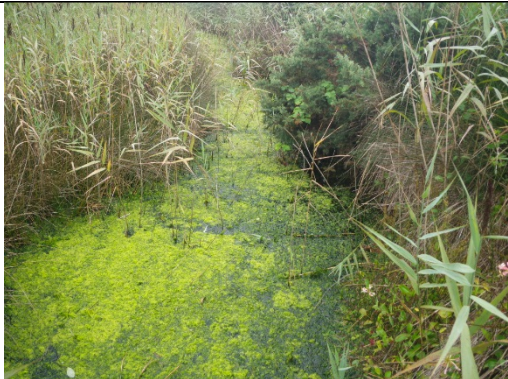
13	91325	10641	Auger hole #4 0-20 cm Damp, brown, crumbly PEAT with abundant roots. H2 20-65 cm Wet, mid-grey, fine SAND Hole collapsing, running sand				
13	91273	10566	Tributary from W part of site past northern hide. 2 m wide, no flow apparent. Potential sign of oil pollution on surface - doesn't break into platelets.	7	o/s	17	
14	91260	10520	Main ditch, occluded with weed (and algae?)
