# Heritage Statement

Recovering of roof to plant room and porch  
At Chaplaincy, St Marys, Isles of Scilly

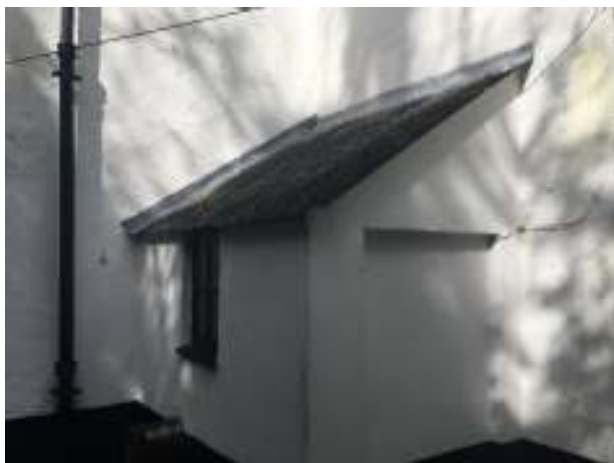
Photograph 1 – Plant room External

- 2.1.1. The plant room is a small lean-to extension on the north east corner of the building - leading off the principal hallway. This part of the extension is constructed in solid block or brick with a rendered finish. It forms part of the thermal envelope of the building. The boiler and hot water cylinder for the property are located in this room. The roof is asbestos profile sheeting secured on sawn purlins, with no insulation. As such the roof is difficult to safely maintain and suffers from high heat losses and condensation.

- 3.1.1. The proposal is to strip the existing roof covering and structure over the plant room and replace with a new natural slate roof.

New principal rafters will be installed to accept breathable roofing felt and slating battens over.

It is proposed to use Riverstone 1<sup>st</sup> Slate 200 x 400mm fixed with copper nails. This slate closely matches indigenous slate and is widely accepted for use on listed buildings.

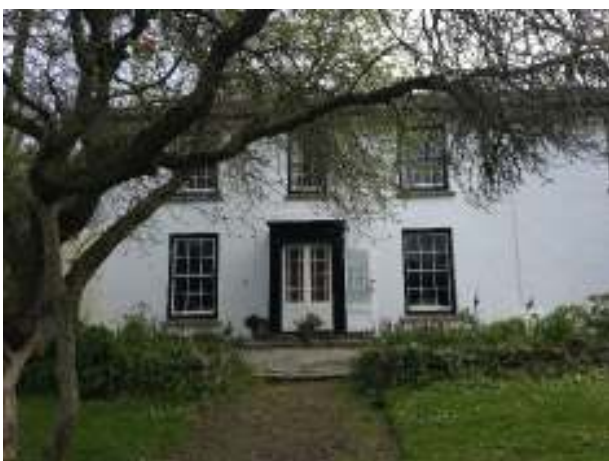
Photograph 3 – Porch front elevation

- 2.1.2. The flat roof over the front porch currently has an asphalt covering which appears to have been laid over metal sheeting. This is in poor order and life expired.

- 3.1.2. The porch roof will be recovered in Code 5 Lead sheet to comply with Lead Sheet Association.
