PERMISSION FOR DEVELOPMENT

Application No:	P/22/019/HH	Date Application Registered:	8th February 2022
Applicant:	Mr Alistair Martin Duchy Of Cornwall 10 Buckingham Gate London SW1E 6LA	Agent:	Mr Nathan Dean Duchy Of Cornwall Hugh House St Mary's Isles Of Scilly TR21 0LS
Site address:	Ashvale Farmhouse Lower Town St Martin's Isles Of Scilly TR25 0QW		
Proposal:	Replacement of existing wet laid scantle slate with dry laid Trevilletts slate (Listed Building).

The proposal is to replace the slate roof covering of a farmhouse.

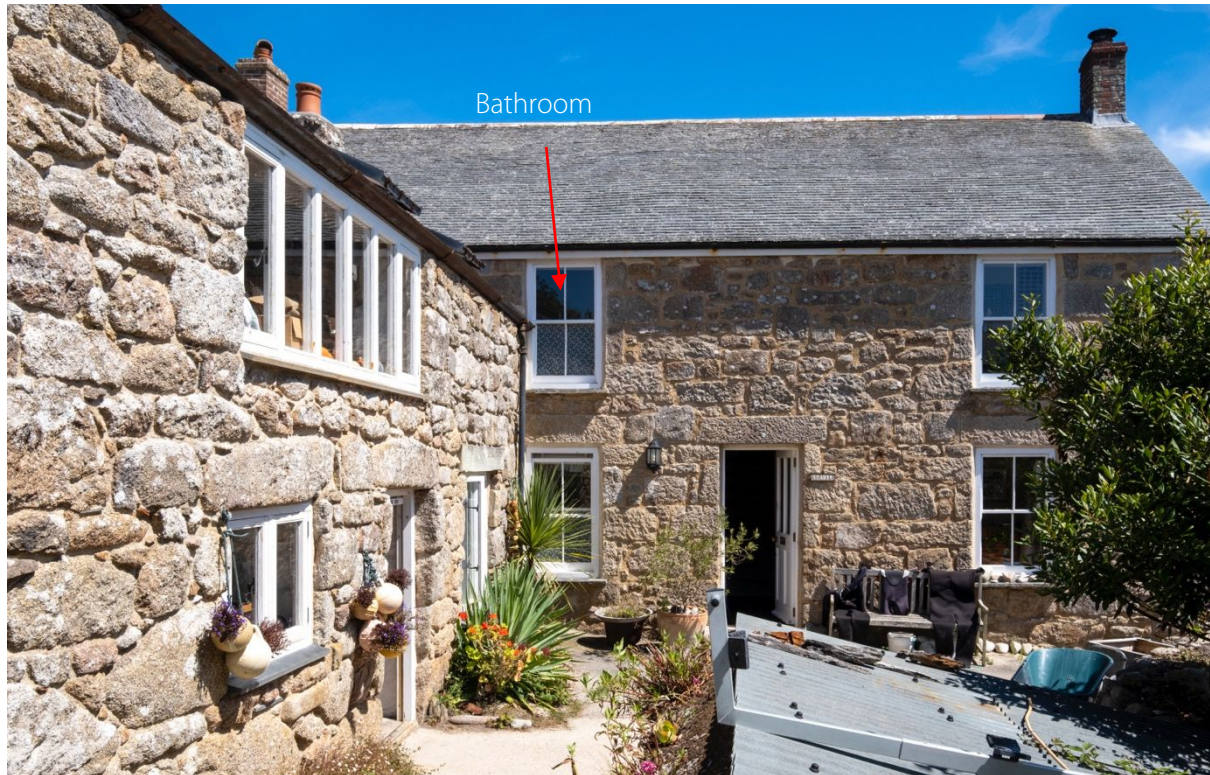
West elevation

Example of the friable mortar around windows and doors

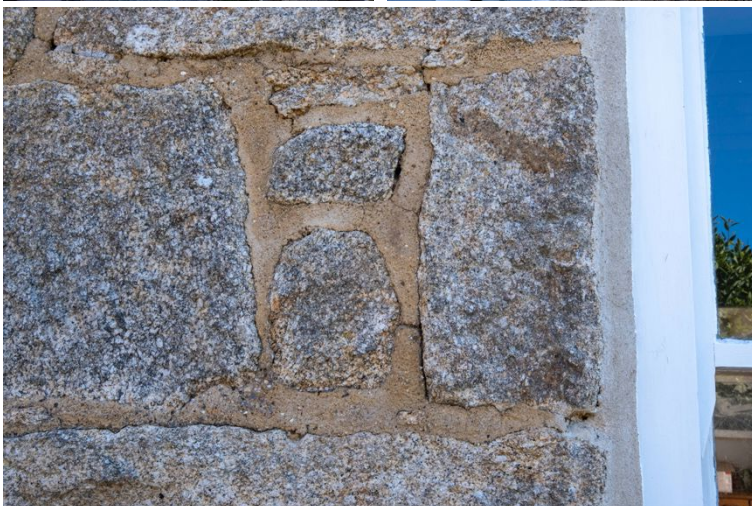
Example of perimeter shrinkage and cracking of mortar

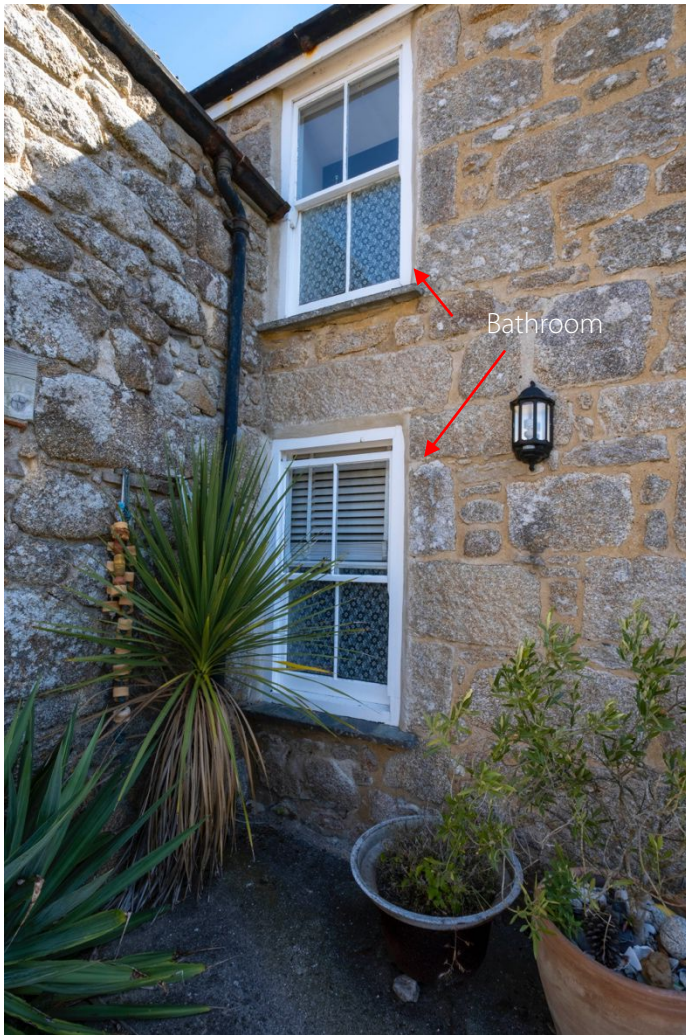
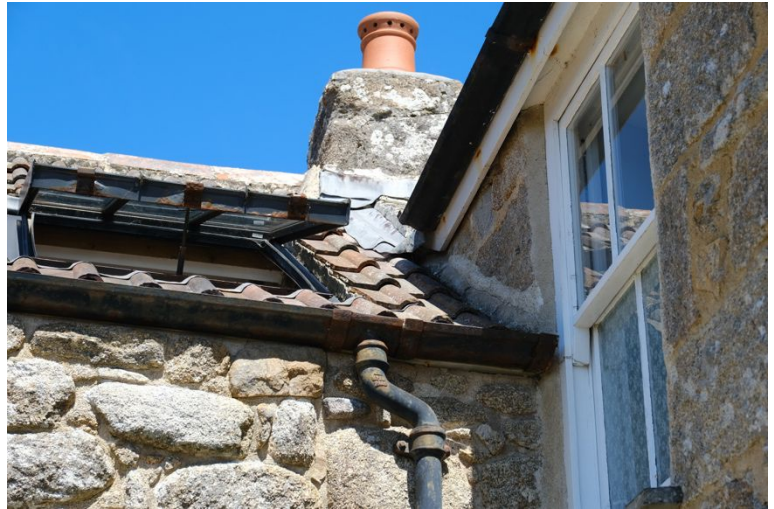
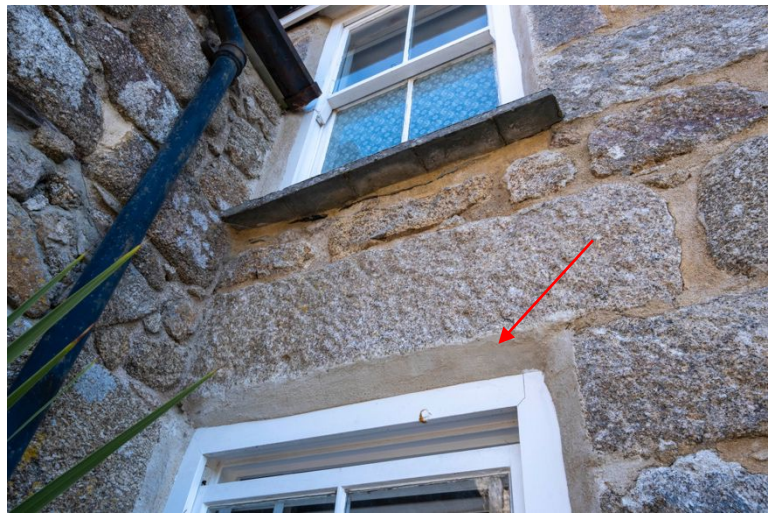
West elevation and junction between house and barn

Below right shows the angled mortar beneath the lintel which may contribute to the wetting of this window.

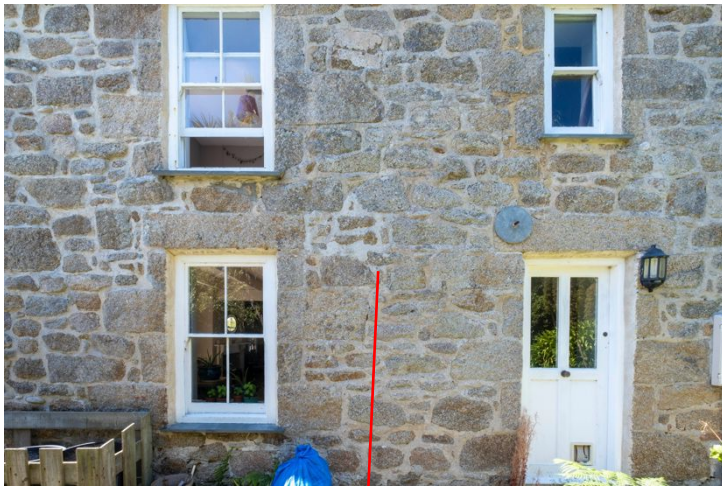
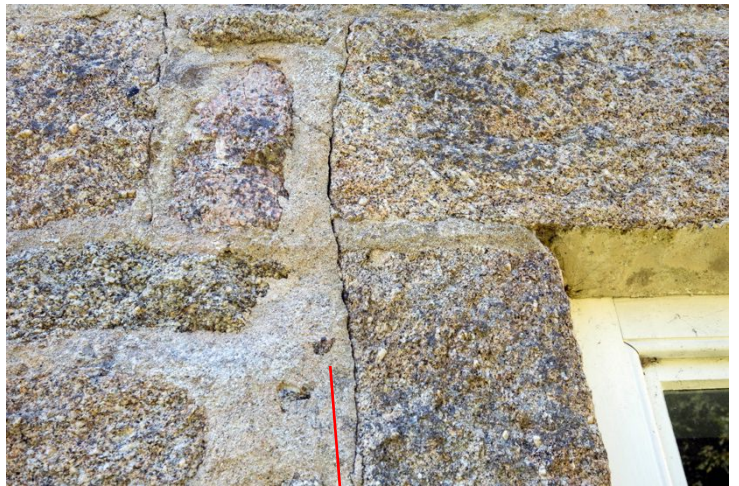
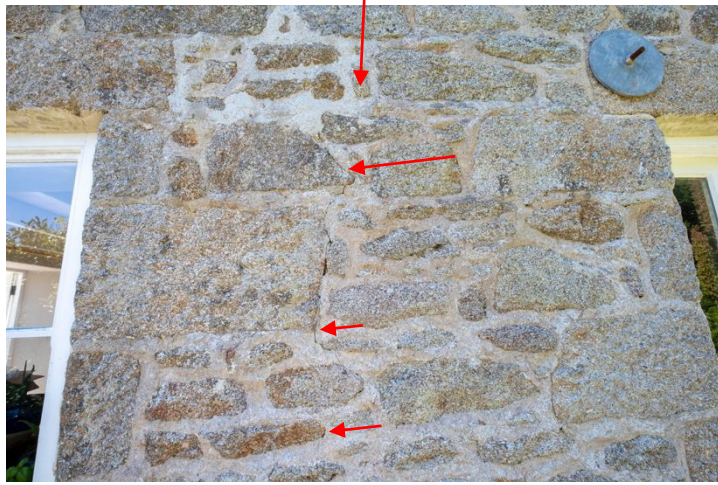
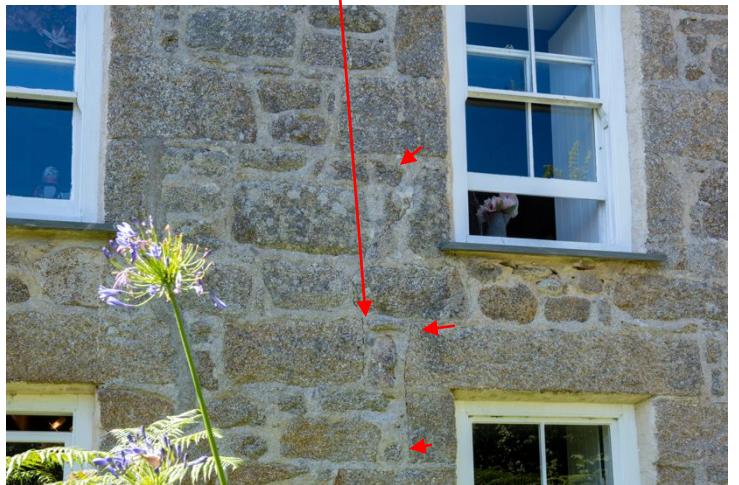
East elevation indicating cracks in mortar

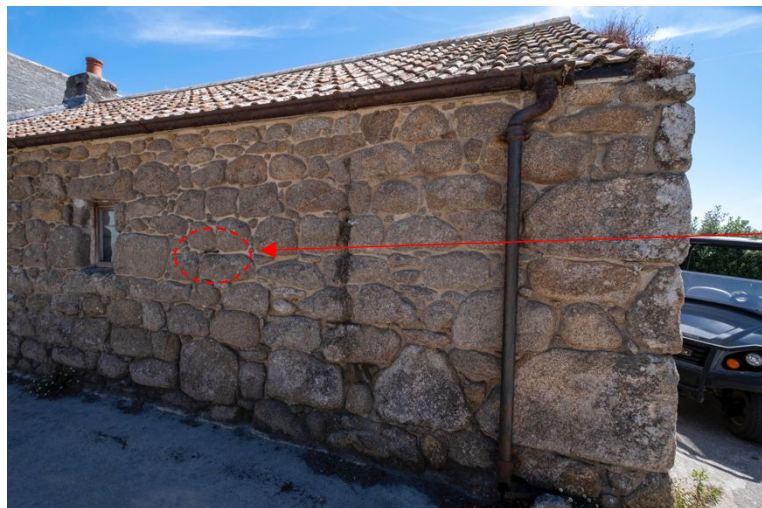
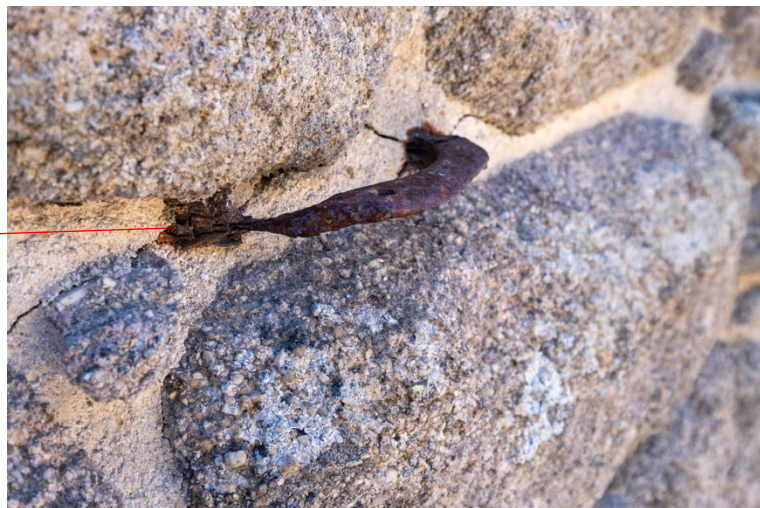
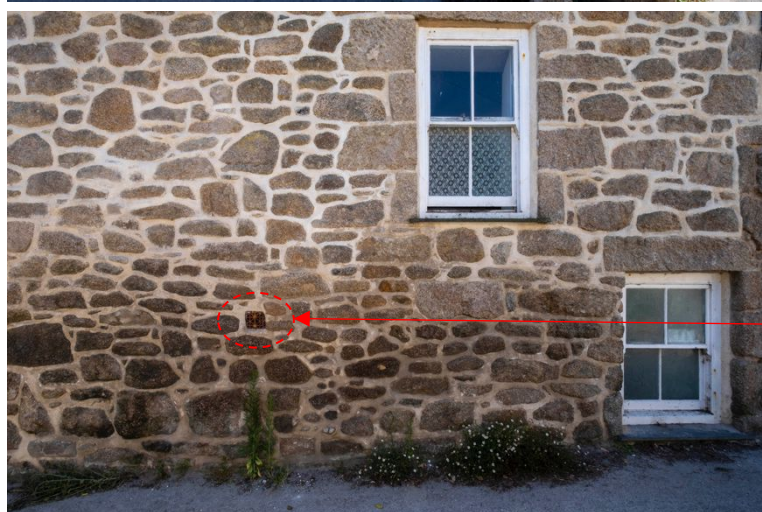
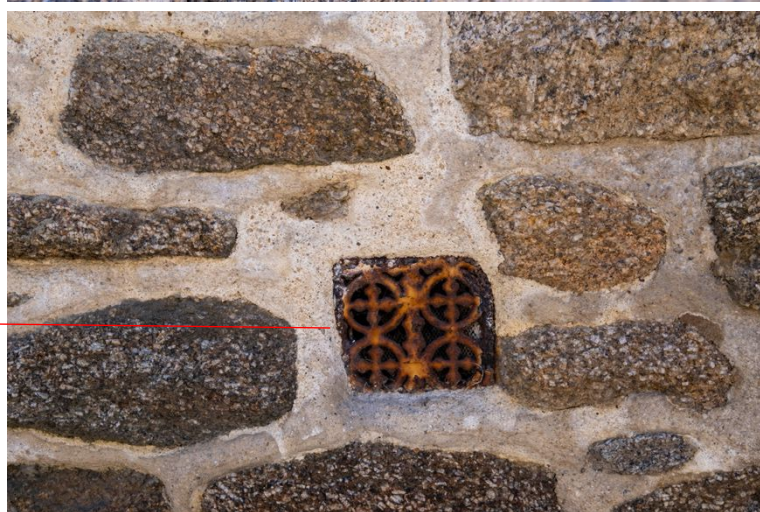
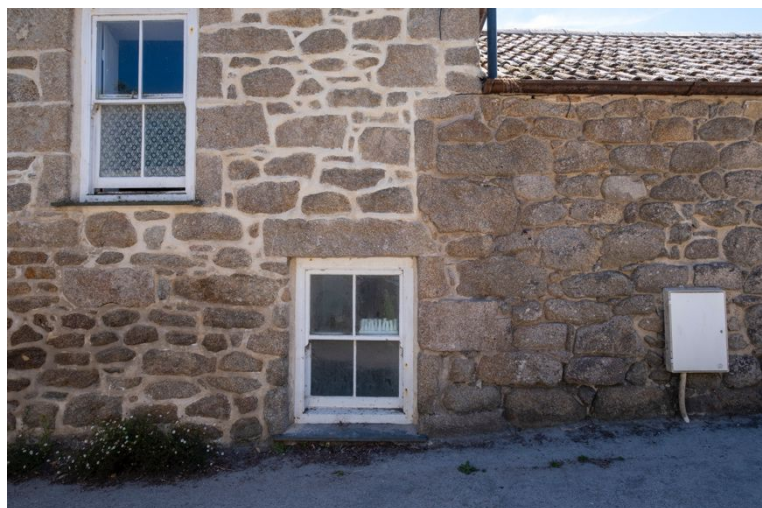
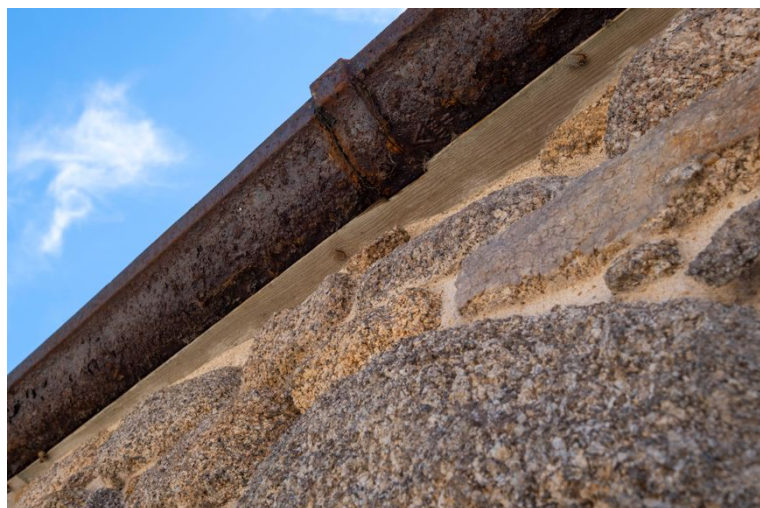
North Elevation

Top: Embedded horseshoe causing rust-jacking

Centre: North gable showing discolouration of mortar at lower level and cast iron ventilation grille

Below: Junction between house and barn and guttering to barn

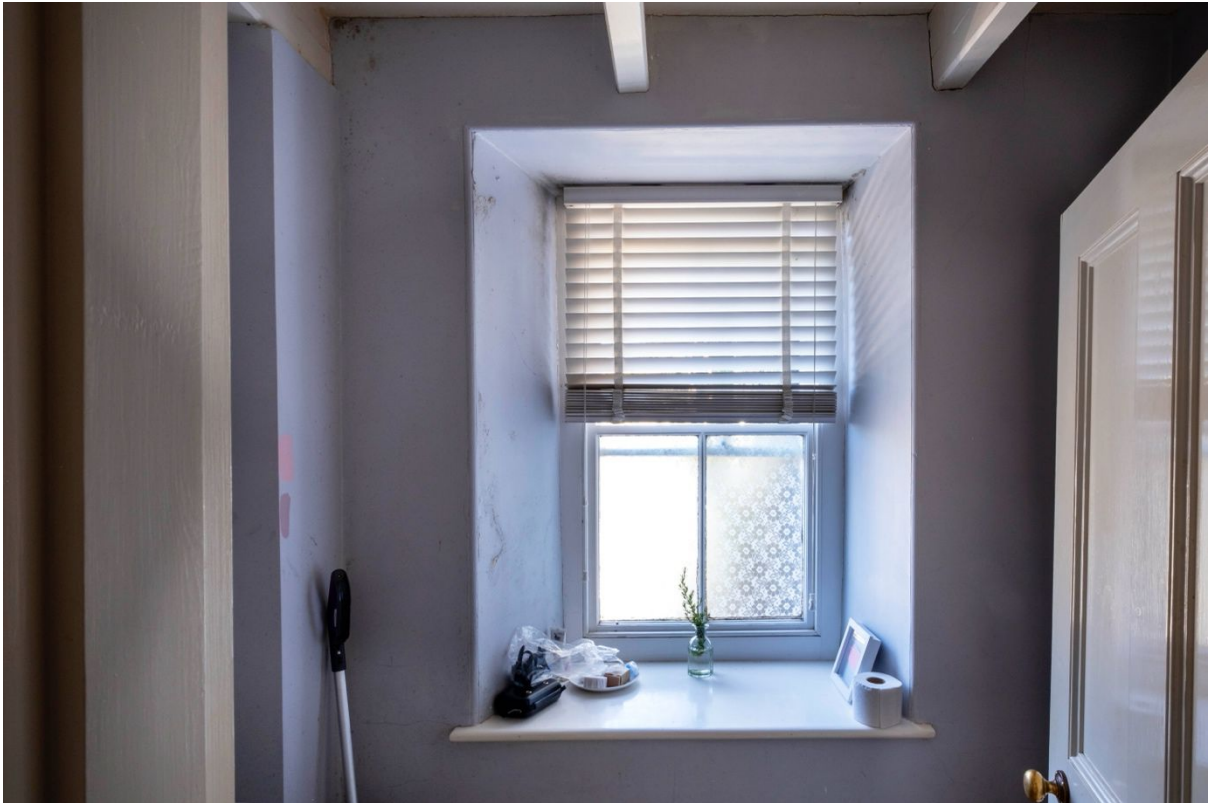
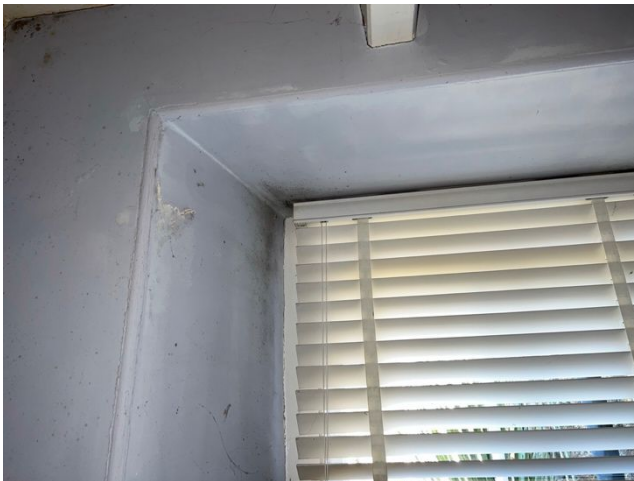
Ground Floor Bathroom

Shows damp to reveals and wall at ceiling height

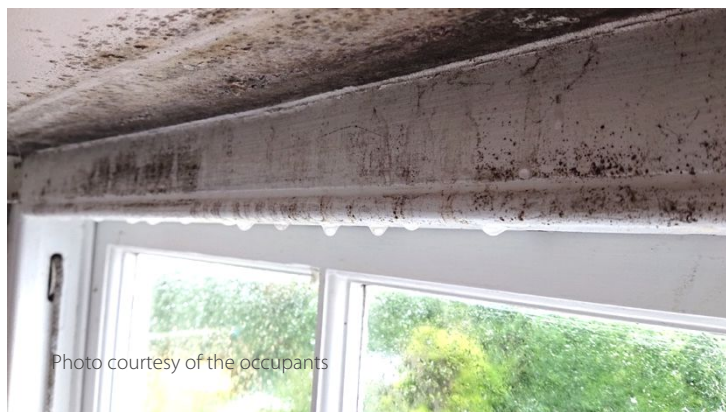
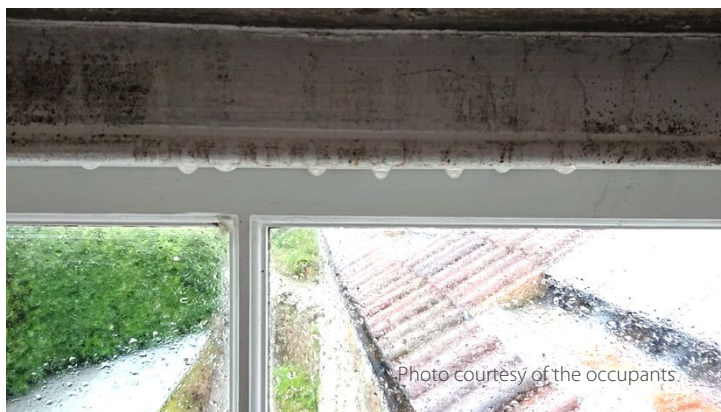
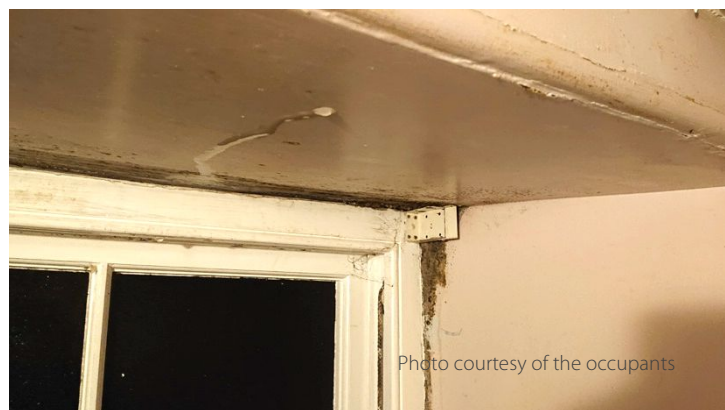
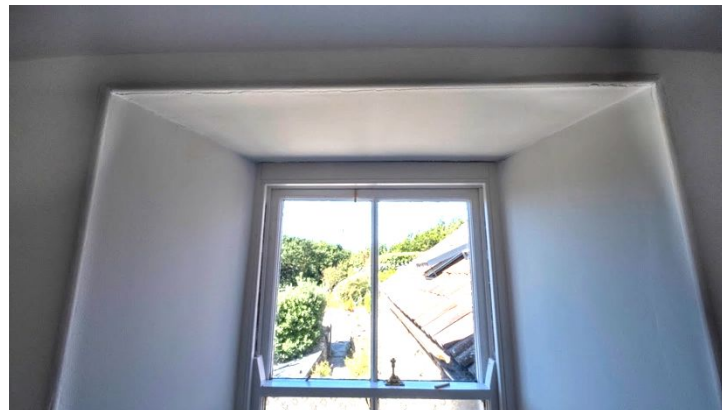
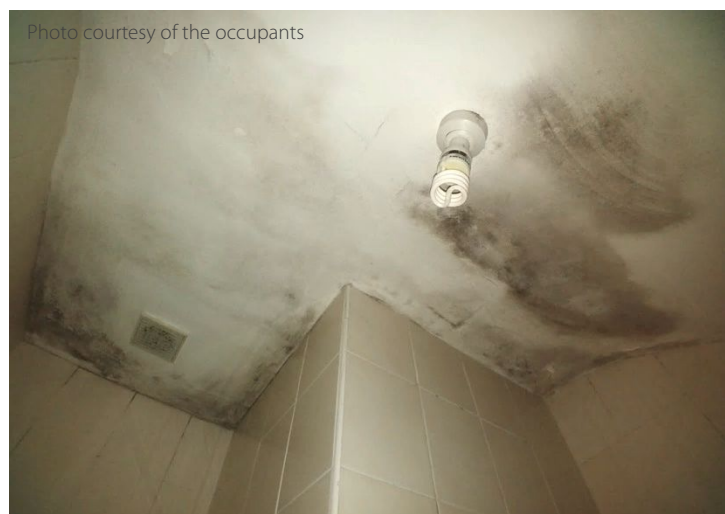
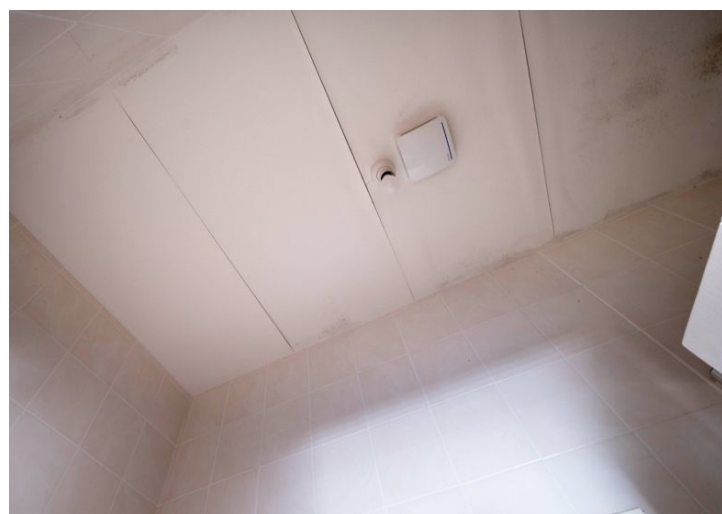
- Most notably, the first floor bathroom window (west elevation) head runs with water during rain and a temporary system has been installed to direct it away from the wall head. A new bathroom interior window reveal head has been recently installed due to the damage from water ingress, however, an inspection by the Duchy of Cornwall's Deputy Head of Building IOS has shown the wall plate above the window to have rotted and in need of urgent repair. There is also an area above this where roof timbers require repair due to decay. The bathroom ceiling was also partially replaced due to water damage. Despite being repainted within the year, and with prolonged dry weather, there are still obvious signs of damp to the window and ceiling in this area.

- The south bedroom ceiling has several areas where damp has penetrated the ceiling, which is repainted every couple of years to disguise the problem. Again, despite the prolonged dry weather damp staining is extensive. The ensuite ceiling also evidences considerable patches of mould, despite remedial intervention.

Top: First floor bathroom window showing running water, prior to temporary repair and renewal of window head.

Centre: FF bathroom window prior to repair and renewal

Centre right: FF bathroom now, following repair and renewal of window head.

Below left: Ensuite to S bedroom prior to recent redecoration

Below right : The ensuite now, following recent redecoration, still shows significant mould

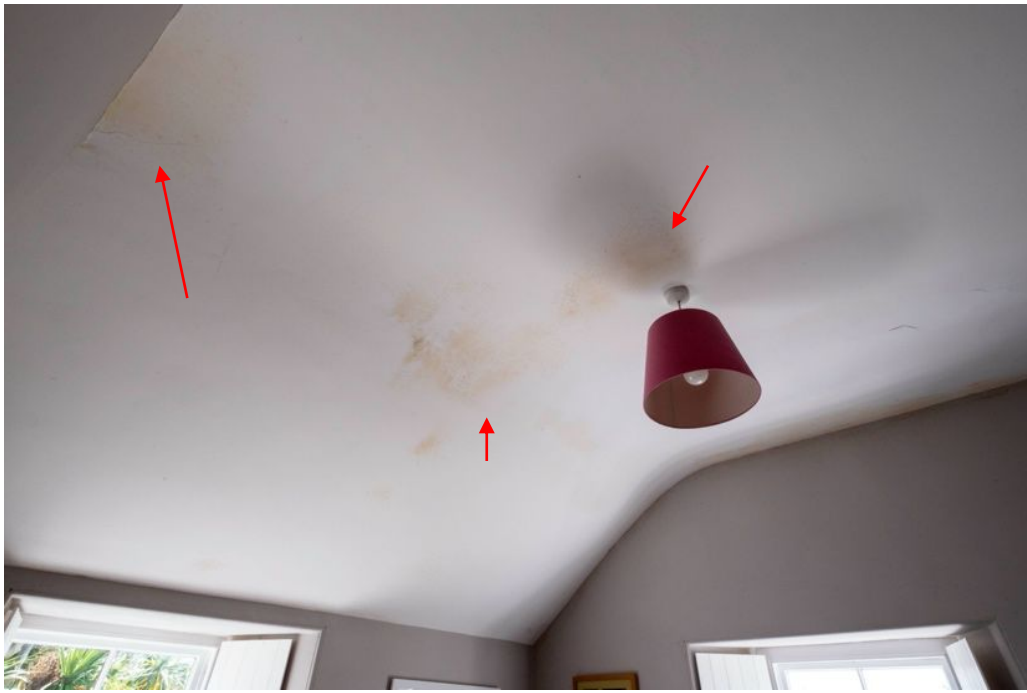
Top: South Bedroom showing damp to ceiling within 2 years of painting.

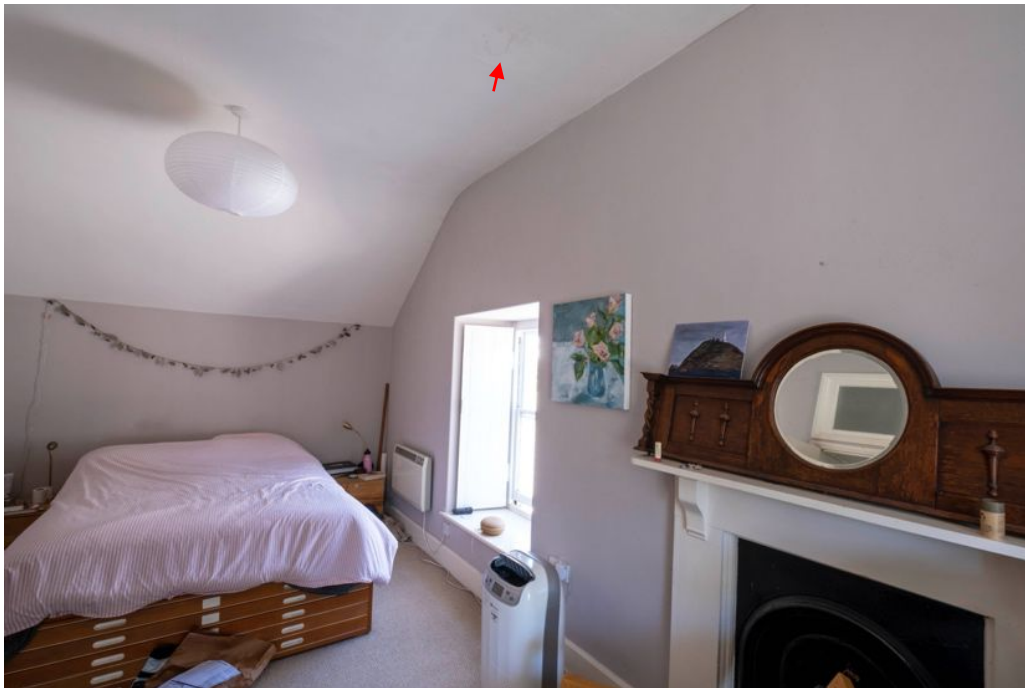
- The north bedroom ceiling has some small areas of damp, although the most significant problem to the NE corner of the room, at the junction between wall and ceiling, is most likely due to the end of the metal gutter having corroded, leading to wall wetting.
- Black mould growth is extensively visible, but there is also likely to be hidden growth. It arises from problems such as condensation, thermal bridging, damp from water ingress. Fungal growth can produce toxins known to adversely impact on human health such as respiratory symptoms. The occupants report that family friends with asthma have stopped visiting because of exacerbation of their symptoms.

Below: North bedroom shows small areas of damp.

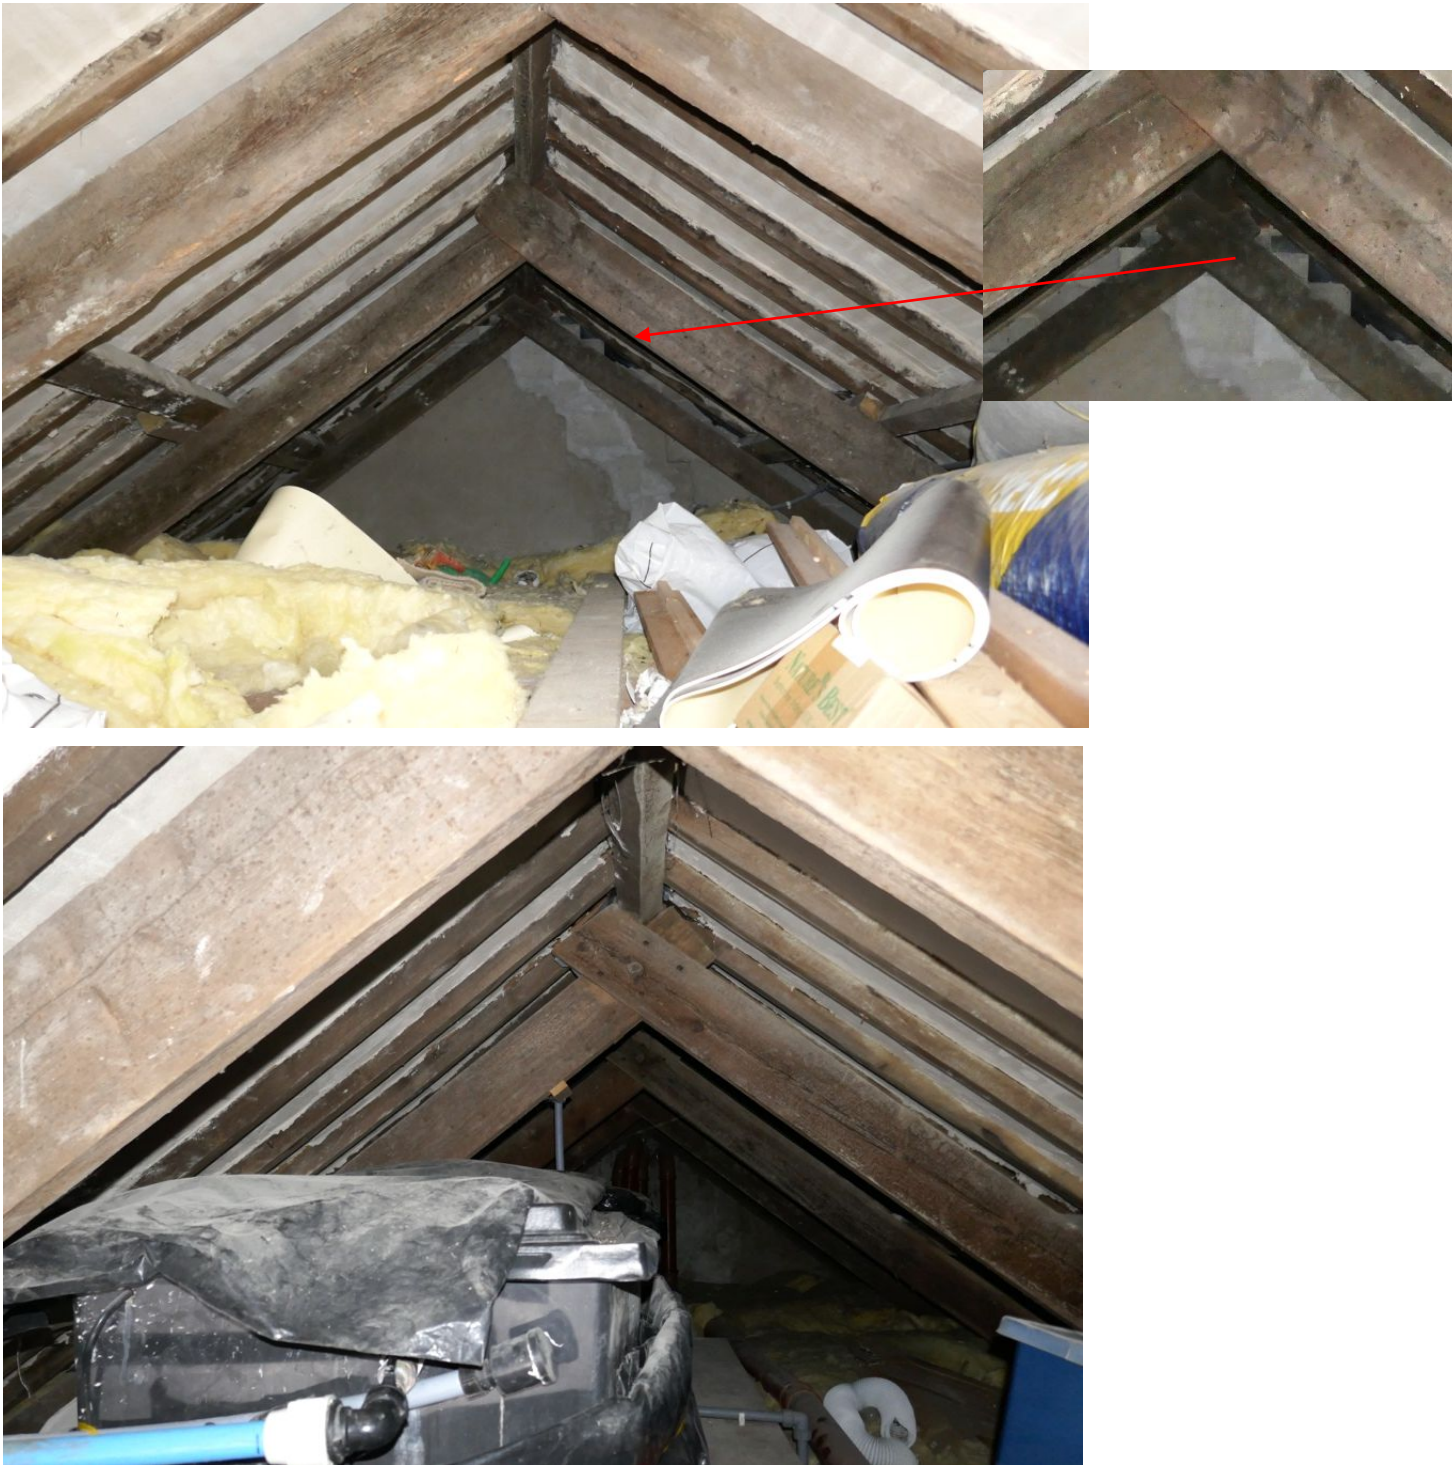
- Principal rafters do not appear of uniform sizes suggesting some later replacement and/or, as is common on the islands, architectural salvage. High collar trusses appear half lapped, pegged and nailed and appear of late C19 in character. All timbers appear saw cut. Some small sections of historic sawn purlins remain, largely partnered with new timbers. There are emergence holes indicative of wood boring insects, although it not clear if there has been a recent infestation. However, the current damp conditions in the roof space would create vulnerability to insect and fungal attack.

Top: Roofspace looking to the rebuilt south elevation showing incomplete infill to the west side

Below: Looking to the north elevation showing pegged and nailed trusses

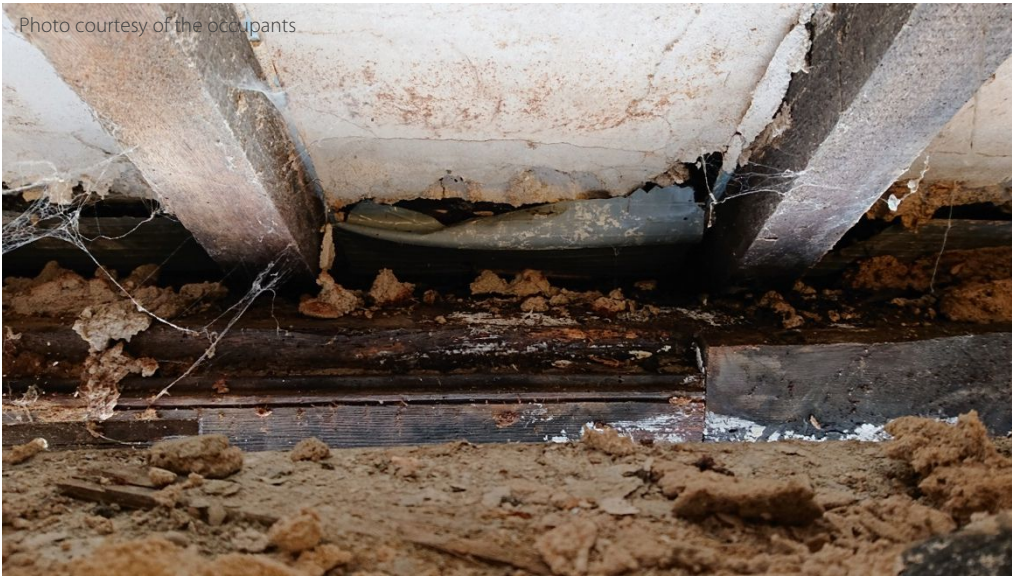
Above the first floor bathroom window prior to temporary repair. Note the two different pieces of timber

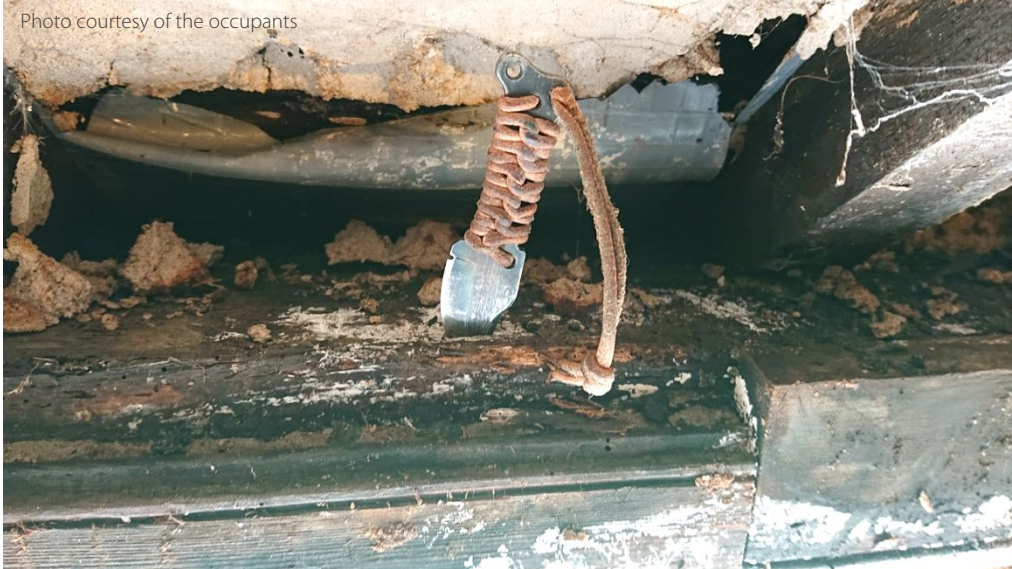
As above. A small blade (approx. 6") shows the decayed timber

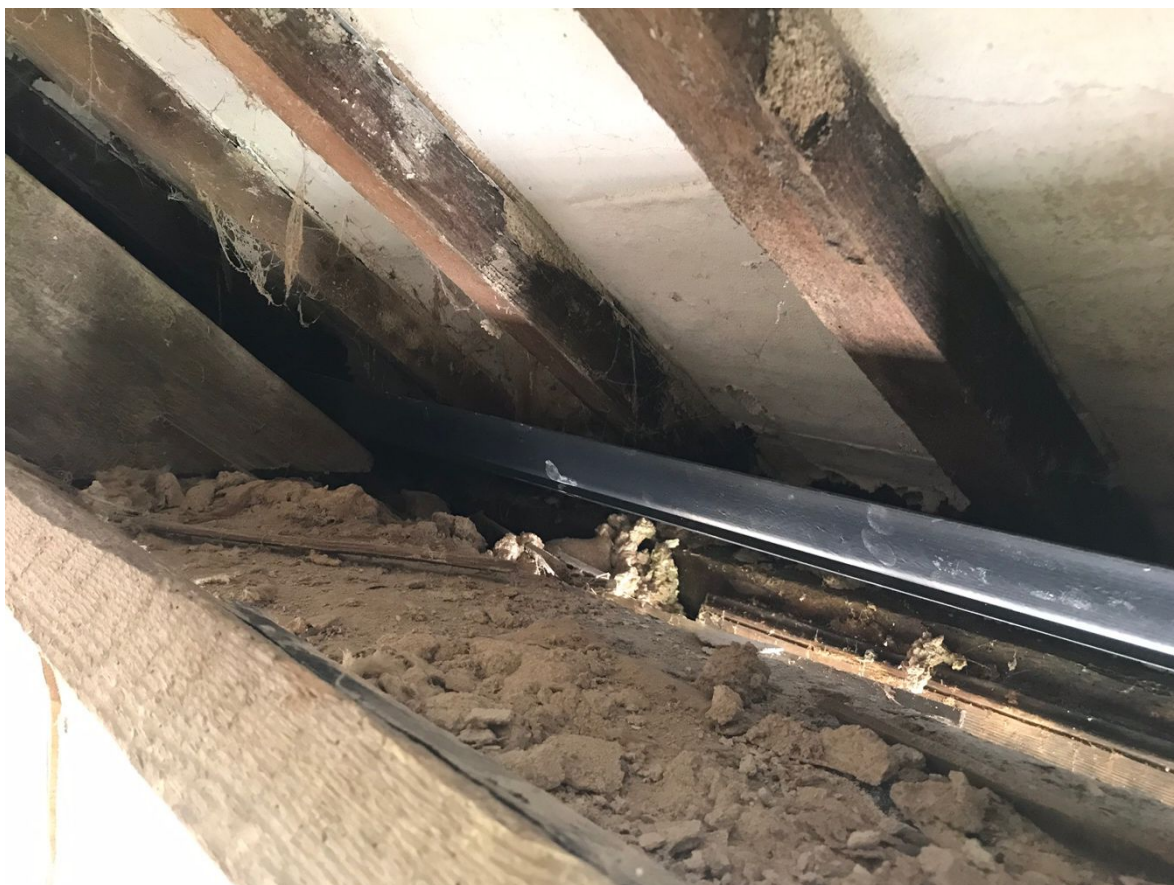
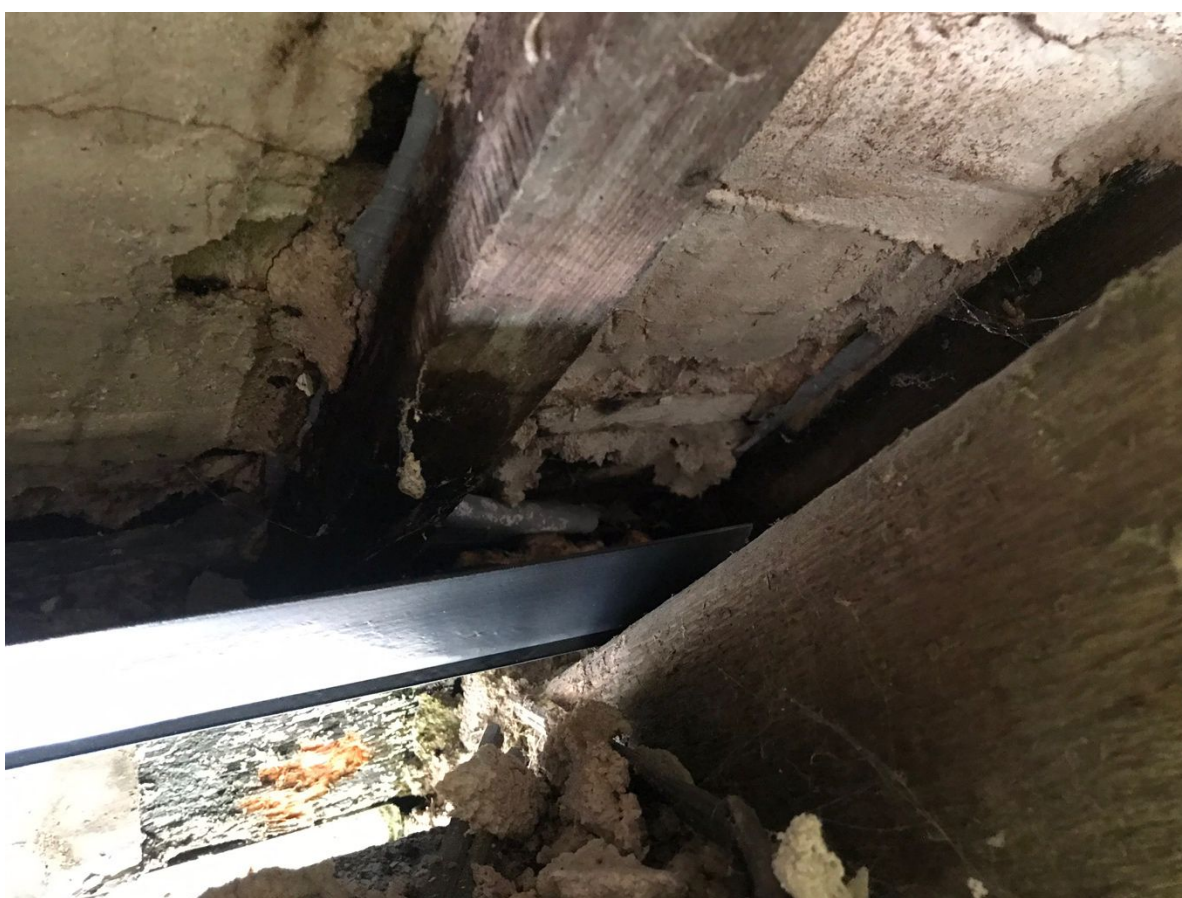
Photographs courtesy of the Duchy of Cornwall showing the temporary repair above the bathroom window to provide drainage
