Palm at the front of the property (T1)

Palms at the rear of the property (T2)(T3)(T4)(T5)

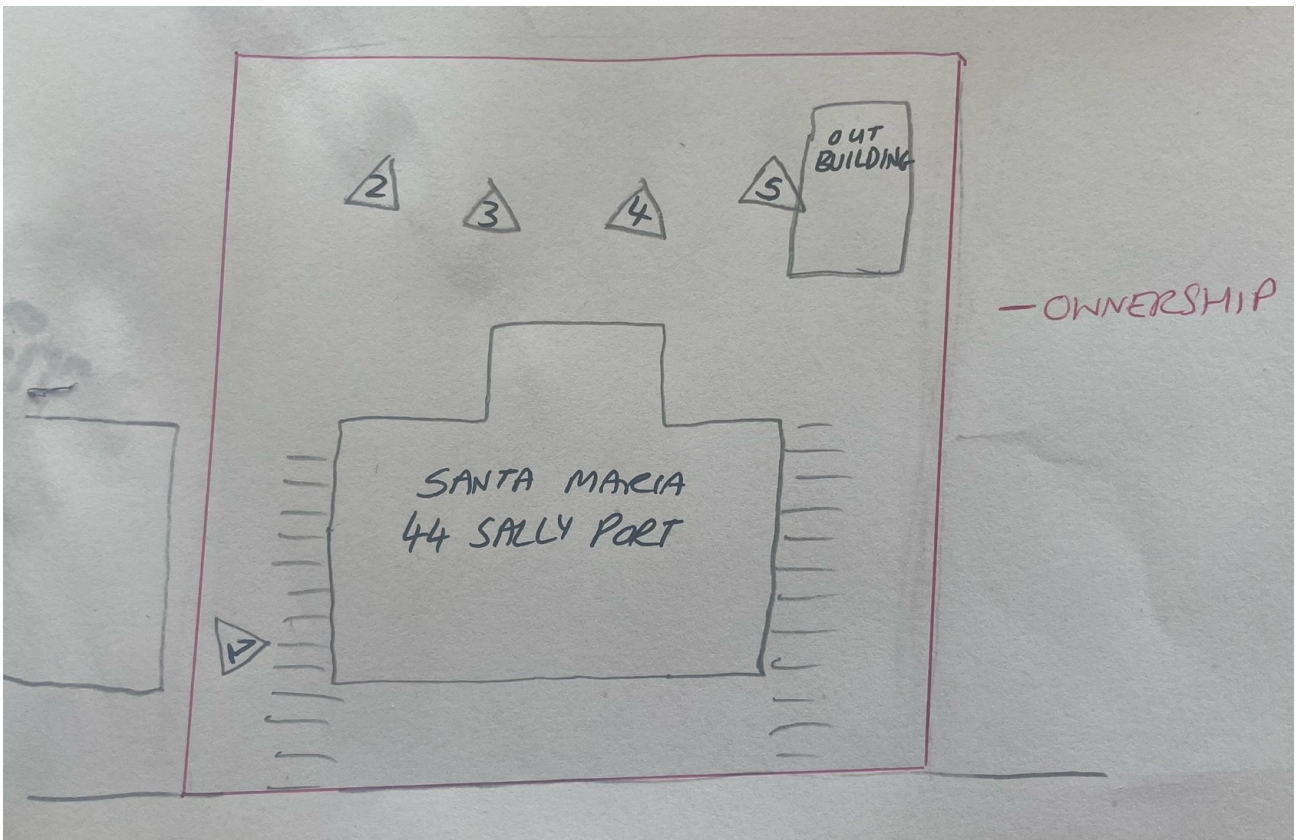
The Palm trees at the rear of the property are growing at a substantial rate. They have been planted in a rockery that will not support the continued rates of growth. We consider the height of the trees to be dangerous as they would hit the property if they fell. The rooms in the tree's trajectory are all bedrooms.

The trees will be replaced with shallow rooted scrubs – in a more suitable part of the garden.
