Climate Adaptation Scilly  
Porthmellon Enterprise Centre  
St Mary's  
Isles of Scilly TR21 0LW

**APPLICATION FOR THE INSTALLATION OF GEOBAGS AT PERIGLIS TO REPLACE THE CORE OF EXISTING DUNES, WRAPPED IN GEOTEXTILE AND COVERED WITH EXCAVATED MATERIAL AND TO STABILISE THE DUNE CREST WITH GEOMAT TO ENCOURAGE RE-VEGETATION. INSTALLATION OF ROCK BAGS AT PORTH COOSE TO HEIGHTEN THE EXISTING PROTECTION, BACKED BY EARTH BUND AND INSTALLING ROCK ARMOUR AT THE BOTTOM OF THE EXISTING SEA WALL AT PORTH KILLIER. TO REDUCE THE RISK OF COASTAL FLOODING ON ST AGNES. (EIA DEVELOPMENT) (MAJOR DEVELOPMENT) LAND ADJ TO WASTE SITE, THE QUAY, ST AGNES, ISLES OF SCILLY**

Subject: EA Objection to scheme at Port Coose and need for design changes

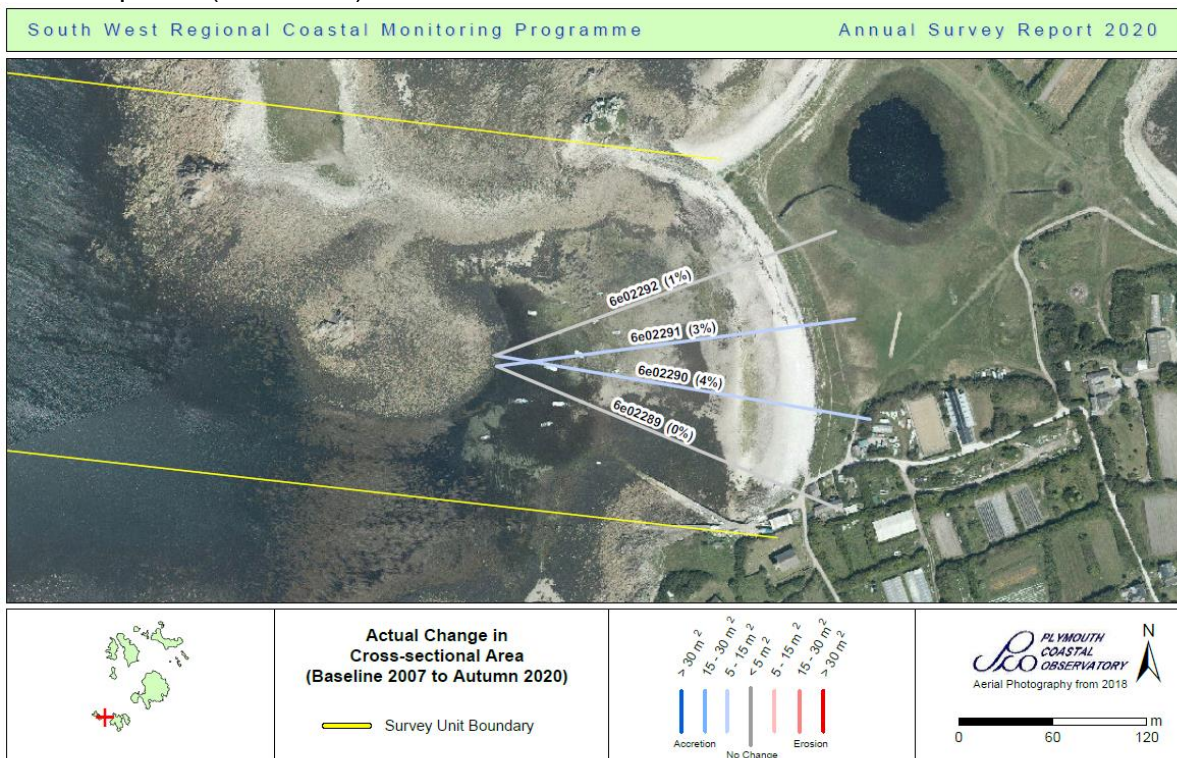
The independent Plymouth Coastal Observatory annual surveys for this beach from 2007 to 2020 shows that the trend for Periglis is actually accretional (Figure 1). These data include observations both before the 2014 storm and after the 2014 storm.

**Figure 1:** Actual changes in cross-sectional area at Periglis beach, from autumn 2007 to autumn 2020. Positive percentages would indicate accretion, while negative percentages would indicate erosion. All cross sections at Periglis show no change or up to 4% accretion over this period (PCO 2020).

Despite this actual positive trend to accretion at Periglis over this period, Council proposes to move the geobags further back within the dune in response to the objection. Shifting the geobags rearward will increase the volume of material excavated. In the northern part of the dune, this is likely to remove the dune entirely before reconstruction is undertaken. Council proposes to move the bags back 3 m laterally compared to the originally submitted designs towards the back of the dunes, to minimise the volume of additional material to be excavated and associated increased costs.

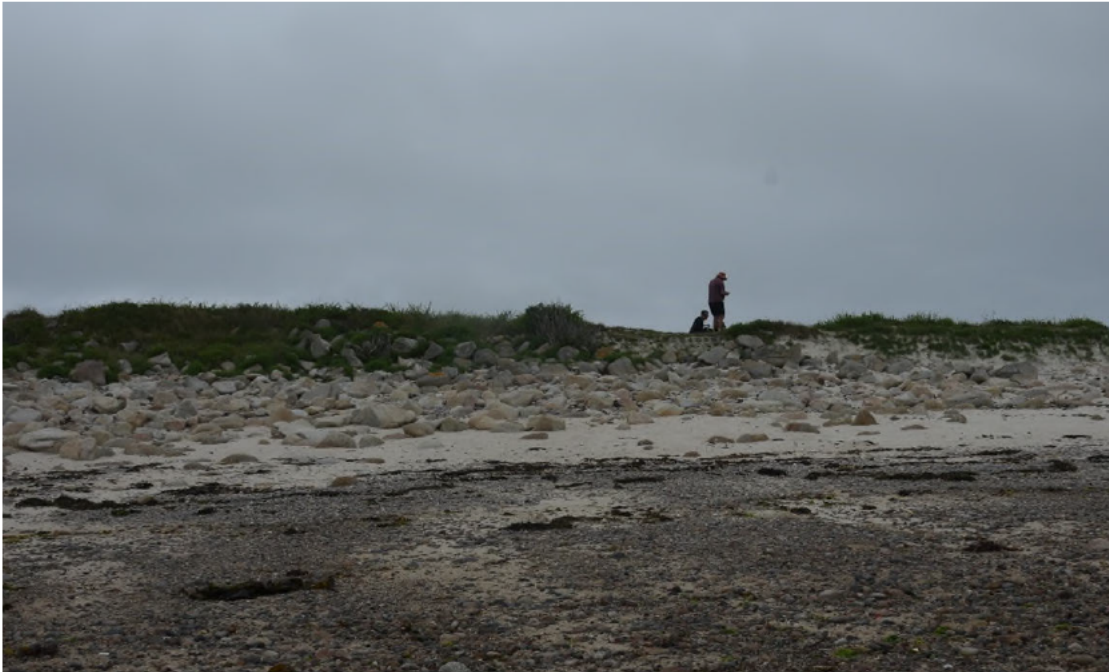
Presently the ridge is protected by an Armourflex concrete mattress, as shown in Photograph 1 and 2 below, which is fronted by a layer of boulders and cobbles. As built drawing or any design information was not available, to be incorporated in the design. Therefore assumptions on the condition, and toe elevations were

**Photograph 1** – View of the ridge armoured with the Armourflex concrete mattress, fronted by boulders, at its toe, and a layer of cobbles and gravel over the beach

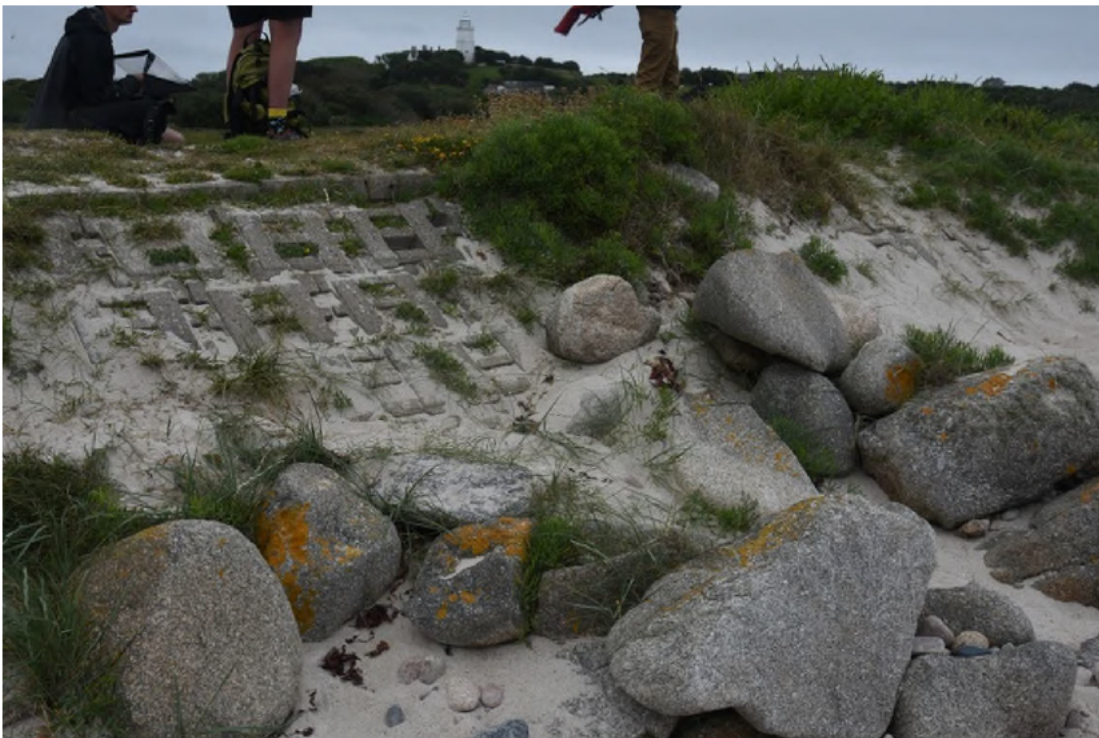
**Photograph 2** – Armourflex concrete mattress fronted by large boulders

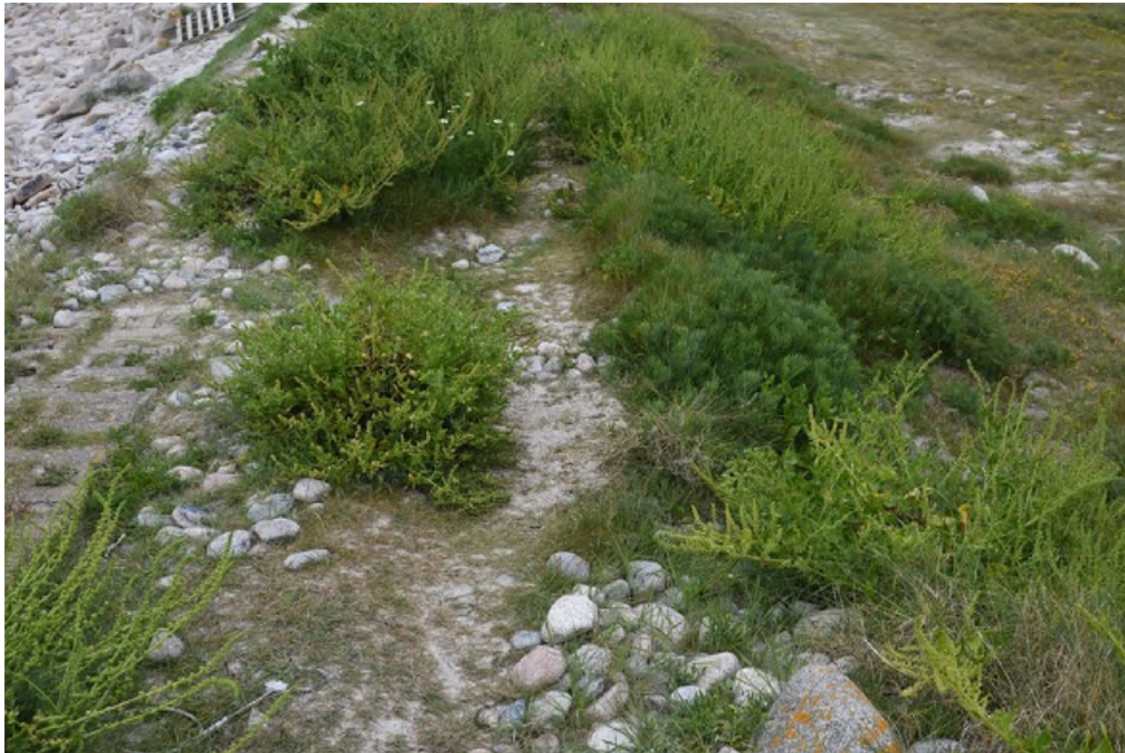
**Photograph 3** – Ridge crest artially vegetated with cobbles washed over during storms

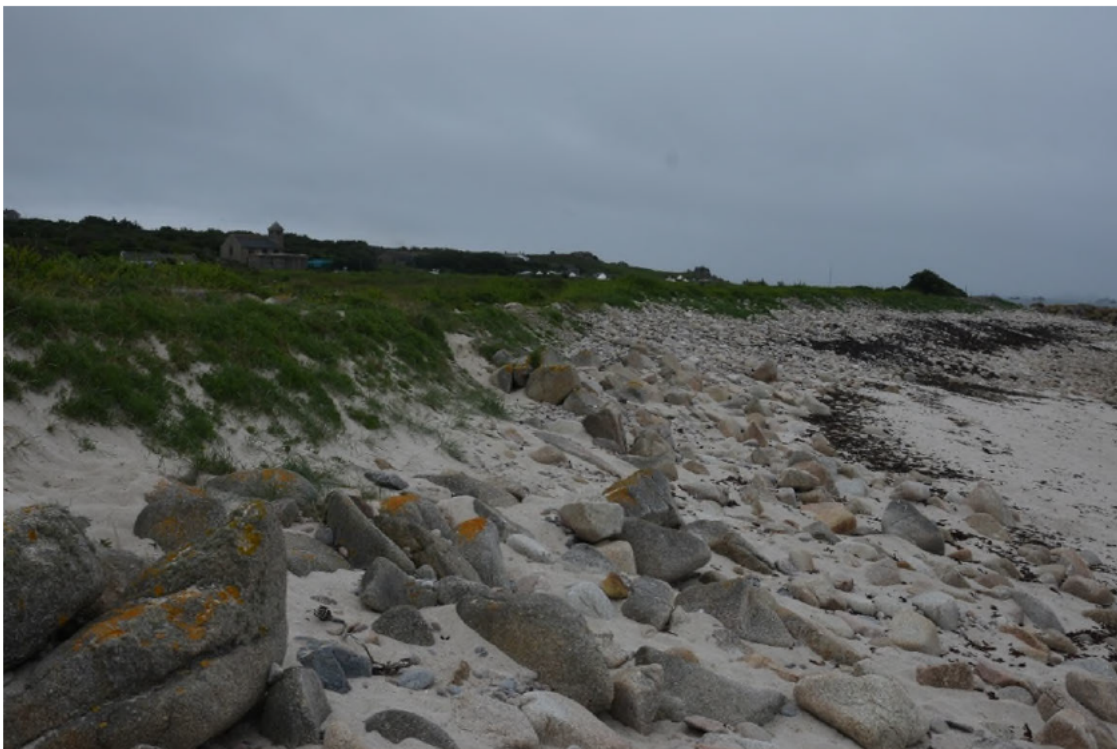
**Photograph 4** – Looking towards South-West, with evidence of presence of boulders and cobbles along the upper beach

The condition of the concrete mattress appeared fair during that inspection, though at some specific locations along the front, rear and along the crest will require some local repairs as also discussed in the section below.

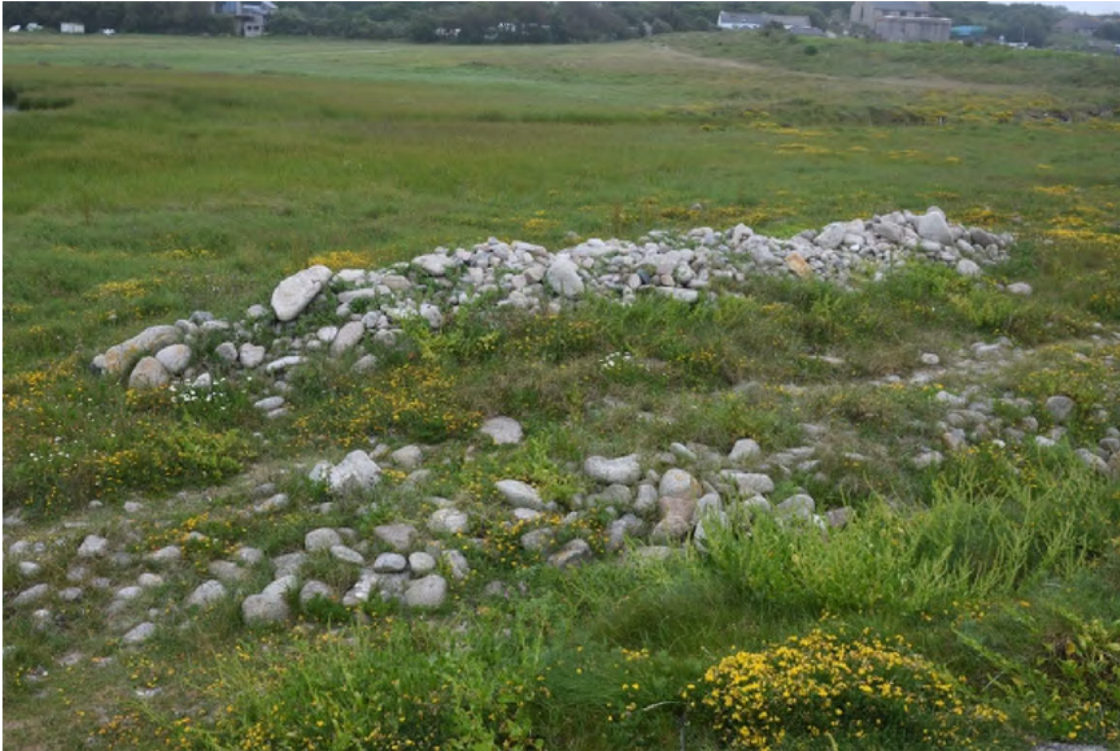
In addition, cobbles currently are overwashed by storms (photograph 5 in the accompanying memo), which means they can no longer dissipate energy on the seaward side of the existing Porth Coose coastal protection works. The proposed protection works would reduce the likelihood that more cobbles were lost from the beach system in future, thereby reducing the impact of waves on the structures.

Photograph 5 below show a pile of cobbles along the back of the ridge, which are assumed to have been overwashed during storms. At present, these cobbles are no longer available along the front face of the beach to naturally dissipate wave energy.

**Photograph 5** – Cobbles thrown over the ridge or overwashed by severe storms and overwashing events.

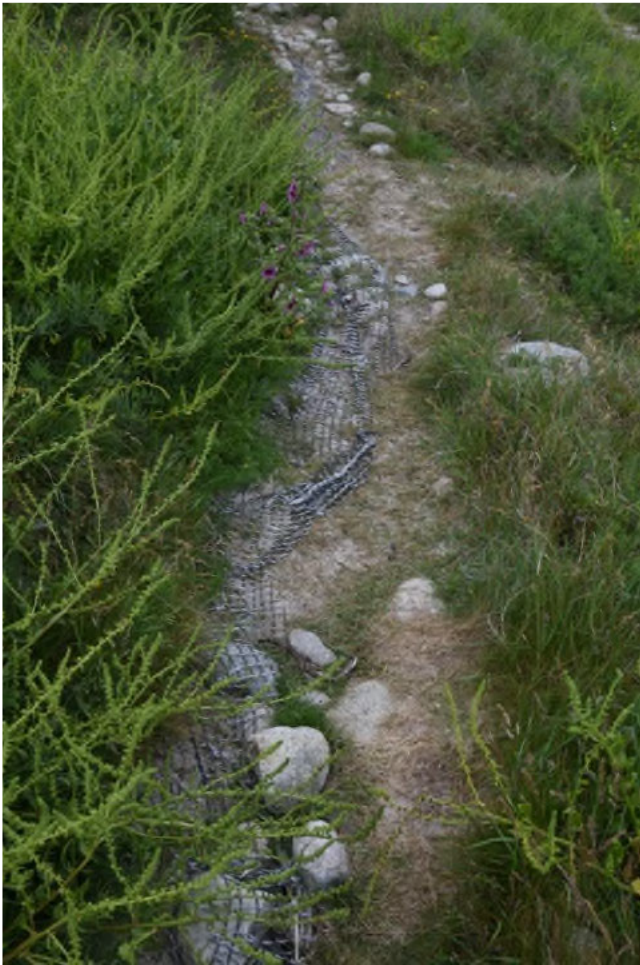
A detailed condition survey was not undertaken as part of the present design, but, as identified in a visual inspection carried out during the walkover survey in the summer 2021, overall the slope appeared in fair condition, rather than poor; although along some sections parts of the mesh at the crest and along the rear side had been exposed.

Left unprotected and unrepaired the crest of the ridge will continue to erode causing eventually the failure of the concrete mattress protection, see Photograph 6.

The residual life of this structure is currently probably between 10 and 15 year; the repair works would likely increase the residual life to 25 years, in line with the required design life of the proposed works.

**Photograph 6** – Exposed mesh on the ridge

Therefore, as part of the proposed design, a surface preparation for the placement of the rock bags will be carried out with localised repair/preparation works, ahead of placing and the rear side will be buried by the fill as shown above.

These measures will provide some level of repair, which would improve the current structure's conditions to re-establish a "Fair" overall condition and extend its present residual life.

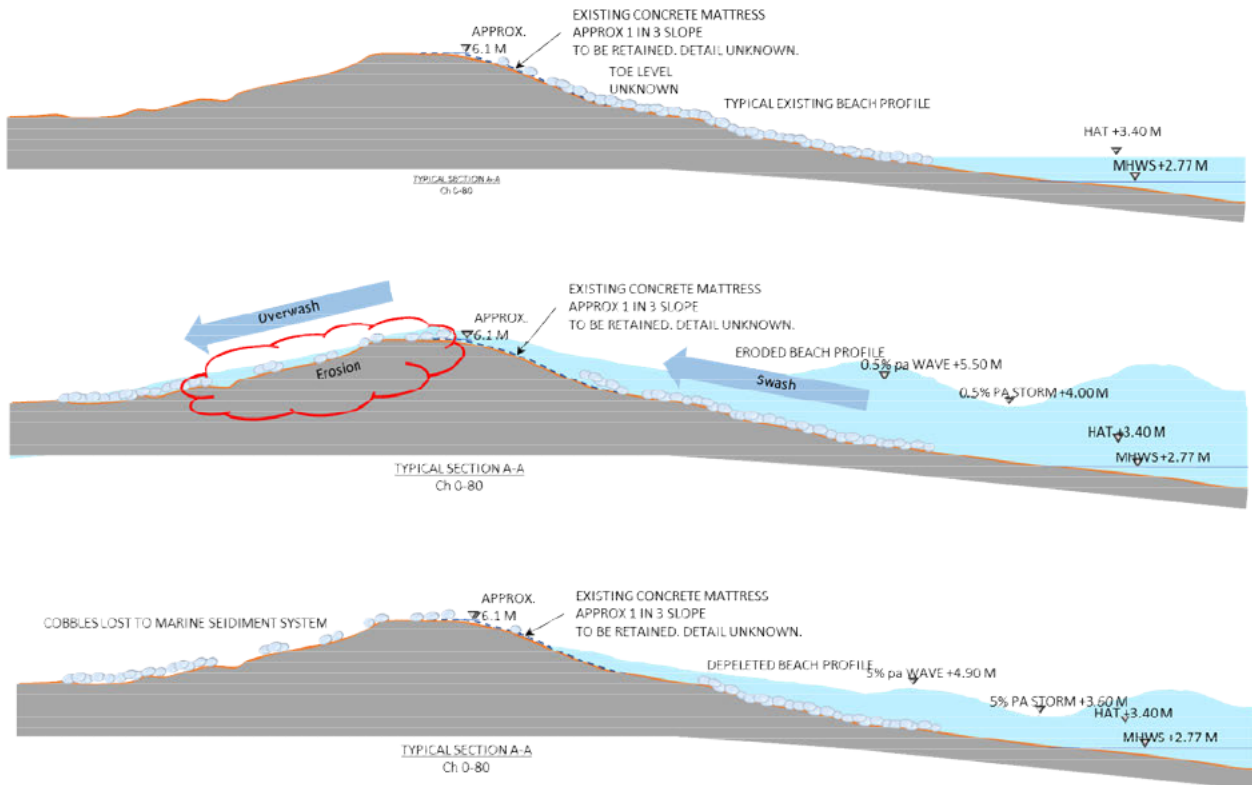
There is no evidence that would suggest that the presence of the bags can create an offshore movement of cobbles, capable of leaving the system. It is more likely that the cobbles will be moved across and along the shore during a storm, and then will be moving back to the upper beach/toe of the ridge during calmer sea conditions, see Figures 2 and 3 below.

Embankment reinforced with concrete mattresses are not generally designed to be overwashed, though some overtopping may be tolerated. Overwashing would lead to the erosion of the crest and the rear side and then failure, as also shown in Figure 2, and as it is currently happening along some sections. The protection from overwashing, the repairs and the further protection of the rear slope will improve the overall stability and extend the life of the protected ridge to meet the 25 years design requirement.

Figure 2 Present schematic representation of the movement of cobbles during storms
