PRELIMINARY ROOST ASSESSMENT (PRA)

RICHARD HAND HAULAGE,
PORTHMELLON INDUSTRIAL ESTATE, ST MARY'S,
ISLES OF SCILLY

Report date: 16th January 2023

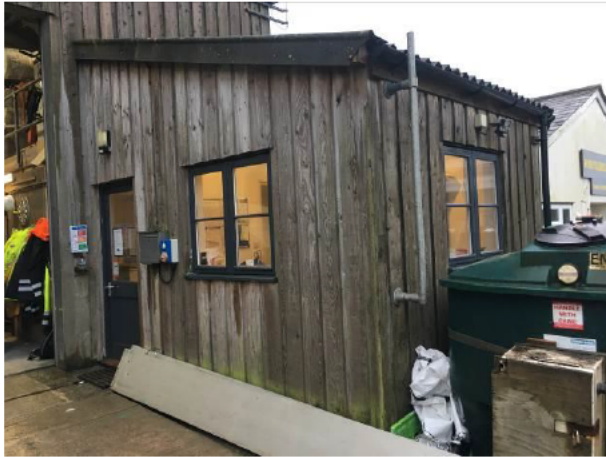
The proposed works involve very limited impacts to existing structures – this is restricted to the removal of the existing northern wall of the office unit to allow it to be extended. The existing roof would remain in situ, only modified such as is necessary to allow new roofing sheets to be settled below existing sheets to allow continuous run-off of rain.

Photograph 1: Showing the office unit – the northern face would be removed to allow the building to be extended over the footprint of the existing oil tank (visible to the far right).

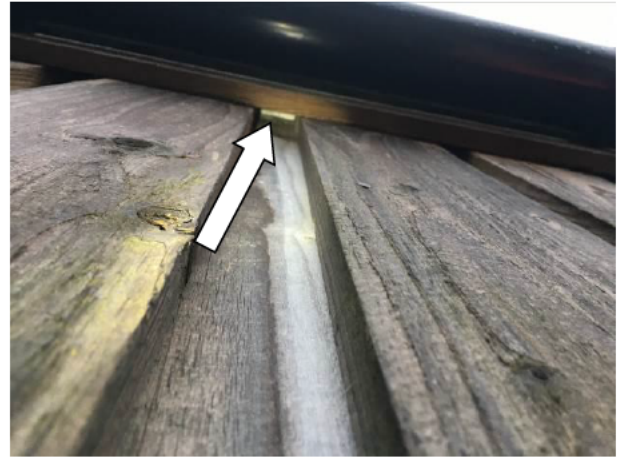
There is a wooden fascia board running along the eaves on each aspect – this creates multiple gaps where it joins the hit & miss boarding – however they are open at the top and do not provide the apex niche characters favoured by common pipistrelle. The roof sheets which lap over the edge of the fascia on the eastern and western aspects is tightly fitted with no gaps.

Photograph 2: Showing the gap behind the fascia board at the eaves – however this is open at the top with no apex cavity which would reduce its suitability for use by roosting bats.

There are gaps created where the fascia board attaches over the hit & miss boarding at the top of the wall – this is open at the top and doesn't create an apex cavity which significantly reduces its suitability for use by bats. However as a precaution, these cavities should be visually inspected using a torch prior to the board being removed. If any bats are present, or suspected, works should pause and the Named Ecologist contracted to review the situation. If no bats are present, the board can be removed and works can continue.

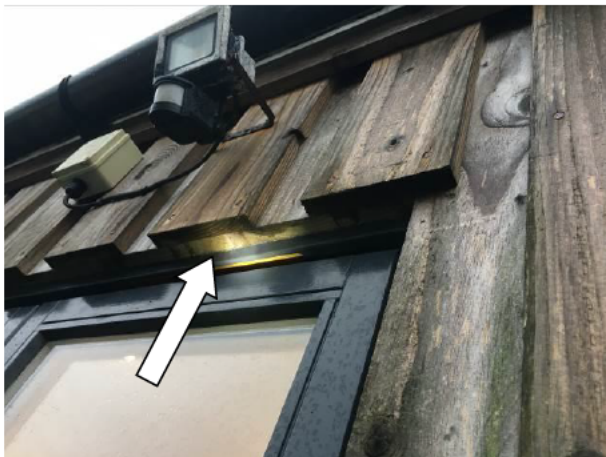
The unit is clad with hit & miss boarding. The potential cavities which could be created by the boarding above windows and doors are not present as these are filled with timber. There are two missing boards on the northern aspect below the window – however any potential fly-in access to these is blocked by a cluttered environment dominated by an oil tank and associated services. A video endoscope was used to inspect behind these boards and it was found to be densely cobwebbed with associated debris indicating no recent or current occupation by bats. Aside from this feature, there were no identified access features behind the boarding.

Photograph 3: Showing that the potential gaps in the hit & miss have been sealed above the window.

Boards should be removed carefully, in such a way that if any bats are present behind the boards, they are not killed or injured. Particular attention should be paid to the points where boards attach to the battens – common pipistrelles often seek apex cavities where they are in a crevice surrounded on the sides and the top, with open access only in a downwards direction. The underside of boards should be checked for the potential presence of bats before being put aside.

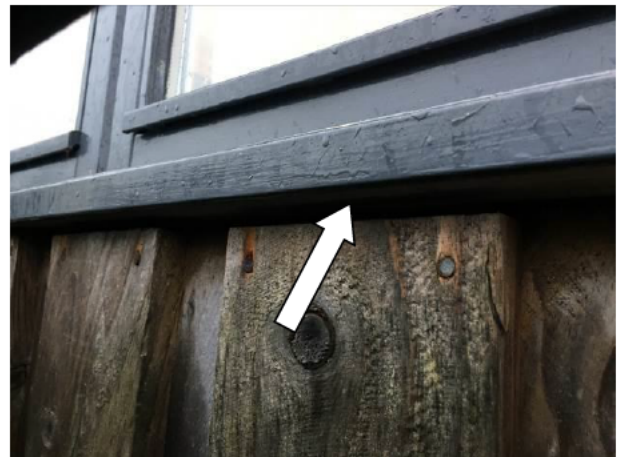
The aluminium-framed windows are well-fitted with a gap noted under the sills – this gap was inspected and found to be densely cobwebbed indicating no current or recent occupation by bats.

Photograph 4: Showing the very minor cavity below the sill of the aluminium window frame.

There is a minor gap below the aluminium window frame which should be fully inspected visually before works commence in order to confirm that no bats are present.

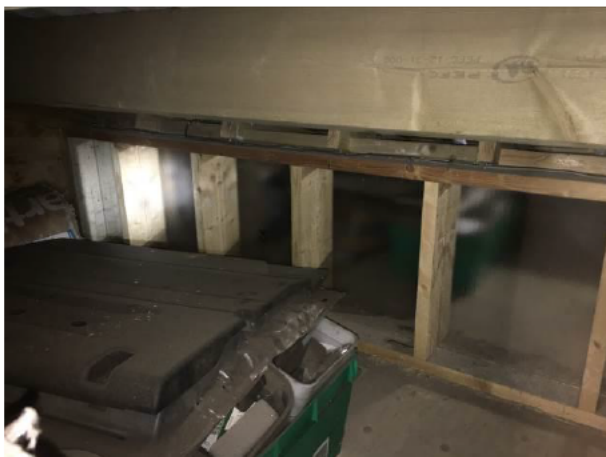
It was not possible to fully inspect the sealed void as it is only partially open and visible from the warehouse. This constraint is taken into account in the assessment - minor residual risk can be controlled through an appropriate Precautionary Method of Works (PMW) which is provided in Appendix 1.

Photograph 5: Showing the accessible portion of the void as seen from the warehouse – the CLS internal structure and insulation boards are visible.

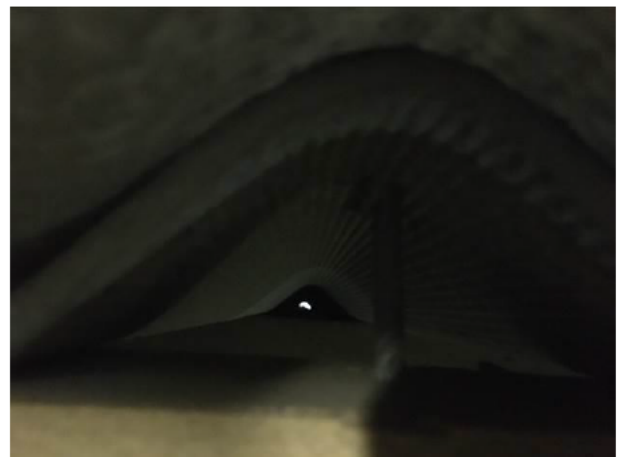
The roof is constructed of corrugated sheet material – the peaks in the corrugations are blocked in places but in others, light can be seen throughout the length. Where gaps were open, these were inspected fully with a torch and endoscope. No evidence of use by bats or other species could be determined and the construction means that the features do not provide the apex niche characters favoured by common pipistrelle. The flashing where the roof sheets join the main warehouse structure were tight and well-fitted.

Photograph 6: Showing view along the corrugated roof sheet from the interior of the warehouse – the light is visible at the end in some instances only.
