PRELIMINARY ROOST ASSESSMENT (PRA)

1 & 2 PORTHCRESSA TERRACE,
HUGH TOWN, ST MARY'S, ISLES OF SCILLY

Our reference: 23-1-2

Report date: 15th January 2023

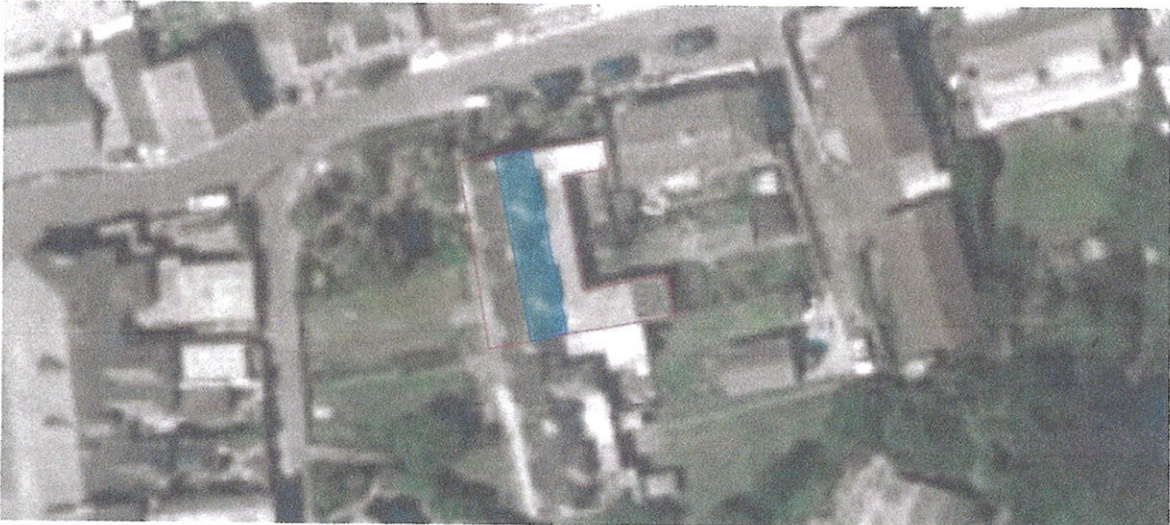
Map 02 - Showing the roof to be replaced (blue) which includes the eastern pitch of both 1 and 2 Porthcressa Terrace. The footprint of the properties are indicated with the red line for reference - the building structures to the east are single-storey flat-roof components whilst to the west is the western pitch of the main roof.

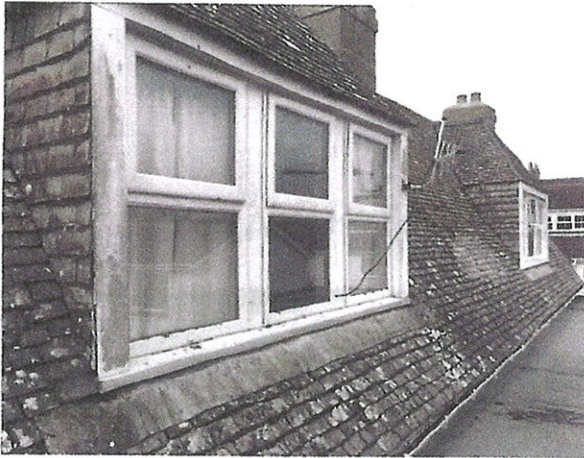
The eastern pitch of the roof has closely-fitted scantle tiles which are well sealed with cement and further by moss, lichens and other plant species. Where historic slippages have occurred, these have been repaired and sealed such that no gaps between tiles was identified. Any minor apparent gaps were inspected at close distance using a torch and binoculars to confirm that they are superficial and unsuitable to support roosting bats. Ridge tiles are similarly well-sealed. Inspection of the gable end of 1 Porthcressa Terrace confirmed that the roof verge is well-pointed with no gaps present.

Photograph 1: Showing the pitch of the roof as viewed from the adjacent flat roof.

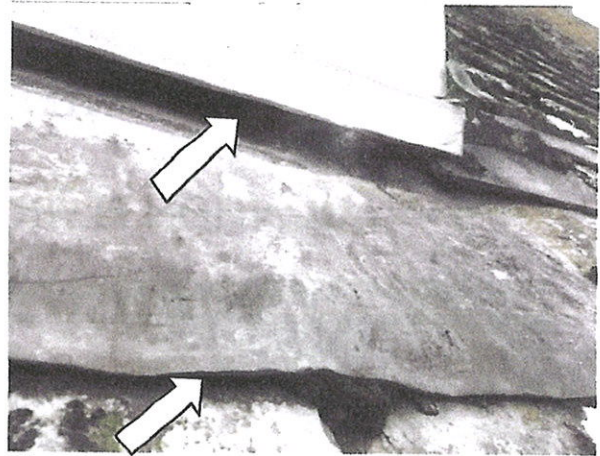
The uPVC windows of the dormer are well-sealed although there is a small space beneath the sill which was fully inspected with a torch – no evidence of current or historic presence of bats were noted. There are minor cavities extending up the side of the window frames in the property at 1 Porthcressa Terrace – these were fully inspected with a video endoscope and found to be relatively shallow and filled with cobwebs and debris indicating no recent occupation. The equivalent gaps of the property at 2 Porthcressa Terrace were blocked with expanding foam.

The lead flashing where the uPVC windows meet the roof below were slightly lifted in places. These gaps were largely superficial and were fully inspected using a torch. Debris confirmed a lack of recent occupation and the restricted fly-in, coupled with the suboptimal dimensions would make occupation by bats highly unlikely.

Photograph 2: Showing the very minor gaps beneath lead flashing (lower arrow) and beneath the uPVC sill (upper arrow) associated with the dormer windows.

If these are to be removed as part of the works, locations where the flashing is lifted should be exposed carefully such that if any bats were present behind the lifted element, they would not be crushed or otherwise injured by the operation. Contractors should satisfy themselves that no bats are present before proceeding with works in these areas.

There is a minor gap below the uPVC window frame which should be fully inspected visually before works commence in order to confirm that no bats are present.

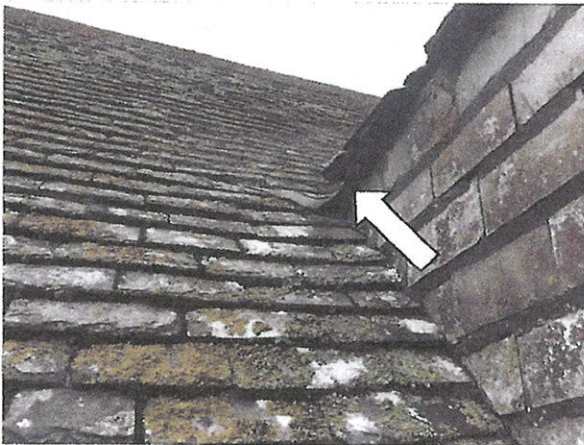
The valley in the roof where the dormers meet the main pitch of the roof have minor gaps beneath the flashing – these were fully inspected with a video endoscope and found to be relatively shallow and filled with cobwebs and debris indicating no recent occupation.

Photograph 3: Showing the location where flashing is lifted at the base of the valley between the dormer and main roof pitches. By contrast, the very tight fit of the remaining scantle tiles and hanging tiles on the dormer can be seen.

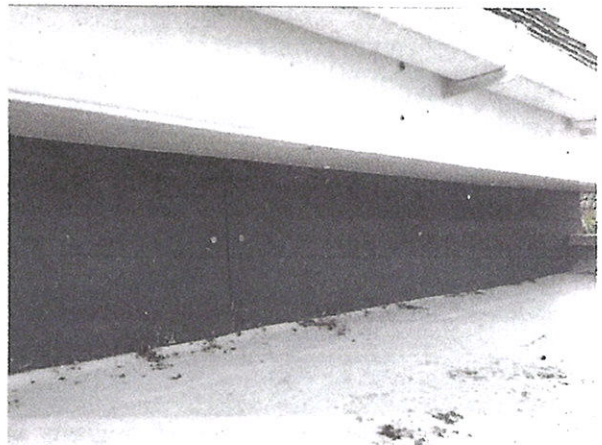
There are uPVC fascias and guttering along the eaves which are well sealed with no gaps noted. The flat-roof extensions on the eastern aspect of the properties connect with the main building just below the eaves which would block direct fly-in access for bats.

Photograph 4: Showing the uPVC fascia and guttering at the eaves of the pitched roof, with the flat roof visible below.

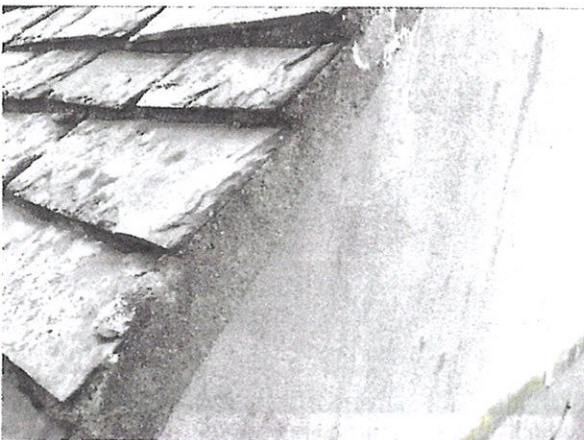
Photograph 5: Showing the tight cement pointing on the roof verge – this is at the gable of No 1 Porthcressa Terrace on the northern aspect.

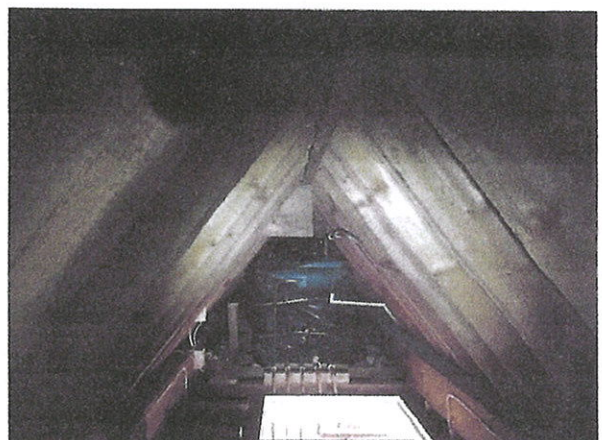
The loft space of 1 Porthcressa Terrace was inspected internally – this is a small void built above the collar beam of A-frame timbers with a ridge board at the apex. No insulation was noted. There is ply boarding throughout above the rafters – this was largely well-sealed with only very minor locations where gaps occurred. The chimney is boarded out internally and has only aesthetic function – it could be fully inspected from the loft space. Evidence of mouse and white-toothed shrew were noted but no evidence of bats was identified. There is no loft access to the property at 2 Porthcressa Terrace but the roof and loft space is understood to be of equivalent construction.

Photograph 6: Showing the interior of the roof void of No 1 Porthcressa Terrace.
