## PRELIMINARY ROOST ASSESSMENT (PRA)

### SIGNAL ROCK STABLE BLOCK HIGHER TOWN, ST MARTIN'S, ISLES OF SCILLY

*Report date: 23<sup>rd</sup> July 2023*

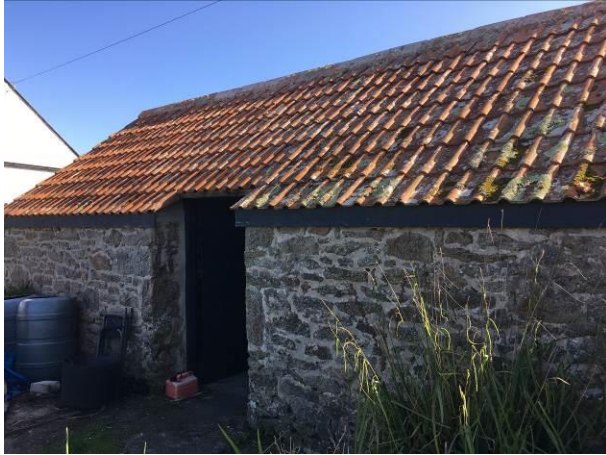
**Photograph 1:** Showing the north-eastern aspect of the stable block

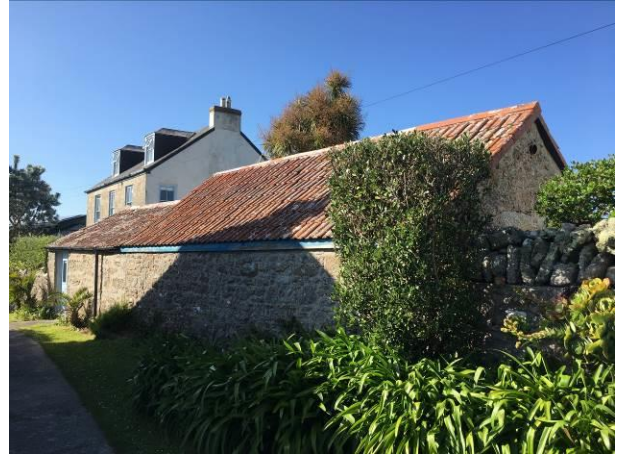
**Photograph 2:** Showing the south-western aspect of the stable block

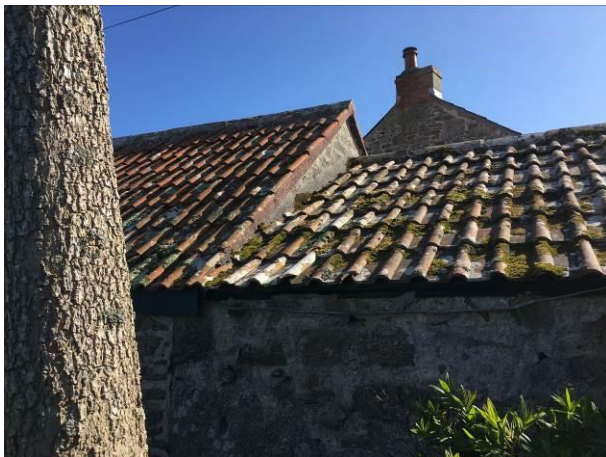
The building is attached to an offsite outbuilding on the north-western aspect. The partition wall is of breeze block and granite construction and there are gaps which would permit bats to move between the two buildings.

**Photograph 3:** Showing the location where the stable block (left) adjoins the offsite outbuilding (right)

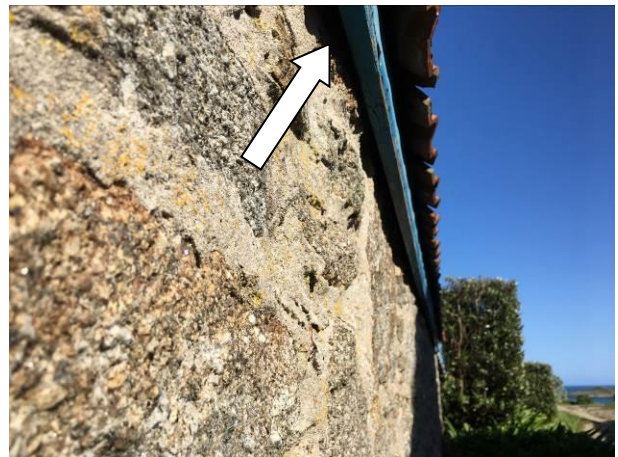
There is a fascia running along the eaves on both sides of the building – the gaps behind it are often too large to offer roosting opportunities in their own right but there are locations where the interaction between the uneven granite block and the fascia board creates crevice cavities of a suitable size to provide roosting opportunities for bats such as common pipistrelle. These gaps, where they occurred, were fully inspected with a video endoscope and found to be cobwebbed at the time of survey. They would potentially provide access to the wooden wall plate and the interior of the building.

**Photograph 4:** Showing an example of gaps beneath fascia boards on the building – these were fully inspected with a torch or video endoscope.

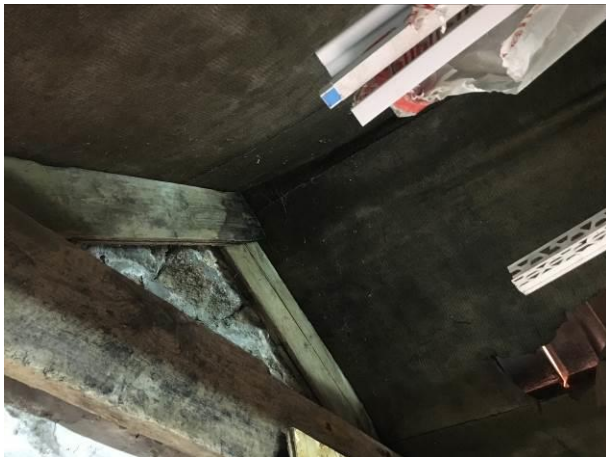
**Photograph 5:** Showing the interior of the stable block – the terminal roof timbers can be seen abutting the granite gable wall. The underfelting is generally intact.

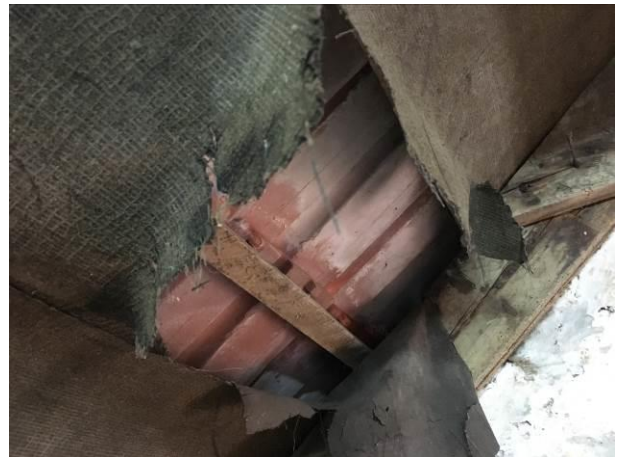
Access to the interior would be possible via several opportunities including locations where the underfelt is torn. The interior of the building is light, due to a window in the south-eastern gable, and is used for routine storage of household and garden equipment. The roof is built around A-frame trusses with no ridge board present. The terminal timbers abutting the walls at the gable do create small gaps, but these were inspected and found to be of suboptimal dimensions and well-cobwebbed at the time of survey.

**Photograph 6:** Showing a gap in the underfelting where the tiles can be seen, attached directly to battens.

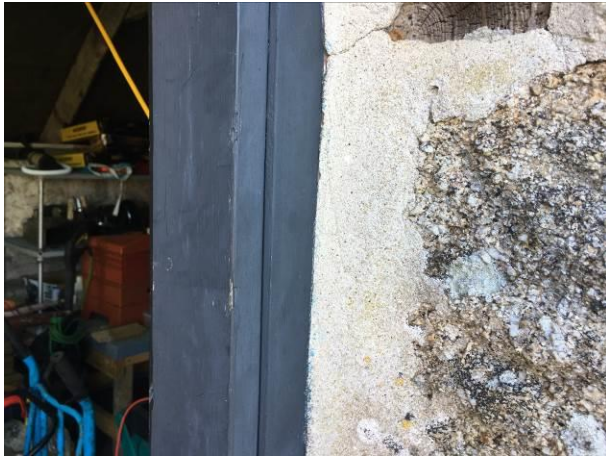
The granite block walls are in good condition and well-pointed with only occasional mortar gaps. These gaps were inspected, where they occurred, and found to be well cobwebbed with generally unsuitable internal dimensions. The entrance to the building is a single door on the north-eastern aspect – the frame is well-fitted with no gaps around the edge.

**Photograph 7:** Showing an example of the pointing where the door frame meets the walls – no gaps were identified.

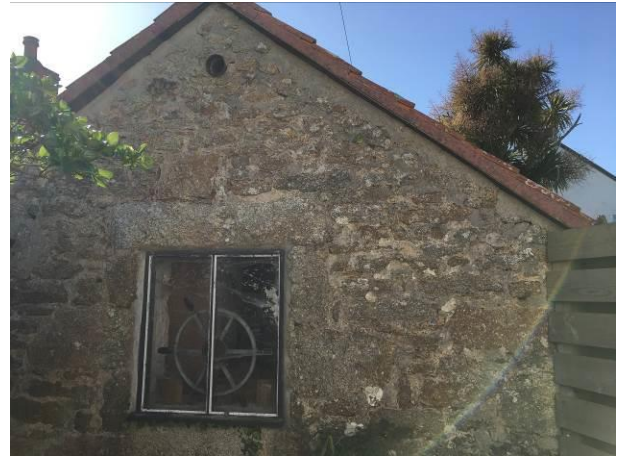
**Photograph 8:** Showing the south-eastern gable of the stable block.
