PRELIMINARY ROOST ASSESSMENT (PRA)

CONSERVATORY REPLACEMENT, TURK'S HEAD, ST AGNES, ISLES OF SCILLY

Our reference: 23-6-5

Report date: 11th July 2023

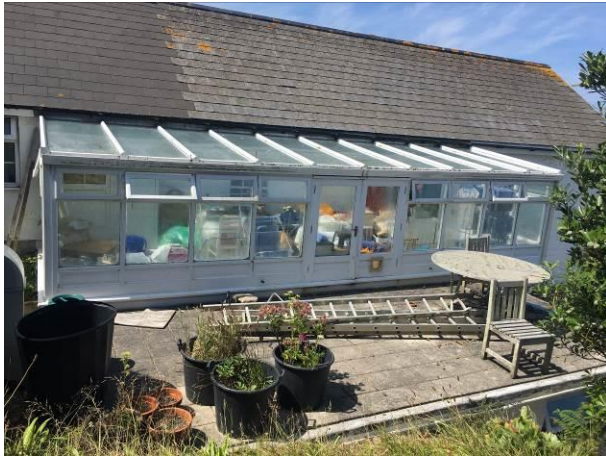
The conservatory to be removed is a relatively modern uPVC structure with double-glazed windows. There are no fascia boards or other elements of the construction which would provide suitable roosting habitat for bats, and the interior of the structure is unsuitable due to lack of features, routine residential use, high light levels and significant diurnal temperature variations.

The junction between the conservatory and the main pub building (Section A) against which it is built is well-sealed with no gaps noted.

Photograph 1: Showing the conservatory (Section B) attached to the southern aspect of the main building (Section A)

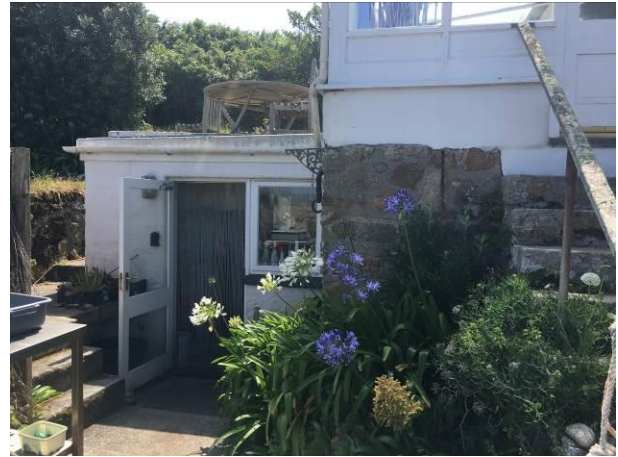
This is a flat-roof extension on the southern aspect of the main building (Section A) upon which the conservatory (Section B) is constructed at the first-floor height.

Photograph 2: Showing the conservatory (Section B) built on top of the flat-roof extension (Section C)

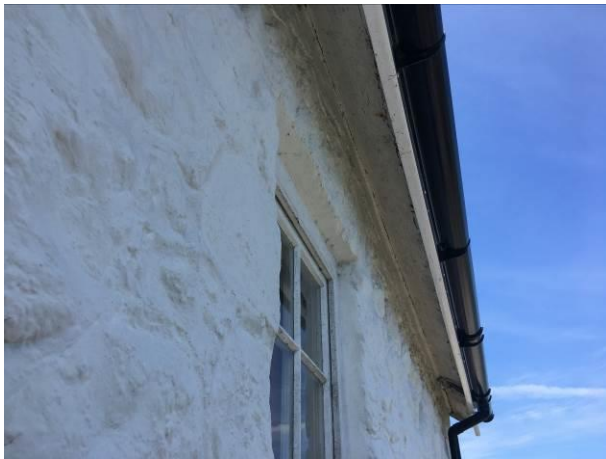
The roof is tiled with flat slate tiles and ridge tiles – all appear well fitted and in good condition. A chimney is present – the flashing at the junction with the tiled roof is well-sealed and in good condition. Soffits around the eaves of the roof are well-sealed with attached guttering. The potential for minor gaps beneath tiles at the eaves is largely restricted by the position of the guttering which would preclude a direct fly-in access.

Photograph 3: Showing the well-fitted soffits supporting guttering on the southern aspect of the main building (Section A)

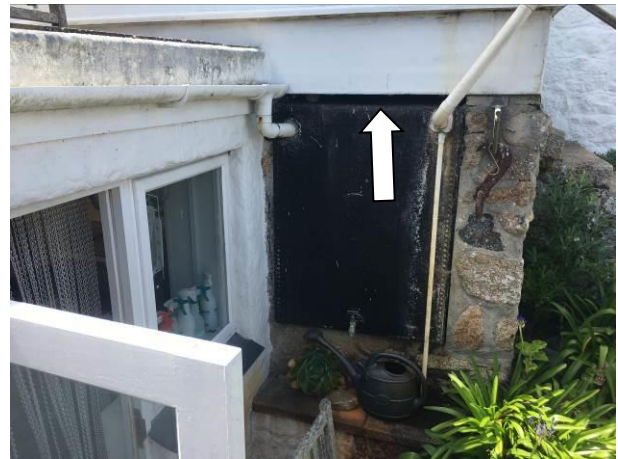
access to the conservatory (Section B). This is generally well-pointed though there is a recessed water tank used to collect rainwater from the roofs. At the back of the tank is evidence of a historic bird's nest, not active at the time of survey.

The historic nest on top of the recessed water tank would not be directly affected – this feature would remain – however works would take place in close proximity to this. There are also areas of shrubs and other vegetation in close proximity to the conservatory which would potentially be used for storage of materials or subject to disturbance by contractors during demolition / construction.

Photograph 4: Showing the integral water tank beneath the conservatory. The gap at the top providing access to the location where a historic nest was confirmed can be seen.

The features identified above should not be directly impacted by the proposed works; however care should be taken erecting scaffolding etc. in order to ensure these are not disturbed if works proceed in the nesting season.

Caution and vigilance should be exercised if works take place during the breeding season (March – September inclusive) to ensure that if any birds are nesting in features associated with

the structures in close proximity to the works, they are identified and works are designed to avoid damage or disturbance.

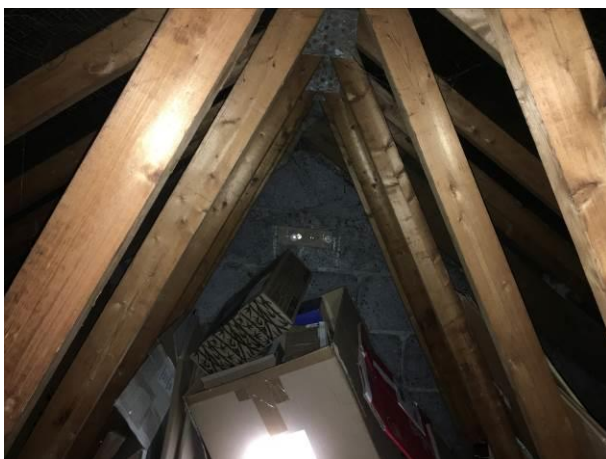
Internally, the roof is built around a modern timber truss framework with no ridge board. Insulation is present between the joists. The roof is under-felted throughout in good condition. Internal gable walls of granite or breeze block appeared well-pointed. The central section of the loft space is boarded on the floor and used for storage – this was clean and relatively accessible though some areas towards the eaves or around water tanks could only be inspected from a close distance. This was not considered to be a constraint on the survey efficacy. No evidence of bats was identified, although individual rodent droppings were noted.

Photograph 5: Showing the interior of the loft space of the main structure (Section A)

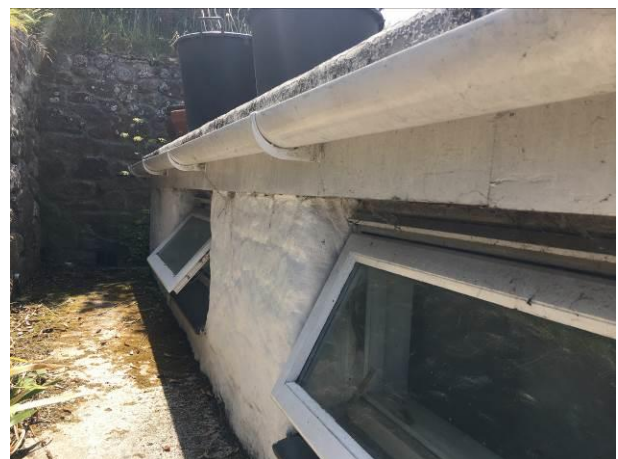
The construction is standard at the front, with a kitchen entrance, but is built into the rising hillside on the southern and western aspects such that only the top 1m of wall is visible. Walls, where present, are rendered and in good condition with well-fitted uPVC window and door frames. The flat-roof is well-sealed with no gaps noted. The fascia is tightly fitted with no gaps noted.

Photograph 6: Showing the fascia and guttering below the flat-roof section of the building (Section C) with well-fitted uPVC windows visible.
