PRELIMINARY ROOST ASSESSMENT (PRA)

PARKSIDE, ST MARY'S, ISLES OF SCILLY

Our reference: 23-8-2

Report date: 29th August 2023

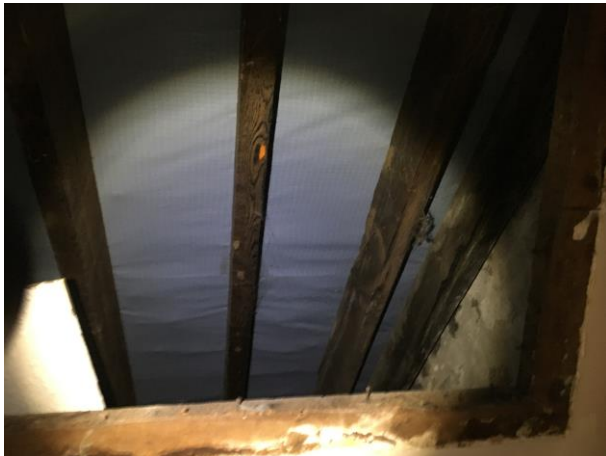
Internally, the loft space is partitioned into a lower void and an upper. The lower void does not offer any roosting opportunities. The upper void, accessed via a second hatch, is relatively shallow and built around a timber frame with well-fitted underfelt throughout. No evidence of bats was noted; however access was restricted by the size of the void which precluded full inspection – please see Survey Limitations for further consideration of the visibility of potential evidence.

Photograph 9: Showing the roof structure within the minor loft space of the Extension.
