PRELIMINARY ROOST ASSESSMENT (PRA)

1 BUZZA STREET,
ST MARY'S, ISLES OF SCILLY

Report date: 4th August 2024

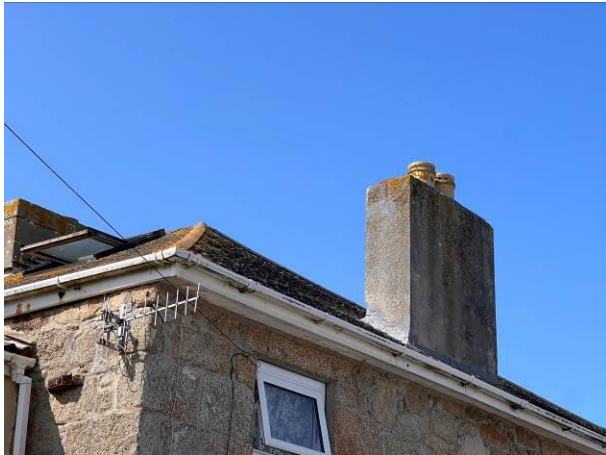
There is a boxed soffit running along the northern aspect – this is well-fitted and sealed with no gaps noted.

Photograph 1: Showing the northern aspect (with the chimney inset) – the tightly fitted boxed soffit is visible

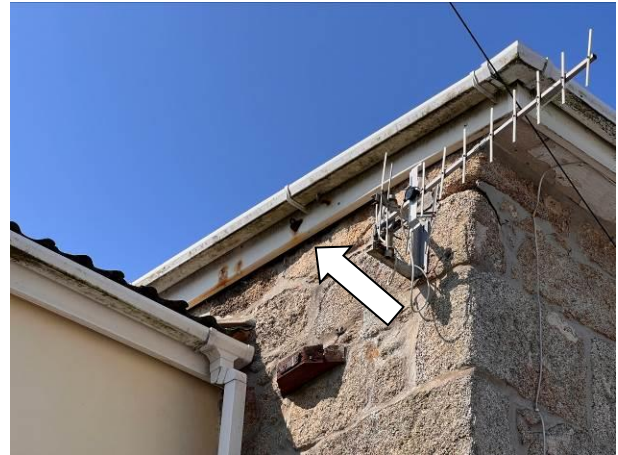
The fascia on the eastern aspect has multiple gaps which arise from the conjunction of the linear board and the irregular blockwork of the granite wall to which it is attached. This could provide potential roosting opportunities for bats in its own right, as well as permit access to the interior of the roof space as confirmed by the light visible at the eaves during the internal loft inspection.

Photograph 2: Showing the gaps behind the fascia on the eastern aspect

- 1x Presence/Absence Surveys (PAS) with 1x surveyor and 2x Night Vision Assistance (NVA) cameras

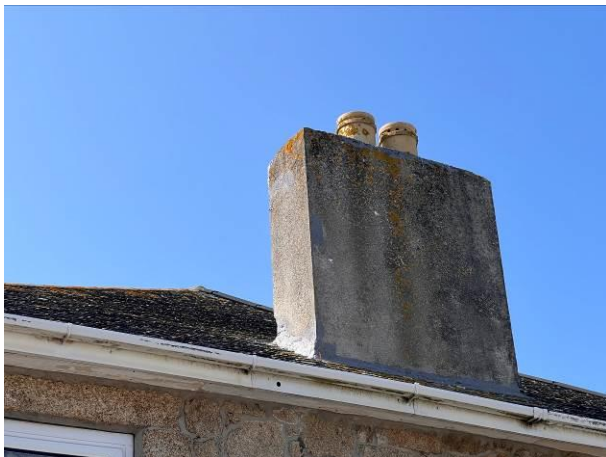
these are rendered externally with the covering in good condition. The well-sealed junctions with the main roof do not appear to offer any gaps or roosting opportunities.

Photograph 3: Showing the rendered chimney to be removed

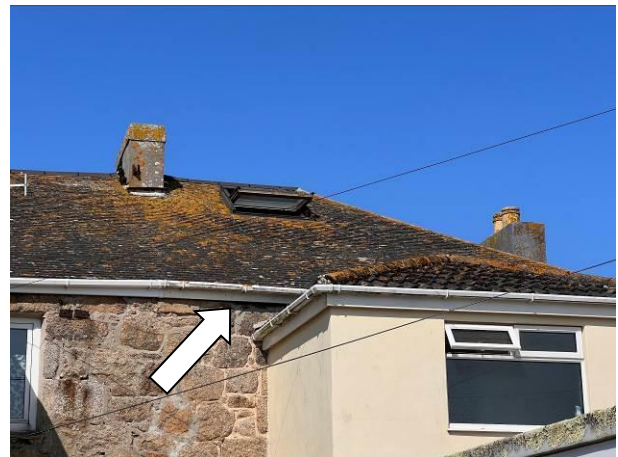
Photograph 4: Showing the gaps behind the fascia on the eastern aspect. The hipped-roof extension is visible on the RHS

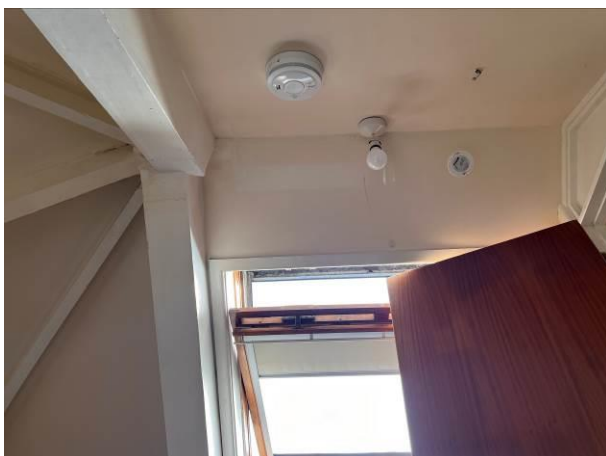
Internally, the attic space is converted to residential use with no void at the apex. There are boxed storage cupboards built in at the eaves – these are insulated and well-sealed and used for routine storage. One of the access hatches provides access to the void behind these storage cupboards – this void is contiguous across the three aspects of the roof and is unfinished with scantle tiles attached directly to battens with no underfelting present. The floor is partially boarded with some insulation present between joists. Access to inspect the full extent of the unfinished void is restricted by the incursion of the boxed storage cupboards which are built into the space.

Photograph 5: Showing the top floor accommodation with no apex void

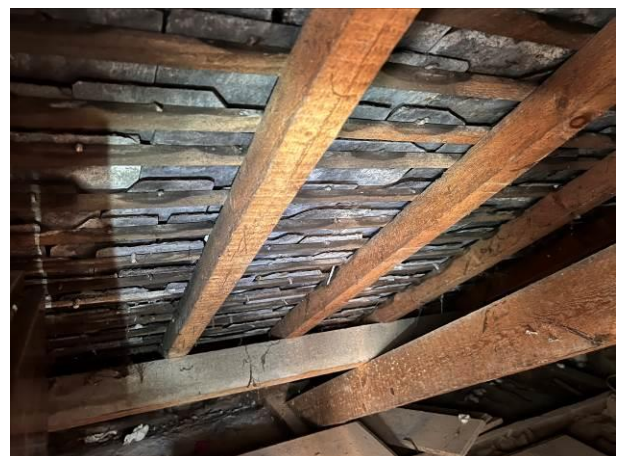
There were abundant cobwebs within this unfinished void but a number of potential roosting opportunities were noted. These are accessible to bats, as confirmed through the light visible at the eaves on the eastern aspect, though the northern aspect appeared well-sealed.

Potential internal roosting opportunities would include gaps between battens and tiles; gaps between individual tiles and pointing; and minor gaps between roof timbers at the joins. These gaps are abundant and widespread throughout the void interior, but small in size and likely to be suitable only to support individual bats.

Photograph 6: Showing the interior of the unfinished portion of the eaves void – the wet-laid scantle tiles attached directly to battens are visible

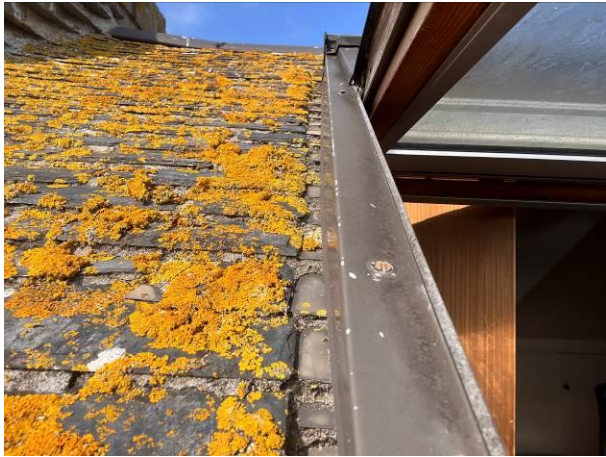
Photograph 7: Showing the well-fitted junction between the rooflight window and the adjacent tiles

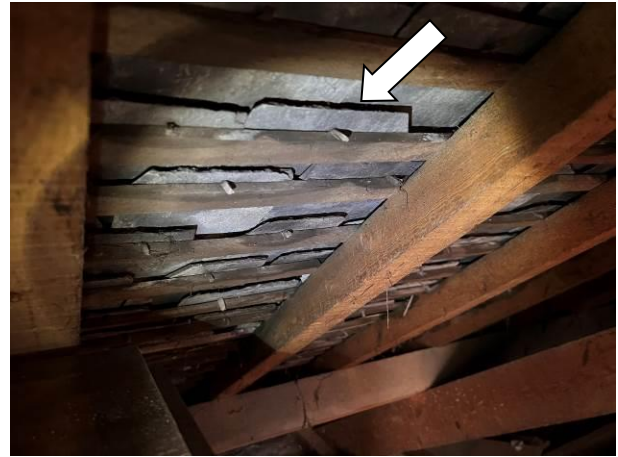
Photograph 8: Showing an example of the minor roosting opportunities available internally between scantle tiles
