PRELIMINARY ROOST ASSESSMENT (PRA)

HARBOUR BUILDING, ST MARY'S, ISLES OF SCILLY

Our reference: 24-6-2

Report date: 2nd July 2024

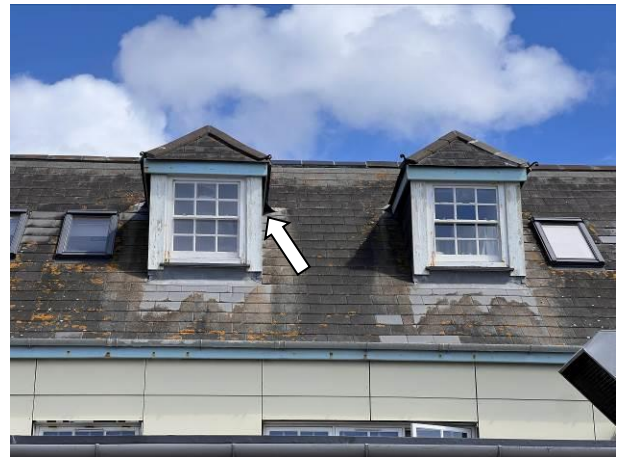
Dormer windows are built into the western aspect of the building – these have pitched, tiled roofs. The apex of the valley where the dormer pitch connects with the main roof pitch is sealed with lead flashing which is lifted in places providing potential access features for roosting bats.

Photograph 4: Showing the main western aspect of Harbour B - the partially hipped dormers with sealed voids above can be seen. An example of the gaps in the flashing is indicated.

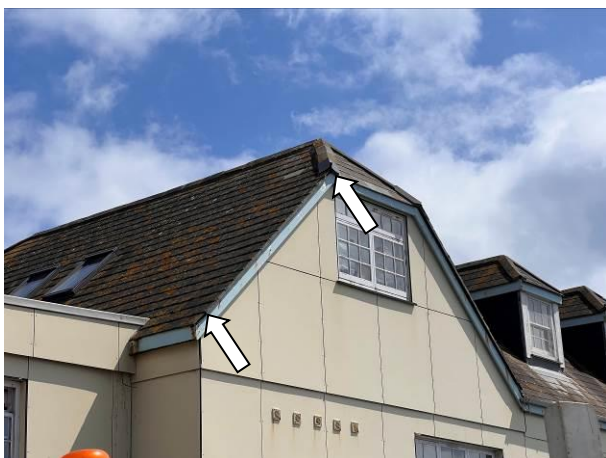
The majority of potential features which could be used by roosting bats are associated with the termination of the roof span on the southern, northern and western aspects. These include features at the ridge where pointing is missing beneath individual tiles; at the gable where gaps occur in the verge; or at the termination of hipped ridge runs on both the main roof span and the dormers. All of these would provide potential access features for bats or offer roosting opportunities in their own right.

Photograph 5: Showing examples of gaps in the verge (LHS) and at the base of hipped ridge (RHS) on Harbour B

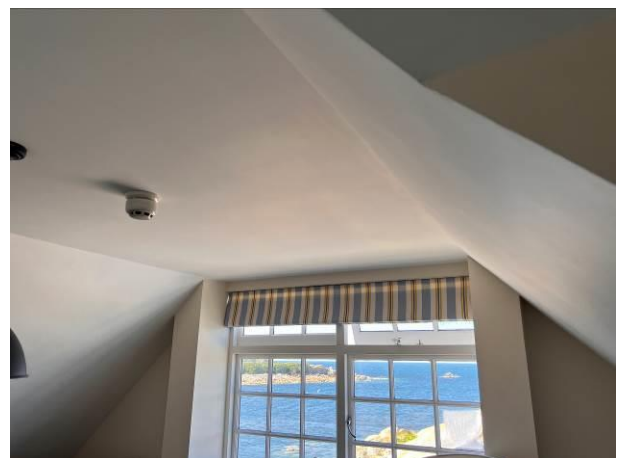
Internally, there are no accessible voids but there are both apex voids and at the eaves where the upper floor living space is built into the roof space. These could not be inspected due to the lack of access, but would be accessible to roosting bats through the external access features noted.

Photograph 6: Showing the interior of Harbour B with sealed voids above the gable.

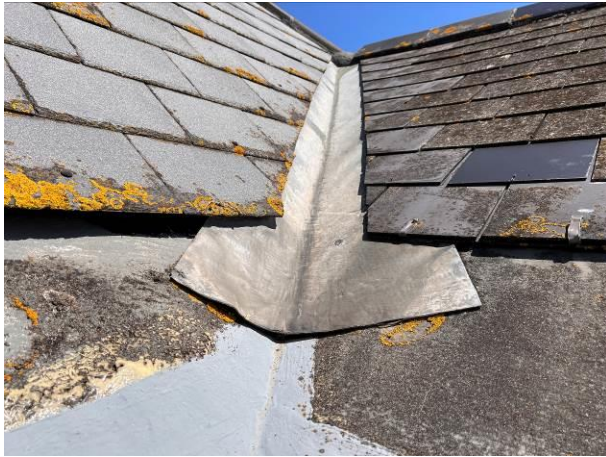
There is a roof-well in the centre with the pitches of the roof descending to a flat roof drainage area – this was accessed and inspected at height. This area of the roof is well-sealed including the roof tiles themselves and the ridge pointing. The termination of the pitch at a flat roof component excludes the potential for the majority of roosting features noted on the western aspect especially as terminal battens appear tightly fitted and comprehensively intact. Flashing in the valleys is similarly tight and well-fitted.

Photograph 7: Showing the typical roof structure within the roof-well of Harbour B – well-fitted synthetic tiles with well-fitted flashing are visible. Battens tightly fitted and present just above the termination of the tiles create a broad but superficial gap which does not have ideal dimensions nor fly-in access for use by roosting bats.

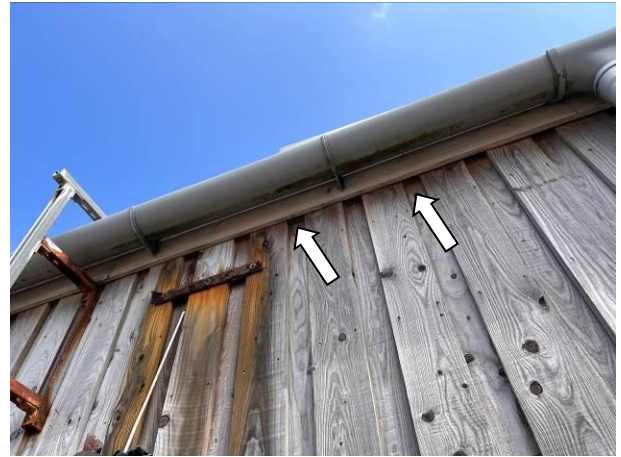
The walls are clad with vertically aligned hit and miss boarding and this provides potential roosting features behind the fascia where access to the gaps behind the alternate boards provides a feature similar to the voids created by a Kent Bat Box. This type of feature is known to support common pipistrelle roosts elsewhere on the islands.

Photograph 8: Showing examples of potential roosting opportunities on Harbour C where the fascia overlaps the hit and miss boarding.
