PRELIMINARY ROOST ASSESSMENT (PRA)

WINDRIDGE,
MCFARLAND'S DOWN, ST MARY'S, ISLES OF SCILLY

Report date: 1st March 2025

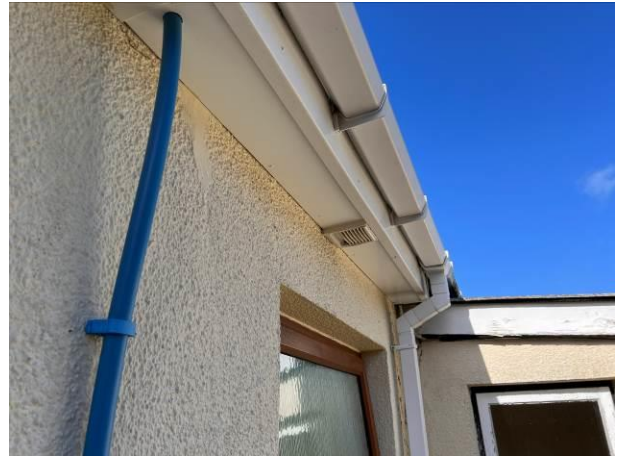
The uPVC windows, doors and soffits on the rear aspect of the main property are well-fitted with no gaps noted around apertures or behind boards. Guttering runs along the soffits at the eaves which would preclude direct fly-in access at this location. uPVC fascias at the gables are well-fitted with no gaps noted.

Photograph 2: Showing the uPVC soffit running along the eaves of the rear aspect of the main dwelling

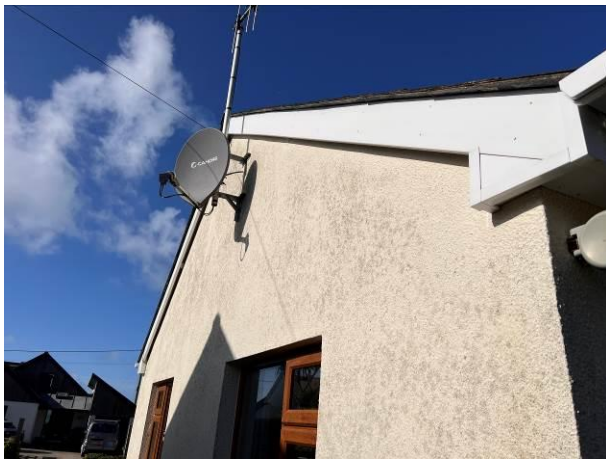
Photograph 3: Showing the uPVC fascia on the gable of the property

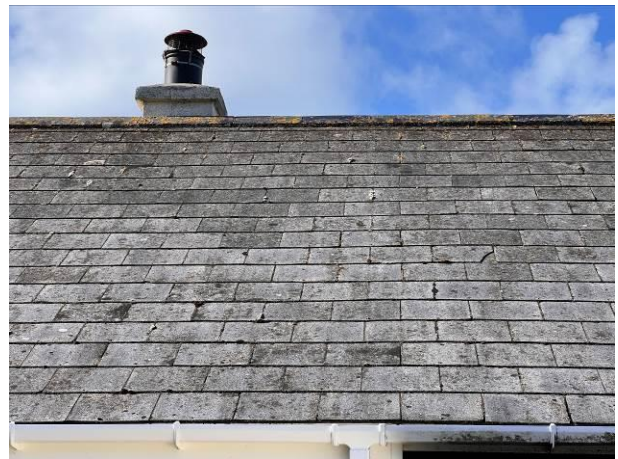
The pitched roof is covered with synthetic flat tiles which are well-fitted and in good condition. The ridge tiles are well-pointed with no gaps noted. A small chimney is present – this is in good condition with the flashing at the junction with the main roof well-fitted. There is an apparent minor gap beneath the ridge tiles at the gable on either end of the property. It should be noted that the proposals would tie in the new roof beneath the existing ridge line and would not therefore affect the existing ridge tiles. All other aspects of the roof verge are well-pointed and well-fitted.

Photograph 4: Showing the tightly fitted roof tiles and ridge

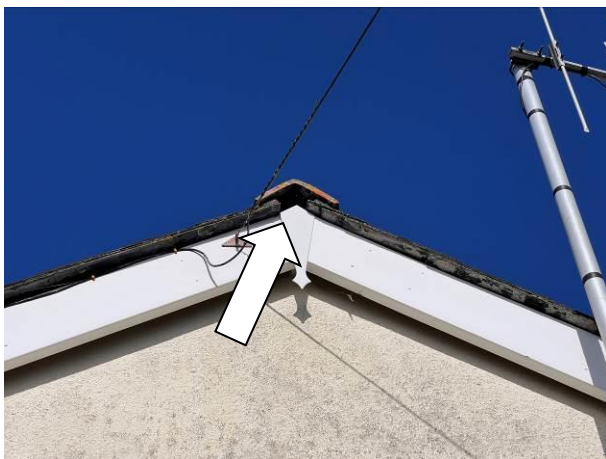
- Gaps beneath the ridge tiles at the two gables – note no direct impact to the ridge of the existing property is proposed;
- Minor gaps between overlapping corrugated sheets on the lean-to.

Photograph 5: Showing the gap under the terminal ridge tile at the gable. The gap behind the uPVC fascia below is too broad to provide suitable roosting dimensions for bats.

There is small residual risk for individual bats to use roosting opportunities associated with the end ridge tiles of the property around the gables.

Care should be taken during works to ensure that the ridge is not disturbed, obstructed, or damaged. This may include a contractor briefing to ensure that those working on the property understand the requirement. Other measures such as tape or a physical barrier should be installed if deemed necessary.

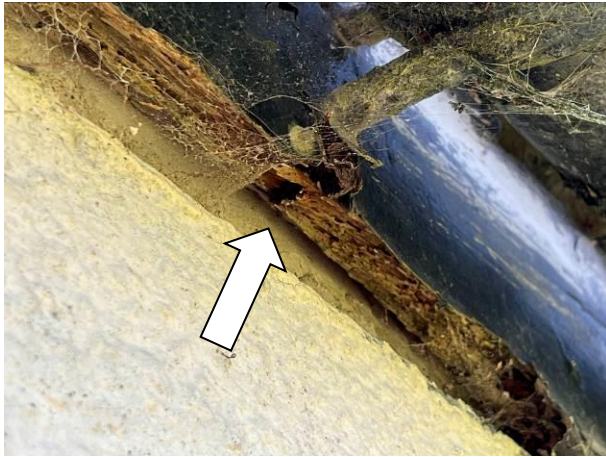
A wooden fascia runs along the eaves and gable – this is rotting in places creating subsequent gaps but they do not provide terminal apices due to their presence below the open corrugated sheets which overtop the eaves. These gaps were fully inspected with a video endoscope and no evidence of recent occupation could be identified.

Photograph 7: Showing the minor areas of rot in the wooden fascia of the lean-to structure.

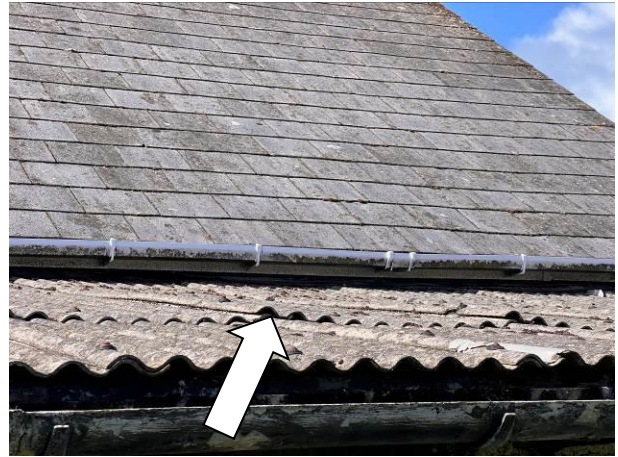
The roof is covered with corrugated sheets and is open at the eaves – this could potentially provide nesting opportunities for small garden bird species but is unlikely to be suitable for use by roosting bats due to the materials, fly-in and the dimensions/character of any voids created. The guttering attached to the fascia would largely block the fly-in at this location. Where roof sheets overlap across the span, there are often minor gaps present but these appear largely superficial and relatively exposed. The terminal sheets are well pointed at the gables precluding any access potential at this location. Internally, the ceiling of the rooms below follow the angle of the roof indicating that there is no roof void present.

House sparrows have the potential to nest in features associated with the corrugated roof sheets on the lean-to structure. Additional minor opportunities may be found elsewhere on the structure, or within the associated garden.

Photograph 8: Showing the gaps between overlapping corrugated sheets on the lean-to structure

Gaps between overlapping sheets have a negligible risk of supporting roosting bats, but careful removal would permit the control of this residual risk to ensure that in the unlikely event of a bat being present, they are not harmed.

Any sheets should be removed carefully, by hand, in such a way that in the unlikely event that a bat is present beneath, they are not crushed or harmed by the action. The underside of the sheet should be checked carefully to ensure no bats are clinging to the underside before being set aside.

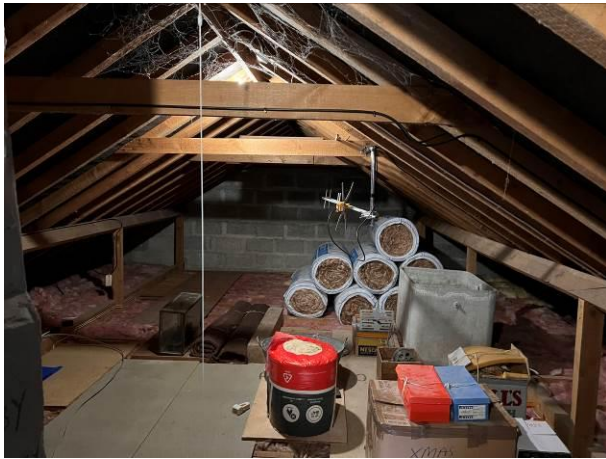
Internally, the roof space is used for routine long-term storage. It is built around a timber framework with a ridge beam present. Breeze-block gable walls were well-pointed and the chimney was rendered to a high standard internally. Underfelt throughout the roof is in good condition with no tears or gaps noted. There is insulation between the joists and a full inspection was possible – no evidence of bats was identified.

Photograph 9: Showing the interior of the loft space

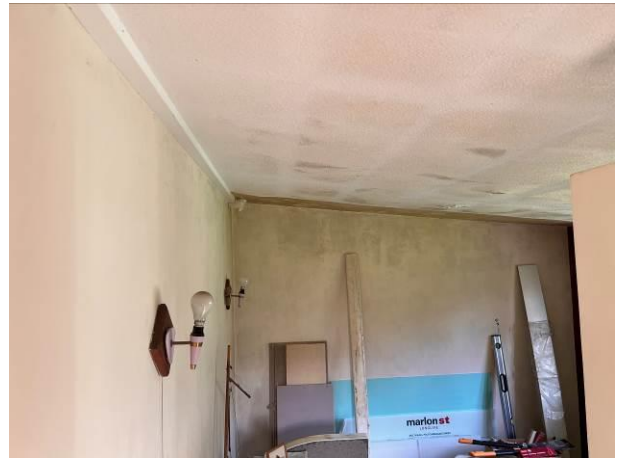
Photograph 10: Showing the interior room within the lean-to structure with the sloping ceiling mirroring the pitch of the roof above.
