BAT PRESENCE/ABSENCE SURVEYS (PAS)

ATLANTIC VIEW, ST MARY'S, ISLES OF SCILLY

Our reference: 25-6-4

Report date: 16th July 2025

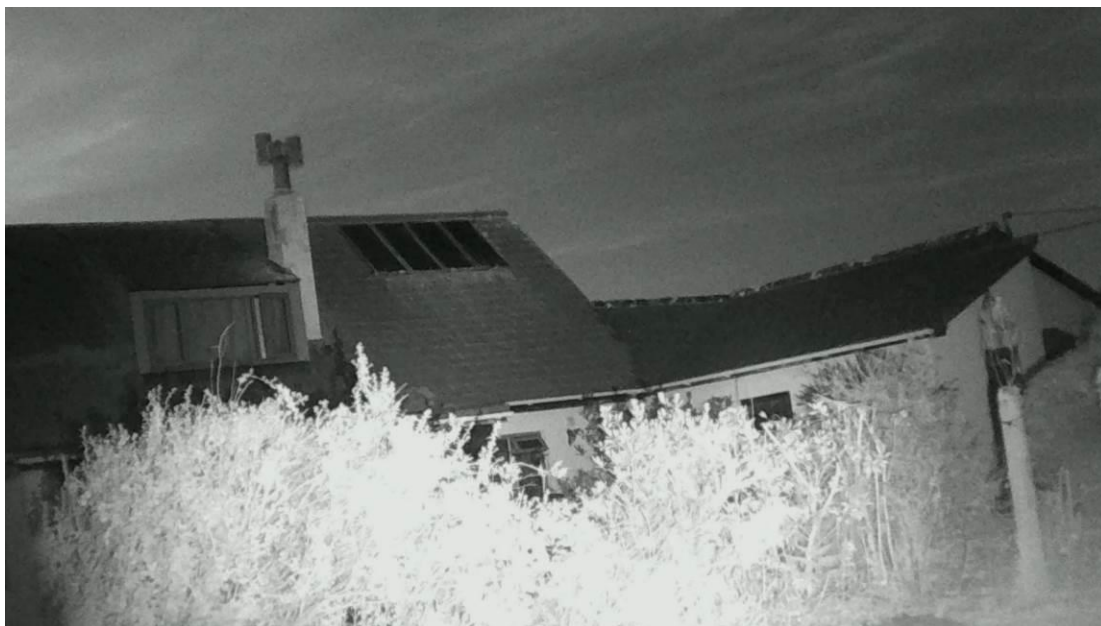
NVA3 – showing a screenshot from the Nightfox Whisker at position S3. The NVA did not comprehensively cover the conservatory due to the vegetation; however no suitable features for use by roosting bats were identified on this structure.
