## PRELIMINARY ROOST ASSESSMENT (PRA)

### ATLANTIC VIEW, HIGH LANE, ST MARY'S, ISLES OF SCILLY

*Report date:* 21<sup>st</sup> June 2025

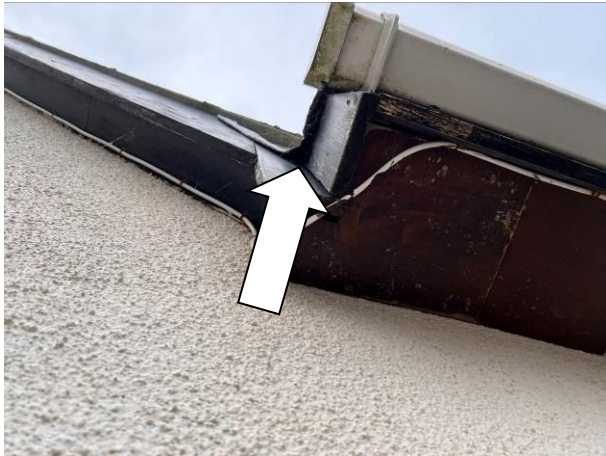
There are two chimneys present within the roof structure – these are rendered and in good condition with sealed flaunching to the capped pots. A minor element of lifted flashing appears to be present on the western gable but this appears to be superficial.

The porch on the front of the property is a flat-roof structure with the roof covering in good condition. Timber soffits are well-sealed and the door frame is sealed in its aperture. A minor gap occurs in the lead flashing which links this structure to the Dormer Bungalow.

**Photograph 3:** Showing an example of the lifted flashing offering a potential roosting opportunity.

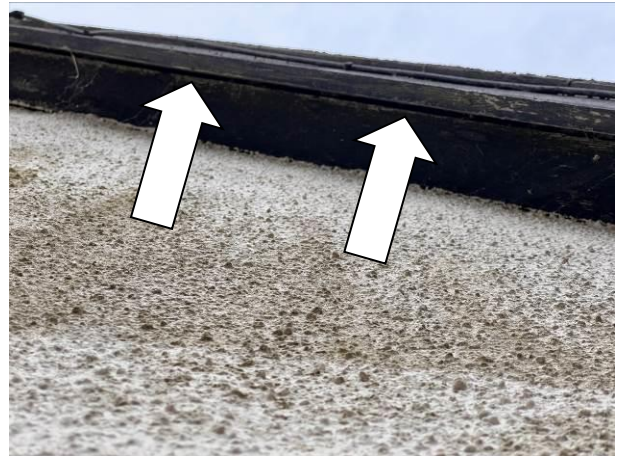
There are timber soffits around the roofline including both eaves and gables – these are largely in good condition but occasional gaps were noted including on the northern and eastern aspects. These features could provide access to roosting opportunities associated with the soffit itself, or with the wall plate of the main building.

**Photograph 4:** Showing an example of a structural gap between the soffits on the western gable.

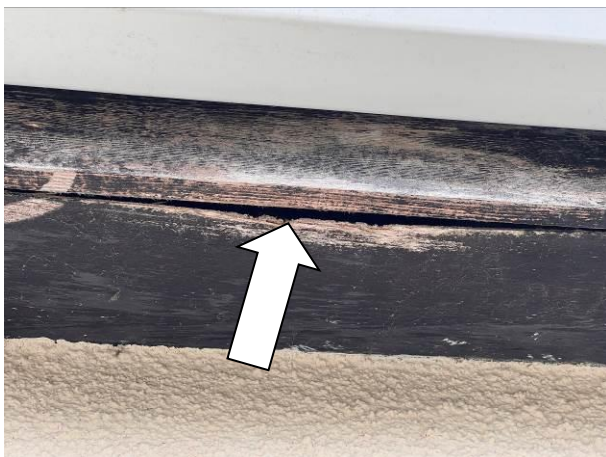
The extension on the eastern aspect of the Dormer Bungalow uses the same materials and overall aesthetic including the asbestos tiles, timber soffits and rendered walls. Internally the roof structure is of a more recent and modern material including insulation between the joists and polyethylene underfelting. Rodent droppings – including white-toothed shrew – were again identified within the loft space. Light is visible at the eaves, and a historic bird's nest was identified in one location which corresponds with a damage feature on the external soffit where access is permitted.

The soffits on the southern and western aspects of this property have rot or damage features which could provide access to roosting opportunities associated with the soffit itself, or with the wall plate. Slight gaps also occur on the eastern aspect where soffit boards have been replaced.

**Photograph 5:** Showing a damaged portion of the soffit on the Single Storey Extension with indications of historic access by animals or birds.

It is recommended that bird boxes are installed to offer nesting habitat for common garden bird species. This would compensate for the removal of existing features which are associated with damage or structural deterioration of the soffits and would therefore be removed as part of the renovation works proposed.

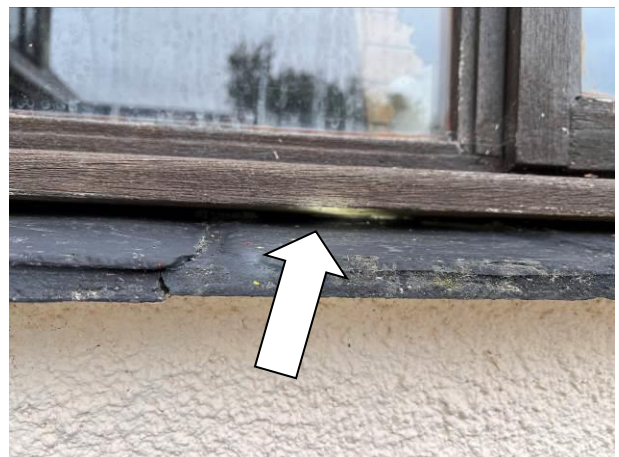
Windows and doors are a mixture of uPVC and timber – frames are well fitted within their apertures. There are occasional gaps beneath sills but these were fully inspected at the time of survey and, whilst potentially capable of supporting individual bats on a transient or opportunistic basis, were found to be cobwebbed and showing no sign of recent or historic use.

**Photograph 6:** Showing an example of a gap beneath a sill which was inspected fully.

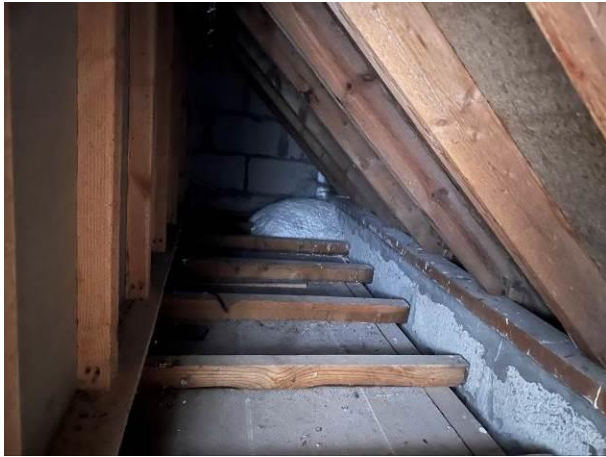
Internally, there are voids at the apex and at the eaves of the roof. The roof is lined with tar paper with a boarded floor and no insulation. There are occasional tears in the tar paper which would allow access to the void from beneath the tiles. There are exposed timber trusses which were tightly fitted with no gaps between timbers. Daylight visible at the eaves indicates that there is potential for bats or birds to access these voids in principle. Evidence of rodents was noted but no evidence of bats was recorded in this void.

**Photograph 7:** Showing the interior of the eaves storage within the Dormer Bungalow.

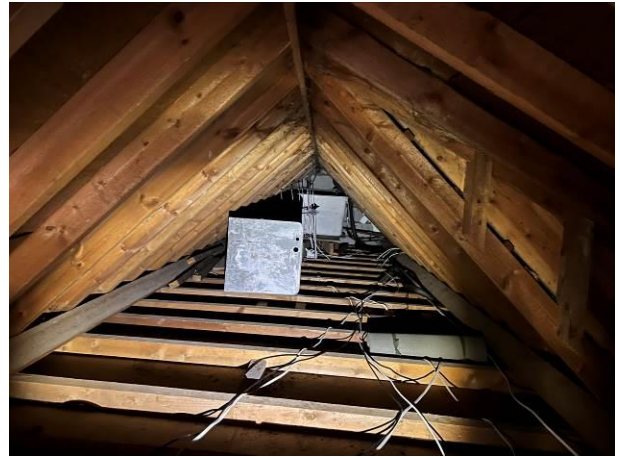
**Photograph 8:** Showing the interior of the loft space at the apex of the Dormer Bungalow.

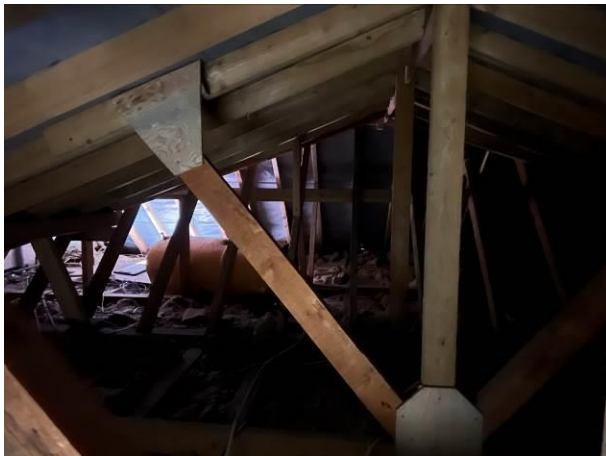
A single historic nest was identified in the roof of the Single-Storey Extension. Damage features associated with the soffits and other gaps at the eaves of the property may also allow species such as house sparrow to find nesting opportunities within the building.

**Photograph 9:** Showing the interior of the more recently constructed Single Storey Extension loft space.
