## PRELIMINARY ROOST ASSESSMENT (PRA)

4 PORTHCRESSA TERRACE,  
HUGH TOWN, ST MARY'S, ISLES OF SCILLY

***Report date:*** 28<sup>th</sup> October 2023

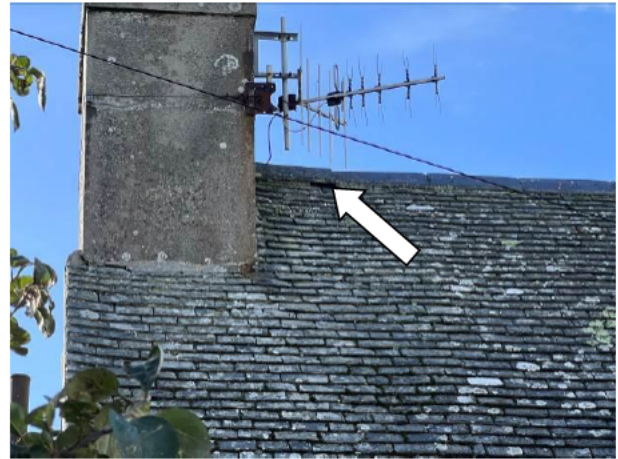
The roof tiles on the eastern aspect are generally in good condition and any gaps present are too small for access by bats. Minor gaps occur at the apex of the dormer and at a ridge tile on the southern edge of the aspect – these appear superficial through inspection with close-focusing binoculars. The join between the roof of this property and the adjacent 3 Porthcressa Terrace is marked by a low concrete parapet – no gaps or other features are noted associated with this feature. There is a concrete chimney at each edge of the roof under consideration – these appear well-sealed and in good condition.

There are minor gaps noted beneath individual ridge tiles on the apex of the dormer and the southern edge of the main roof, close to the chimney. These appear superficial but it is possible that minor niches may occur. In addition, further gaps may appear if the condition of tiles deteriorates between the time of survey and the time of works.

**Photograph 2:** Showing the roof structure – this is largely well-sealed with no gaps noted; however occasional minor gaps are noted including the gap in the ridge highlighted.

If there are gaps beneath tiles, these tiles and those adjacent to them should be lifted carefully in such a way that if any bats were roosting beneath, they would not be crushed or injured by the action. The undersides of the tiles should be carefully checked before being set aside. Contractors should satisfy themselves that no bats are present before proceeding with works in these areas.

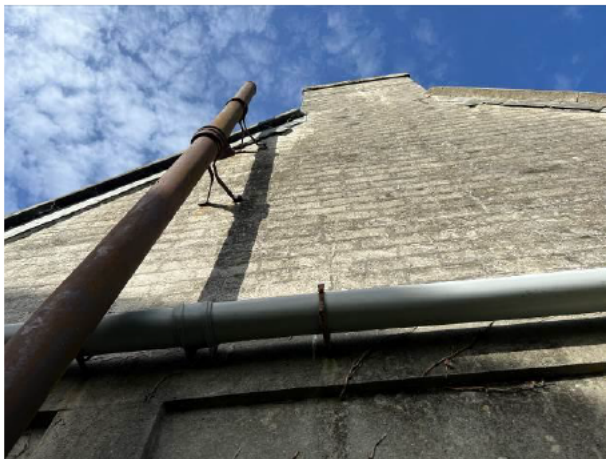
Minor gaps occur behind the drop tiles on the southern gable of the building – these appear superficial through inspection with a torch and close-focusing binoculars.

**Photograph 3:** Showing the southern gable of the property – there superficial gaps behind the drop-tiles on the eastern aspect can be seen on the right-hand side. Those on the western aspect would not be affected.

The following protocol also applies to the drop tiles on the southern gable.

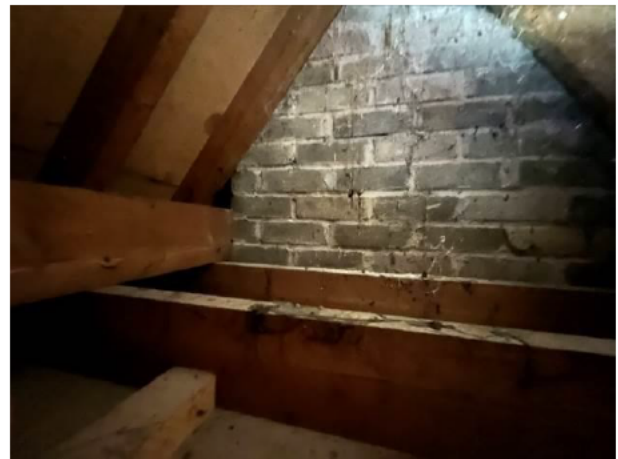
The loft space was inspected throughout – this is a small space built above the collar of the A-frame timbers with the living space built into the lower part of the roof. The loft is boarded out above the rafters and appears very well sealed. There is no insulation present between the joists. The loft space was densely cobwebbed with dusty, old webs indicating no recent flight by bats within the space. A full inspection of the floor identified no droppings or other evidence of bats – individual small rodent droppings were noted.

**Photograph 4:** Showing the loft space with boarding visible between the rafters.

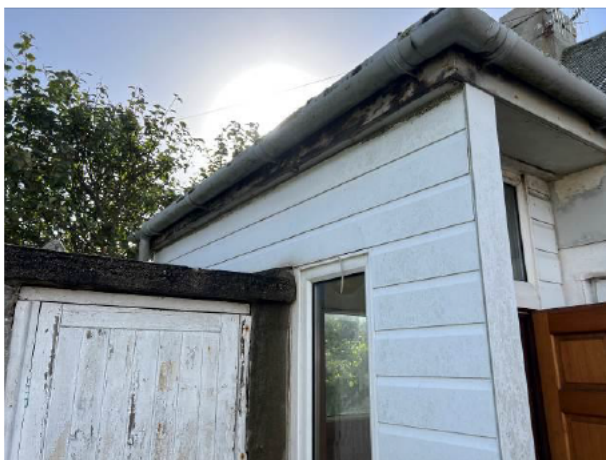
A flat-roof single-storey extension is attached on the eastern aspect of the property. This is block-built and uPVC-clad in places. No features were noted associated either with the pointing or the cladding. Window frames are well-fitted with no gaps noted at the edges.

The fascias throughout the flat-roof extension are well-fitted and tightly sealed. In places, there are small gaps behind the roof cladding where it overlaps the top of the wall; however the guttering attached to the fascia below would prevent a clear fly-in and would significantly

reduce the suitability of a feature here.

**Photograph 5:** Showing the flat-roof extension with uPVC cladding.

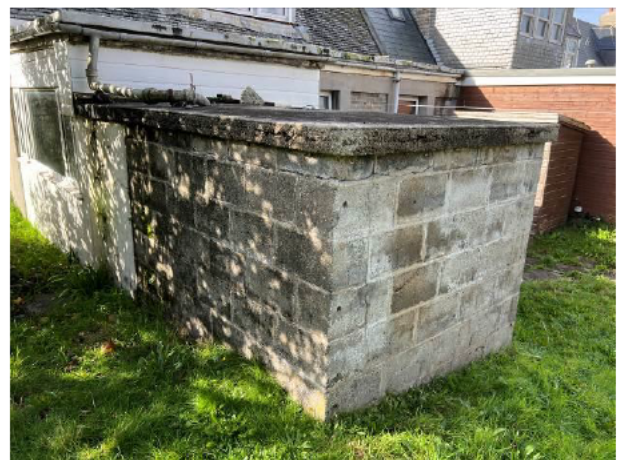
There is a flat-roofed water tank enclosure attached on the eastern edge of the flat-roof extension. This also houses a small shed/garage unit which was accessed and inspected and found to provide no roosting opportunities.

The structure did not have any gaps, cracks or other features which would provide roosting opportunities for bats.

**Photograph 6:** Showing the enclosed water tank.
