PRELIMINARY ROOST ASSESSMENT (PRA)

POLTAIR,
ST MARY'S, ISLES OF SCILLY

Client: Wright Construction

Our reference: 25-10-1

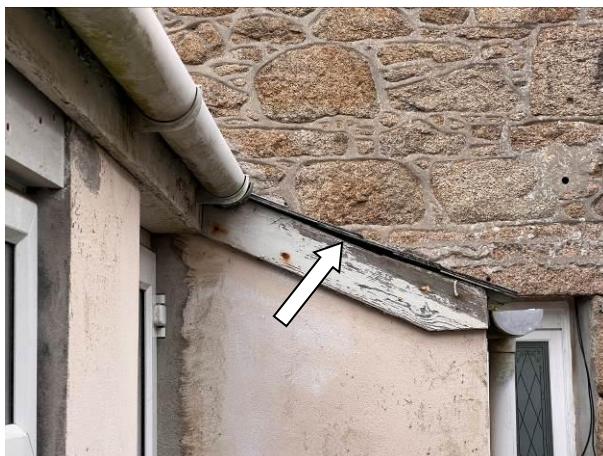
Minor gaps occur at the roof verge on the northern aspect of the structure where the roofline extends where the footprint of the building steps out – these gaps appear superficial offering minor access to the gaps beneath the tiles but were blocked with cobwebs and debris at the time of survey. This location was inspected with a video endoscope and no evidence of current or historic use by roosting bats was noted.

- The gap in the verge on the single-storey extension was filled with cobwebs and was inspected fully with a video endoscope – no evidence of recent or historic occupation by roosting bats was noted.

Photograph 5: Showing the gap in the verge on the single-storey extension where the footprint of the building extends out.

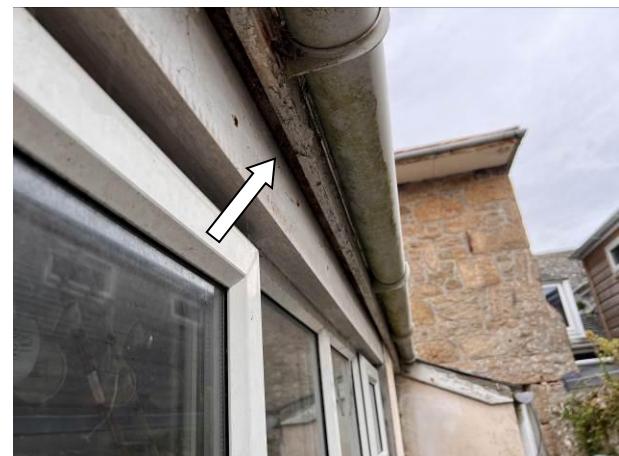
The soffits and fascias are well-fitted throughout – gaps behind the fascia on the northern aspect are too wide to be suitable for use by roosting bats as features in their own right; and are sealed at the apex precluding access to the roof structure.

Photograph 6: Showing the fascia on the single-storey extension with gaps (indicated) which are too wide to provide roosting opportunities for crevice-dwelling species.

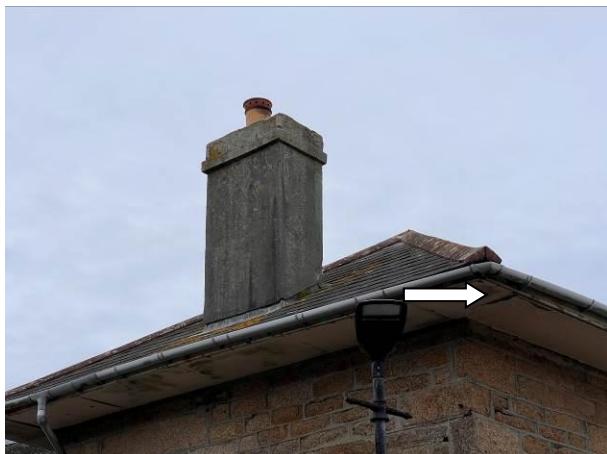
There are broad soffits at the eaves with fascias and guttering attached. These are well-sealed at the junction with the granite stonework, though gaps occur where boards are damaged or where the fascia is poorly fitted to the soffit at the edges. Whilst these could potentially provide access for bats and nesting birds, the situation of the gaps away from the junction with the wall makes them unlikely to offer roosting opportunities aside from potential for access to the roof itself.

- The wide soffits are well-fitted to the stonework and any gaps noted are in the extended space away from the walls and do not form these crevice features. Whilst features associated with gaps in fascias are often used by bats on the islands; all known confirmed roosts are associated with gaps between the stonework and the fascia which offer crevice roosting opportunities for common pipistrelle, or access to roosting opportunities within wet-laid scantle tiles which can be accessed from these features. The asbestos slates with tar paper present in Poltair, are considered unlikely to provide roosting opportunities for this species based on the structural features present and the typical roosts used within the islands.

Photograph 7: Showing an example of damage to the soffit away from the junction with the main building wall.

There are intermittent gaps where the fascias and soffits are damaged. Where these are to be removed or impacted as part of the proposed works, they should be carefully removed and the gaps behind exposed in such a way that, in the unlikely event that bats are present, they are not injured or killed by the action.

Once these areas are fully exposed, they can be visually inspected by contractors. Any cavities exposed by this action including features around the wall plate and lower run of tiles should also be carefully inspected and features dismantled by hand where necessary until absence of bats can be confidently confirmed.

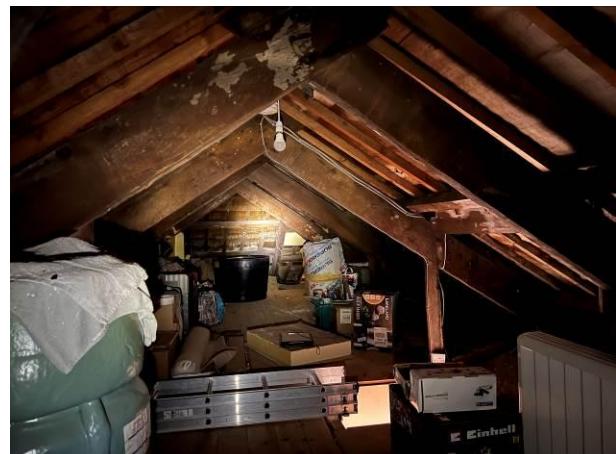
Internally, the loft space is used for routine storage and the floor is partially boarded out with insulation below. There is tar paper above the rafters – this is in poor condition with multiple gaps and tears. Internally visible granite work is well-pointed internally at the chimneys. No evidence of bats or rodents was identified during the internal inspection.

Photograph 8: Showing the interior of the loft space of the main house, used for routine storage.
