PRELIMINARY ROOST ASSESSMENT (PRA)

PIER HOUSE, ST MARY'S, ISLES OF SCILLY

Report date: 20th January 2024

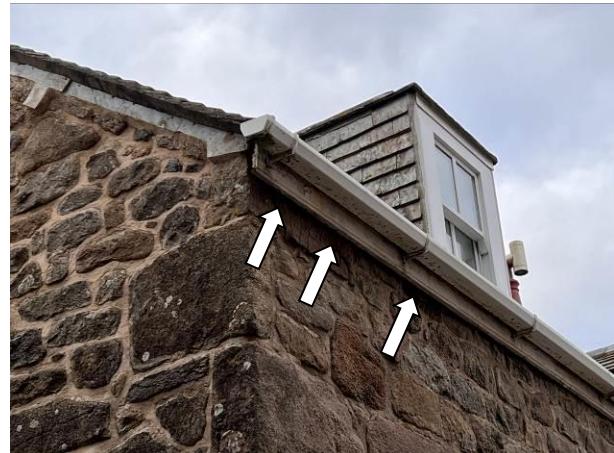
Dormer windows are present on the north-eastern aspect – these have hanging tiles which are generally in good condition with no gaps visible, though there are gaps beneath the flashing where the dormers join the main roof which could potentially provide roosting opportunities.

The fascia on the eaves of the south-western aspect is well-sealed with no gaps noted, but there are a range of different sized crevices created by the fascia on the north-eastern aspect. The gaps are formed at the interface between the fascia board and the irregular granite blockwork and could offer roosting opportunities in their own right, or access to further opportunities associated with the roof tiles.

Photograph 2: Showing the dormer windows with hanging tiles on the north-eastern aspect of Pier House. Gaps beneath the fascia are indicated.

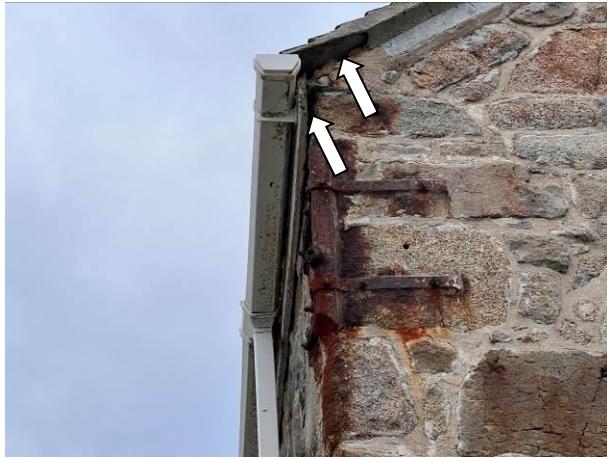
Drop tiles on the gables appear well fitted with only minor superficial gaps beneath one of the tiles on the north-western aspect. The verge is generally well pointed, with the exception of missing mortar just above the fascia board on the north-western gable.

Photograph 3: Showing the gaps behind the north-eastern fascia and on the north-western verge of Pier House.

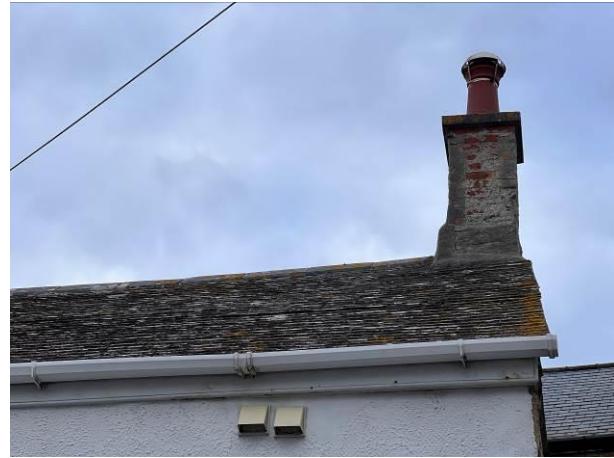
Photograph 4: Showing the south-western aspect of Pier House with the well-sealed fascia and concrete-rendered chimney visible.

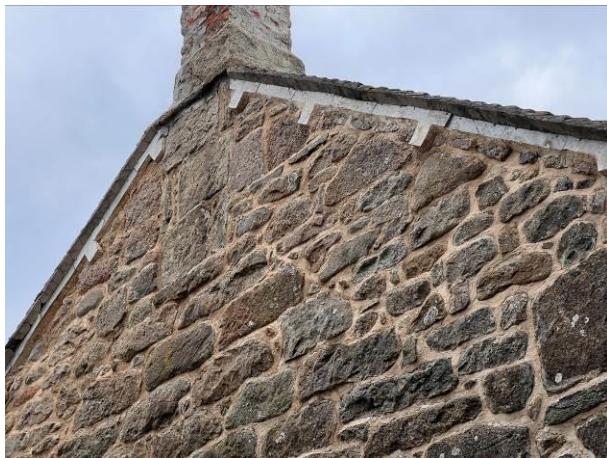
Photograph 5: Showing the south-eastern gable of Pier House with well-pointed drop tiles.

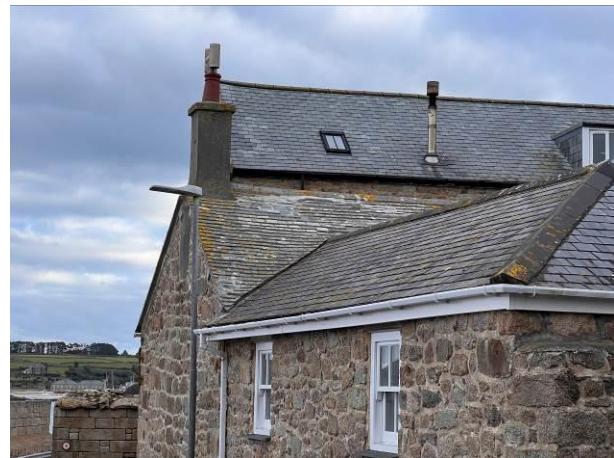
The fascia on the south-eastern aspect facing the courtyard is tightly fitted and offers no roosting opportunities; however the boxed soffit on the north-western aspect has some gaps present at the intersection with the irregular blockwork of the building which could potentially provide roosting opportunities or access to locations beneath the tiles.

Photograph 6: Showing the north-western aspect of The Annex (foreground) connected to Pier House (background).

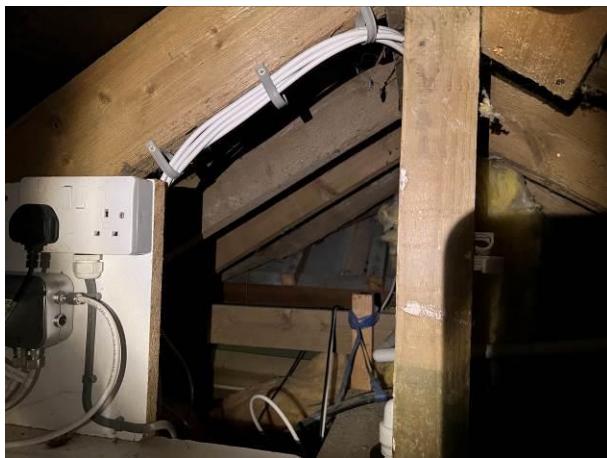
Internally, the upper floor rooms are built partially into the roof space with a sealed void present only above the tie-beam of the A-frame timbers. The loft could not be accessed fully but was inspected from the loft hatch. The roof appears to be well-underfelted throughout with no gaps or light visible. There is insulation between the joists. The loft space is small, and access is further restricted by pipework and services.

Photograph 7: Showing the loft space in The Annex.

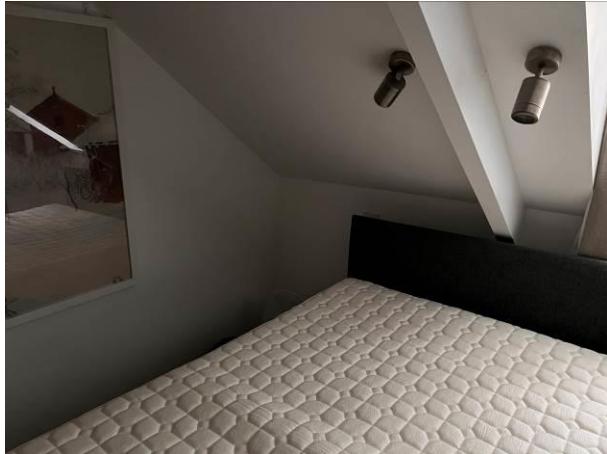
Internally, the upper floor rooms are built into the roof with no void present at the apex. There are however sealed voids present at the eaves which could not be accessed for inspection.

Photograph 9: Showing the interior of the upper floor room of Pier House with the boxed soffit voids visible.

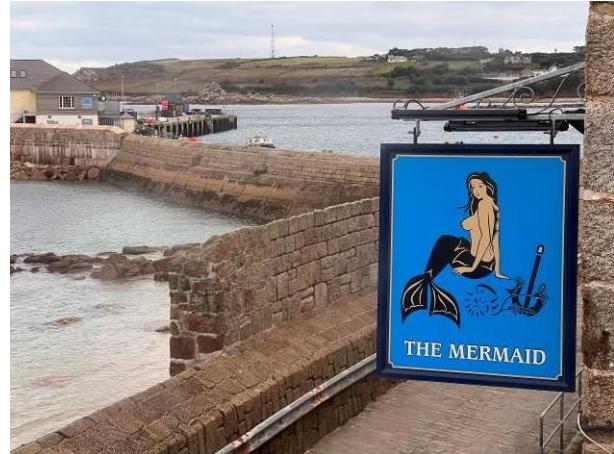
The potential for roosting bats is associated primarily with the north-eastern aspect of the roof of Pier House – it should be noted that this aspect faces directly onto the Mermaid pub which will result in light, noise and disturbance during most evenings. The aspect is also very exposed to the weather given its location directly adjacent to the harbour wall to the north. These are considered to reduce the overall potential of the features to low, rather than moderate which they would likely be in a more sheltered and undisturbed location.

Photograph 10: Showing the view from the upper dormer window on the north-eastern aspect of Pier House illustrating immediate proximity to The Mermaid and the exposed position with the harbour wall directly to the north-west.
