## **Lower Moors SSSI**

### **Improved Hydrological Management: Scoping Study**

**May 2016**

<b>Project Name:</b>	Lower Moors SSSI
<b>Report Title:</b>	Improved Hydrological Management: Scoping Study
<b>Project Number:</b>	16_0201
<b>Client:</b>	Council of the Isles of Scilly
<b>Version:</b>	V3.0
<b>Author:</b>	D.J. Mould
<b>Date:</b>	20 <sup>th</sup> May 2016
<b>Status:</b>	Final

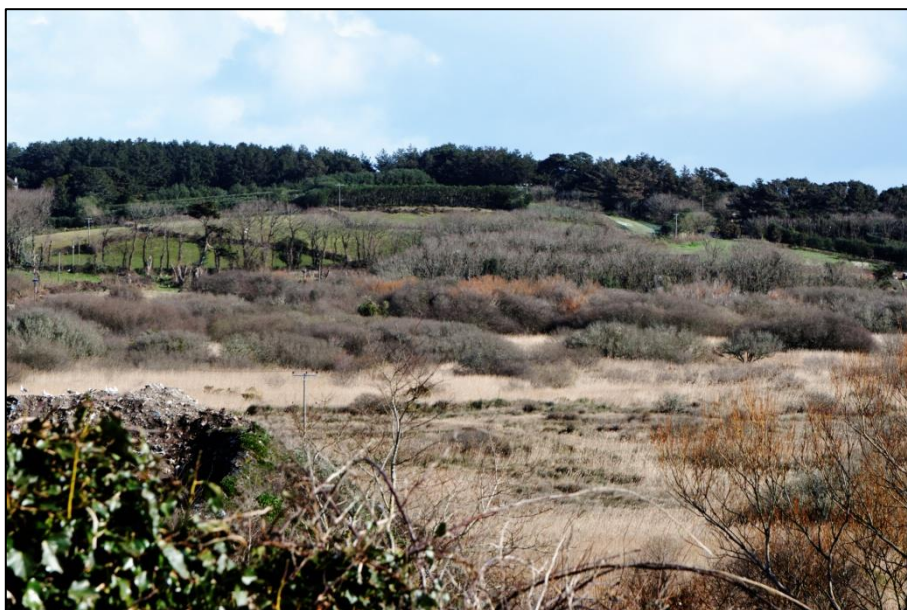
**Figure 2 – The northern extent of wetland site, looking east from Hugh Town**

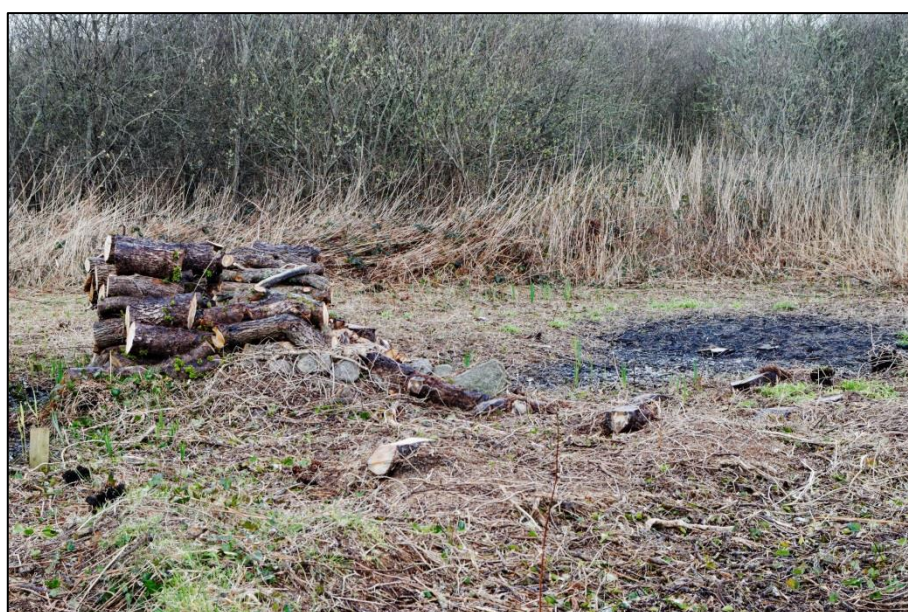
The IoSWT management plan aims to remove 1.86 ha of willow coverage over a 10 year period, with this so far being ahead of schedule (D. Mason, IoSWT; personal communication). A four-way rotational reed-cutting programme is focussed to the east of the central ditch, as shown in Figure 3 (observed during the site visit).

**Figure 3 – Active *Salix sp.* management on site**

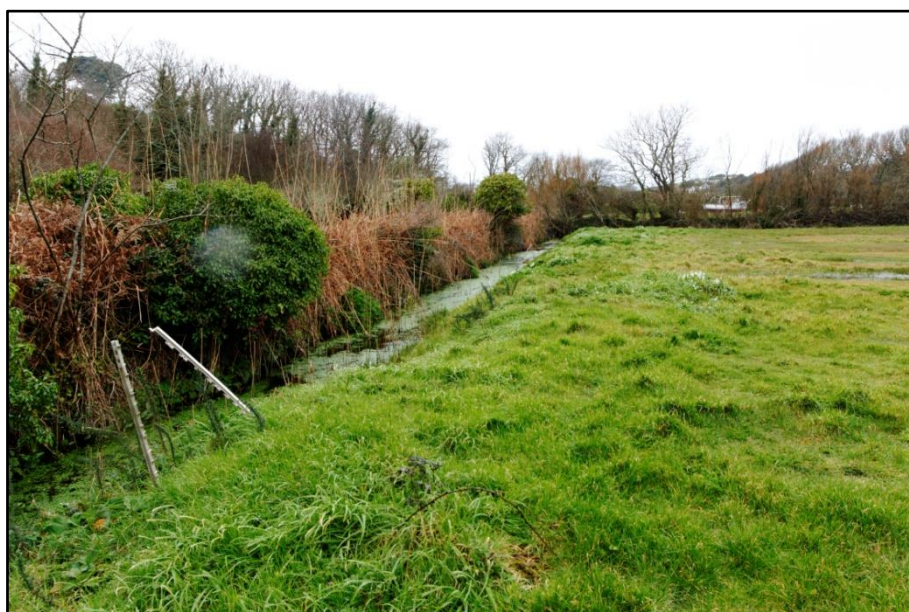
The upper end of the central ditch has an inflow from a small upstream catchment lying outwith the wetland to the north, adjacent to Porth Loo Lane, shown in Figure 4. This flows beneath the road at a culvert to the northeast boundary of the SSSI site. Flow velocity was too low to observe, but the cross sectional area appeared to be approximately as great as at any other point in the length of the central ditch.

**Figure 4 – Channel upstream of the wetland**

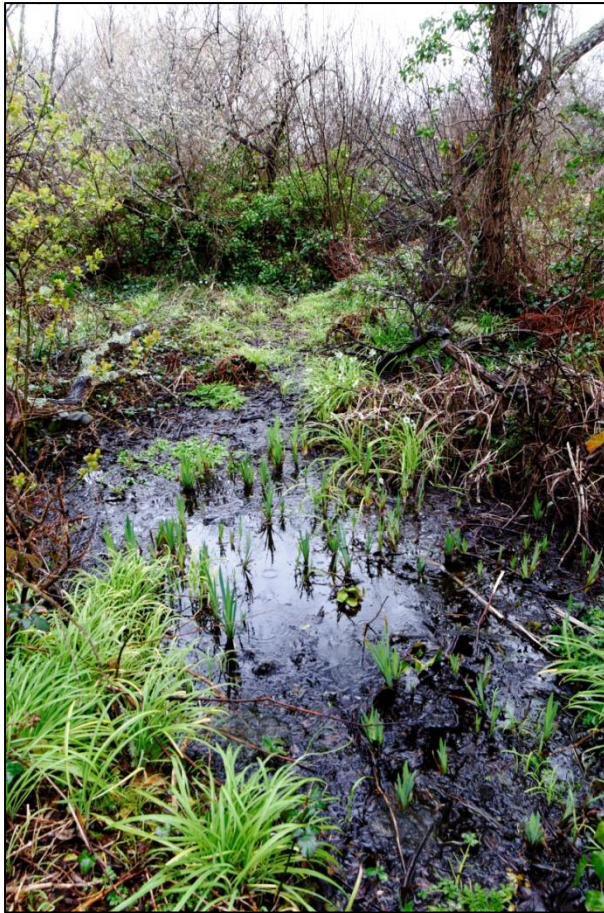
At the top of the site, tree cover is dense and surface splashing (occasionally open water) is prevalent across expanded areas, as shown in Figure 5, which is taken close to the site of Aunt Joaney's Well: it is assumed that excess runoff (i.e. that not taken for public water supply) transfers through this surface runoff towards the central ditch at times of saturation in winter months. The central ditch continues south through the wetland, largely adjacent to the main footpath running through the site, as shown in Figure 6.

Figure 5 – Surface splashing and increased tree cover at the top of the site

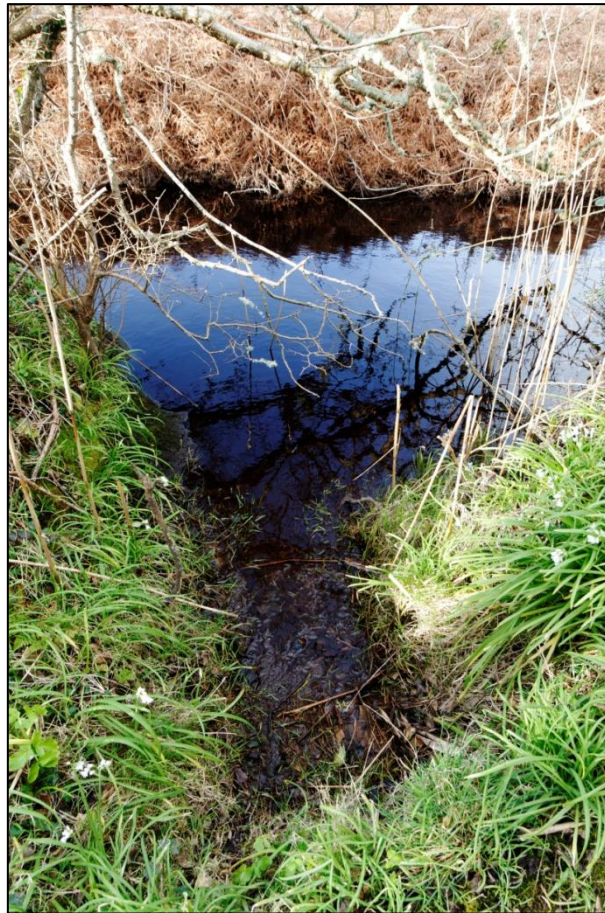
**Figure 7 – Location of the eastern ring ditch flowing into the central ditch**

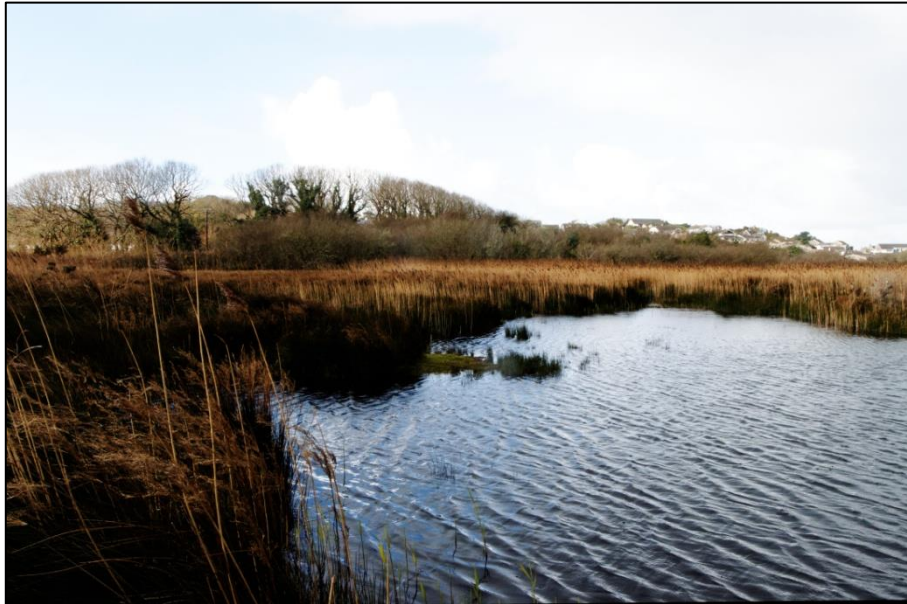
Areas of open water were observed in the centre of the site. These are thought to be artificial features created to enhance the attractiveness of the site for bird species, adjacent to the two bird hide structures. Although not thought to be deep (approximately 0.5 to 1.0 m), they vary in extent and depth seasonally, water levels appear to be substantially higher than in summer (as reported by Rigare, 2015), suggesting that the local groundwater level also varies. Natural England (2015) state that in late July 2015 the open water areas “were in danger of drying out.”

Figure 8 – Open water ‘scrapes’ in the centre of the wetland

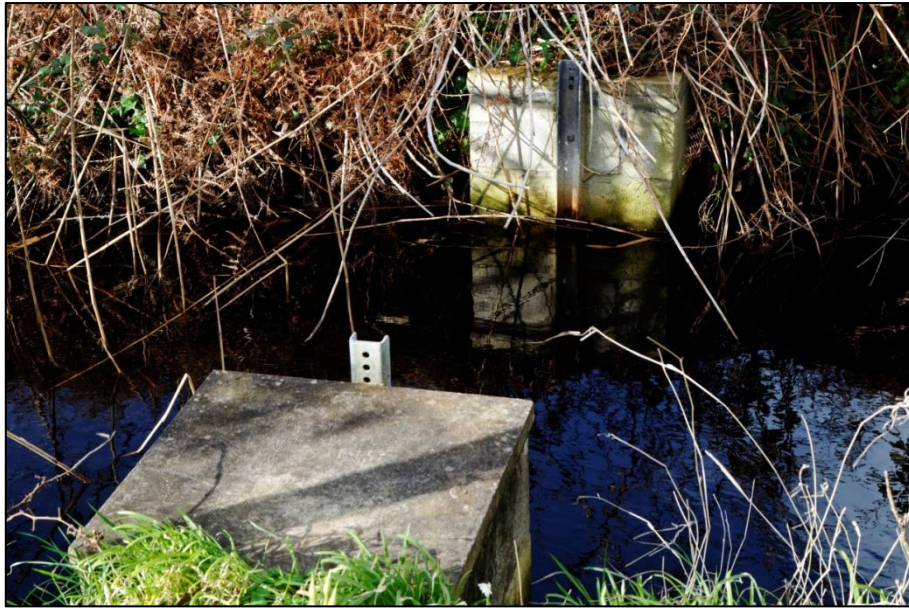
The wetland drains towards the south, with all ditches converging to the central ditch. Just upstream of where the eastern ring ditch joins, a substantial structure exists, mostly comprising concrete but with stop plank grooves (1,850 mm cross-channel width: Figure 9). CloS documents, including those from the Nature Conservancy, suggest that the stop plank structure was installed in the early 1980s to maintain water levels in the central ditch, for the purpose of preventing contaminated water from the waste site – which at the time included an incinerator that burnt all of the Islands’ waste – reaching the potable water abstraction point at Aunt Joaney’s Well. It is unknown as to whether this would be successful, given the permeability of the substrate as highlighted by Rigare (2015). This is considered to be the southern extent of the site boundary.

**Figure 9 – Stop plank structure at the downstream point of the site boundary**

The boards should be in place only in the summer months, with the aim of creating a hydraulic gradient along the length of the central ditch within wetland to maintain levels in the north of the site. It must be appreciated that *if* this is successful, storage capacity in the northern areas of the site would *not* be available for flood storage. Note that close monitoring of prevailing meteorological conditions and resultant surface water levels should be monitored continuously during this experimental period, given the potential for causing upstream flooding. Stop boards should be removed or adjusted if site water levels rise beyond the target water levels to prevent upstream flooding.

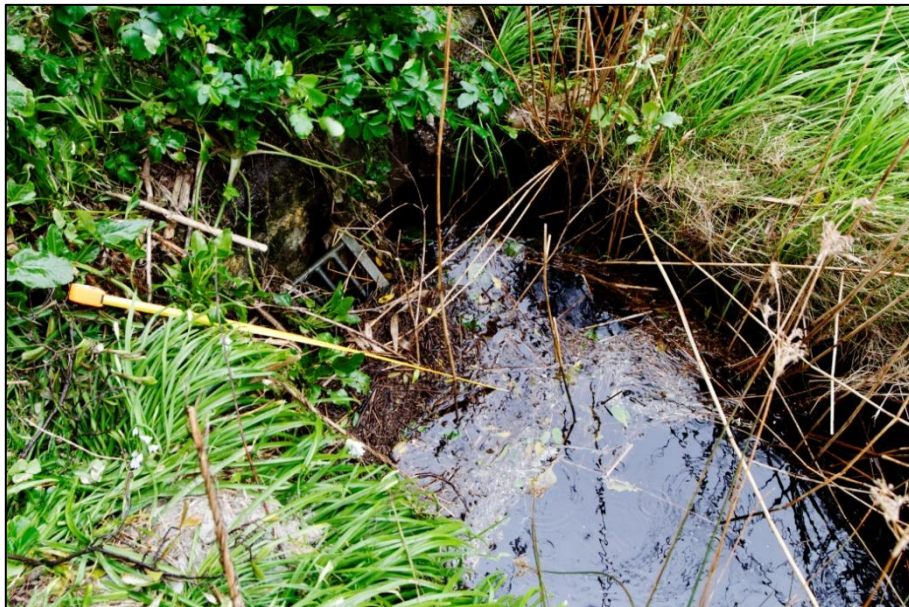
Below this point, the central ditch continues beyond the site boundary further for approximately 80 m, where it is taken into a culvert (Figure 10) that runs beneath Trench Lane to be discharged to the sea at an unknown location. The culvert inlet is 450 mm in diameter, and has a trash screen. Its invert level was just below the water surface, suggesting that this is a controlling factor for the flow out of the site: a flow of ~ 5 l/s was observed.

It is considered that saltwater intrusion from the outlet is feasible, and a non-return valve was not observed on the culvert inlet (the culvert’s outlet could not be located). However, *Juncus maritimus* (Sea Rush) has been observed by IoSWT (D. Mason, IoSWT; personal communication).

**Figure 10 – Culvert inlet (partially obscured by vegetation); tape measure extended to 1 m for scale**

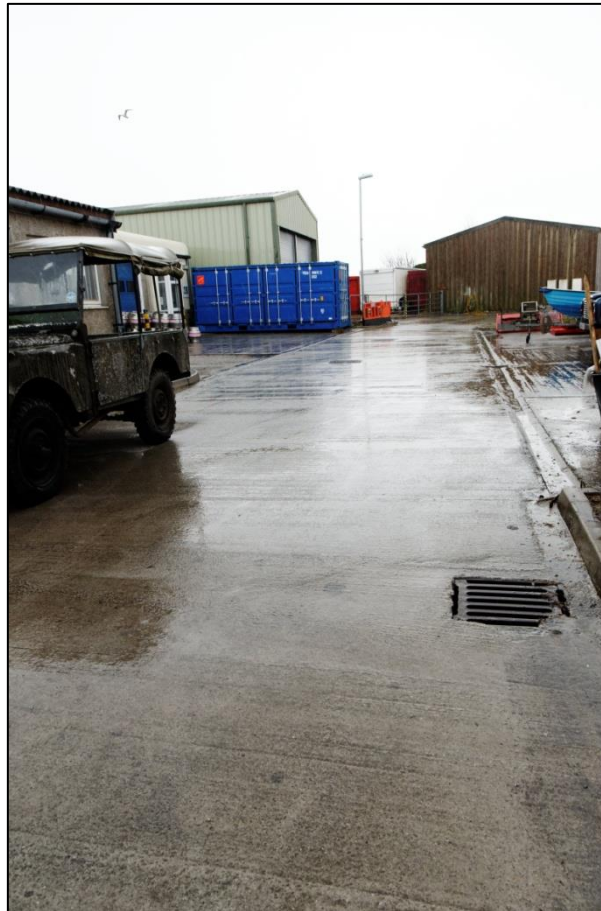
The industrial site comprises numerous leased units housing varied light industrial operations, lying on the northern edge of the wetland site. Despite its proximity to Port Mellon beach (~15 m) in the north, the site drains towards the wetland and thus towards Old Town Bay. The drainage system of the industrial site is relatively modern (Figure 11) and thus likely to be efficient, conveying flows to the lower end of the hardstanding areas and to the adjacent channel rapidly. The hydraulic efficiency of this ditch, running behind the industrial site towards the wetland, is anecdotally poor, confirmed during the site visit (Figure 12). Thus it is thought that water backs up from this point towards the industrial area in storm events, flooding the site with its own runoff due to the lack of conveyance capacity through the wetlands downstream from here. Given the relatively extensive area of the wetland, and large vertical storage both within the soil profile and in surface splashing, it is unlikely that water from the wetland is transferred to the industrial site.

Figure 11 – Drainage from the industrial site

It is recommended that further hardstanding development is prevented, as this would further prevent infiltration and percolation of water through the substrates, and in turn further increase runoff rates. Runoff rates pre- and post-development should be fully evaluated to quantify the impact of the existing development, with mitigation measures implemented as appropriate to alleviate the impact on the wetland. This should be done for existing developments in addition to those proposed in the future.

Given the close proximity of the site to the sea (~200 m) and the agreeable topography, it is recommended that solutions are sought for managing runoff from the site, either through on-site storage or potentially using pumped or otherwise artificial discharge to the sea at Porth Mellon. This would remove any negative impact the site already has on the hydrology of the wetland through decreasing runoff lag times. Although potentially economically unfeasible in the short term, this should be kept in mind for longer timescales should funding become available.

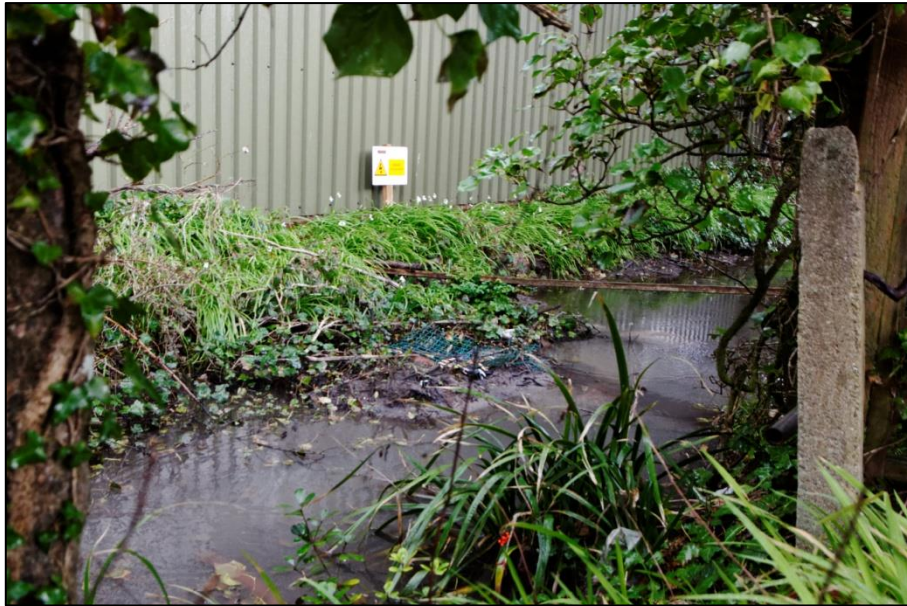
**Figure 12 – Drainage ditch running along the southern edge of the industrial site**

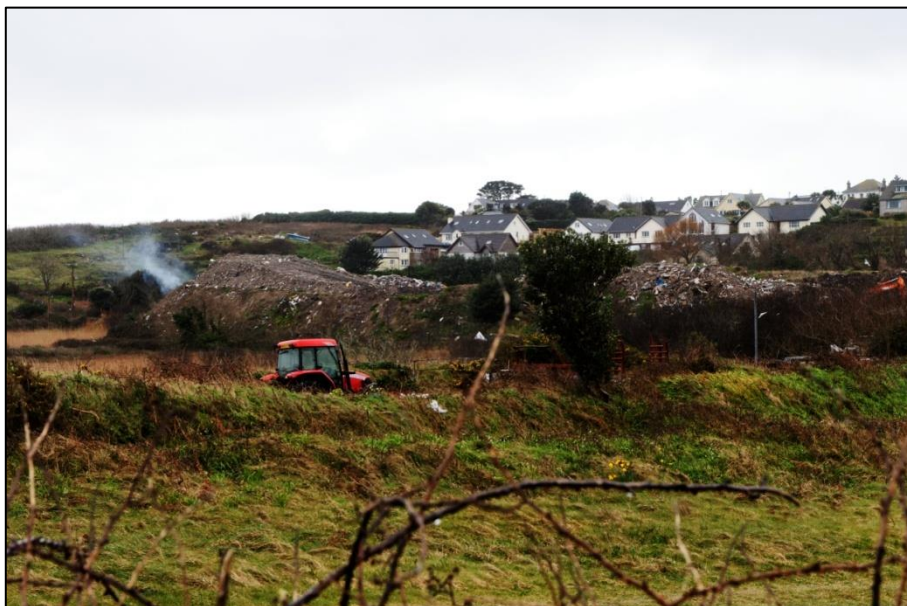
The waste site lies on the eastern boundary, unmistakable given the legacy stockpiling of waste (Figure 13).

**Figure 13 – Waste site (viewed from Telegraph Road the eastern end of the industrial estate)**

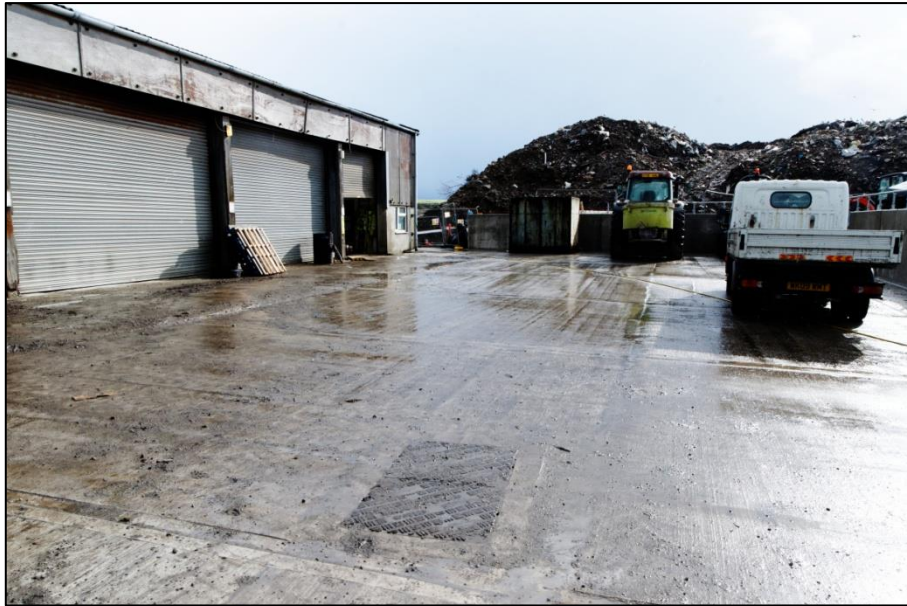
A new hardstanding area to the northwest of the waste site (Figure 14) is part of the site refurbishment, and work has begun on a surface water interceptor tank (Figure 15) to store runoff from this area.

**Figure 14 – New hardstanding area, northeastern part of the waste site**

As with the industrial site, it is recommended that pre- and post-development runoff calculations are made to quantify the problem and thus highlight potential mitigation measures.

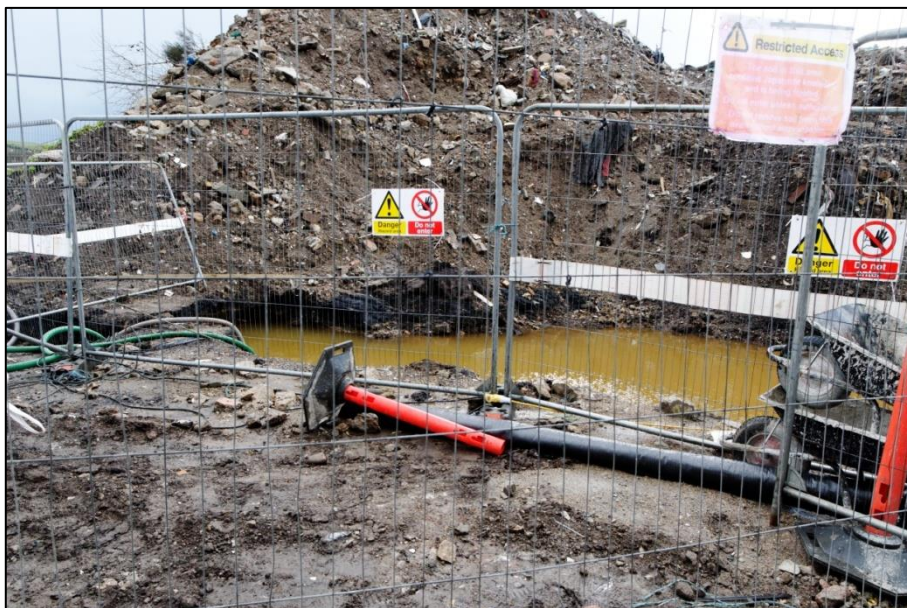
**Figure 15 – Works for new interceptor tank, northeastern area of the waste site**

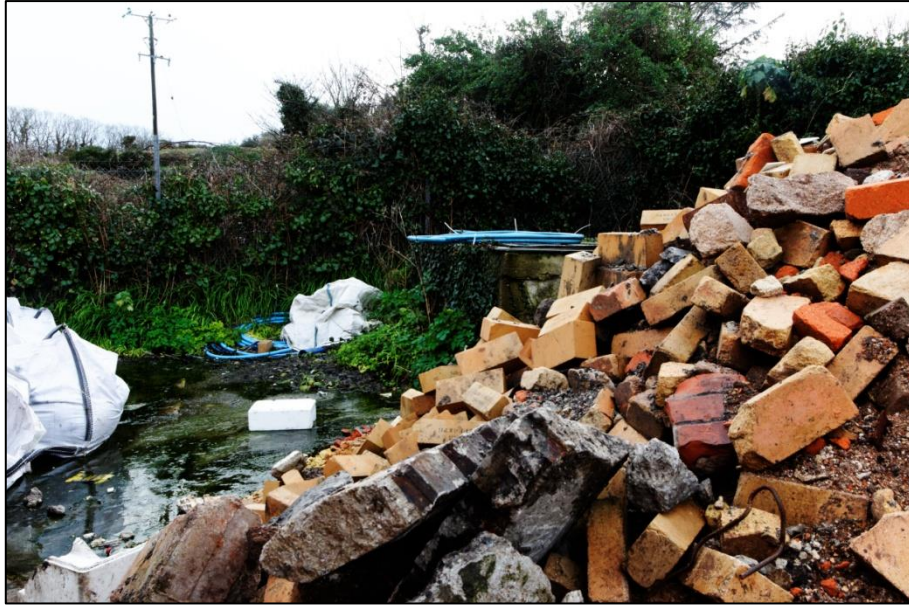
The centre of the site is dominated by substantial legacy waste piles. The southern end of the site is the location of the recently-decommissioned incinerator: this was previously used to burn all of the waste from the Islands. Two springs emerge at this southwest of this area, with flow visibly running across the hardstanding (Figure 16). The water here is anecdotally from salt water intrusion, supported with ecological investigations from the wetland site by Dawson (2015). This area has some surface flooding, the source of which is unknown: this could be rising groundwater or surface runoff sitting on impermeable ground.

**Figure 16 – Spring at the southern end of the site (behind hardcore)**

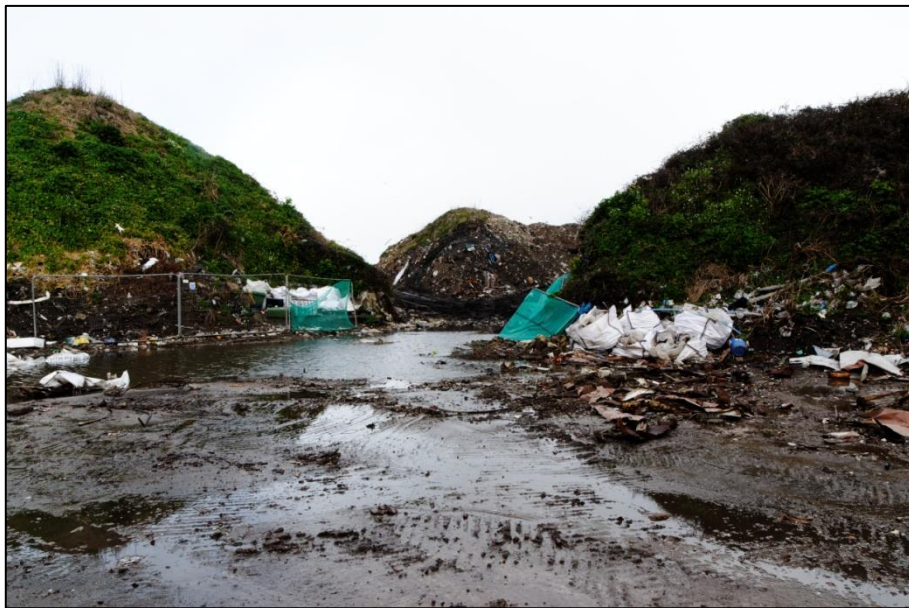
**Figure 17 – Surface flooding at the southern end of the site**

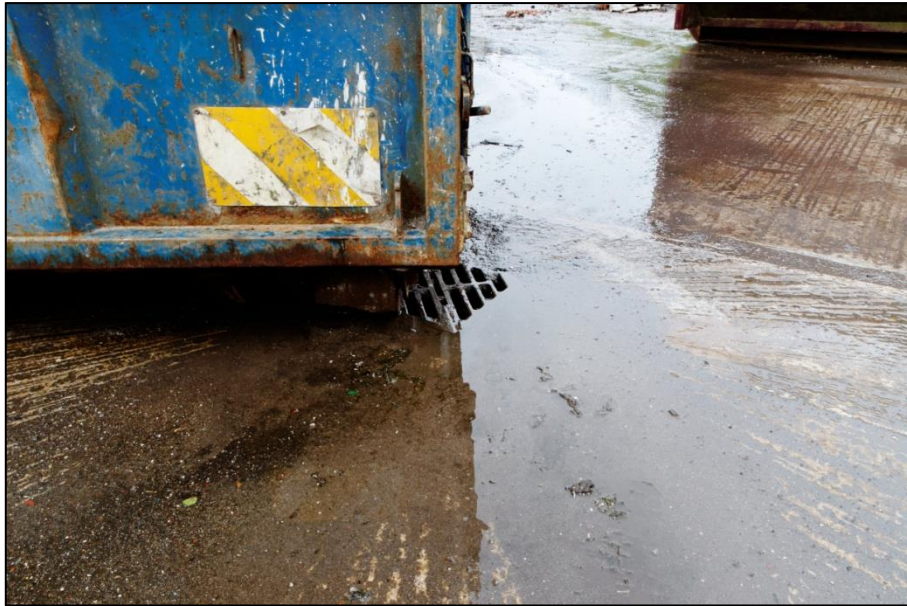
As with the industrial site, the southern portion of the waste site appears to have an efficient drainage network, discharging directly into the northeastern extent of the wetland drainage ditches, as shown in Figure 18.

**Figure 18 – Drainage from the southern area of the waste site**

The water quality risk posed by the waste site remains at present, but a waste strategy is being implemented at the site that should minimise the direct runoff from the waste site flowing to the wetland. This is a very positive step, and represents a significant investment. Plans include interceptor tanks to store runoff, bunding to prevent diffuse site runoff, and legacy waste stockpiles being processed to remove hazardous material. It is unclear what technical work has been completed in preparation for these works: it is assumed herein that the works are based on sound understanding of the flow pathways here. Perhaps most importantly, the incinerator that for many years burnt all of the waste from the archipelago, has already been decommissioned, removing a substantial source of water quality risk. Despite this, legacy contaminants are considered likely to remain in substrates on the site for many years; thus rapid implementation of the aforementioned strategy is critical. Water quality risk management is beyond the scope of the current work, although inherently linked to water flow through the site. Thus effective surface water management of the site should be completed as a matter of urgency.
