Leslie  
**Cornell**  
BUILDING RESTORATION LTD

# Heritage Assessment

## Newman House, TR21 0LS

November 2016

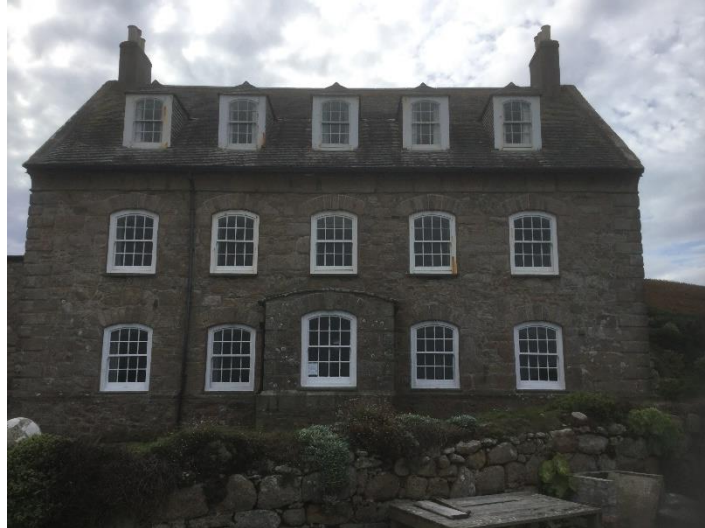
**NEWMAN HOUSE NORTH ELEVATION**

*North Elevation* (inc Porch) – Drawing Ref: NH/10516/ELEV-NTH/01

- 1.1 Remove, using non-power tools, existing cementitious pointing application/s (inc opening reveals.
- 1.2 Using an appropriate Natural Lime/sand mortar, repoint all exposed jointing/s

- 1.1 Removal of existing cementitious pointing applications should be achieved using hand tools only ie hammer and plugging chisel. The use of power tools for removal is not recommended...principal reason being that [potentially] irreversible damage to surrounding fabric/s may result. As good practice the depth of jointing should be 1 and a half times that of the jointing gap (guideline).

- 1.2 **Repointing preparation-** All exposed jointing/s are to be cleaned free of dust and detritus. Prior to repointing, all jointing/s are to be thoroughly dampened using either hand-sprayers and/or light use of hose-pipe.

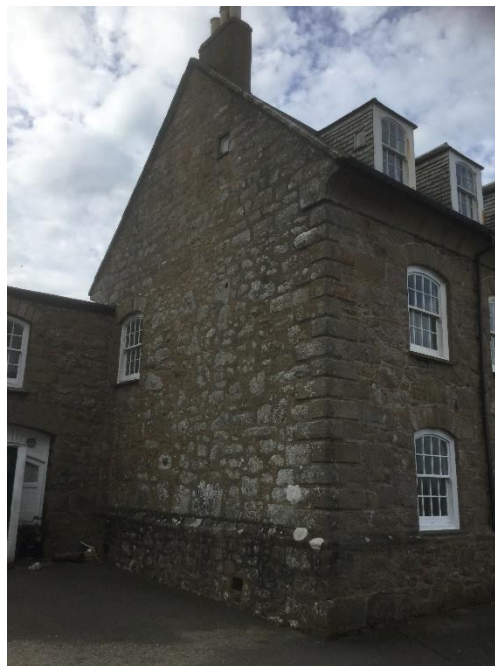
**NEWMAN HOUSE EAST ELEVATION**

*East Elevation* – Drawing Ref: NH/10516/ELEV-EST/02

- 1.3 (as 1.1)
- 1.4 (as 1.2)

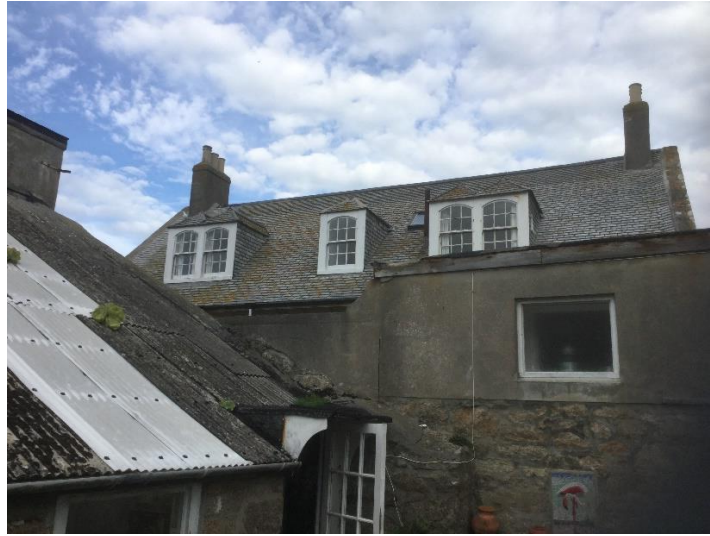
**NEWMAN HOUSE SOUTH ELEVATION**

*South Elevation* – Drawing Ref: NH/10516/COURTYARD-ELEVS/01 and ANNEXE-ELEVS/02

1.5 (as 1.1)

1.6 (as 1.2)

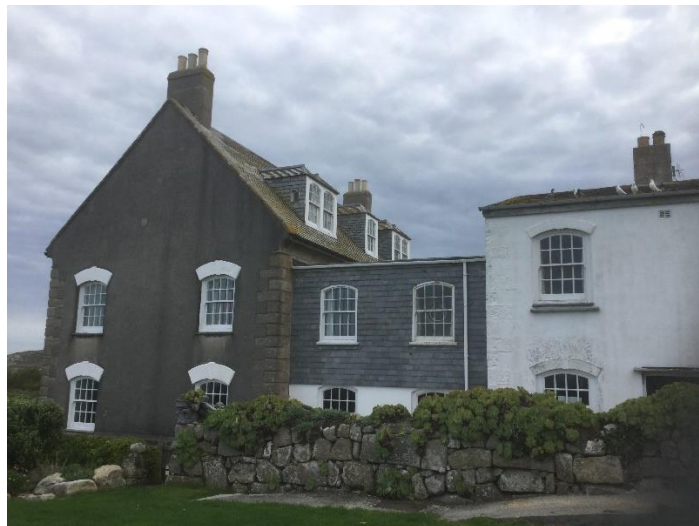
**NEWMAN HOUSE WEST ELEVATION**

*West Elevation* – Drawing Ref: NH/10516ELEV-WST/03 AND 04

- 1.7 Remove, using non-power tools, existing cementitious render application/s
- 1.8 Remove, using conservation approved methods and materials, existing paint surfacing/s to window arches and keystones
- 1.9a (as 1.2)
- 1.9b Using an appropriate Natural Lime/sand mortar, introduce a ‘bag-rub’ application\*
- 1.9c Using an appropriate Natural Lime/sand mortar, introduce a 3-coat render\*
- 1.10 Items 1.9a and 1.9b – Introduce a Mineral Paint System

- 1.7 Removal of existing cementitious render application/s should be achieved using hand-tools only ie hammer and (varying) chisels. Continue (as 1.1)

- 1.8 **Removal of existing painted surfacing/s to window arches and keystones.** Peelaway 7 is recommended as an approved paint removal process. Reason: Non-toxic, sympathetic to substrate/s and environmentally (in comparison) considerate. Test areas must be introduced prior to full application. As per manufacturers specifications

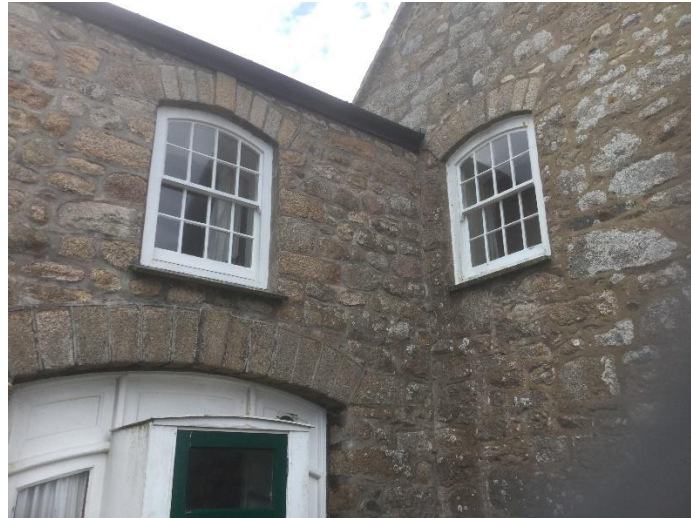
**NEWMAN HOUSE ANNEXE NORTH ELEVATION**

### *North Elevation*

2.1 (as 1.1)

2.2 (as 1.2)

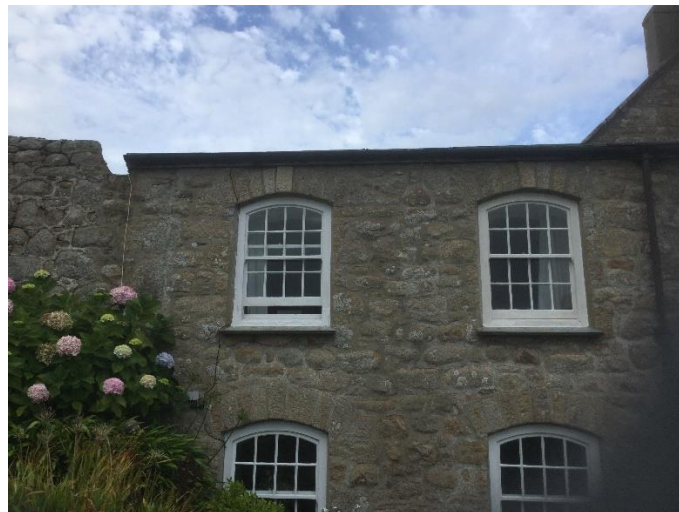
**NEWMAN HOUSE ANNEXE EAST ELEVATION**

### *East Elevation*

2.3 (as 1.1)

2.4 (as 1.2)

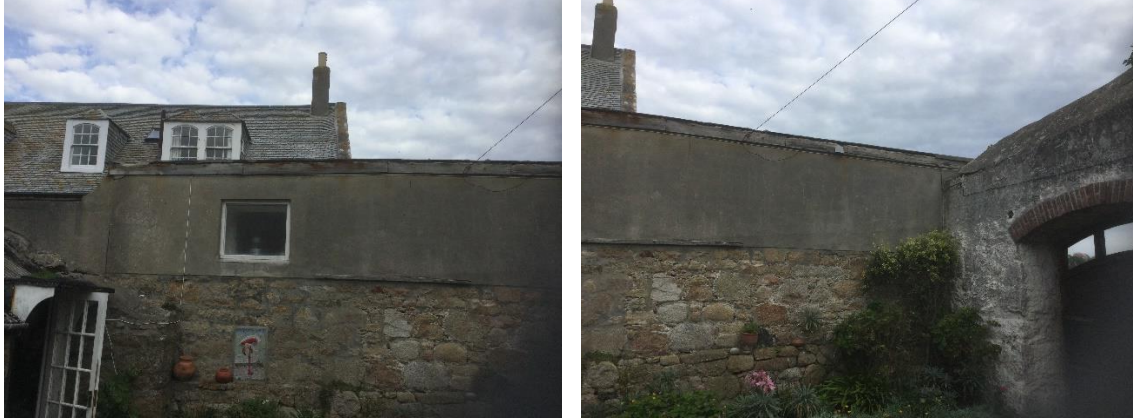
**NEWMAN HOUSE ANNEXE SOUTH ELEVATION**

*South Elevation*

2.5 (as 1.1)

2.6 (as 1.2)

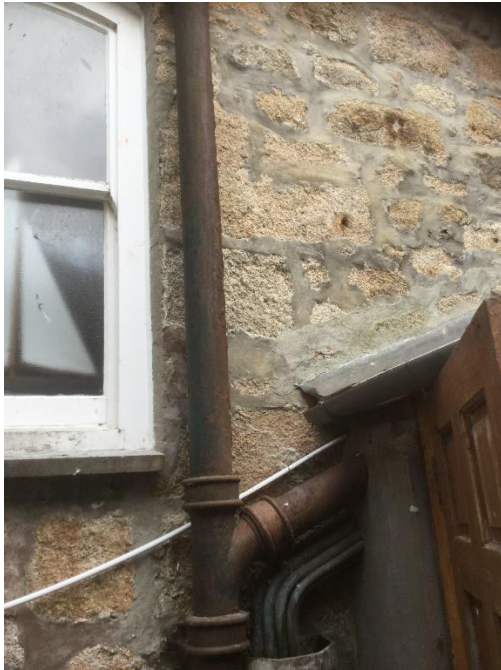
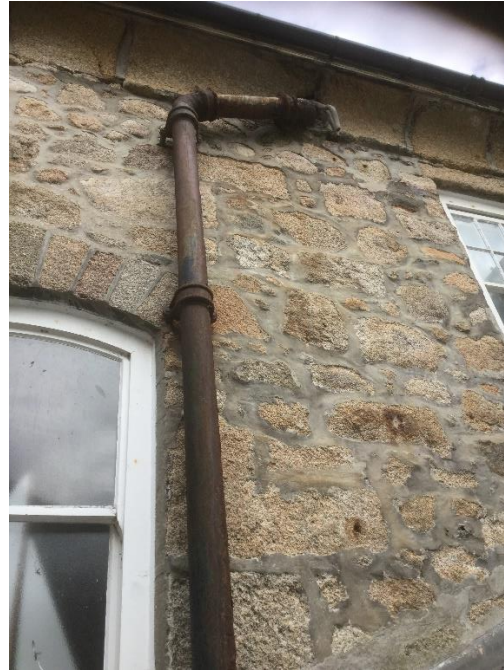
**NEWMAN HOUSE COURTYARD FWP**

**6.0 Courtyard** Drawing Ref: NH/10516/COURTYARD-ELEVS/01

- 6.1 Remove existing failing cast-iron foul waste pipe (FWP) from low-level to eaves only
- 6.2 Introduce a cast-iron FWP replacement

**6.1 Courtyard** – Foul Waste Pipe (FWP) to be removed from the existing, low-level branch tee only. Items to be removed are: 1 x section of pipe, 1 x 45 degree bend, 1 x section of pipe and 1 x 45 degree bend. Reason: Deterioration. These items are to be removed by hand, potentially a small angle grinder may be required to assist with corroded fixing/s. Items removed to be replaced with like for like components. All [newly introduced] fixings to be stainless steel.

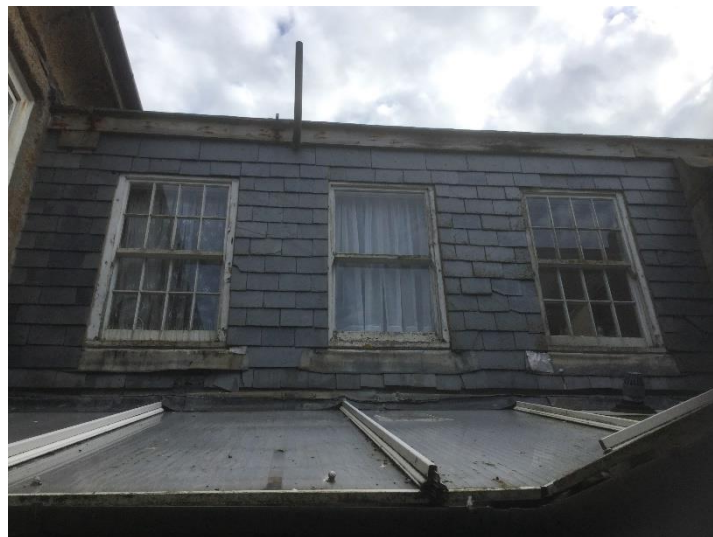
**NEWMAN HOUSE STUDIO WEST ELEVATION**

- 6.3 West Elevation (Studio) – Replace and/or reinstate all missing, broken, failed natural slate to 1<sup>st</sup> floor covering/s.

- 6.4 West Elevation (Studio) – Introduce treated 150mmx25mm timber fascia board, rainwater gutter and downpipe
- 6.5 In-situ restoration to: W27, W28 and W29

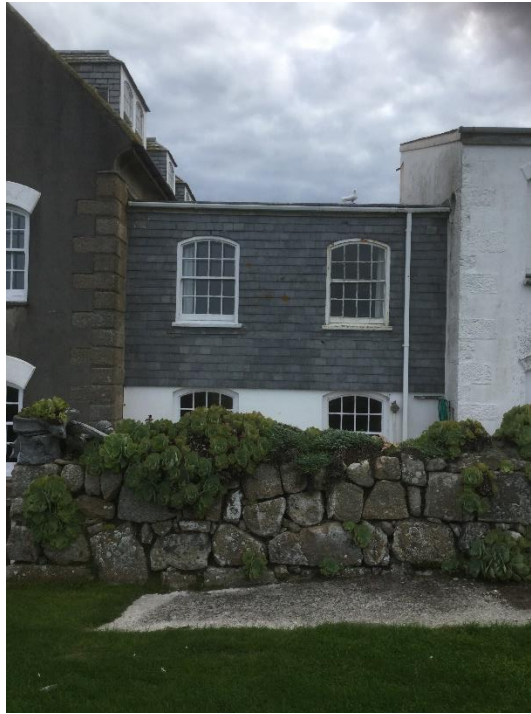
**NEWMAN HOUSE POTTERY WEST ELEVATION**

**7.0 West Elevation** (Pottery) Drawing Ref: NH/10516/ELEV-WST/03 and 04

- 7.1 Remove existing natural slate (to be re-used for Item 6.3)
- 7.2 Introduce an appropriate render to exposed substrate/s (substrate unknown at present)
- 7.3 Introduce 4x natural slate window cills
- 7.4 Introduce a Mineral Paint System (as detailed for Item 1.10) to Ground and 1<sup>st</sup> Floors
- 7.5 In-situ restoration to: W15, W16, W17 and W18

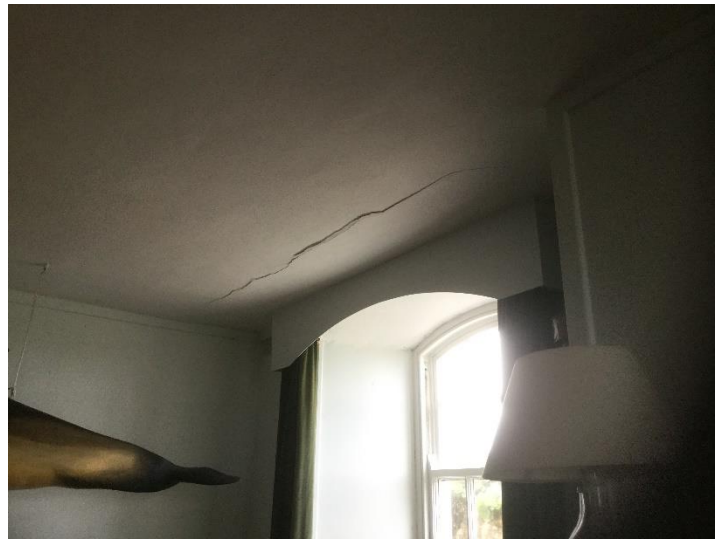
**NEWMAN HOUSE GROUND FLOOR DINING ROOM**

**8.0 Newman House Ground Floor** (Internal) Drawing Ref: NH/10516/PLAN-GRD/02

- 8.1 Dining Room – Item 1 – Remove localized failed/failing surface plaster/s to ceiling
- 8.1a Introduce an appropriate Natural Lime/sand base-coat plaster
- 8.1b Introduce an appropriate Natural Lime/sand top-coat plaster
- 8.1c Introduce an appropriate Natural paint
- 8.2 Dining Room – Item 2 – Remove localized failed/failing surface plaster/s to R/H window reveal.
- 8.3 (as 8.1a, b and c)

**Removal** of existing failed areas of plaster to be undertaken with hand-tools. Note; where 'patching-in' is required and/or unavoidable, use of a multi-tool may be necessary. Reason: Multi-tool can effectively remove a recognized area without disruption to surrounding, stable plaster/s. Care must be taken not to 'chase' too deep. Reason: To ensure underlying fabric and/or lathes are unaffected.

**Lime Applications** - Introduce an NHL 3.5+ medium coarse sand (with natural hair) base coat. After initial curing, comb-scratch. Scratch (or float coat) to be NHL 3.5 + fine/medium grit sand applied to moistened background. Finish coat to be NHL 2 + fine sand. Trowel to finish.

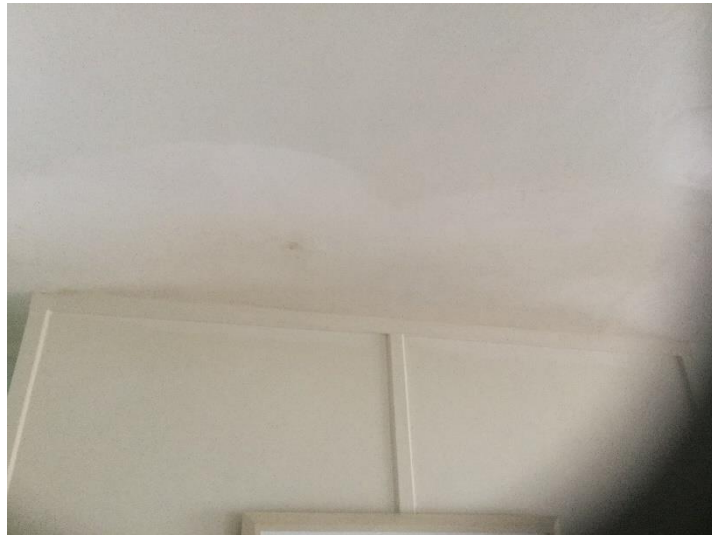
**NEWMAN HOUSE 1<sup>ST</sup> FLOOR MASTER BEDROOM**

**9.0 Newman House – 1<sup>st</sup> Floor** (Internal) Drawing Ref: NH/10516/PLAN-1<sup>st</sup>/03

- 9.1 Sitting Room – Item 1 – (as 8.1, 8.1a, b and c)
- 9.2 Sitting Room – Item 2 – (as 8.2, 8.2a, b and c)
- 9.3 Landing Wall – Item 3 – Remove existing failed wallpaper and replace
- 9.4 Master Bedroom – Item 4 – Remove existing wallpaper/s to ceiling and replace

- 9.3 Wallpaper (all)** – Removal of existing failed/failing wallpapers must NOT be undertaken using steam operated systems. Reason: High risk of separating underlying, natural plaster/s from fabric/s. We recommend that controlled ‘saturation’, using warm water, sponges and upvc (round-edged) scrapers.

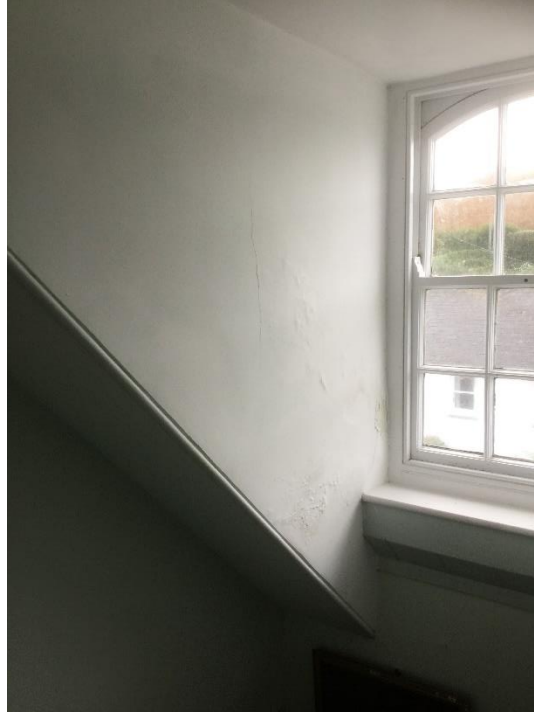
**NEWMAN HOUSE 2<sup>ND</sup> FLOOR  
DORMER REVEALS (TYP)**

**10.0 Newman House – 2<sup>nd</sup> Floor** (Internal) Drawing Ref: NH/10516/PLAN-1<sup>st</sup>/04

- 10.1 WC – Remove and replace existing wallpaper/s
- 10.2 D1 – D10 – Dormer reveals (all). Remove localized existing failed/failing surface plaster/s
- 10.3 (as 8.1a, b and c)
