HERITAGE STATEMENT AND IMPACT ASSESSMENT

Automatic Dosing Shed

Vane Hill

Tresco

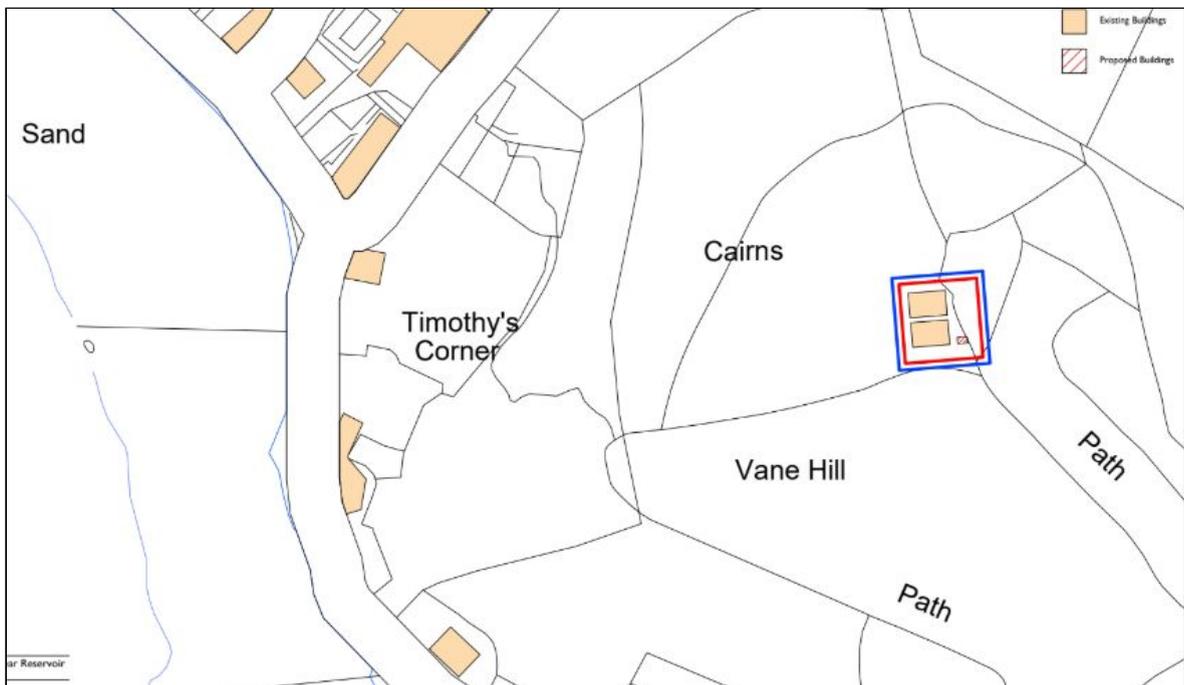
Figure 1: Revised location of proposed shed (full plan in planning application).

The client intends to erect a wooden shed on the PDS. This will be constructed on a concrete base, roughly 2m by 3m in size. It will have a pent roof and will be stained a brownish green colour in order that it be as inconspicuous as possible. It is anticipated that the bramble which currently covers the PDS will rapidly grow up at the sides of the shed. The shed will stand less than 3m tall, and will be dwarfed by the existing reservoir, and though it will be clearly visible from the top of the hill, it will be hidden from view from two of the four platform cairns present on the hill, and it will be partially obscured from another due to the topography of the summit. The only cairn from which it will be in full view is the one nearest the existing reservoir.

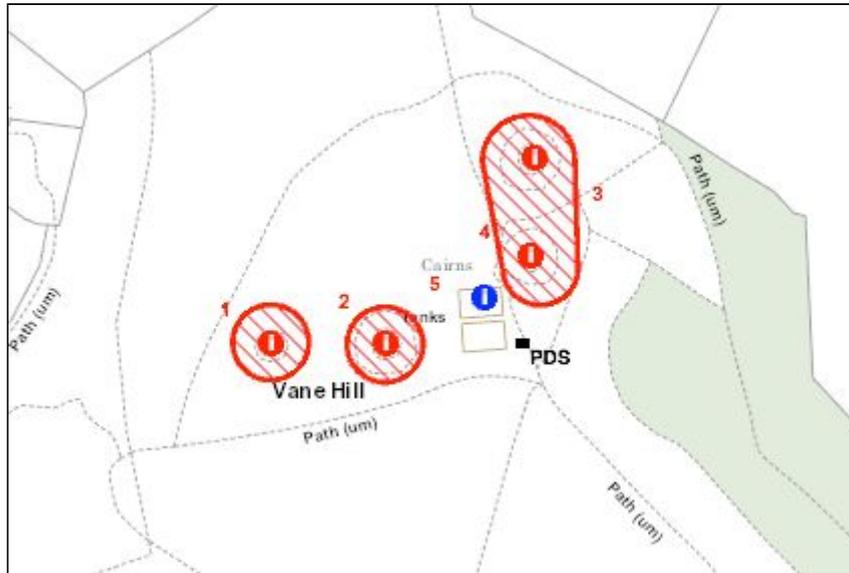
Figure 2: Heritage Assets within the search area

There follows a list of all archaeological sites and finds, and other historical sites within the Search Area (shown on Figure 2). There are no Listed buildings, battlefields or Registered Parks or Gardens in the search area.

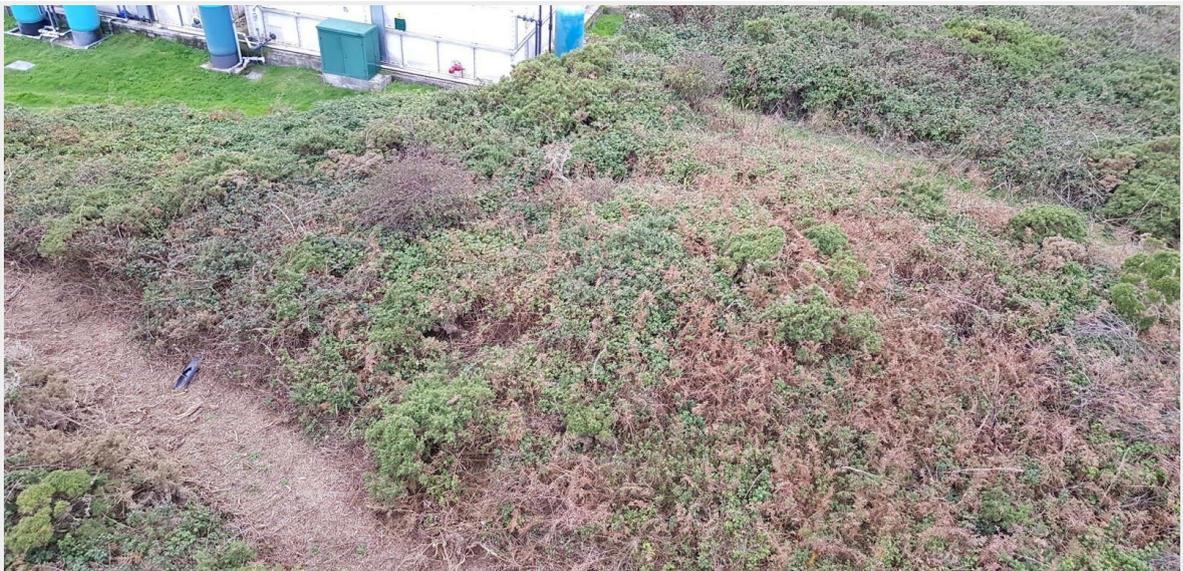
Plate 2: The southern of the pair of cairns within SAM 15429.

The monument includes two prehistoric funerary platform cairns situated close to the north east of the summit of Vane Hill, a prominent rounded hill south east of New Grimsby on central Tresco in the Isles of Scilly. These cairns form the north east part of a dispersed group of four cairns spaced around the hill's summit. The southern cairn (Cairn 'B') in this monument (Plate 2) contains the largely dismantled remains of a post-medieval coastguard lookout. The two platform cairns in this monument are spaced 12m apart on a north-south axis. The northern cairn (Cairn 'A', Plate 3) survives as a circular mound of heaped rubble and earth, 14.5m in diameter, with fairly steep sides rising 1.2m high to a flattened upper platform 8m in diameter. The platform surface contains some irregularities, many due to rabbit burrowing, but the eastern side contains a larger hollow, 5.5m long, north-south, by 2.5m wide and up to 0.4m deep, considered to be the result of relatively recent stone robbing. The southern cairn in the monument also survives with a circular mound of heaped rubble and earth, 13m in diameter and up to 1.7m high, rising to a small flattened platform, 5m in diameter. The northern and south eastern sides of the mound contain several hollows resulting from relatively recent stone robbing. One hollow, up to 0.7m deep, in the south west edge of the cairn corresponds with the northern corner of a post-medieval coastguard lookout whose dismantled walls are visible as slight grassy banks, generally 0.9m wide and 0.3m high, delineating an internal area 3m square, its sides facing north west-south east and north east-south west. The south east side appears to have been left open. Some irregular stone slabs from the walls' facing are visible in the vicinity. Also visible immediately north west of the lookout's remains is the debris of a much more recent and mostly demolished structure; one corner of this structure's north and east walls, built of mortared concrete blocks, survives in situ on the lower south west slope of the cairn. Beyond this monument, the other two cairns near the summit of Vane Hill form an east-west pair from 30m to the south west.

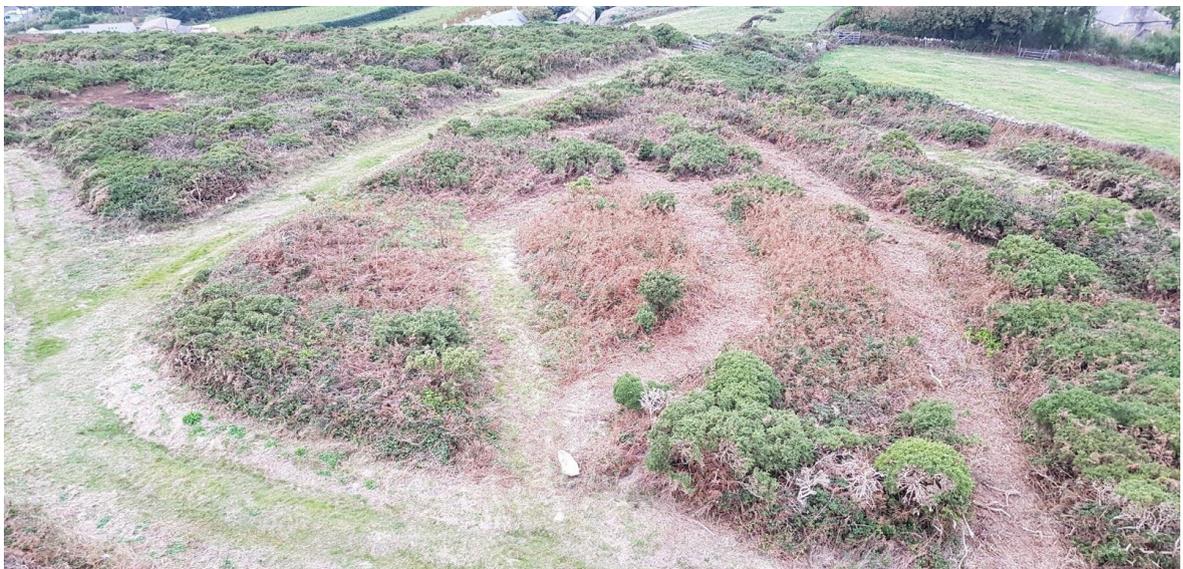
Plate 3: The northern of the pair of cairns within SAM 15429.

The closest asset to the PDS is the SAM immediately to the north-east of the existing reservoir, which comprises the pair of platform cairns. The northern of these cairns (Plate 3) is c. 50m away from, and completely out of sight of the PDS. The southern cairn in pair is around 15m from the PDS, which in turn is around 10m outside of the boundary of the SAM. As the PDS no longer sits within the SAM, the ancient monument itself will remain physically undisturbed by the development. The existing reservoir is far larger than the proposed development and its northern of the two tanks is considerably closer to the SAM than the PDS, so any visual impact on the cairn affected by the shed will be minimal in comparison to the visual impact already affected by the reservoir.

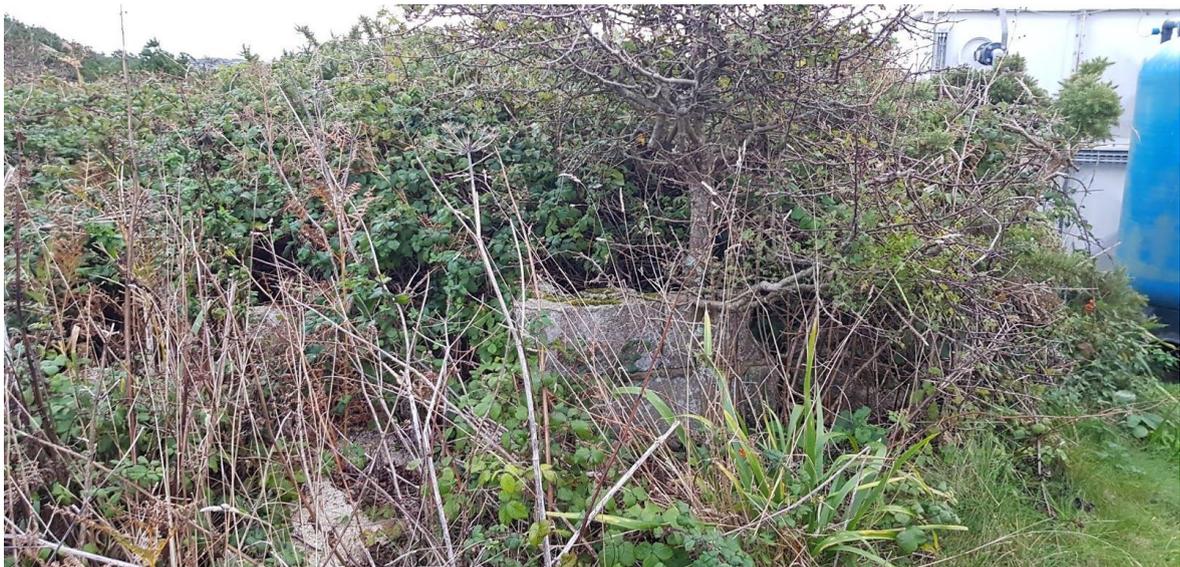
Plate 4: The ruined remains of the 19th century coastguard lookout station

A coastguard lookout station is cut into the side of cairn 'B' on Vane Hill (7373.02). The site was visited by CAU in 1988 and a structure, 3.0m square internally, with walls approx 0.9m wide and 3.0m high, was found. No coursing was visible, but large irregular blocks of stone appear to have

been used as facing. The SE end was open, presumably an entrance. The structure appeared to have been cut into the SW edge of the adjacent cairn to a depth of 0.5m to 0.7m.

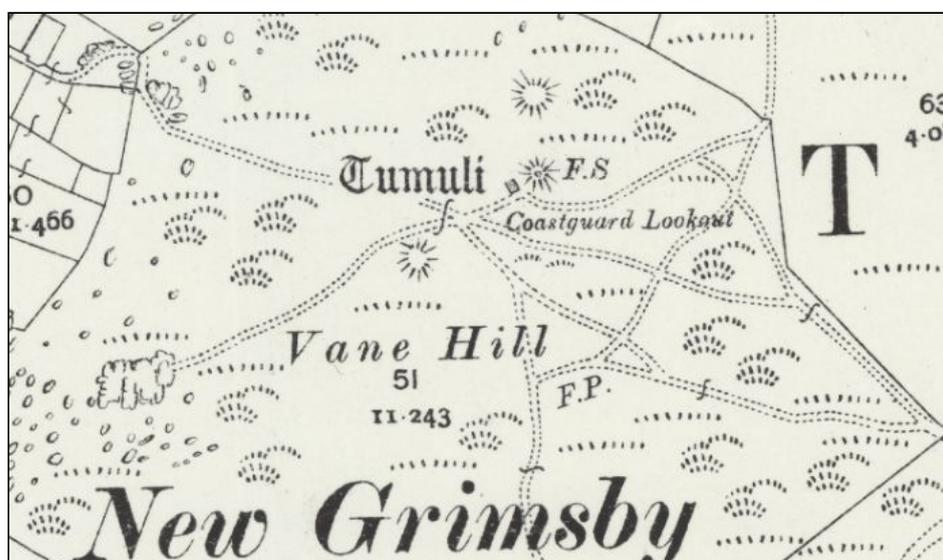
Figure 3: OS 1:25 inch (1892 - 1914)

The presence of four, extant platform cairns on Vane Hill makes it unlikely that any further cairns are present that are as yet unknown. The cairns have been recorded since at least the late 1800s (Figure 3). When the existing large reservoir was erected on the top of Vane Hill in 2003 the only archaeological remains encountered pertained to 19th century quarrying on the hilltop (Taylor 2004), possibly in advance of the construction of the coastguard's lookout.

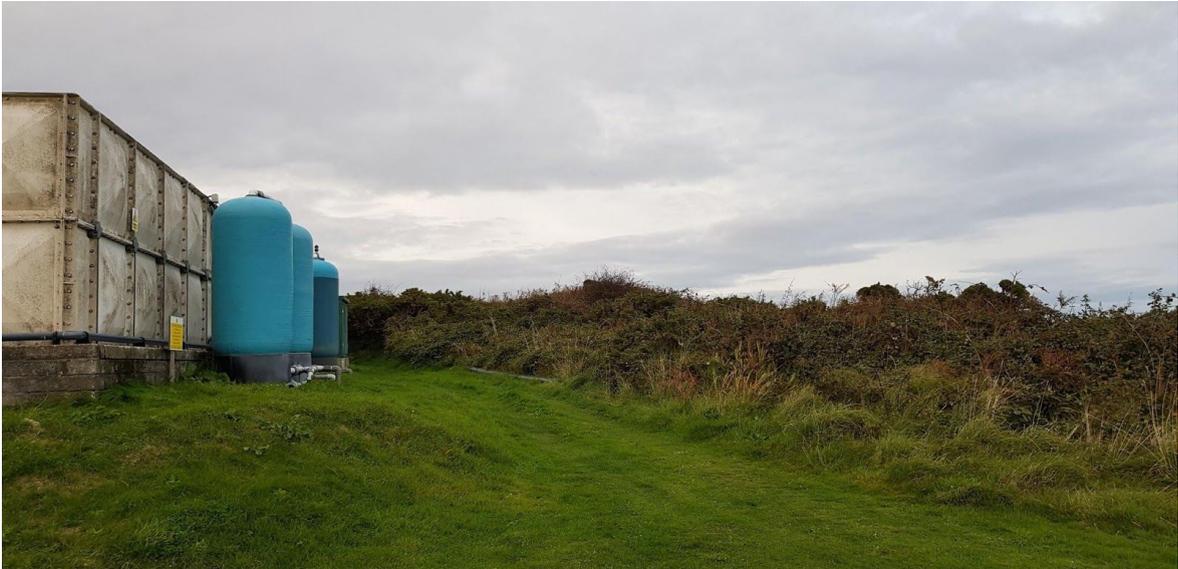
Plate 5: The existing reservoir with PDS opposite. Cairn 'B' is visible as the rise to the rear of the plate.

As this Heritage Assessment has already outlined, the PDS sits in an area occupied by three scheduled ancient monuments. Two of these are around 50m to the west of the PDS and therefore will not be physically disturbed by the erection of the proposed structure. They are also obscured from view from the PDS by the large double-tanked reservoir which occupies the summit of Vane Hill (Plates 5 & 6), so it cannot be argued that they will be impacted visually by the development.

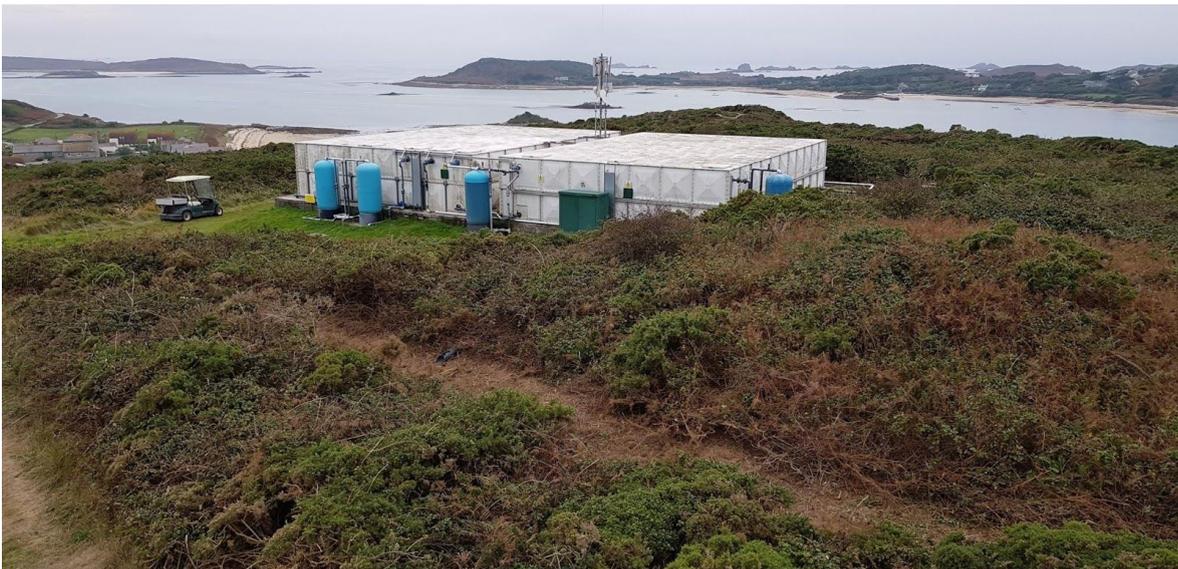
Plate 6: The reservoir on the summit of vane hill. Cairn 'B' is visible as the slight mound on the right of the image and the boundary of the SAM (3) within which it sits extends to roughly half-way along the right-hand water tank. Cairns 'C' and 'D' (1 & 2) are on the far side of the reservoir.
