## **PRELIMINARY ECOLOGICAL APPRAISAL & PRELIMINARY BAT ROOST ASSESSMENT OF:**

# **THE PACKING SHED HIGHER TOWN ST MARTINS ISLES OF SCILLY TR25 0QL**

*Report date: 16<sup>th</sup> November 2018*

*Author: Darren Mason BSc (Hons)*

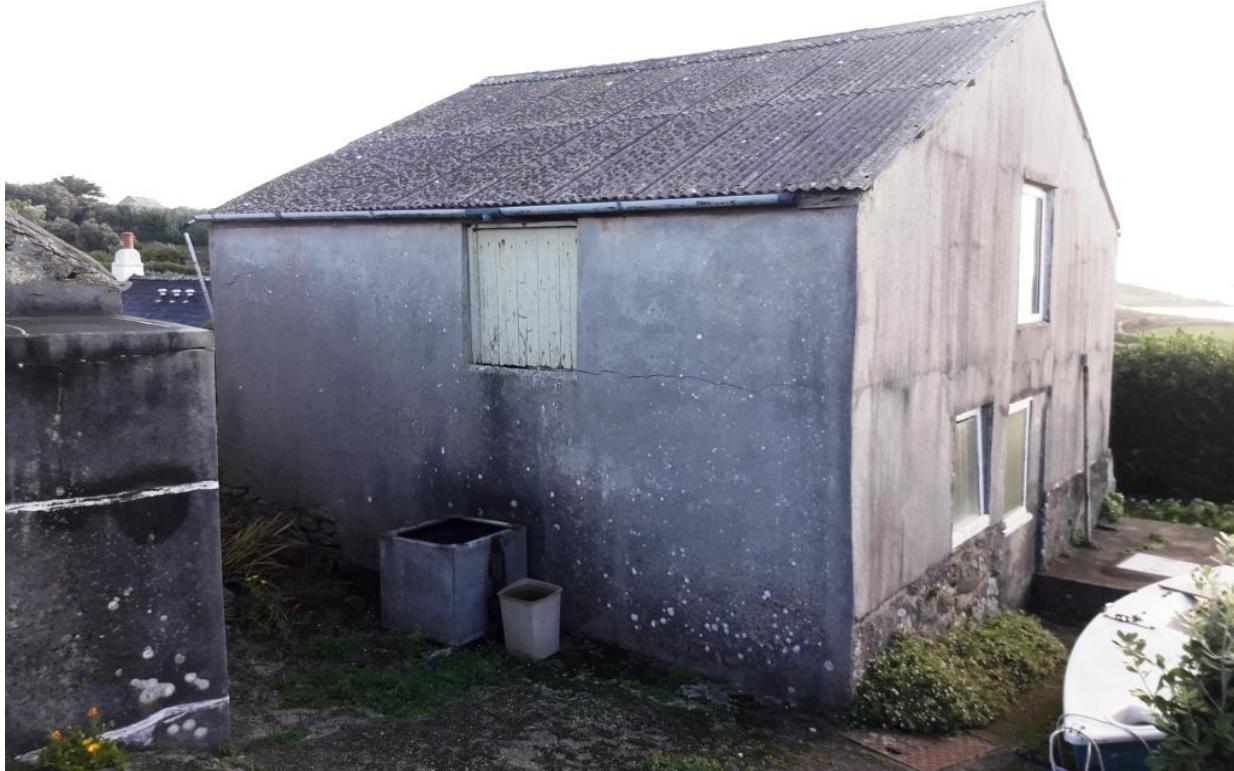
*Photo 1.*

The house is located on the eastern edge of Higher Town, St Martin's (National Grid Reference SV9307715535, Figure 1.). The application site is comprised of a part stone, part single-skin rendered two-storey former bulb shed, with a corrugated cement fibre roof (Photo 1). The footprint of the building is approximately 40m<sup>2</sup> and the sites total footprint approximately 200m<sup>2</sup> (red area, see Figure 1).

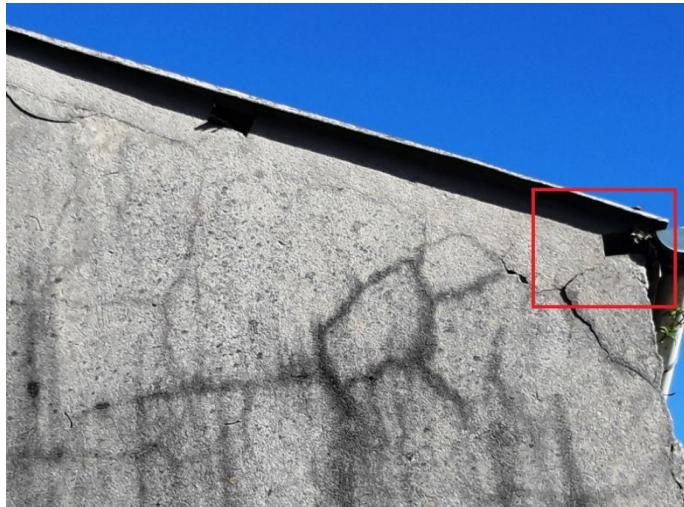
- Gap between the block-work and the wall plate due to the rotting away of the wooden frame at the south-west/south-east corner (see photo 2.)
- Gap into roof space on south-west aspect, due to rotting away of the 1<sup>st</sup> batten above the eaves (see photo 3.)

*Photo 2. Gap between wall plate and block work*

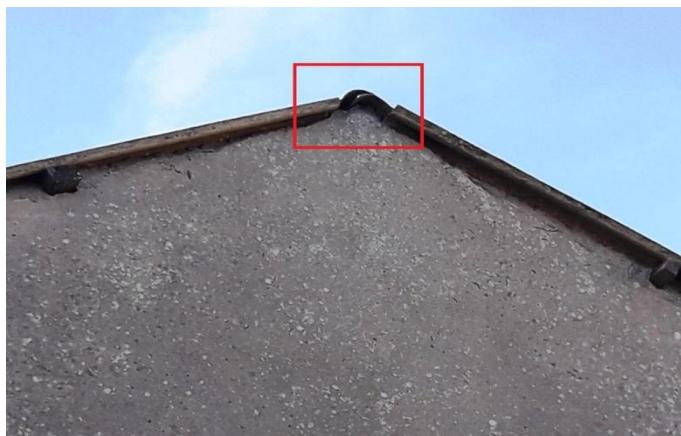
- Gap between south-west gable end ridge tile and corrugated roof sheets (see photo 4.)
- Gap between the south-east aspect ground floor window and the render/block work (see photo 5 and 5a)

*Photo 4. Gap between ridge tile and roof sheet*

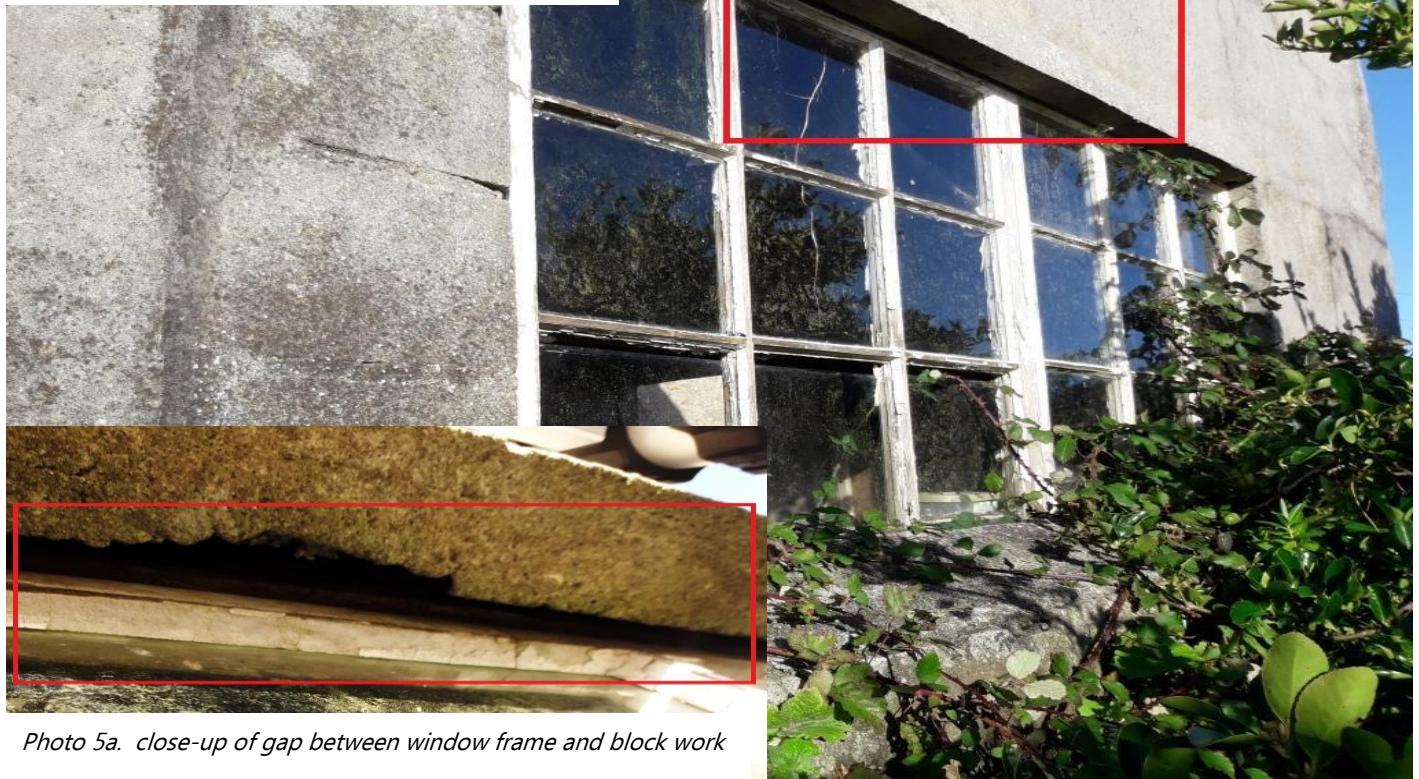
*Photo 5. Gap between window frame and block work*

*Photo 5a. close-up of gap between window frame and block work*

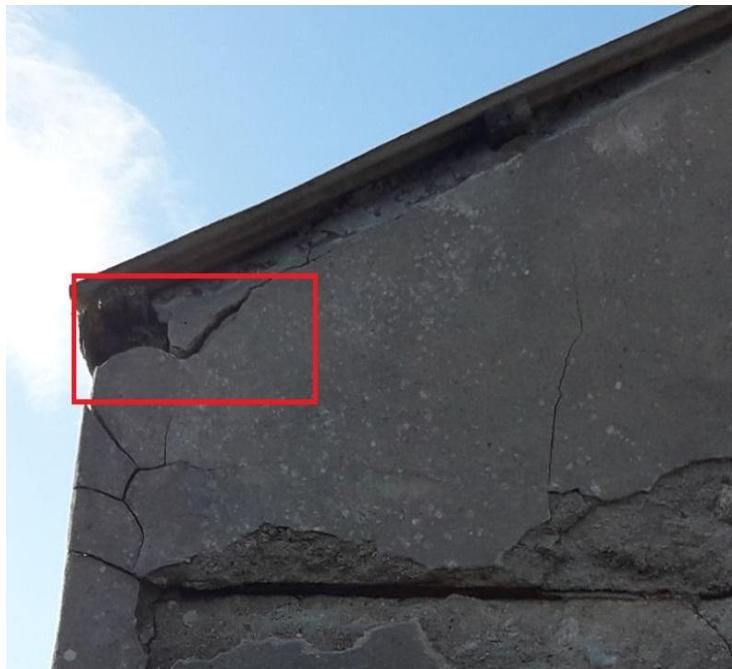
- Large crack in render and block work and gap between the rotten wall plate and block work at the eaves at north-eastern corner of the north-east aspect (see photo 6.)

*Photo 6. Crack in render and gap behind wall plate*

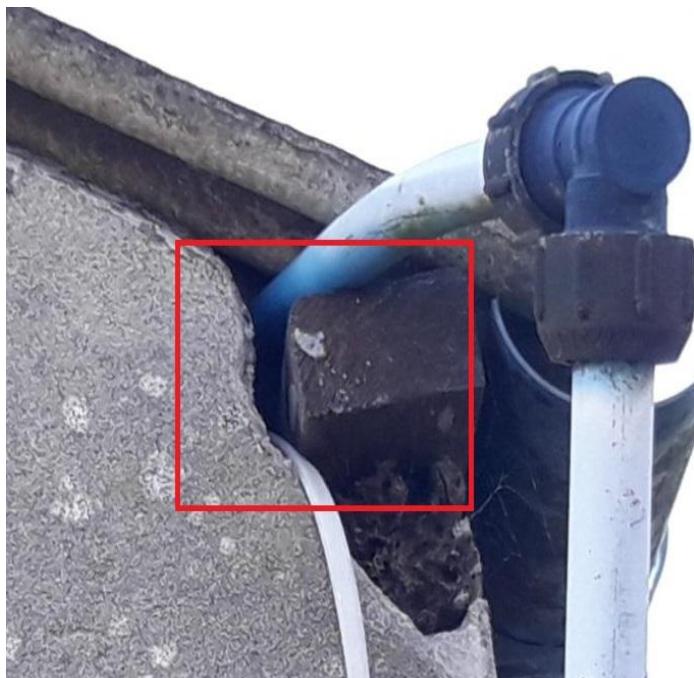
- Gap between block work and render and 1<sup>st</sup> –floor floor joist above door on north-east aspect (see photo 7).
- Gap behind wall plate and block work, where water and power cables enter the eaves at the north-western corner of the north-east aspect (see photo 8.)

Photo 8. Gap behind wall plate for services

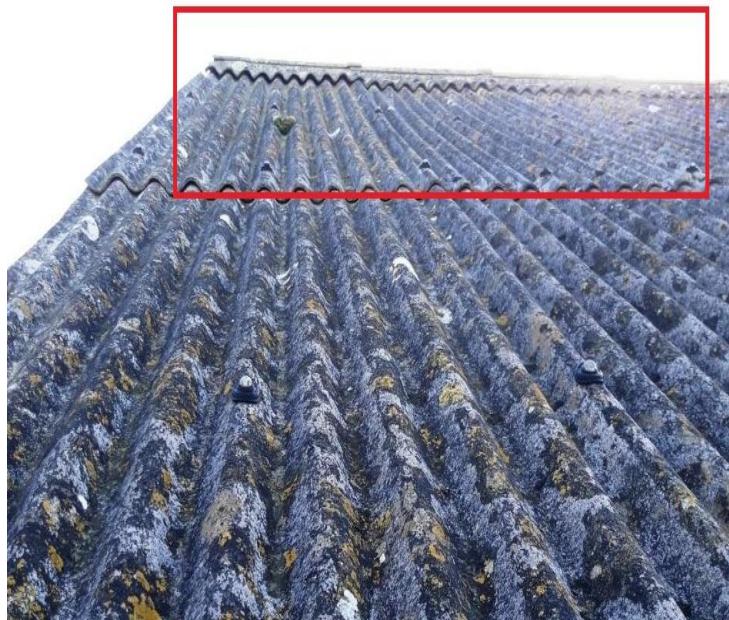
- Gaps between the north-east gable end ridge tile and corrugated roof sheet for approximately 2m (see photo 9).
- Gap in framework around 1<sup>st</sup> floor wooden hatch on the north-west aspect (see photo 10.)

Photo 9. Gap between roof ridge tile and corrugated roof sheet

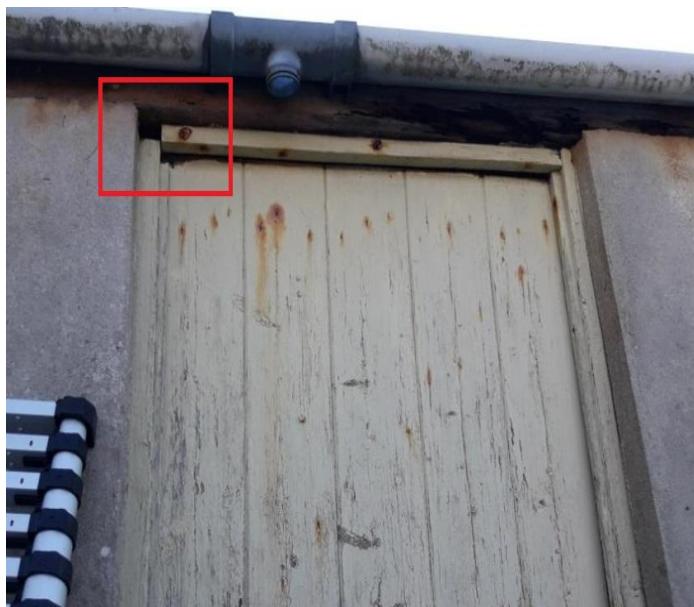
Photo 10. Gap in wooden surround of 1<sup>st</sup> floor hatch

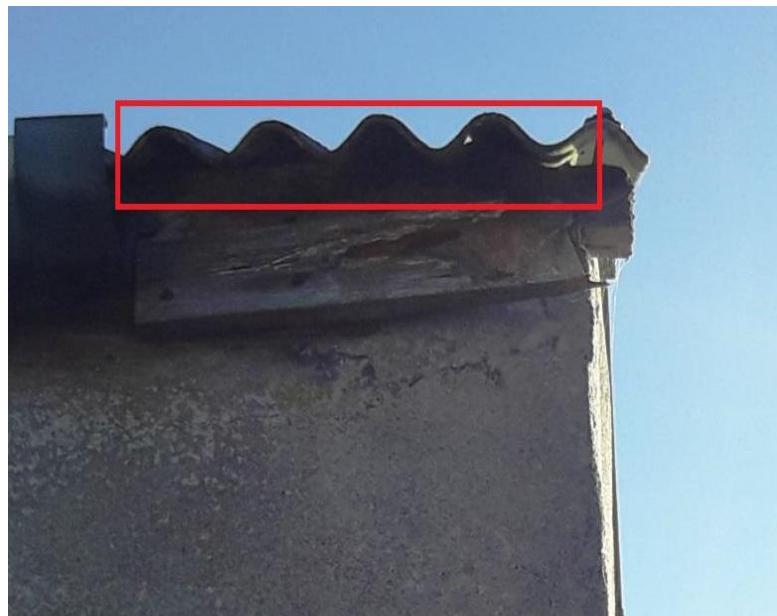
- Gaps between wall plate and corrugated roof sheets where the guttering has come away at the eaves at the south-west corner of the north-west aspect (see photo 11.)

Photo 11. Gaps between wall plate and corrugated roof sheets

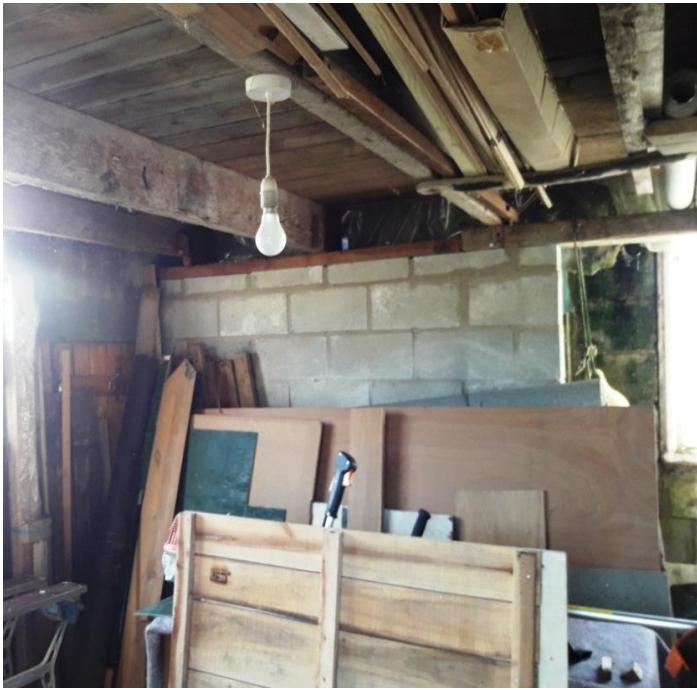
Internally, the packing shed ground floor is open and used primarily for storage (see photo 12.). Along the north-west wall there is floor to ceiling shelving and in front of this a set of wooden stairs up to the 1<sup>st</sup> floor. Examination around the windows and on top of the stored items revealed no evidence of bat droppings. However, numerous Lesser white-toothed Shrew (*Crocidura suaveolens*) and House Mouse (*Mus musculus*) droppings were obvious, particularly along the damp south-west window sill and along the full length of the shelving on the north-west wall.

Photo 12. Open ground floor

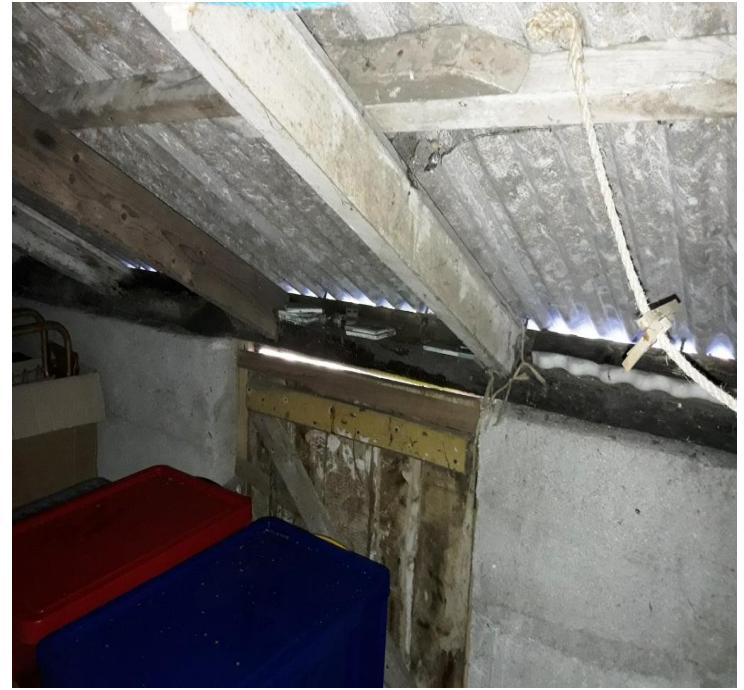
Photo 13. 1<sup>st</sup> floor showing exposed roof sheets

The first floor was divided into two spaces; the first which encompasses the stairs and everything to the north-west (one third) reveals the roof-space fully, clearly showing the gaps between the wall plate and the corrugated roof sheets (see photo 13.). This small area is used for storage and examination of the tops of the boxes revealed several small droppings found in the north-east corner of the north-west aspect, below where the water pipe enters the building (see photo 14). The droppings were found on the top of a box adjacent to a wardrobe (see photos 15 and 15a). These were taken away for examination. The lengths of the droppings were 9mm long by 2mm wide. The texture when broken-up, was of a very fine consistency. These findings are consistent with droppings at the upper size range for a pipistrelle species of bat.

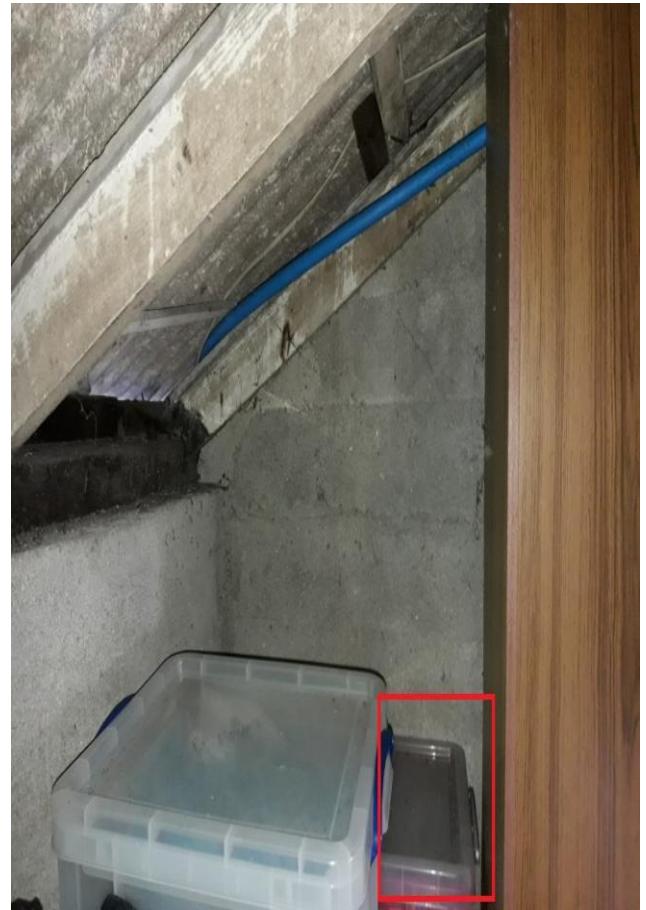
Photo 14. Location of where droppings were found

To confirm whether or not the packing shed continues to host roosting bats, further surveys (see section 5.3) carried out during the bat active season would need to be undertaken.

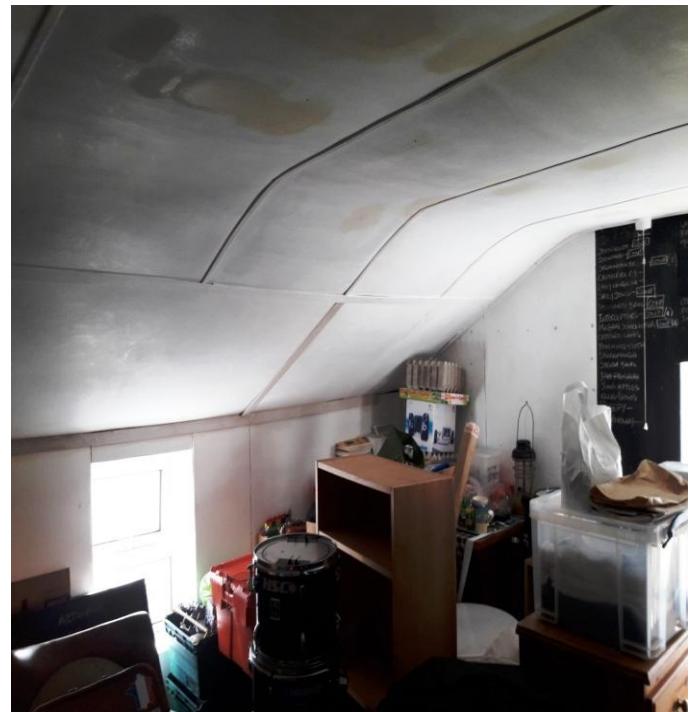
Entering the second space on the 1<sup>st</sup> floor revealed that the whole of this area was clad making an inspection of the remaining roof structure impossible (see photo 17.) Likewise, the wardrobe (as seen in photo 14.) prevented inspection of part of the north-east gable end. Inspection of the window sills, the tops of the stored items and floor of this room revealed no apparent evidence of bat activity.

*Photo 17. Remaining two-thirds of the 1<sup>st</sup> floor*

The survey was undertaken at a time of year suitable for undertaking preliminary bat roost assessments. However, due to the cladding of two-thirds of the 1<sup>st</sup> floor, there was limited space to inspect a large proportion of the roof structure (internally).
