Preliminary Bat & Bird Assessment & Bat Survey Report Version 2

Norrard, Tresco, Isles of Scilly

28th June 2019

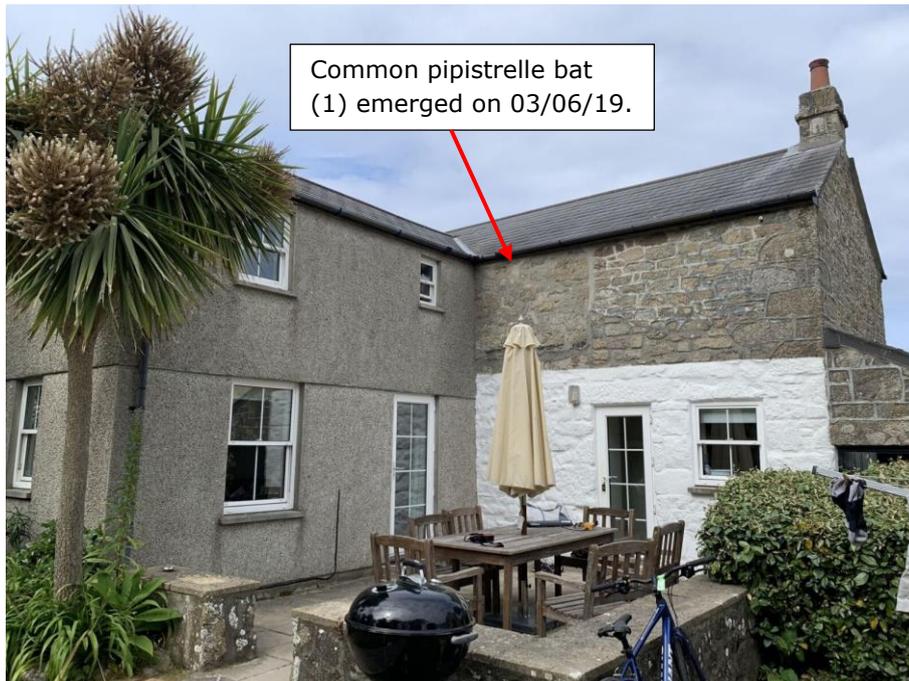
Figure 1: West elevation of Norrard. Red arrow shows emergence point of common pipistrelle bat (1) from beneath fascia.

bat emerged from beneath the fascia board on the west elevation (Fig 1). During the second emergence survey on 17th June 2019, a single common pipistrelle bat emerged from beneath a hanging tile on the gable end of the west projection (Fig 4).

The combined survey results indicate that at least three common pipistrelle bats currently use the building 'Norrard' (gap beneath fascia board on the western elevation (Fig 1) and gaps beneath hanging tiles on the gable end of the west projection (Fig 4)) as a day roost.

- Two 1FE Schwegler bat access panels with back plate will be installed on the south-west elevation of the proposed new extension (Appendix 1). The position of the bat access panels has been chosen to replicate the identified bat access locations. In addition, a c. 30mm gap will be left beneath the wooden fascias on the south-west elevation. See <https://www.nhbs.com> for product specification.

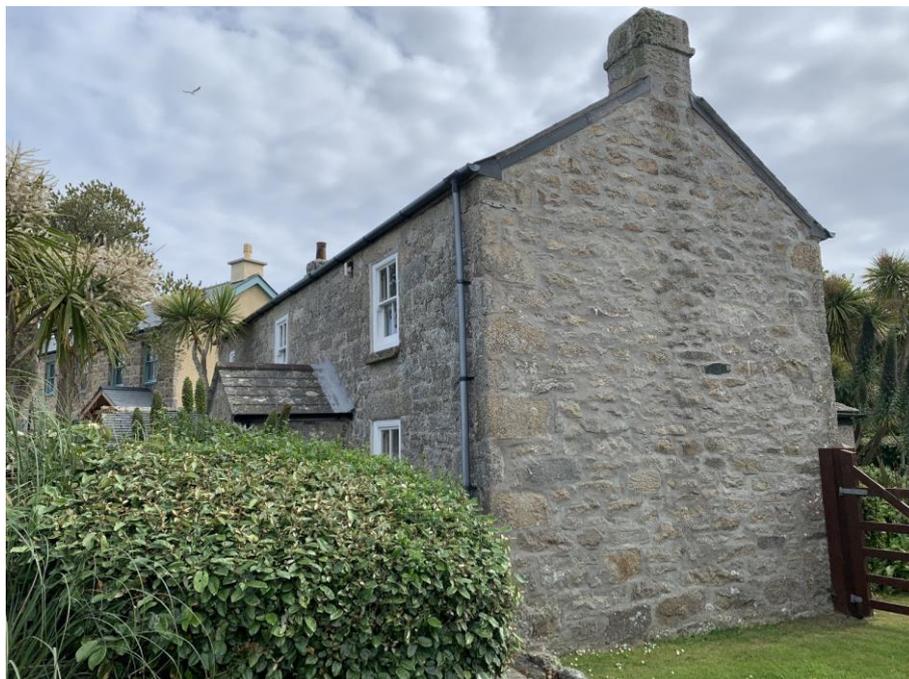
The assessment was undertaken on the 3rd June 2019. The two-storey property is of stone construction with a pitched slate roof, concrete ridge tiles and a single chimney (Figs 1-4). It has a two storey, perpendicular extension to rear, constructed from block work with a pebble-dashed render finish. There are gaps beneath the wood fascias on the west elevation (Fig 6), gaps beneath slipped tiles on the east elevation (Fig 5) and gaps beneath clipped hanging tiles at the gable end of the western projection (Fig 7). These features provide potential features for roosting bats. There are two small single-storey projections off the east elevation with a pitched slate roof (Fig 3) and a lean-to off the north elevation (Fig 4).

Figure 2: North elevation of Norrard.

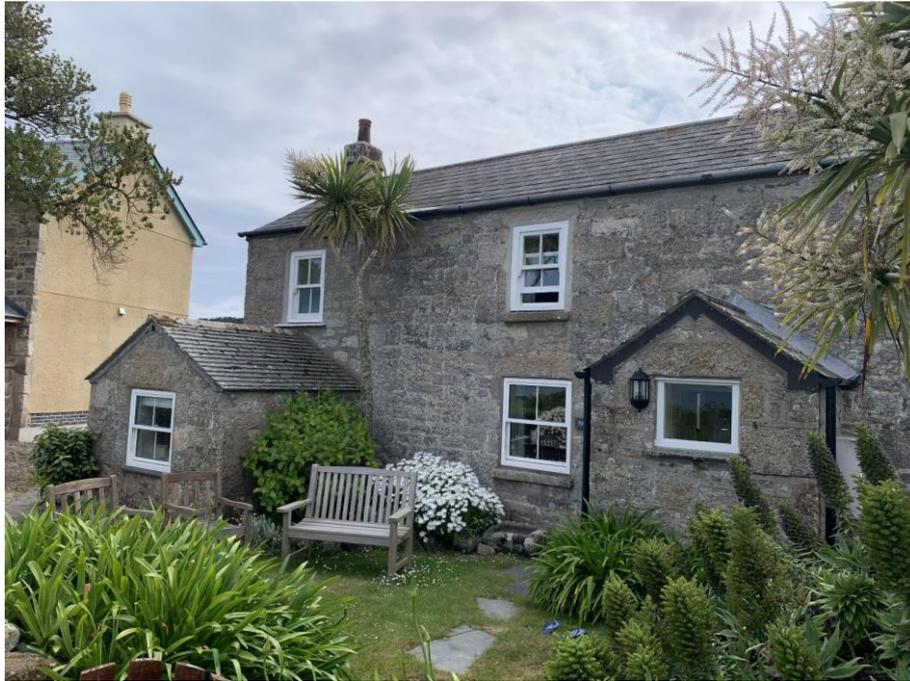
Figure 3: East elevation of Norrard.

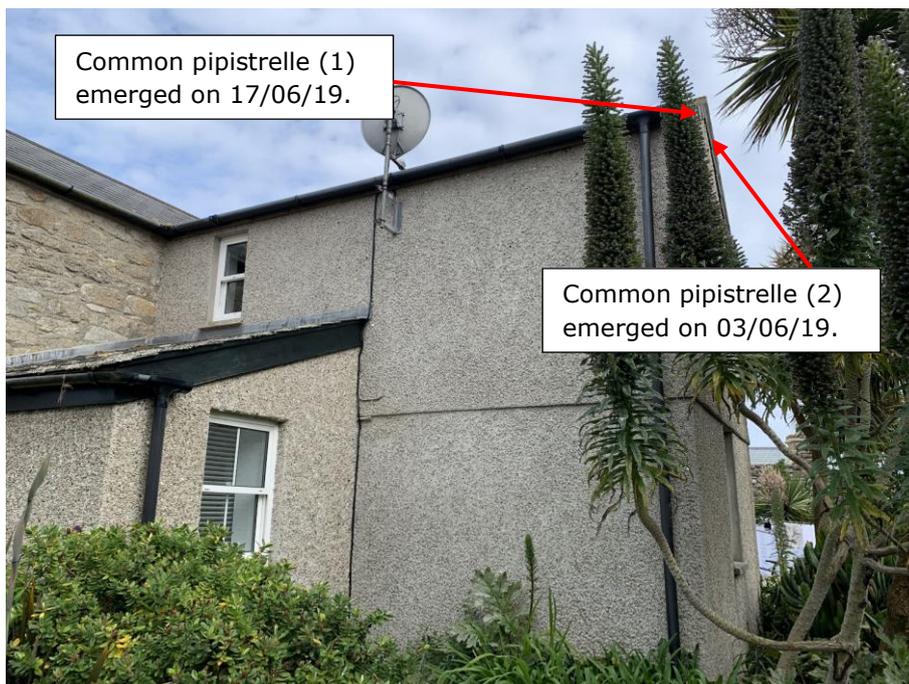
Figure 4: North and west elevations of western projection. Red arrows show emergence points of common pipistrelle bats from beneath hanging tiles.

During the emergence survey on 3rd June 2019, two common pipistrelle bats emerged from beneath a hanging tile on the gable end of the west projection (Fig 4), and one common pipistrelle

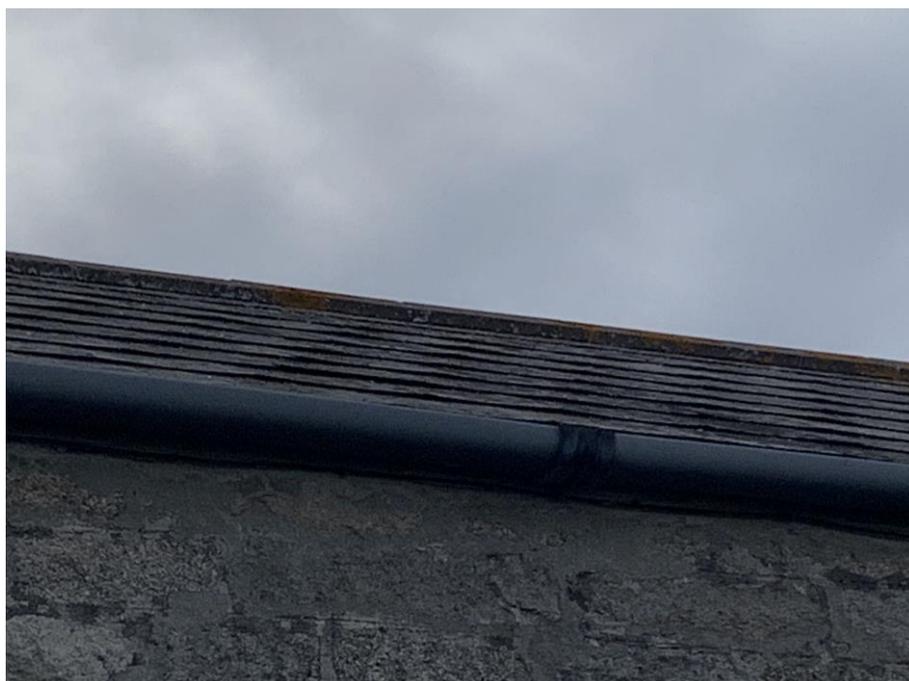
Figure 5: View of gaps beneath tiles on east elevation.

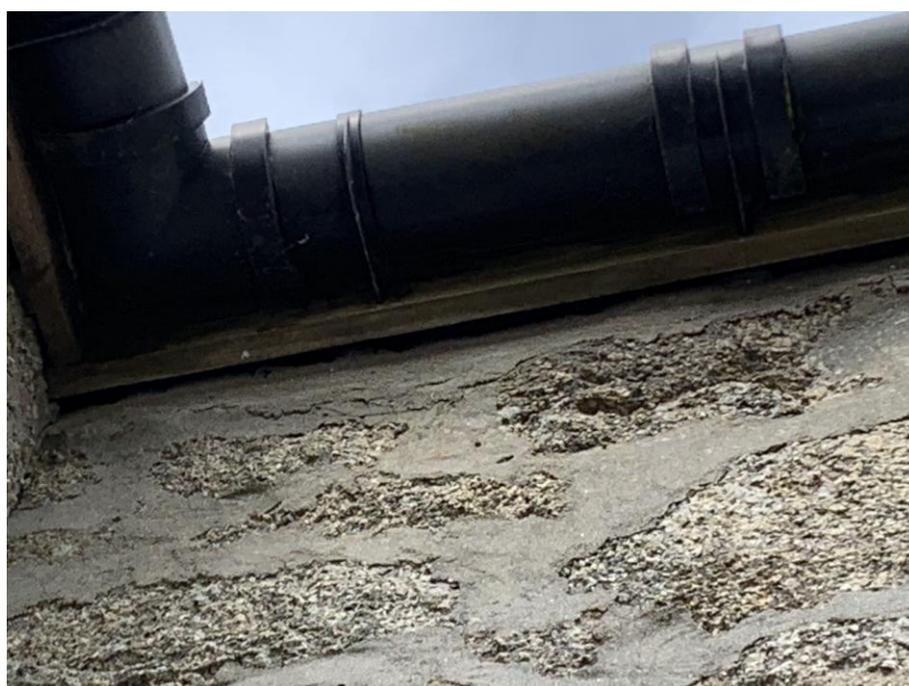
Figure 6: View of gaps beneath fascia board on west elevation.

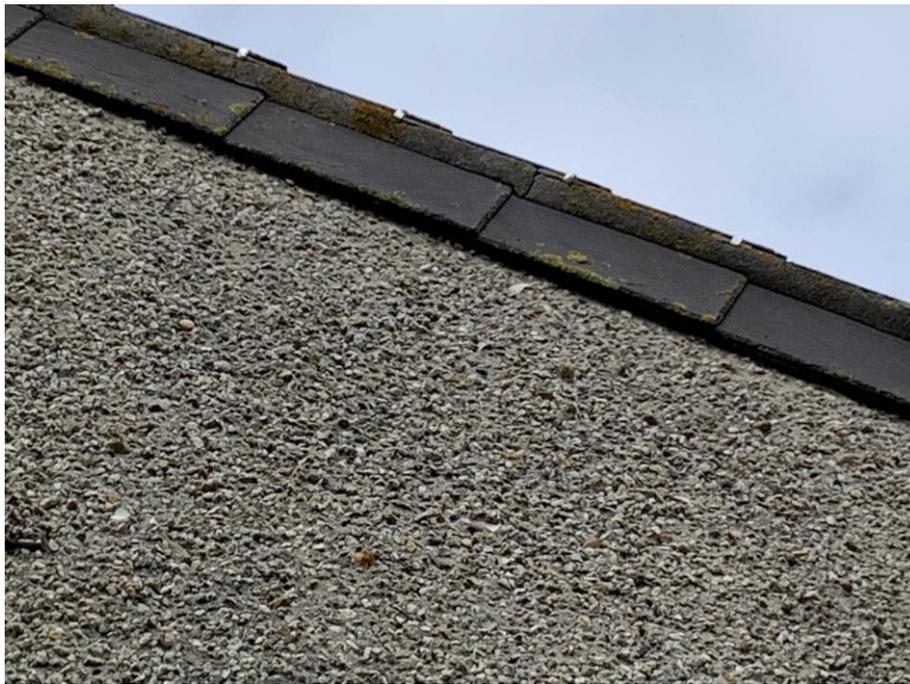
Figure 7: View of gaps beneath hanging tiles at gable end of western projection.

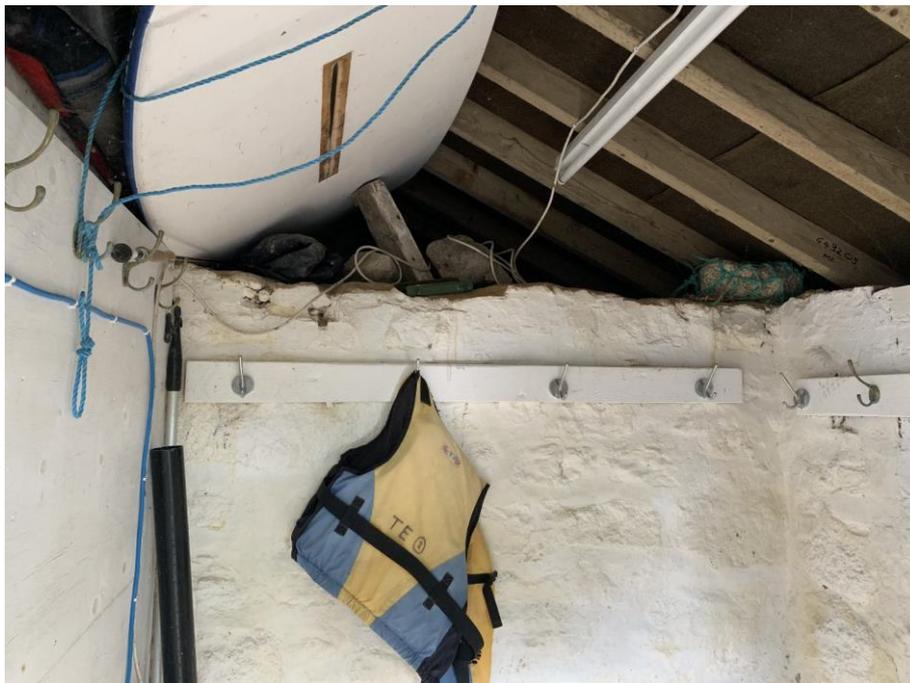
A lean-to shed with a slate roof is situated off the south elevation. Internally, the shed is lined with bitumen, densely cobwebbed and open to the roof timbers. The shed is separated internally with a stone wall to head height. The void continues above and there appears to be a room beyond which is inaccessible (Fig 8). There was no evidence of bats within the shed.

Figure 8: View of interior of shed, showing inaccessible space beyond.

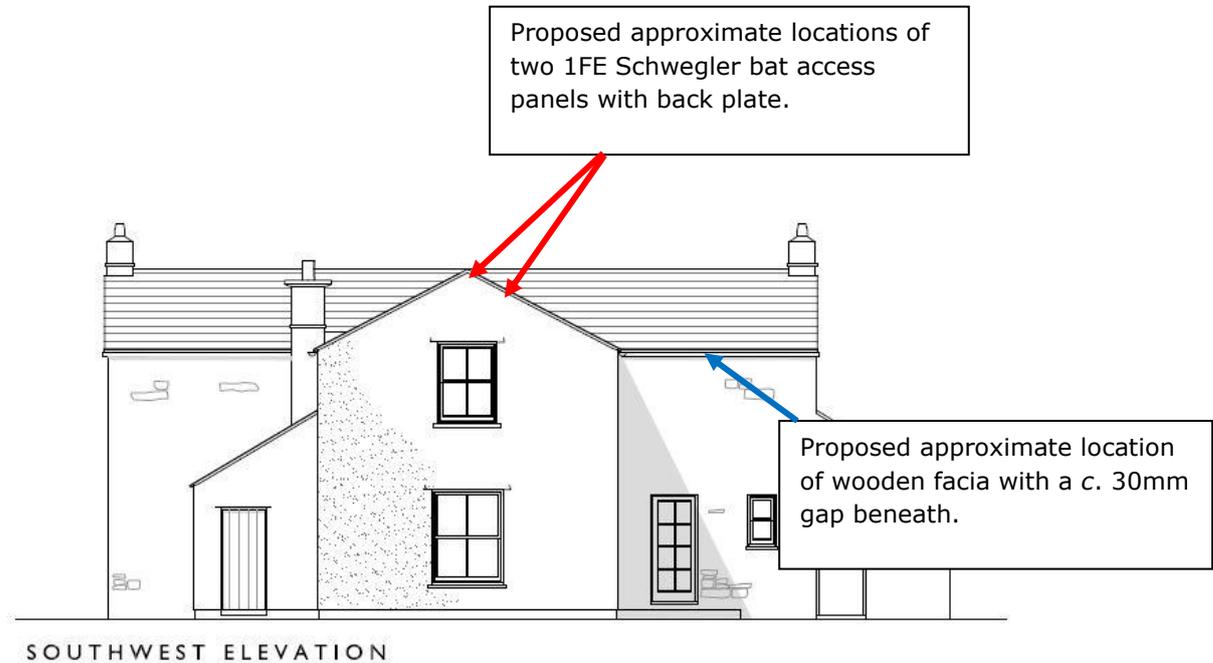
Appendix 1 – Site proposals showing bat mitigation

Proposed south-west elevation of the property post-development showing location of proposed bat mitigation.
