PERMISSION FOR DEVELOPMENT

Application No: P/19/041/HH

Proposal: Replacement of corrugated asbestos sheeting roof with terracotta double roman tiles.

PRELIMINARY ECOLOGICAL APPRAISAL & PRELIMINARY BAT ROOST ASSESSMENT OF:

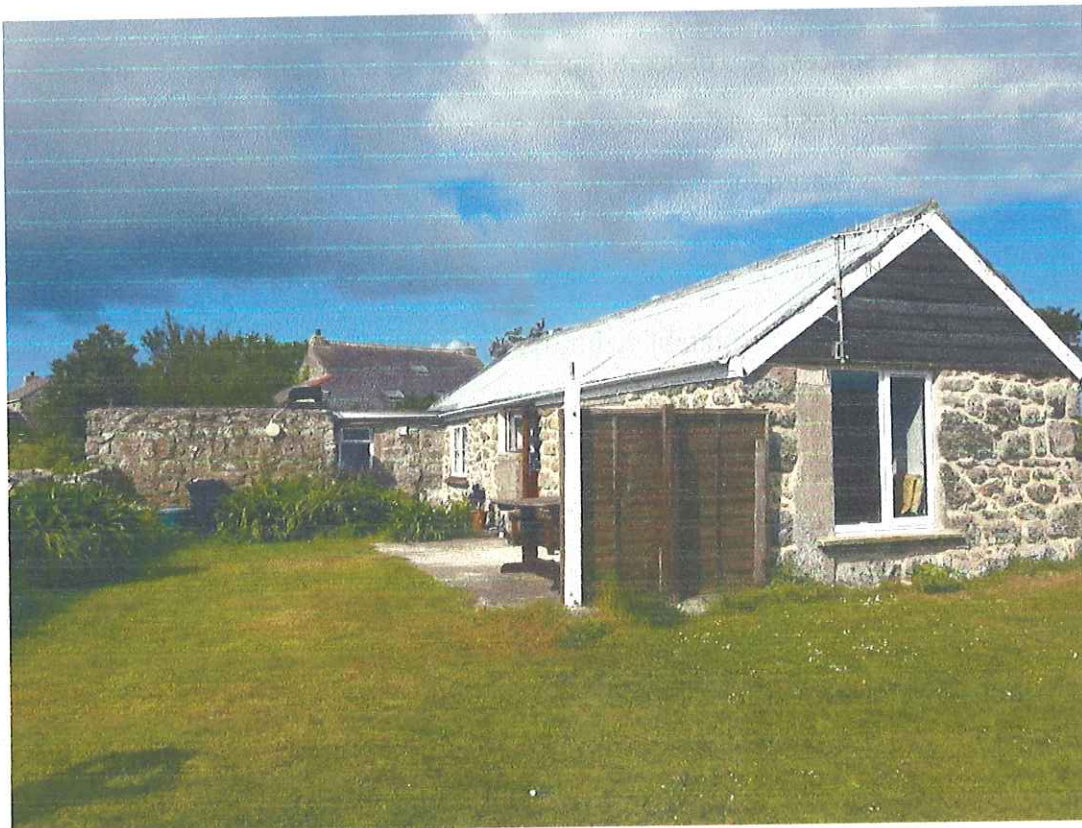
Photo 1.

This report details the results of a preliminary ecological appraisal and a preliminary bat roost assessment of The Hump, Higher Town, St Agnes, Isles of Scilly TR22 0PL (photo 1). The survey, carried out on 3rd June 2019, was undertaken in order to inform proposals to replace the existing main roof and the roof of the bathroom extension with a double roman pantile clay tiled roof.

The Hump is a single story granite cottage with a pitched roof (photo 1) and an extension built onto the southern aspect, this contains the bathroom and water tank. The structure is located in Higher Town, St Agnes on the eastern side of the island (National Grid Reference SV 88391 08317, Figure 1.). The application site footprint is approximately 343m².

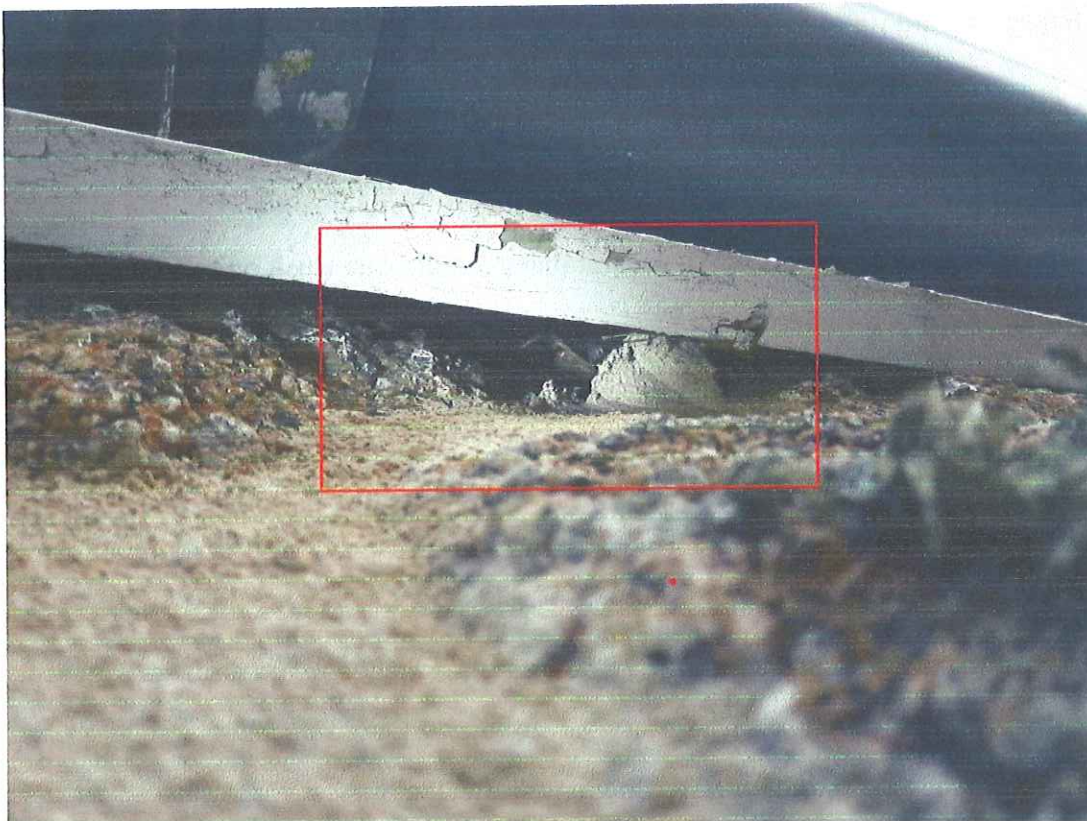
Photo 11.

All wild birds are protected under the Wildlife & Countryside Act 1981 (as amended). Section 1 of this Act makes it an offence to kill, injure or take away any wild bird, or intentionally take, damage or destroy the nest of any wild bird while that nest is in use or being built. During the survey the remains of a dead bird was found in a space behind the fascia on the southern aspect (photo 11). If breeding birds are found during any stage of the works, then all work must stop until the last bird has fledged and left the structure and the structure is no longer being used, so as not to contravene the Wildlife & Countryside Act 1981 (as amended).
