Bat Survey Report

Site: Racket Town, Tresco, Isles of Scilly

9th July 2020

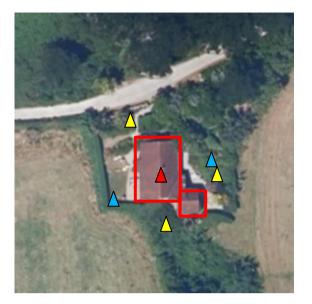
Figure 1: Emergence surveys – surveyor locations. Racket Town is outlined in red. Blue triangles show surveyor locations on the first emergence survey, yellow triangles show surveyor locations on the second emergence survey, and the red triangle shows the location of the static detector within the roof void.

To provide more detailed information about bat activity, a static detector survey was carried out of the building between the nights of 11th and 15th June 2020. A static bat detector (Anabat Express) was installed within the interior of the roof void (Fig. 1; red triangle). The detector was set to record continuously overnight (30 minutes prior to sunset until 30 minutes after sunrise) for a total of 5 nights. The Anabat Express uses the frequency division method of detecting as described in Section 3.2 above.

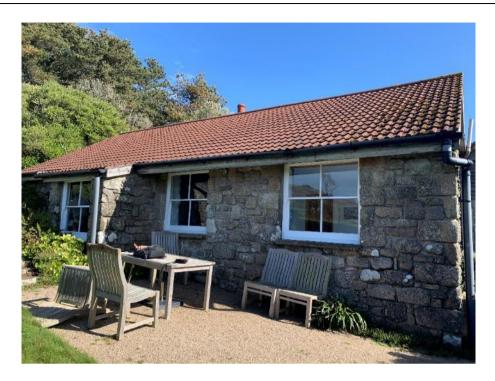
The property 'Racket Town' is a single-story building of stone construction with a pitched roof and a small porch (Figs 2-4). The roof is of interlocking clay roof tiles with clay ridge tiles (Figs 2-4). There are wooden fascias and soffits; on the southwest corner the fascia is rotten. There is wooden cladding on the north and south elevations (Figs 3-4). There is a small projection off the south-eastern elevation, which is clad with ivy (Fig 5). There is a concrete chimney on the eastern elevation and gaps were observed under the lead flashing. Gaps beneath the lead flashing and a gap in the rotten wooden fascia board provide potential habitat for roosting bats/ provide potential bat access to the building interior.

Figure 2: View of the west elevation of Racket Town.

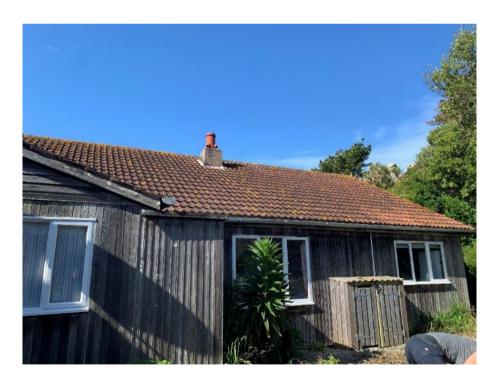
Figure 3: View of the east elevation of Racket Town.

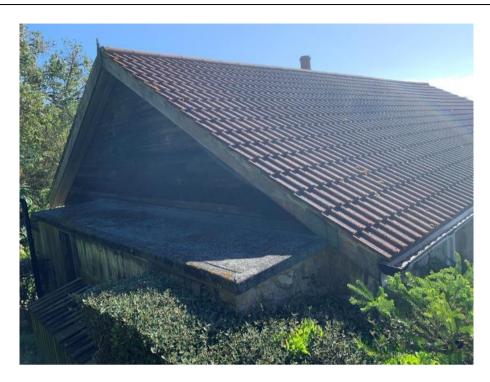
Figure 4: View of the north elevation of the Racket Town.

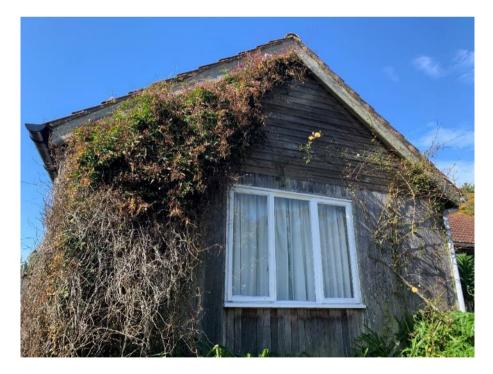
Figure 5: View of the eastern elevation of the south-east projection of Racket Town, showing dense ivy.

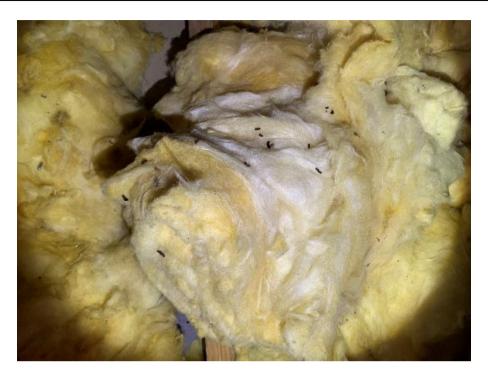
Internally, the roof void supports a fink style traditional wooden roof structure, is bitumen lined, with rolled insulation between the joists. The void measures c. 1.5 m to the apex. Gaps at the wall tops with potential to permit bats access/ provide roosting locations were observed. During the initial visual assessment, c. 50 bat droppings were observed scattered throughout the roof void (Fig 6) and a further cluster of c. 10 bat droppings were observed beneath, and on, the internal chimney breast. No fresh droppings were noted during the inspection on 25^{th} June 2020.

Figure 6: View of the bat droppings scattered throughout the roof void.

- Provision for day roosting brown long-eared bat will be made in the modified building by retaining a roof void measuring c. 4m (length) x 4m (width) x 1.5m (height). Suitable bat access into the roof void will created by spacing off the fascia boards by 25mm to create a gap behind for bats to access at the wall tops, or installation of two bat slates onto each of the eastern and western aspects of the roof with a corresponding slit created in the felt underneath to enable brown long-eared bats to access the roof void below. Alternatively, two raised ridge tiles featuring a gap as described above with corresponding slit in the roof membrane can be used to provide access to the roof void. The roof must be lined with type 1F bitumen as opposed to a synthetic breathable membrane, which can be harmful to bats.

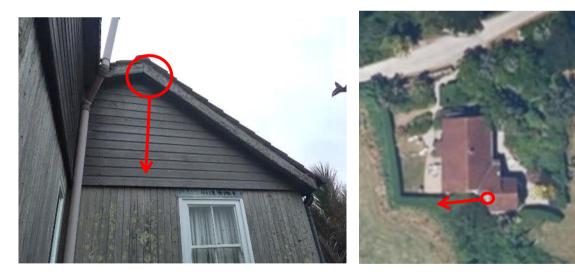
During the first emergence survey on 11^{th} June 2020, no bats were seen to emerge from the building. During the second emergence survey on 25^{th} June 2020, a single common pipistrelle was seen to emerge from the building, from a gap behind the soffit on the western face of the southeastern projection (Fig 7).

Figure 7: West elevation (left) and aerial view (right) of the south-east projection, showing emergence location of a single common pipistrelle bat on 25th June 2020.

Racket Town likely supports an occasional day roost for a single non-breeding common pipistrelle bat. The location of the roost is likely within a gap behind a fascia board/ soffit on the western face of the south-eastern projection (Fig. 7). This roost is considered to be of **low conservation significance** for common pipistrelle bat.

- The existing common pipistrelle day roost behind the soffit on the west elevation of the south-eastern projection will be lost to allow for the development. Loss of this roost will be compensated by creation of a new roost feature within the refurbished building. This could either take the form of spacing off of fascia boards by 25mm to create a gap behind for bats to roost within, or installation of a single Schwegler 1FE bat access panel with back plate within the fabric of the building, to be located at least 4 metres above ground level, on a south or west elevation of the property post-development.
