# PRELIMINARY ECOLOGICAL APPRAISAL & PRELIMINARY BAT ROOST ASSESSMENT OF:

# 16 JACKSONS HILL ST MARY'S ISLES OF SCILLY TR21 0JZ

Our reference: BS31-2020

Report date: 3rd July 2020

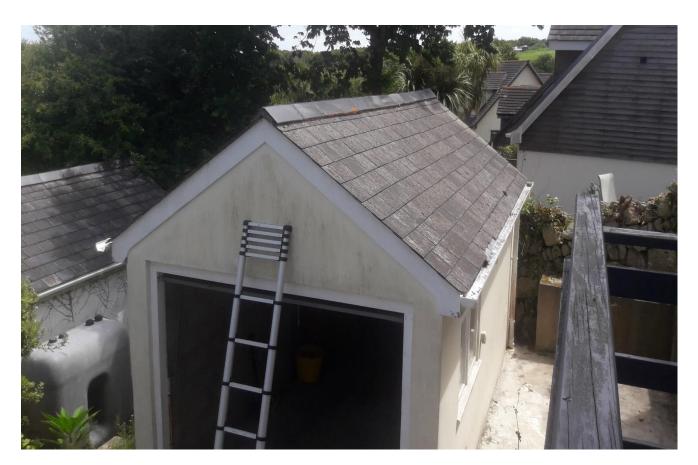
Photo 1.

The planning application (P/20/023) proposes the extension of the detached garage (see photo 1.) southwestward to link with the main house which includes the removal of the garages south-east elevation and the removal of the pitched roof for an extended flat roof.

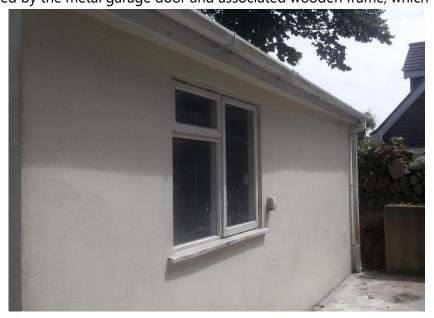
Photo 2.

The detached garage at 16 Jacksons Hill is block-built, single-skin and smooth-rendered in construction. The render is in good condition throughout (see photo 2.), with no cracks or lifted render for bats to roost behind. The north elevation is dominated by the metal garage door and associated wooden frame, which

is tightly bound to the external blockwork with no obvious gaps, providing no opportunities for bats to roost between or gain access into the interior of the building. Likewise, with the timber frame of the single-glazed window in the south-west elevation. Fascia is present along all the eaves and the north and south gable ends.

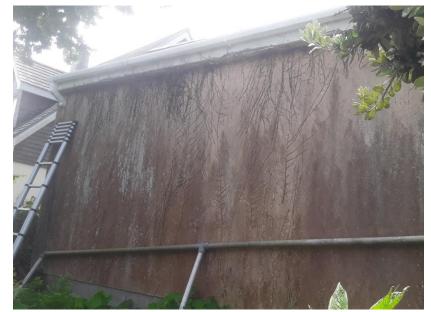
Photo 3.

west and north-east elevations. The north-east and southern elevations were once clad in ivy (see photo 3.), which has resulted in the bargeboard in the south-east corner rotting away, revealing the void between the fascia/soffit and block work of the garage (see photo 4.). Within this void a bird's nest was found (see photo 5.), most likely a Blackbirds (*Turdus merula*). The void could have offered

suitable roosting space for bats, but with the removal of the ivy the void is now too exposed and not likely to be used. The roof of the garage has an approximate pitch of 28<sup>0</sup> with a south-west/north-east aspect. Constructed of well-fitting fibre cement 'faux' slate tiles and capped by glazed concrete ridge tiles which are well mortared to the tiles below the roof presents with no obvious roosting opportunities for bats.

Following the proposed renovation works, it is unlikely that suitable nesting habitat for this species will remain associated with this void. It is therefore recommended that mitigation measures to replace lost nesting features are incorporated into the design.

An open nestbox should be mounted 1.5m, or higher on a wall, but should ideally be concealed to aid predator avoidance. Therefore, the planting of a species that will cover the box in time will help with concealment. Climbing species such as Honeysuckle (*Lonicera pericyclemum*) or Ivy (*Hedera helix*) would be appropriate.

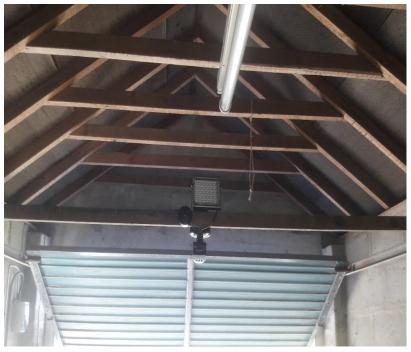
Photo 6.

The roofing membrane throughout was in good condition, presenting with no suitable roosting space for bats between the membrane and the roofing tiles above. Inspection of the wall plates, central braces of the 'A-frame' and the void between the south-west and north-east elevations and the soffit boards revealed evidence of House Mouse (*Mus* musculus) droppings, but no droppings that could be attributable to bats. A search of the floor below the rafters and ridge board revealed no bat droppings either, however it was made aware to the author from the owner of the garage that recently the garage had been cleared, including the removal of all the shelving and sweeping of the floor which is likely to have removed any other evidence, if present.

The well-constructed shell of the garage limits any potential roosting opportunities to the void at the south-east corner of the eaves. However, the removal of the ivy and the rotting away of the bargeboard is likely to leave this feature too exposed for bats. The external lighting and lack of suitable feeding habitat immediately surrounding the garage also reduces the likelihood as the development being used as a roost. Though the garage internally is

open and has suitable perches for void dwelling species of bat, the interior PIR and associated light that illuminates the rear of the garage and the exposed roof space and the garages regular use is likely to cause disturbance to such species.

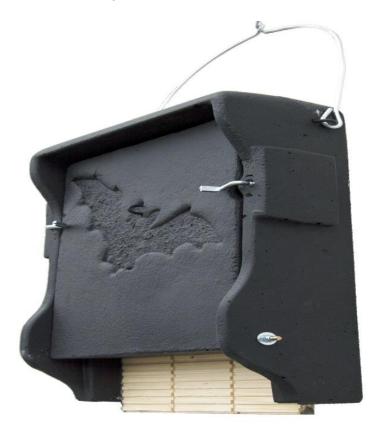
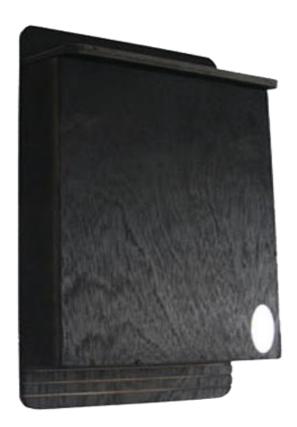
#### Figure 2. free-standing bat box examples

i. Erect two free-standing bat boxes developed for crevice-dwelling species (see figure 2 for examples and Appendix A for supplier details) one on each of the north and south-east elevations. Erect as high as possible below the fascia of the new flat roof.
