PRELIMINARY ECOLOGICAL APPRAISAL & PRELIMINARY BAT ROOST ASSESSMENT OF:

TREVEAN,
HIGHER TOWN,
ST MARTIN'S,
ISLES OF SCILLY,
TR25 0QL

Our reference: IoSWT-BS30-2020

Planning reference: P/20/026

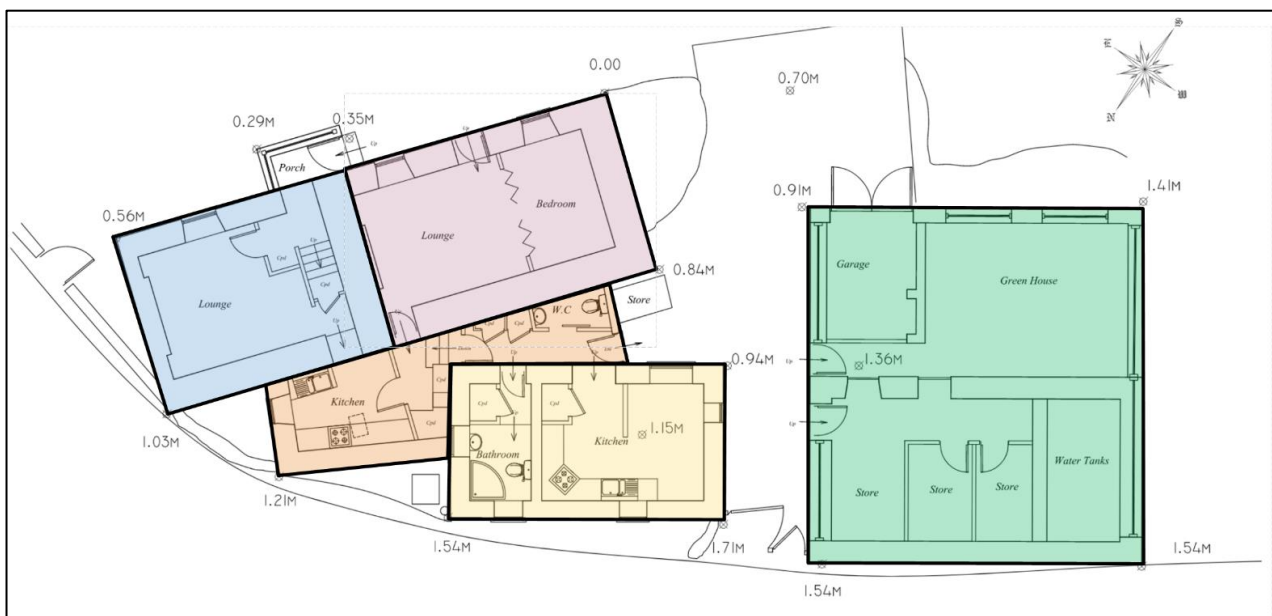
The main detached house can be considered to comprise four distinct components for the purpose of this report and these are indicated in **Figure 02** below. The main residential property comprises:

- a two-storey component with a higher ridge line (shown in blue in **Figure 02** below);
- a two-storey component with a lower ridge line (shown in purple);
- a single-storey kitchen (shown in yellow) and;
- a single-storey linking porch and second kitchen (shown in orange) attaching the main kitchen to the main two-storey components.

In addition to the main residential dwelling formed of the four contiguous components, there is a separate detached workshop/glasshouse is shown in green.

Figure 02 – showing the structurally or physically distinct components of the property – reproduced from the Existing Plans submitted by the Applicant in support of Planning Application P/20/026.

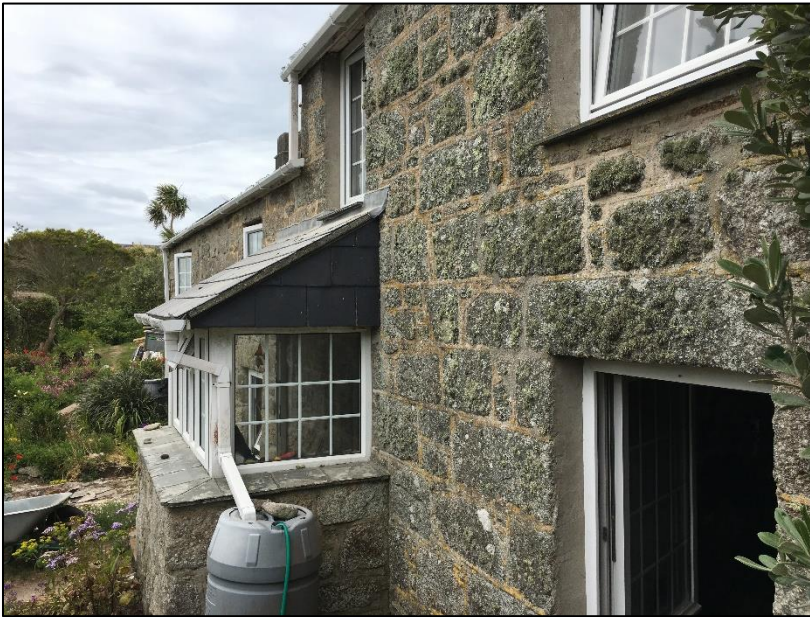
The building is constructed of granite block which are rendered externally in places and otherwise well-pointed and finished externally. The windows are uPVC and the frames are well-fitted offering no cavities suitable for use by roosting bats.

Photo 01 – showing the well-pointed granite exterior and well-sealed uPVC window characteristic of the building.

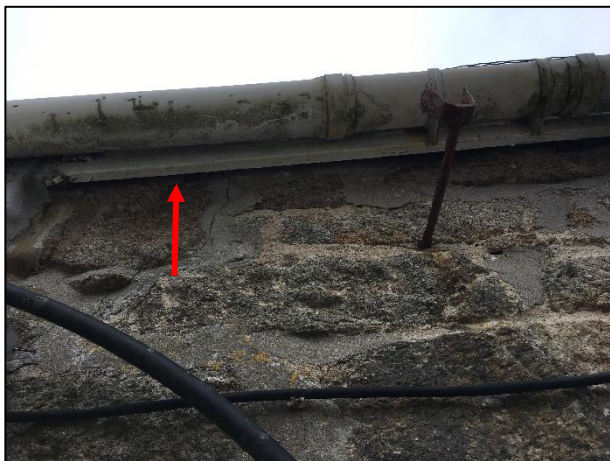
Barge/fascia boards run along the eaves of the roof with gaps created by the junction between the linear board and the irregular texture of the stonework to which it is attached. These present potential roosting opportunities behind the boards themselves as well as allowing access to the wall plate and to potential gaps between the felting and the slate tiles associated with the roof structure (**Photo 02**).

A number of nesting birds are confirmed in the building, all utilising access features associated with the barge/fascia boards and nesting around the eaves, presumably above the wall plate as nests are not visible from the interior of the building. Species confirmed include house sparrow and starling.

Photo 02 – showing the lifted fascia/barge board providing potential access behind – this is an example of a feature which is ubiquitous along eaves of the building.

During the survey, evidence of nesting birds was identified associated with the wall plate with access around the fascia/barge boards – these were also reported by the Applicant. Species confirmed included sparrows and starlings. The current nests are likely to have fledged at the time of determination of the current Application; however second broods may occur and if work was to commence between the months of March and August inclusive, then the site would need to be checked first for nesting birds. If any evidence of breeding activity was found, or nests are identified, then works that would disturb the adults, the nest or young must be postponed until all young have fledged the nest and it is no longer in use.

Following the proposed renovation works, it is unlikely that suitable nesting habitat for these species will remain associated with the wall plate. It is therefore recommended that mitigation measures to replace lost nesting features are incorporated into the design.

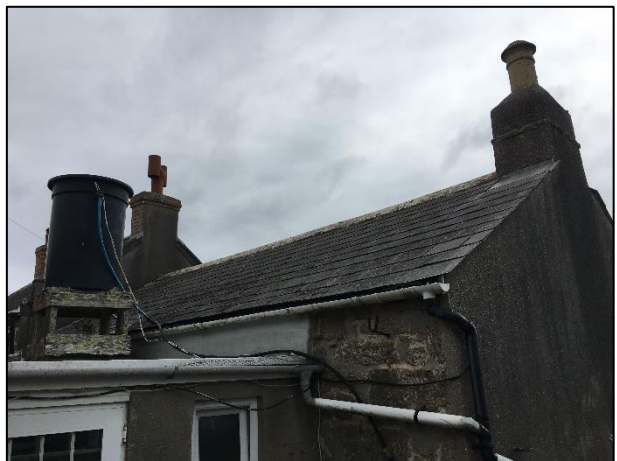
Photo 03 – showing the western portion of the building with the single-storey link in the foreground.

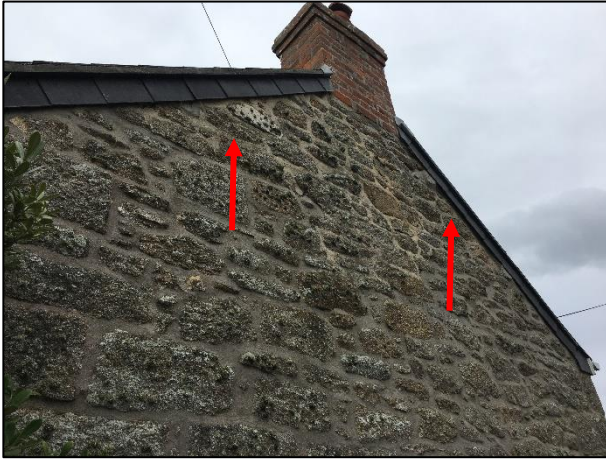
The lower-pitched western component of the building is tied in with the gable of the eastern component, around 1m below the roofline of the latter. The western gable of the eastern component of the building has render which appears slightly lifted which may offer minor niches for use by roosting bats (**Photo 03**). The verges of both gables on the eastern component of the building are lined with hanging slate tiles which appear to have gaps beneath them providing access to potential roosting opportunities (**Photo 04**). The western gable of the western component of the building is rendered to the verge and well-sealed throughout offering no potential roosting

opportunities. Three brick-built chimneys are present – one at the apex of both gable ends as well as one at the junction where the two building components join.

Photo 04 – showing the eastern gable of the building with hanging tiles along the verge and a well-pointed granite external wall. The brick-built chimney is also visible.

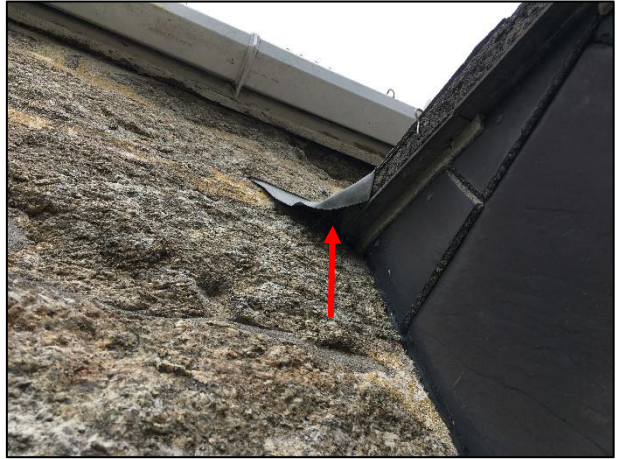
A small porch is attached on the southern aspect of the building – this has a sealed void above a well-sealed, single-pitched slate-covered roof. The only potential access to this feature would be around lifted lead flashing where the roof meets the wall of the main building (**Photo 05**).

Photo 05 – showing the lifted flashing where the roof of the porch meets the wall – the gaps beneath the fascia/barge boards illustrated in Photo 02 are visible above.

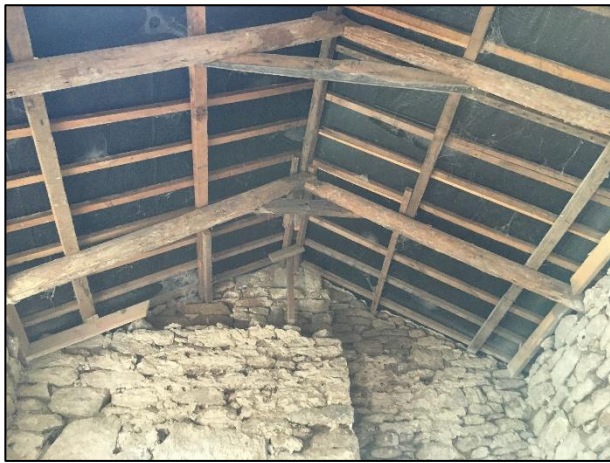
The roof is open to the rafters with no ceiling or loft void present. The roof is built around a wooden A-frame structure with wooden purlins and rafters, and a square wooden ridge beam. The joins between the timbers do not appear to offer roosting opportunities but could potentially be used for roosting by free-hanging bats. The roof is under-felted throughout and is generally in good condition with occasional tears.

Photo 06 – showing the interior of the building, open to the rafters and built around a wooden A-frame structure

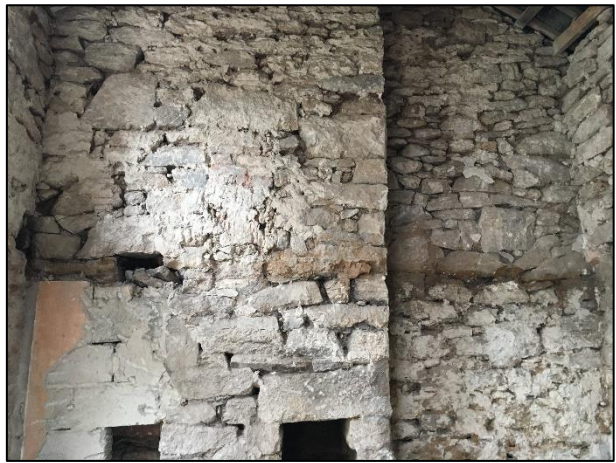
The interior walls throughout are open and largely un-finished with abundant gaps between the granite blockwork where pointing is absent. Internally, there are lintels above window and door frames which have gaps around them providing potential access to roosting opportunities associated with the walls.

Photo 07 – showing the unfinished interior walls with multiple gaps between stonework.

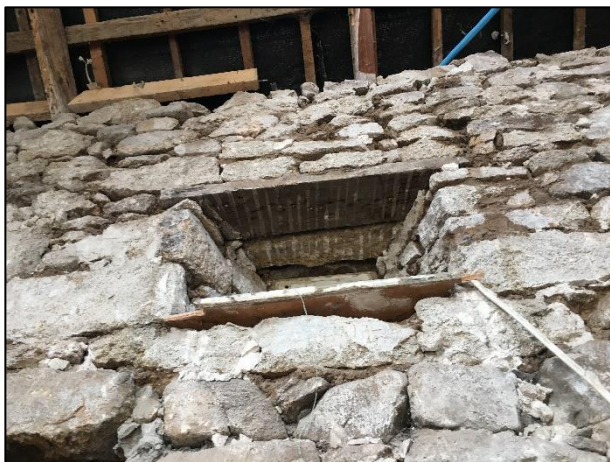
Photo 08 – showing gaps associated with lintels around a window frame

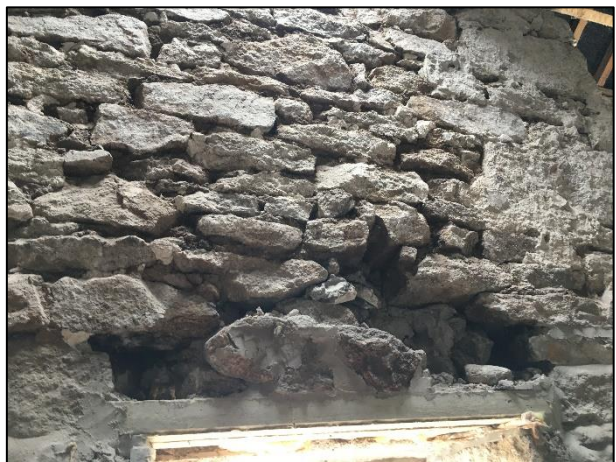
Photo 09 – showing gaps in the stonework internally.
