PERMISSION FOR DEVELOPMENT

Application No:	P/20/073/FUL	Date Application Registered:	28th September 2020
Applicant:	Mr S Mishra Gunner Rock 7 Jacksons Hill Hugh Town St Mary's Isles Of Scilly TR21 0JZ	Agent:	Mr B Coupe Courtney Cottage Fairfield Road Shroton Blandford Forum DT11 8QA
Site address:	Gunner Rock 7 Jacksons Hill Hugh Town St Mary's Isles Of Scilly		
Proposal:	Partial demolition, extension, elevation and interior changes to existing dwellings including replacement of existing UPVC windows and doors with aluminium.

PRELIMINARY ECOLOGICAL APPRAISAL & PRELIMINARY BAT ROOST ASSESSMENT OF:

GUNNER ROCK
7 JACKSONS HILL
ST MARY'S
ISLES OF SCILLY
TR21 0JZ

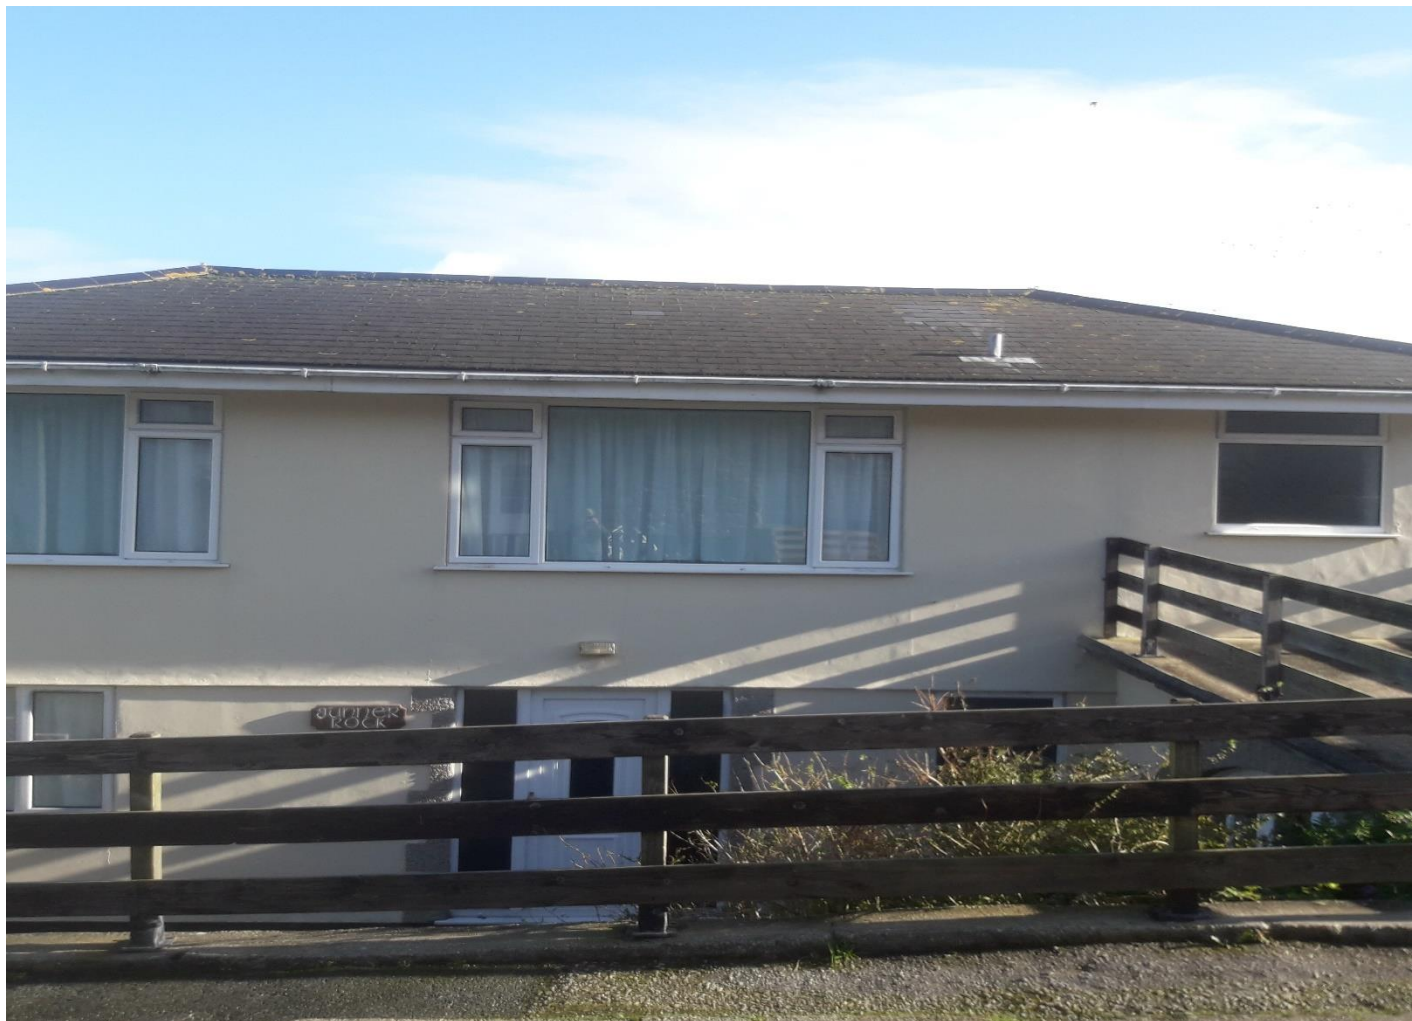
Photo 1. South-west elevation

The planning application (P/20/073) proposes a single storey extension of the south-west elevation, to include new access into the first floor; conversion below of the existing ground floor gym to an office and the replacement of some of the existing UPVc windows and doors on all the elevations to Aluminium (see Photo 1.)

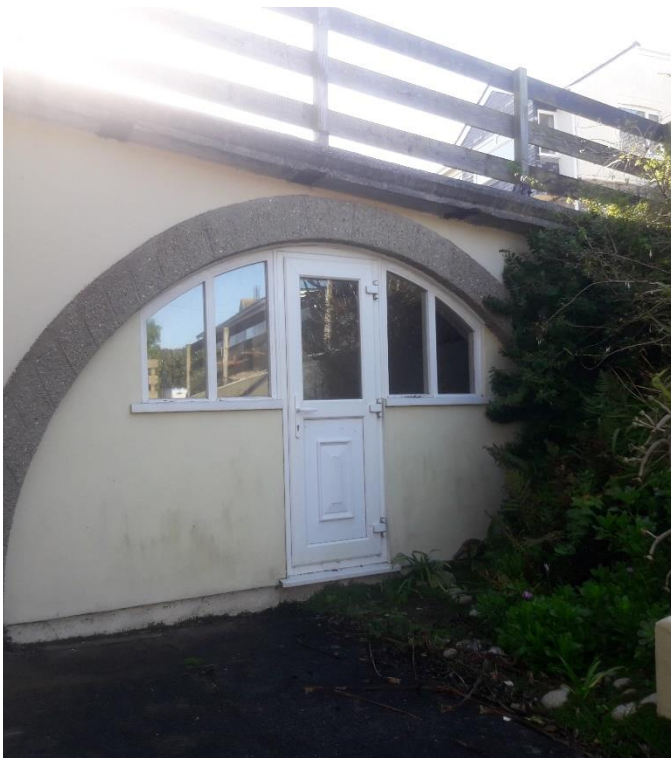
Photo 2. North-west elevation of ground floor gym fenestration

The conversion of the existing gym set on the ground floor below an existing car parking space revealed that

all render was in good condition throughout. Examination of the fenestration on the north-west and south-east elevations revealed no obvious gaps between the frames and the blockwork and examination of the arched lintel and the adjoining flat, concrete parking space above (which forms the roof) revealed no crevices, or voids which a bat could utilise as a roost. Furthermore, exterior security lighting above the existing front door on the south-west elevation and the side entrance on the south-east elevation would cause light-spill onto the gym's elevations, reducing the likelihood of use as a roost further (see Photo 2.).

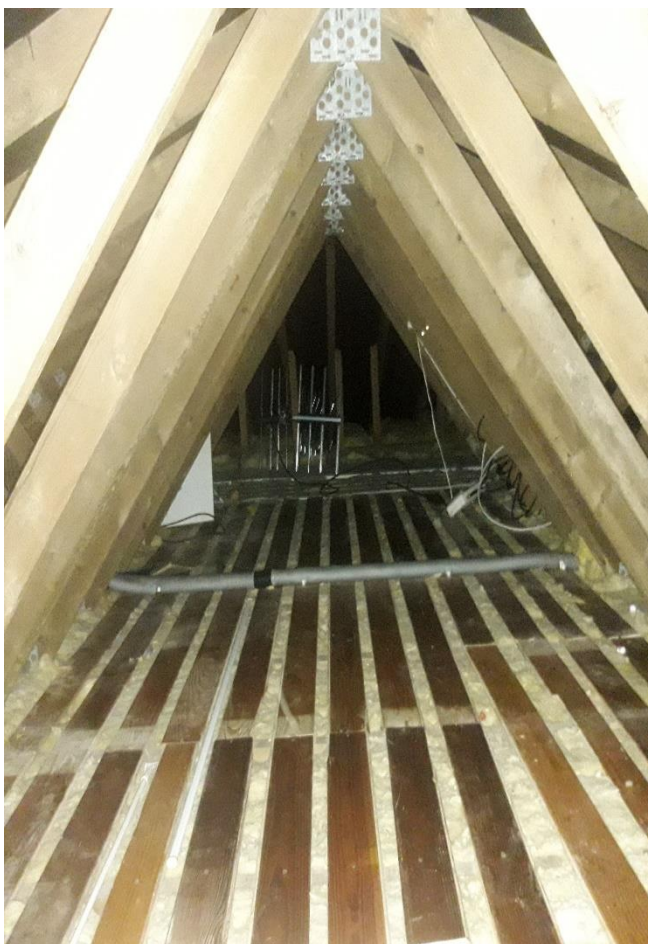
Photo 3. View of internal roof space and modern roof truss construction

The internal roof space is constructed in a modern 'fink' design, with square cut timber and butt joints, held together with metal roof truss straps (see Photo 3.). These modern joints and frame construction provide

no gaps wide enough for bats to utilise as a roost. No ridge board was present either, minimising perching opportunities for void-dwelling species such as Brown Long-eared Bat. The roofing membrane throughout was in good condition, presenting very limited roosting space for bats between the membrane and the roofing tiles above. Cobwebs were present on some, but not all the roof trusses and no small mammal droppings were recorded along the wall plates, the palisade floor, exposed loft insulation and the limited storage items in the roof space. A large fluorescent loft light was also present centrally, facing south-westwards which would illuminate this roof aspect extensively. However, the limited amount of storage items present would suggest disturbance in the loft space would be minimal.
